**HIGHWAYS AND DIRT ROADS AROUND
ITIRAPINA AND BROTAS, SÃO PAULO, BRAZIL**

**FINDINGS AND RECOMMENDATIONS BASED
ON A ROAD ECOLOGY EXCURSION OF THE
ESCOLA SUPERIOR DE AGRICULTURA LUIZ DE
QUIROZ (ESALQ), UNIVERSITY OF SÃO PAULO,
PIRACICABA, BRAZIL**

Dr. Marcel P. Huijser,
Western Transportation Institute – Montana State University
PO Box 174250, Bozeman, MT 59717-4250, USA

August 2015

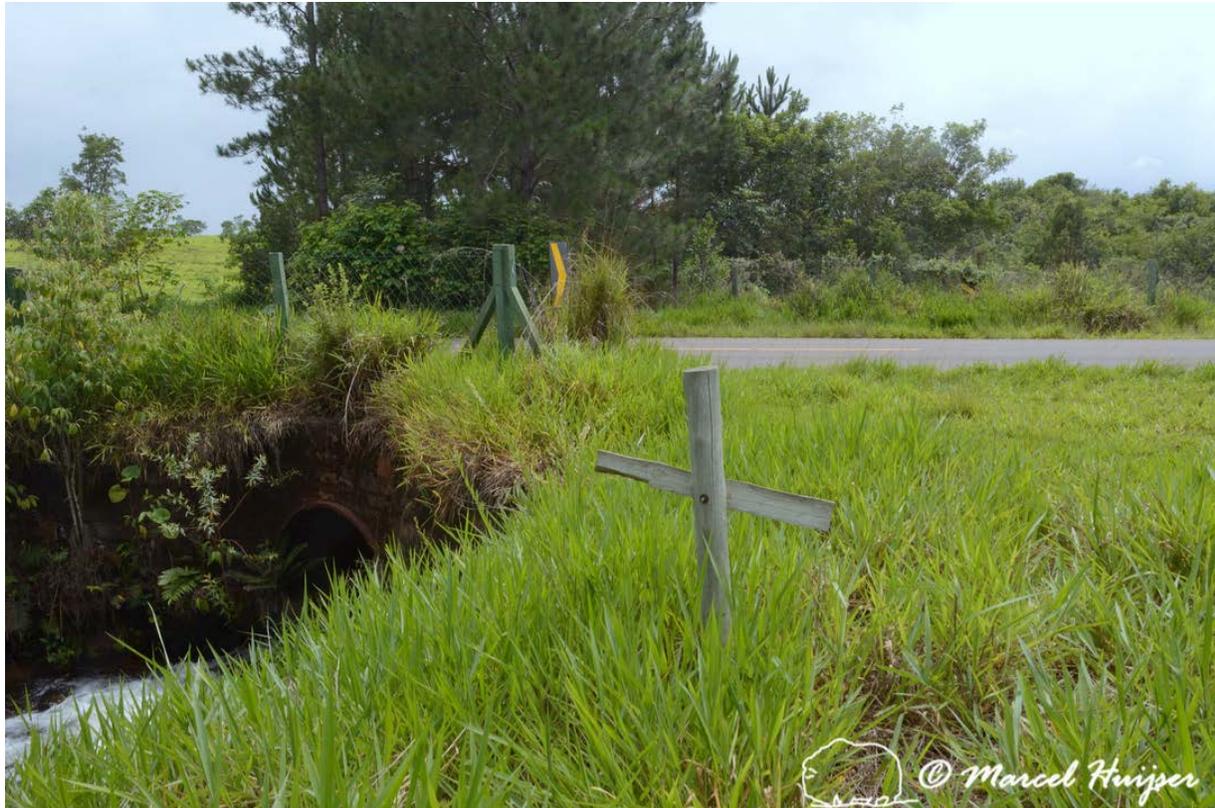
Figure 8: Cross marking the location of a human fatality as a result of a collision with a capybara (*Hydrochoerus hydrochaeris*), northern stream crossing (Córrego do Geraldo), Itirapina Ecological Station, São Paulo, Brazil.

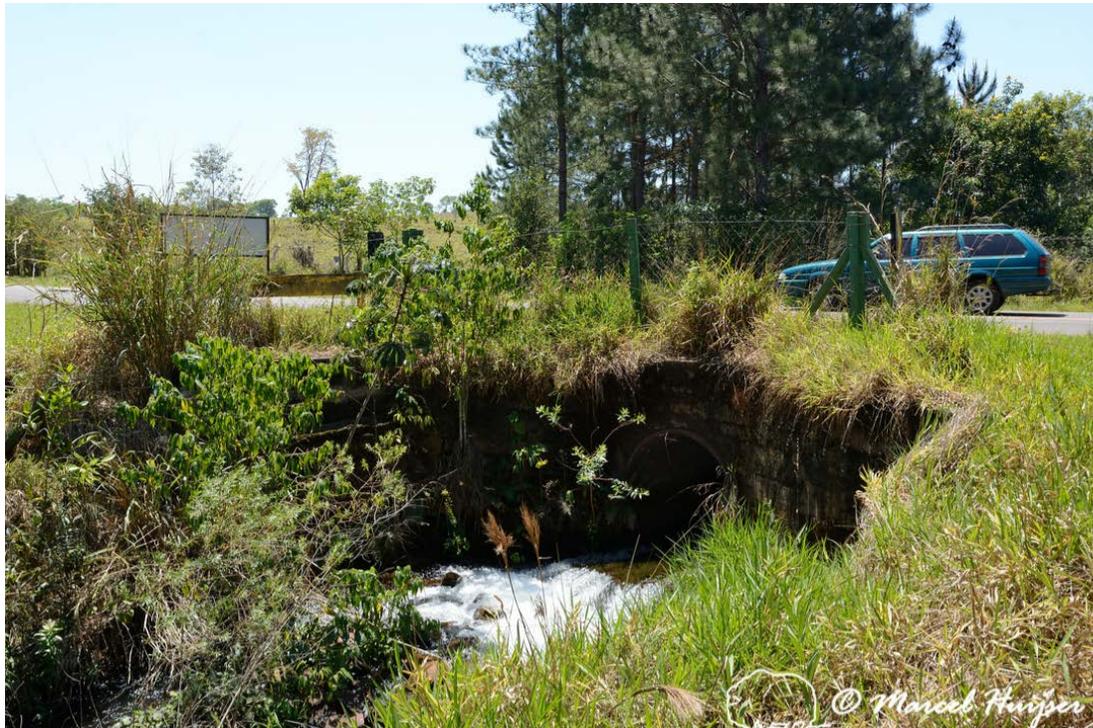
The culvert (northern stream crossing) does not allow for similar stream characteristics in the structure compared to upstream and downstream (Figure 12). The diameter of the culvert is narrower than the stream bed which results in consistently high water velocity throughout the culvert. This is likely to be a barrier to many aquatic species. Furthermore, there is no semi-aquatic or terrestrial habitat inside the culvert at all. Finally, there is a short section of wildlife fencing presumably for capybara, on both sides of the road. (Figure 12-13). However, the fence length is insufficient as is illustrated by the presence of a wildlife trail – presumably from capybara - on the south-east side of the culvert (Figure 13).

Figure 12: Stream culvert (northern stream crossing, Córrego do Geraldo) under two lane road, Itirapina Ecological Station, São Paulo, Brazil. Note the fence that only extends above the retaining wall associated with the culvert.

1. Provide a larger structure that is wider than the stream. Ideally the structure is "bottomless" (e.g. a bridge) so that the stream characteristics inside the structure are similar to those upstream and downstream of the structure.

2. Allow for sufficient space in the structure to also provide semi-aquatic and terrestrial habitat (e.g. at least a 2 m wide dry zone) (Huijser & Ferraz, 2015).

3. Make the structure tall enough (e.g. 3-5 m high) to allow for large mammals (e.g. capybara) to cross through the structure (Huijser & Ferraz, 2015).

4. Extend the fencing at least a few hundred meters on both sides of the structure if capybara are the target species (capybara tend to stay close to streams). Habitat generalists such as the maned wolf may require additional structures away from streams and much longer road sections with wildlife fencing (at least several kilometers long) and associated safe crossing opportunities.

5. Design the fence (e.g. height) based on the requirements for the target species. The strength, the jumping, climbing, or digging abilities of the target species should form the basis for the design of an effective fence.

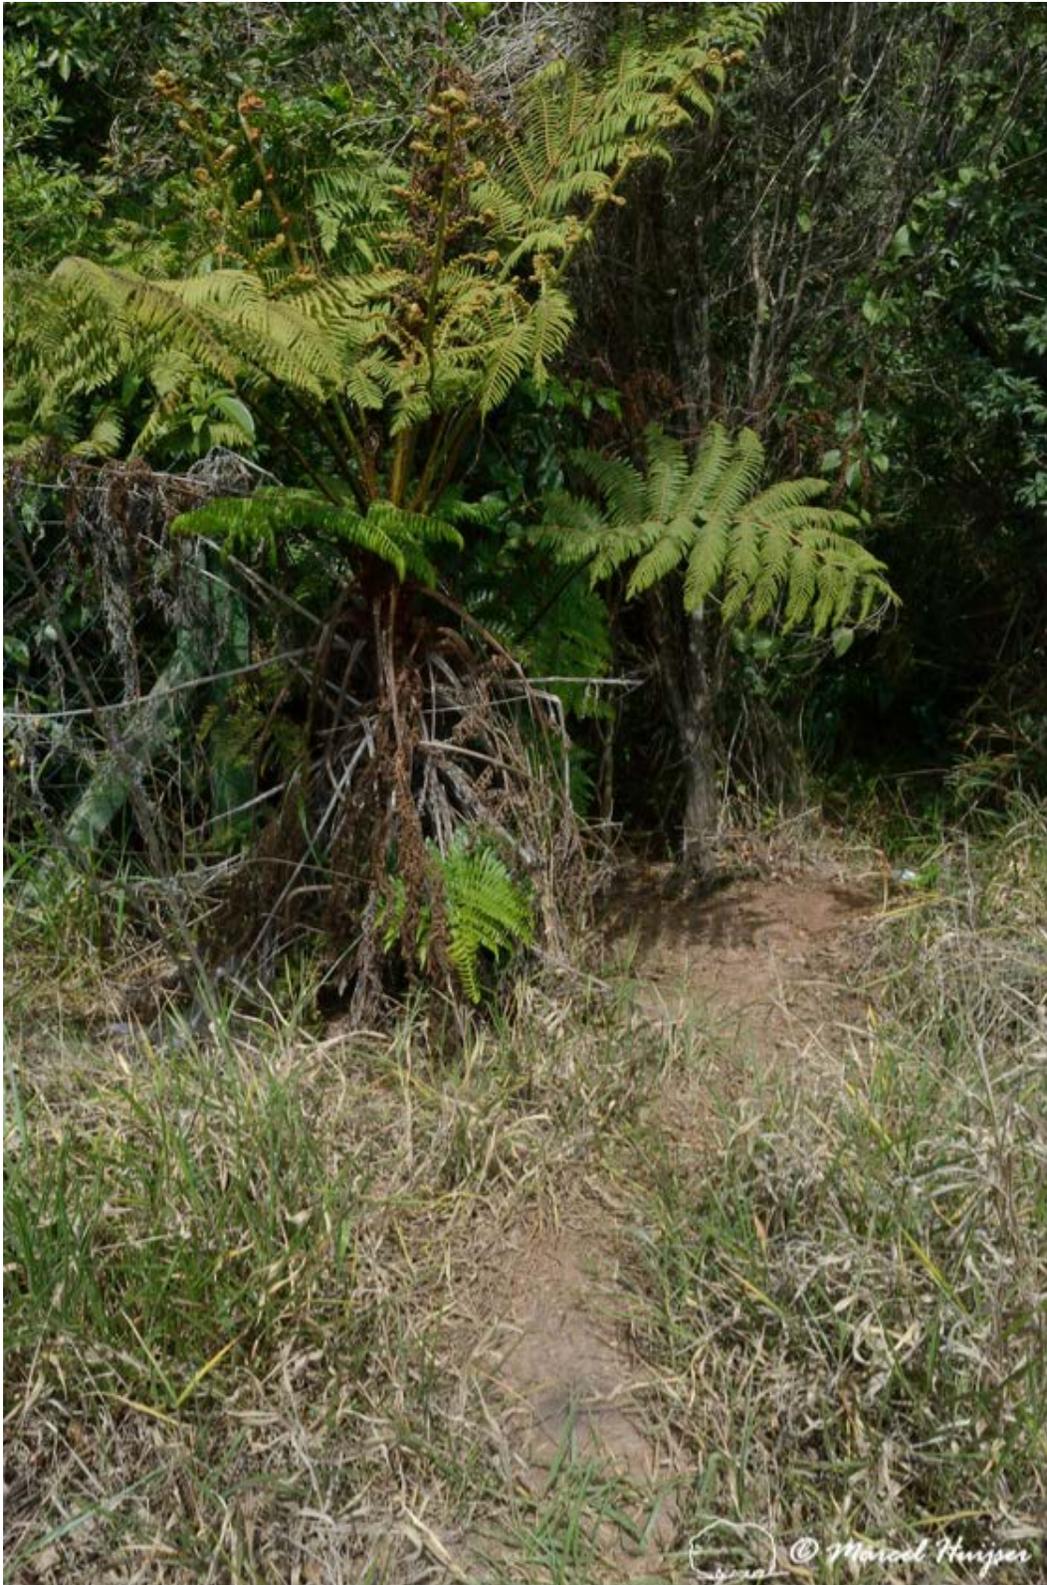
Figure 13: Wildlife trail (probably mainly used by capybara) at fence end of northern stream crossing (Córrego do Geraldo) leading to the two lane road, Itirapina Ecological Station, São Paulo, Brazil. Note the fence coming in from the left and ending at the tree fern.

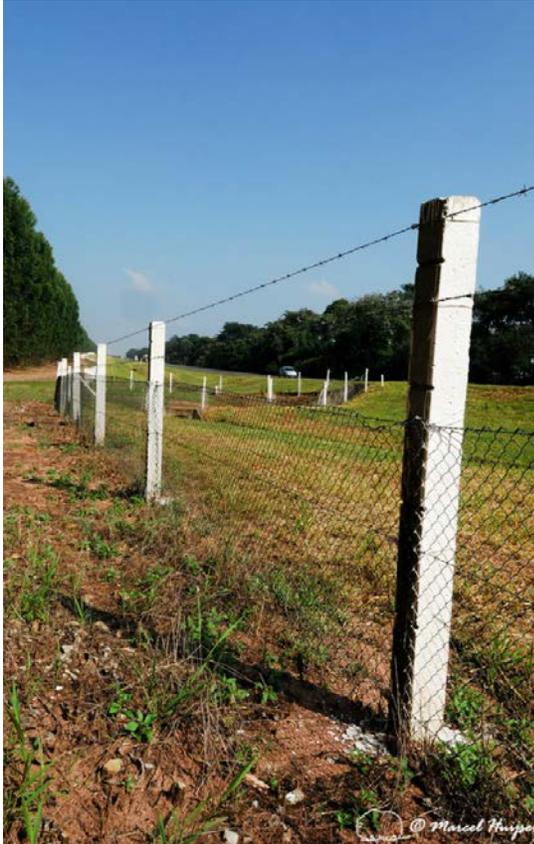
The wildlife fencing along the SP-225 appears to not have been designed with specific wildlife species in mind. It is essentially a livestock fence (similar height as a livestock fence) with chain-link attached to the posts instead of barbed wire (Figure 16), though this design has not been consistently implemented (Figure 17). Since capybara (*Hydrochoerus hydrochaeris*) is one of the most commonly hit large mammal species in this region, capybara can be expected to be one of the target species. However, capybara may require 1.80 m high fencing; much higher than standard livestock fencing.

Figure 16: “Wildlife” fence that is basically a livestock fence with chain-link attached to the lower portions of the fence posts, along SP-225, near Brotas, São Paulo, Brazil.

3. Base the design of wildlife fence on the biological characteristics of the target species.
4. Use material (fence posts, fencing material) that is consistent with the desired lifespan of the fence.

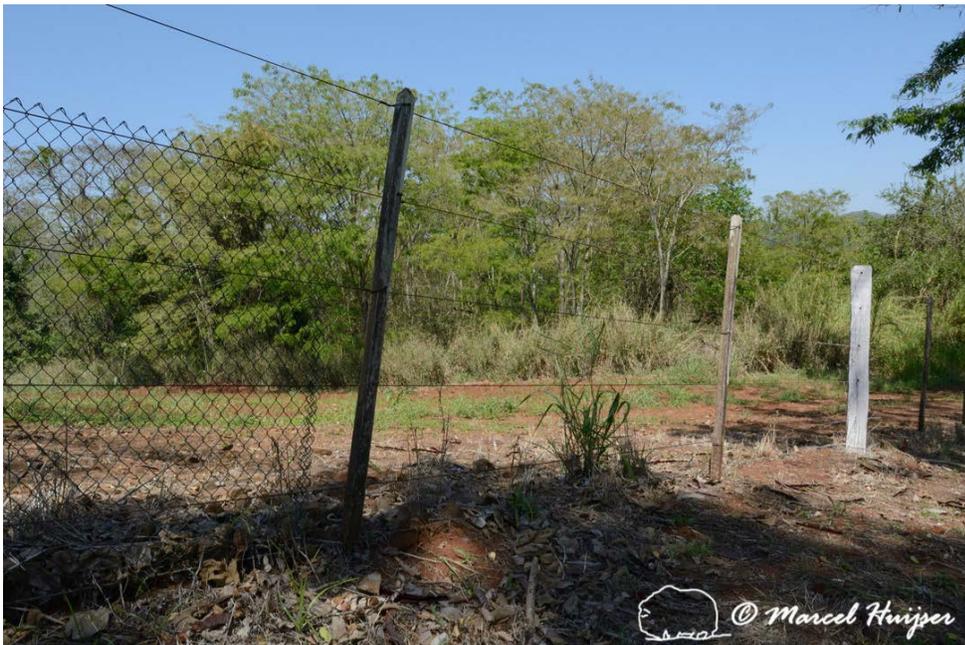
Figure 17: Inconsistent wildlife fencing with a more permeable fence closer to a multifunctional structure (there is a bridge across a river a few hundred meters further on the right), along SP-225, near Brotas, São Paulo, Brazil.

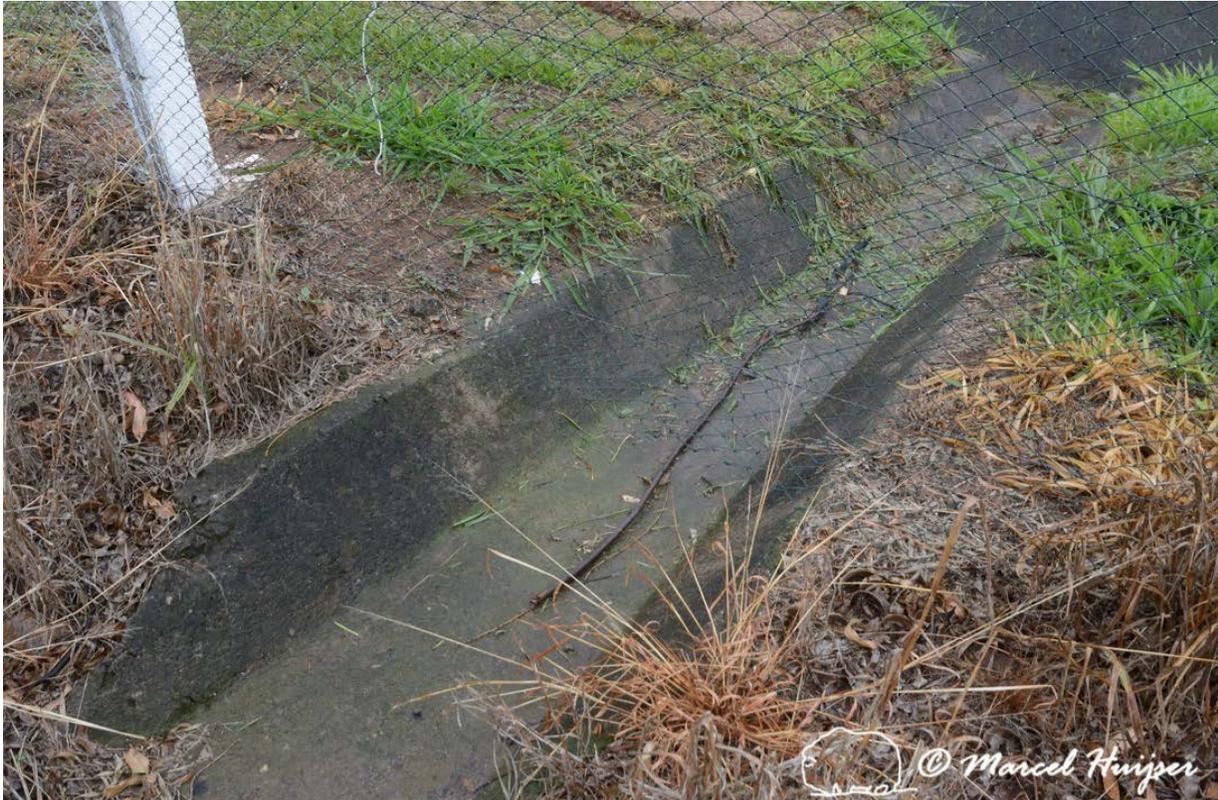
During the installation of wildlife fencing care should be taken not to leave gaps between the ground and the bottom of the fence (Figure 18), and, dependent on the target species and their climbing abilities, a wildlife fence should typically maintain a certain minimum distance from trees and shrubs, including overhanging branches. Constructing a wildlife fence away from shrubs and trees also reduces fence maintenance (e.g. no fallen branches or trees that can damage the fence), and it allows for easy access to repair the fence in case damage – regardless of the cause - has occurred. On the other hand a fence that is positioned close to shrubs or trees may not impact landscape aesthetics as much as a fence that is positioned further away from shrubs and trees.

Figure 18: If medium mammal species are among the target species, care should be taken that the design of the wildlife fence does not result in gaps. In this case a concrete gutter for drainage goes under the wildlife fence and leaves a gap where medium mammal species can crawl under the fence and access the fenced road corridor, along SP-225, near Brotas, São Paulo, Brazil.

5. Oversee fence installation to make sure no gaps or other weak points in the fence result.
6. Implement fence maintenance programs, including for fallen trees and vines and other vegetation growing on and over fences, (e.g. include maintenance requirements in contracts with toll road companies). Without fence maintenance wildlife fences typically become dysfunctional quickly. Currently, most of the wildlife fencing along the SP-225 has serious design, construction and maintenance issues.

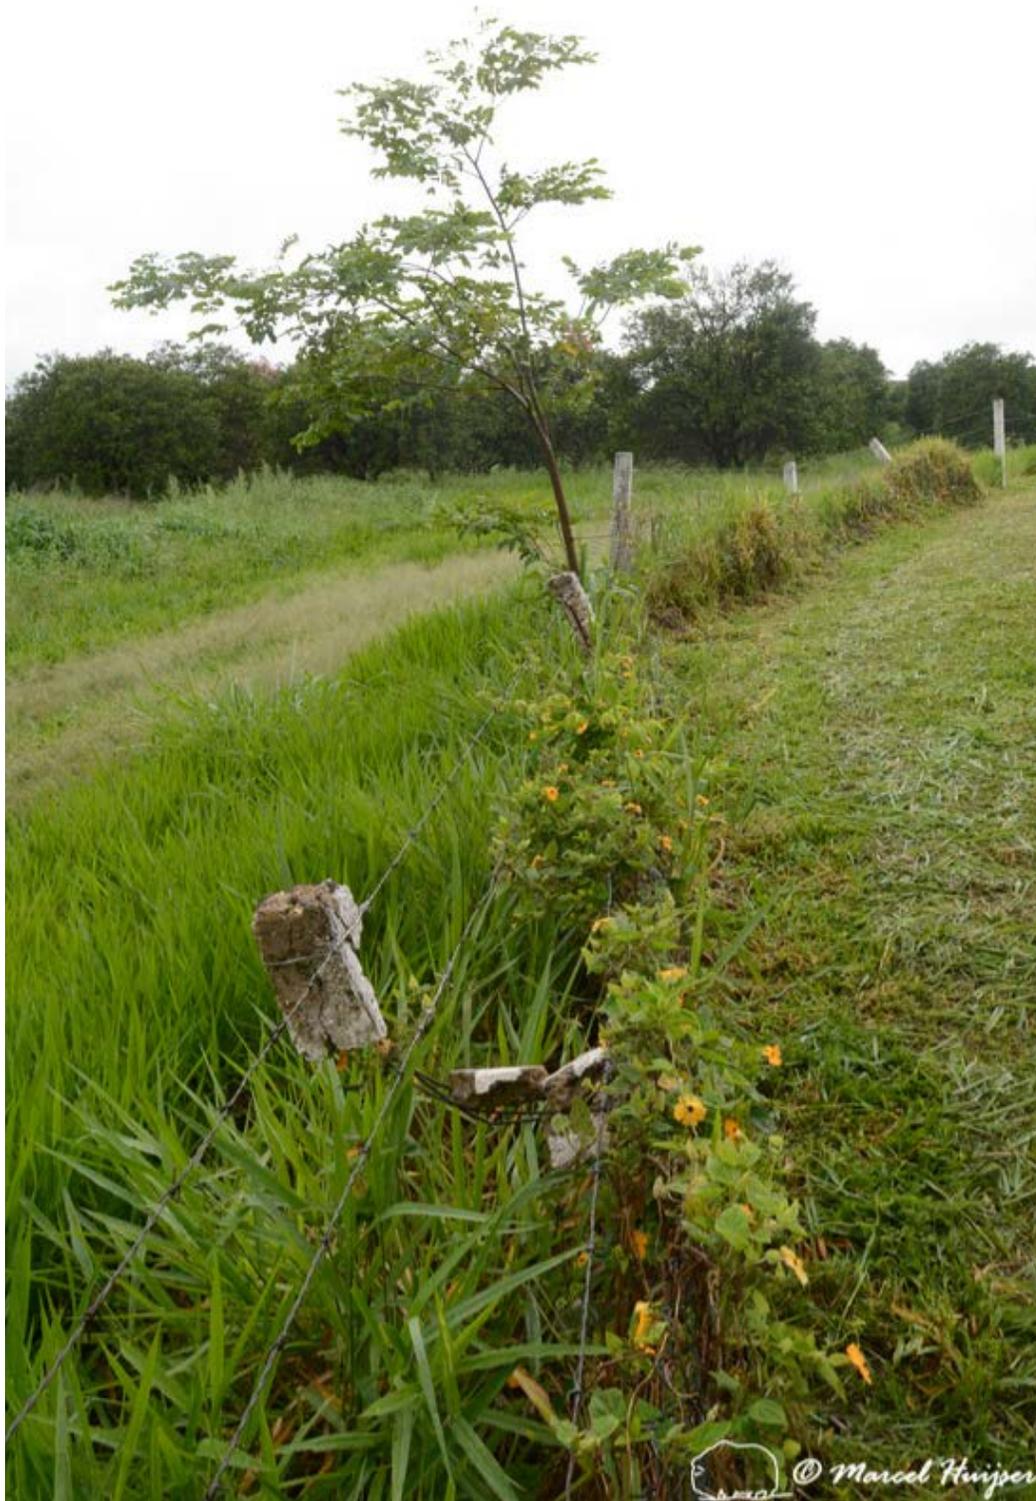
The integrity of a wildlife fence can be affected by abiotic and biotic factors. Abiotic factors can include time affecting the material (e.g. crumbling of concrete (Figure 19) or rust) and physical impacts (e.g. erosion etc.). Biotic factors can include wildlife species and humans creating gaps under or in the fence (Figure 20-23).

Figure 19: Disintegrated fence posts of a “wildlife fence” overgrown with vines (i.e. this is essentially a livestock fence with chain-link attached to the lower portions of the fence posts), along SP-225, near Brotas, São Paulo, Brazil.

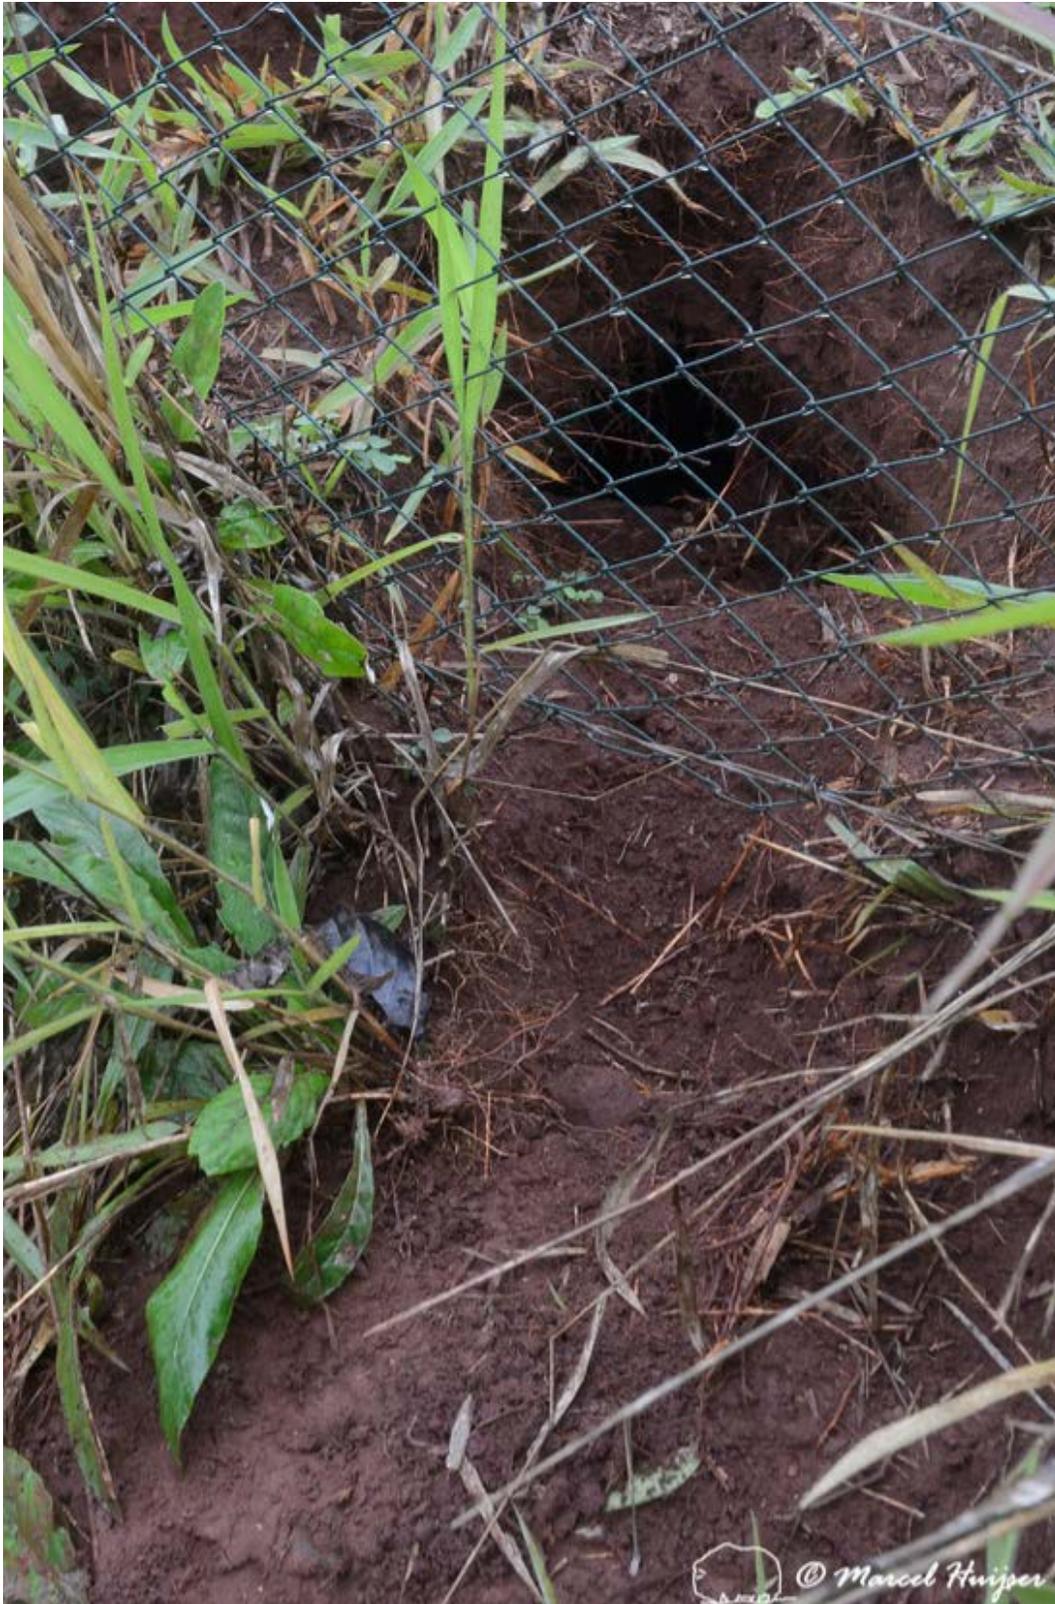
Figure 20: An animal (likely a nine-banded armadillo (*Dasyus novemcinctus*)), has dug under the fence and made its burrow on the road side of the fence in the fenced road corridor.

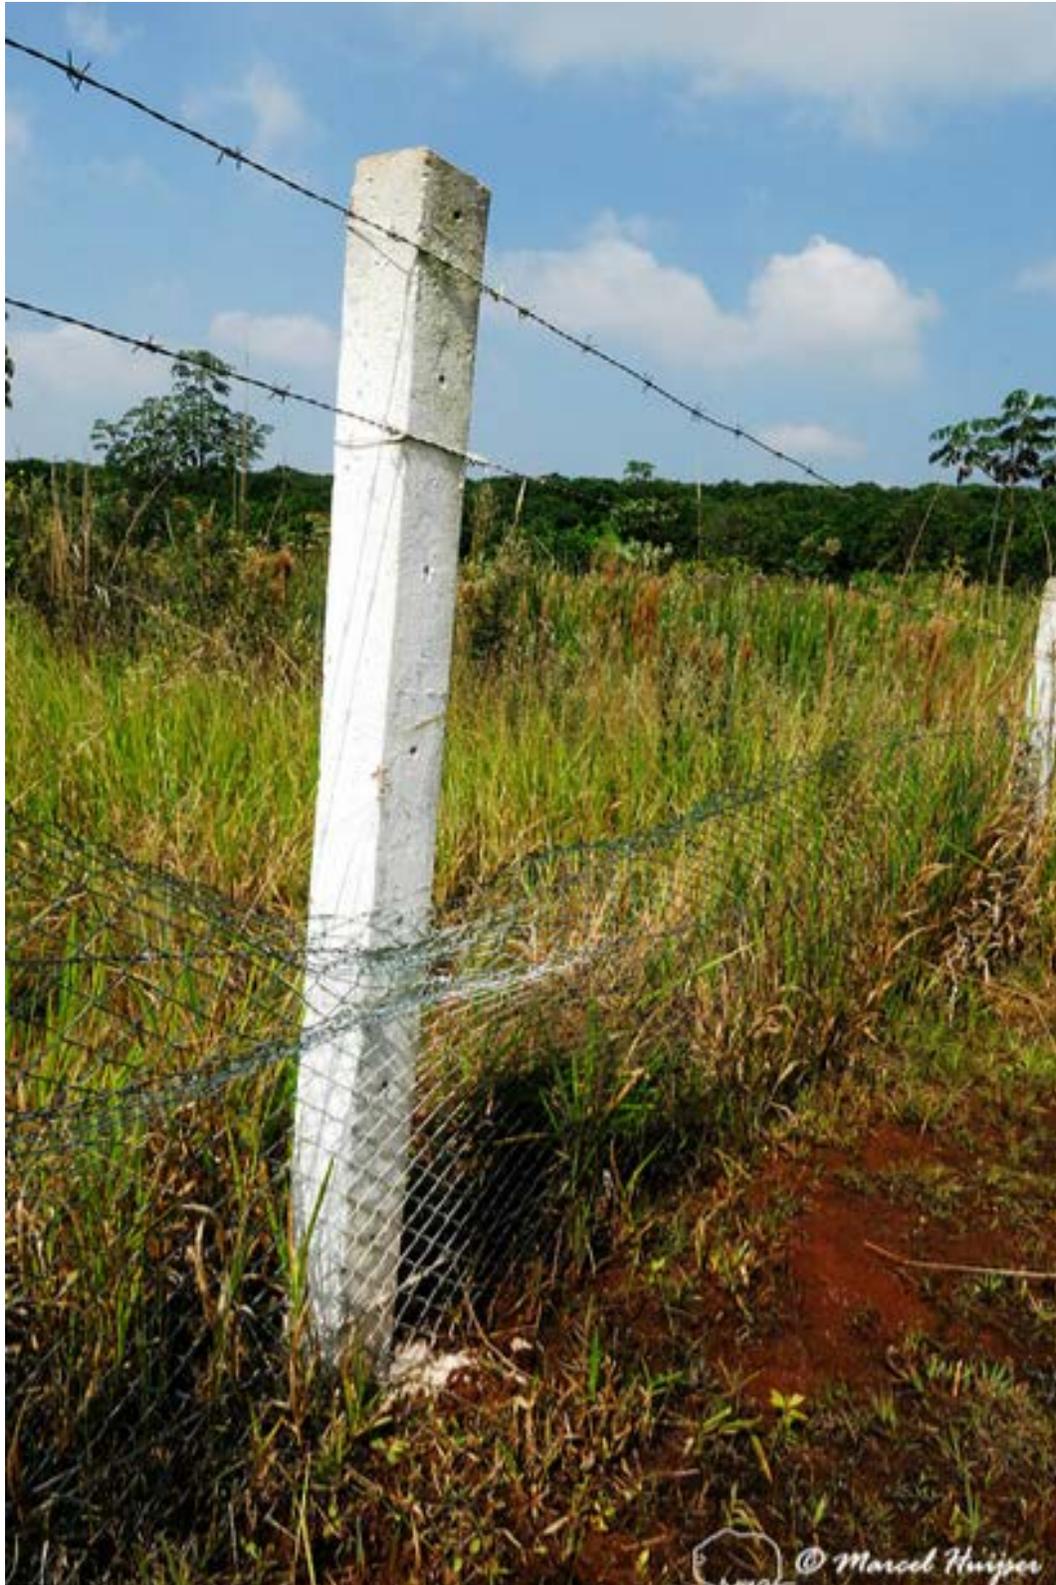
Figure 21: Damaged “wildlife fence” (i.e. this is essentially a livestock fence with chain-link attached to the lower portions of the fence posts), probably because animals have pushed down the chain-link to access the fenced road corridor, along SP-225, near Brotas, São Paulo, Brazil.

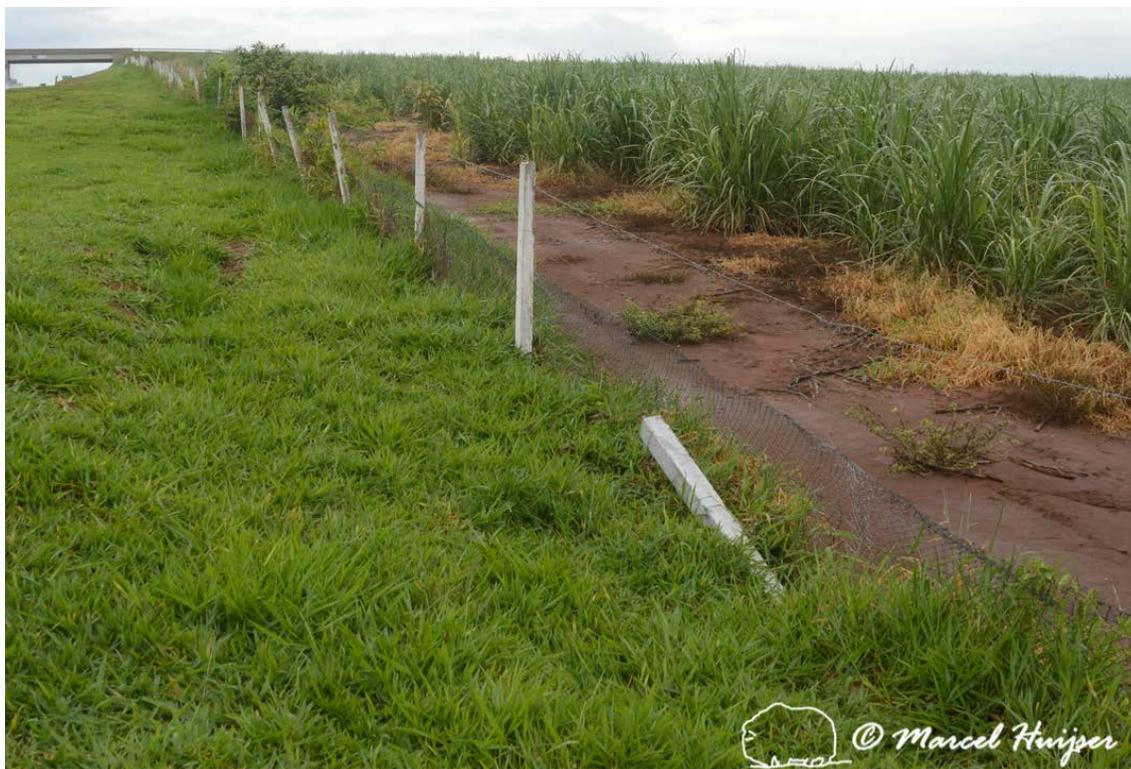
Figure 22: Damaged “wildlife fence” (i.e. this is essentially a livestock fence with chain-link attached to the lower portions of the fence posts), along SP-225, near Brotas, São Paulo, Brazil.

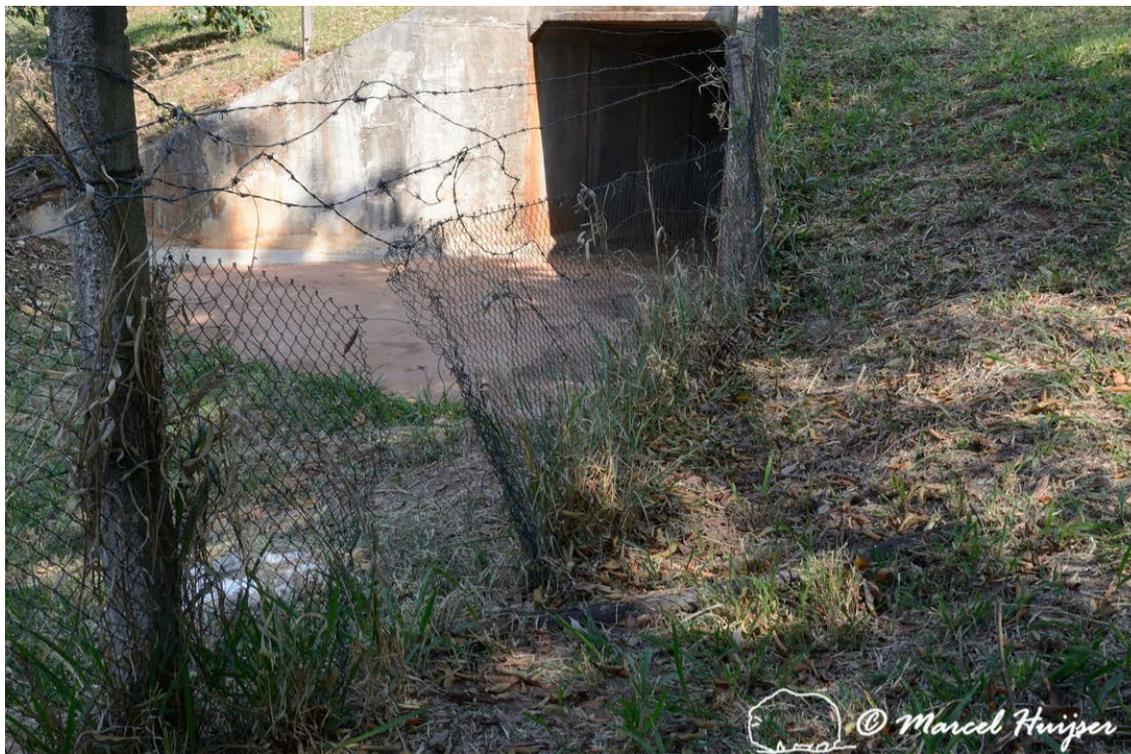
Figure 23: Gap in wildlife fence in median next to wildlife underpass, SP-225 motorway, São Paulo, Brazil.

one large mammal crossing opportunity once every 2 kilometers, make the wildlife fencing connect to the wildlife structures without gaps in between.

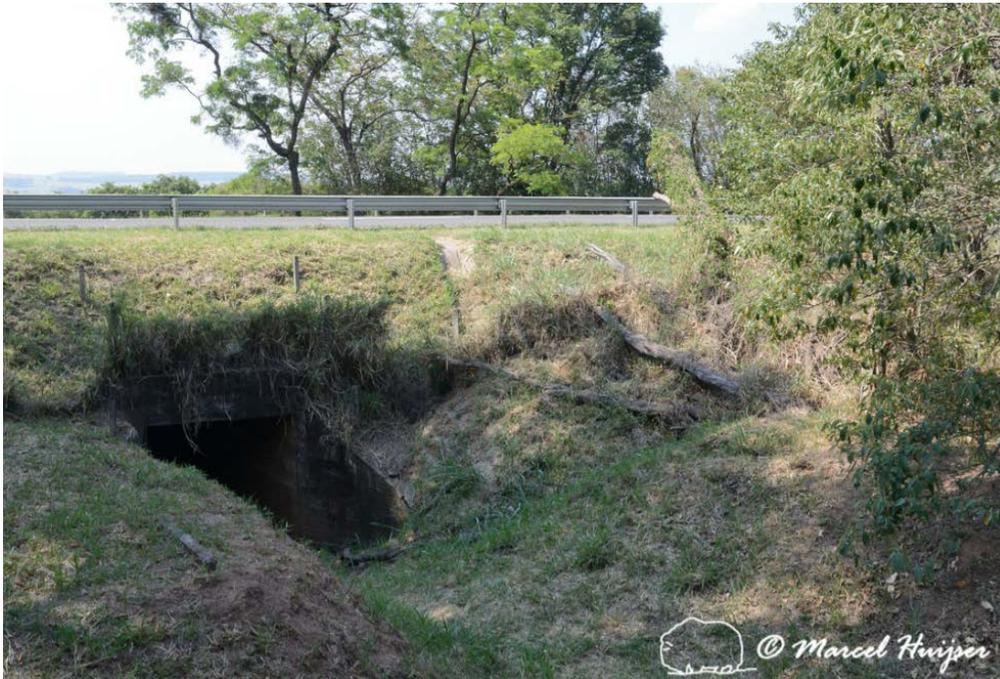
It is best to construct wildlife crossing structures in such a way that it allows wildlife that approaches the road to see the sky and vegetation on the other side of the road through or across the structure. This means that the approach for wildlife should preferably be level (avoid steep slopes at the approaches (e.g. Figure 25-26)), and that two separate structures for the two travel directions should be designed as one wildlife crossing structure with a good line of sight for wildlife.

Figure 25: Wildlife underpass (concrete box culvert), along SP-225, near Brotas, São Paulo, Brazil. Note: this structure is along the “old” highway (now only one travel direction). The “new” two lanes are behind the photographer and are for traffic going in the other direction. However, the “new” roadbed is higher than the old roadbed, and the structure in the “old” highway is substantially lower than the structure under the new roadbed. This does not allow wildlife to see through both structures when they approach the highway, and it requires wildlife to descend into a dark cave (when coming from this direction).

9. Create a very gradual, preferably level, approach for wildlife when approaching wildlife crossing structures. Avoid steep slopes (uphill or downhill), allow wildlife to see the sky and vegetation through or across the structure.

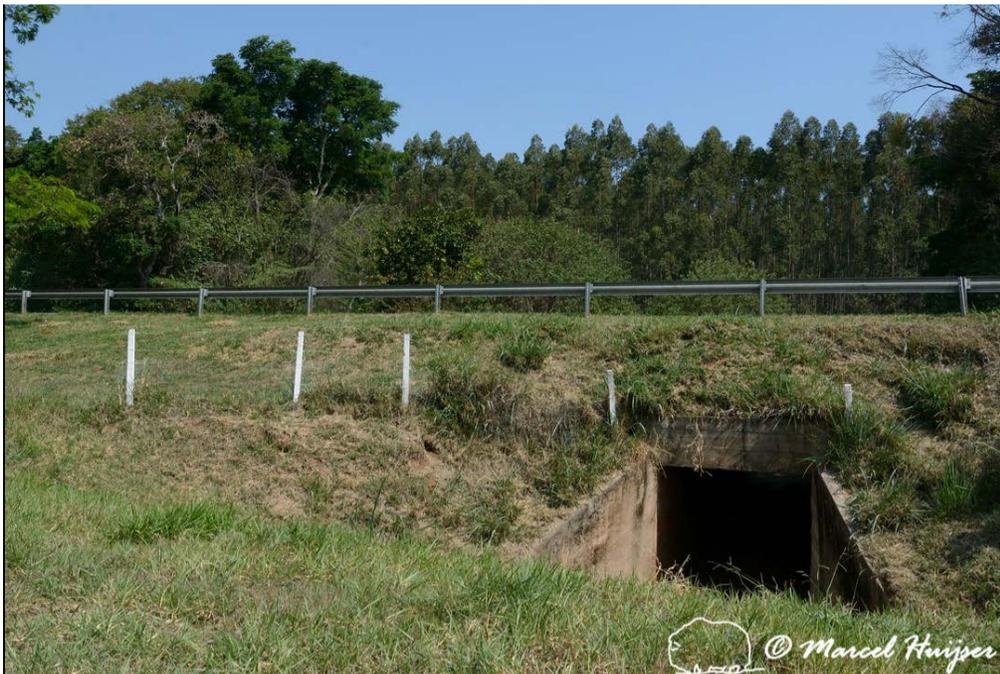
Figure 26: Wildlife underpass (concrete box culvert) that is not visible to wildlife until they are really close to it, along SP-225, near Brotas, São Paulo, Brazil.

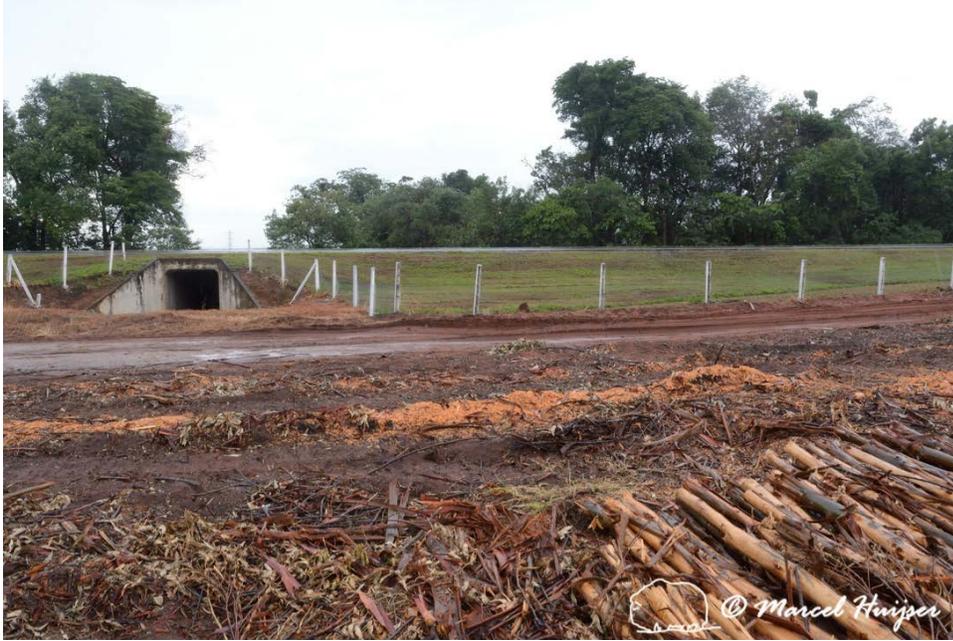
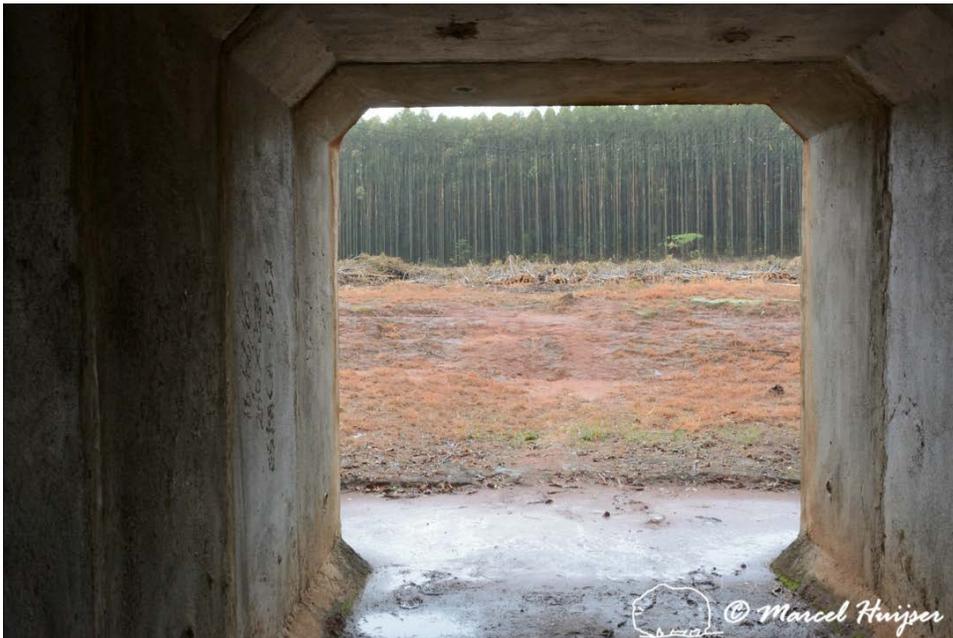
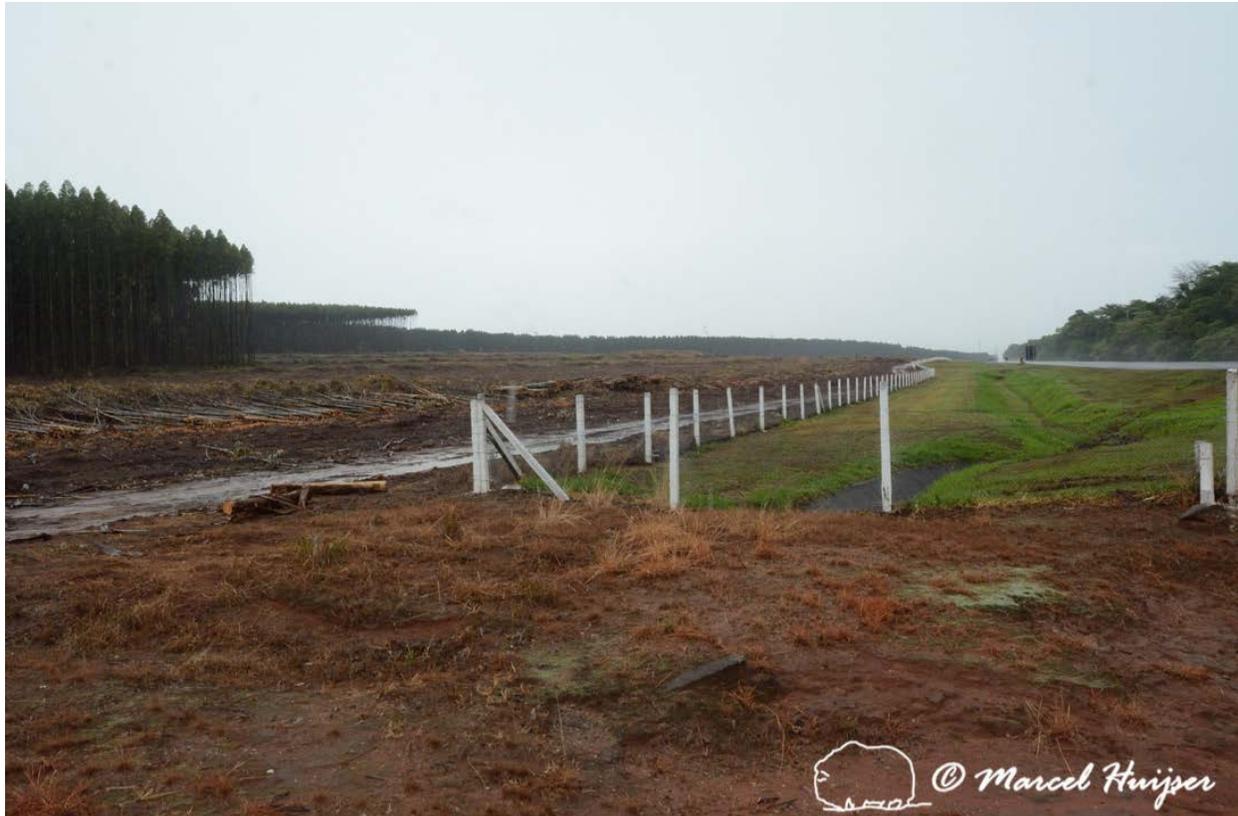
The decision process on where to locate safe crossing opportunities for wildlife should ideally include land use planning to ensure that good wildlife habitat continues to be present leading up to the structures. Otherwise one may run the risk that the habitat, specifically cover, leading up to the structures is destroyed and that the wildlife use of the structure is reduced (Figures 27-29).

Figure 27: Freshly cut eucalyptus plantation next to a wildlife underpass, SP-225, near Brotas, São Paulo, Brazil.

Figure 28: Freshly cut eucalyptus plantation next to a wildlife underpass, SP-225, near Brotas, São Paulo, Brazil.

Figure 29: Freshly cut eucalyptus plantation next to a wildlife underpass, SP-225, near Brotas, São Paulo, Brazil.

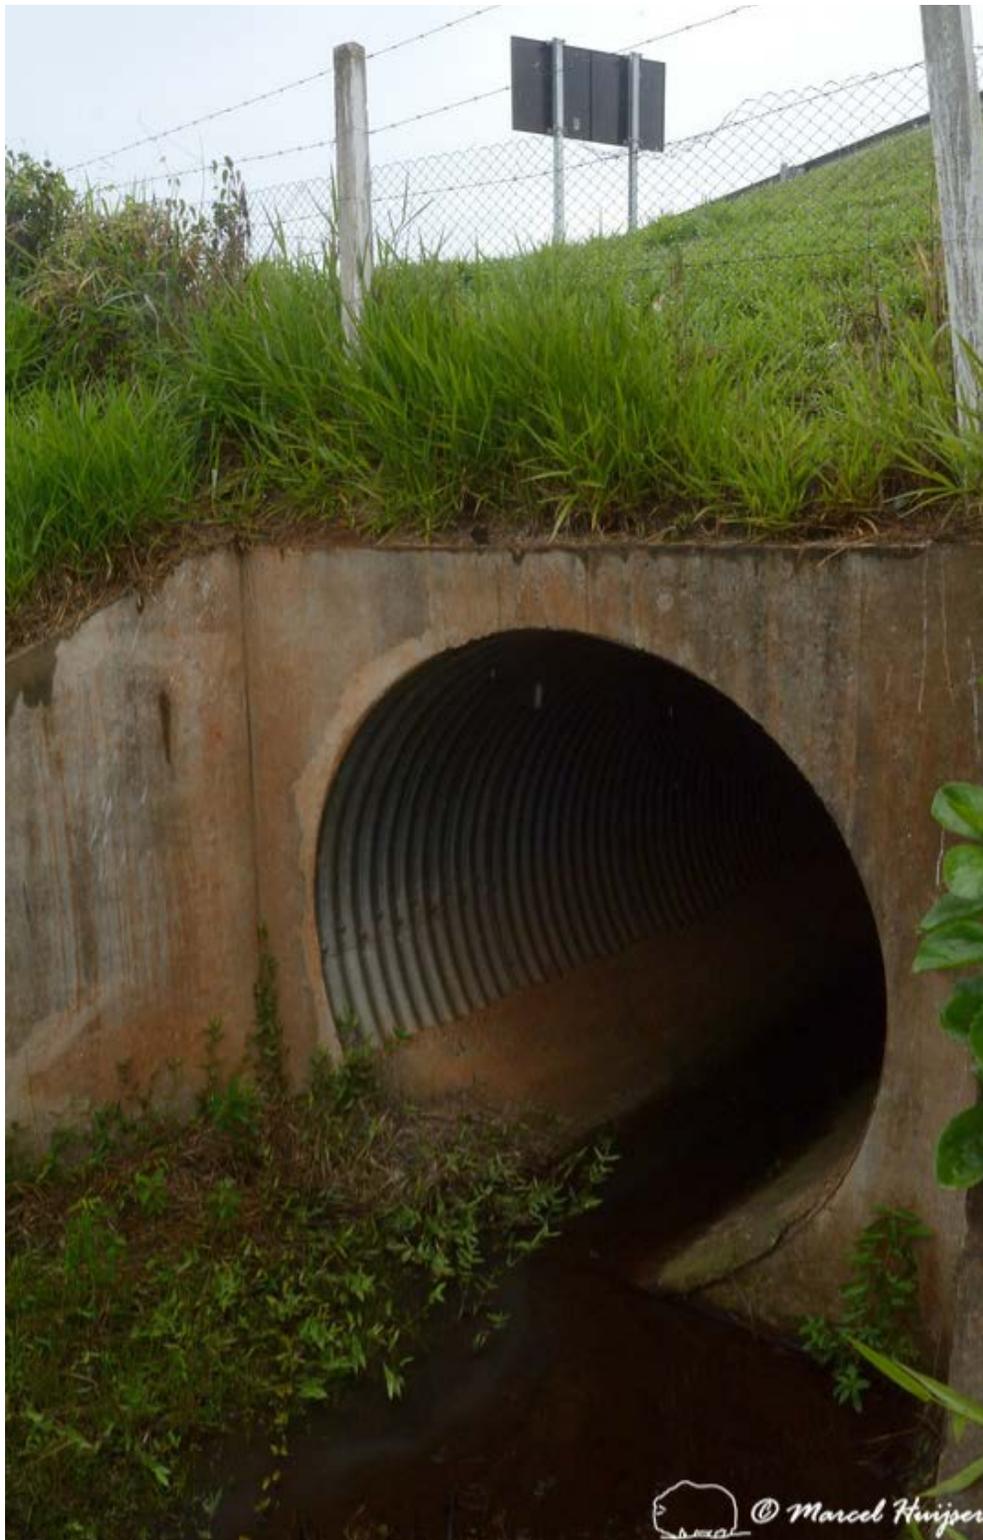
Figure 30: Culvert for hydrology that is also used by wildlife (including capybara), along SP-225 motorway, near Brotas, São Paulo, Brazil. Note that it would be better to have a “bottomless” culvert or bridge to mimic the stream characteristics upstream and downstream of the structure. Furthermore, it would be better if semi-aquatic and terrestrial habitat would also be provided for inside the structure.

1. At stream and river crossings, do build structures that provide space for aquatic, semi-aquatic and terrestrial species. Note that this also reduces the risks for failed structures and failed roadbeds during periods with high precipitation.

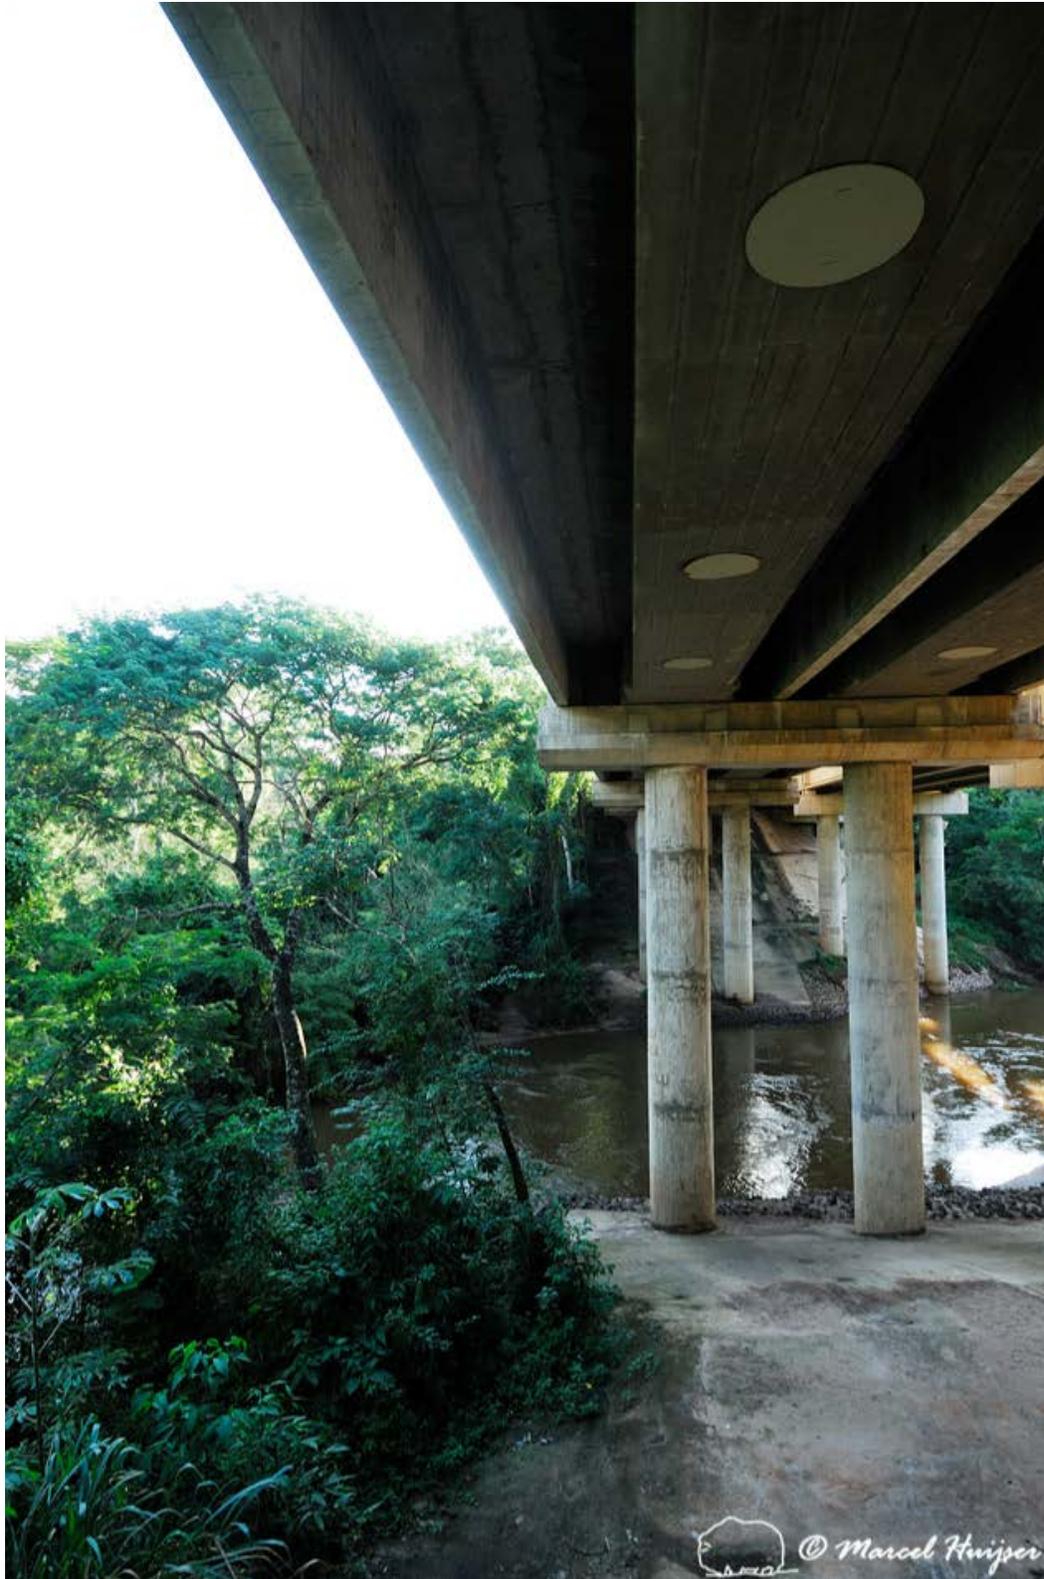
Figure 31: Multifunctional underpass (bridge) along Rio Jacaré-Pepira, SP-225 motorway, Brotas, São Paulo, Brazil. Note that it would be better to have natural surface (soil, rocks) and vegetation under the structure instead of smooth concrete.

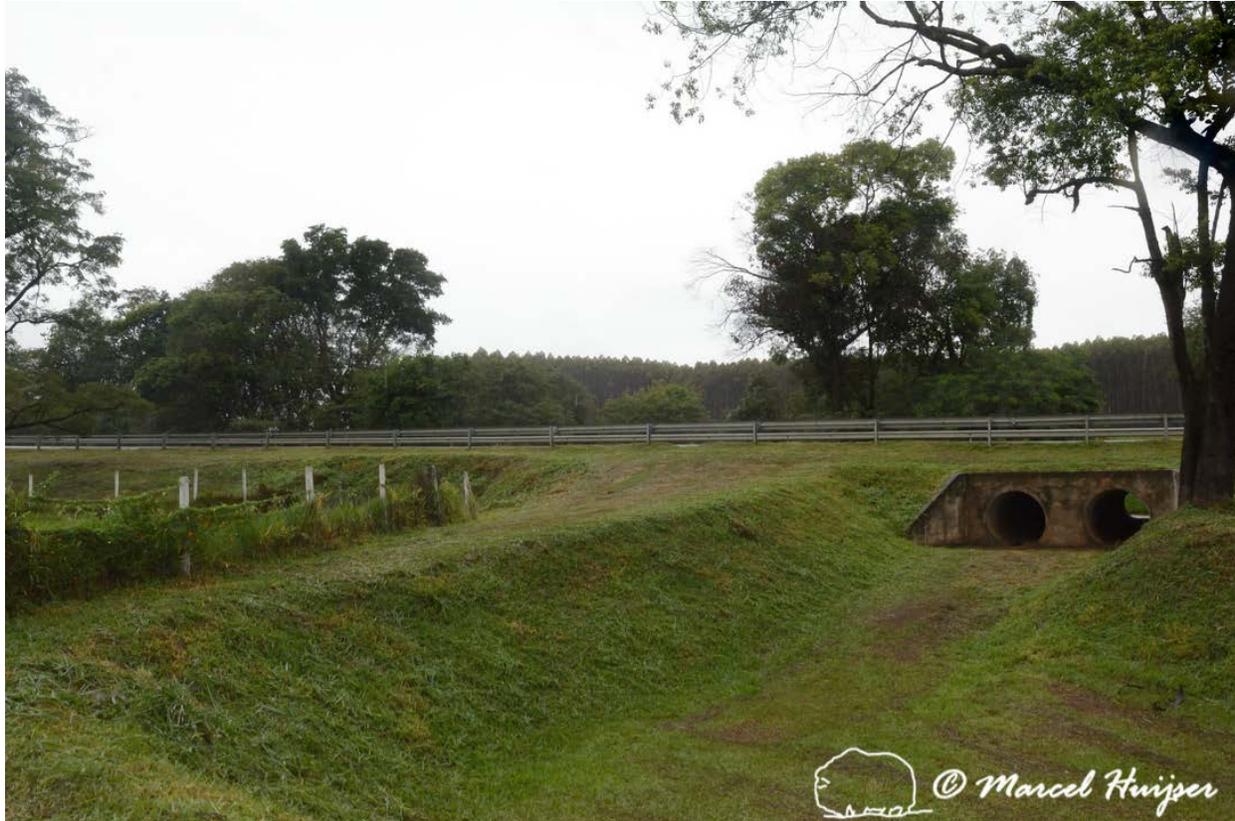
Regardless of any modifications to a structure, the wildlife fencing needs to connect to a multifunctional underpass to allow wildlife to access the structure. However, in some cases along the SP-225, the wildlife fencing bypasses culverts intended for hydrology (Figure 32), essentially preventing wildlife from accessing the culverts.

Figure 32: Culverts for hydrology that are inside the fenced road corridor, SP-225, near Brotas, São Paulo. If wildlife fencing is tied into the structure, the culverts can also be used by wildlife. Currently the wildlife fencing prevents wildlife from accessing the culverts. Note that it would be better for wildlife to have one large structure rather than two separate parallel culverts.
