Wildlife-Vehicle Collision and Crossing Mitigation Measures: A Literature Review for Blaine County, Idaho

Marcel P. Huijser, PhD, Research Ecologist and
Angela V. Kociolek, MSc, Research Associate

Western Transportation Institute
College of Engineering
Montana State University

May, 2008

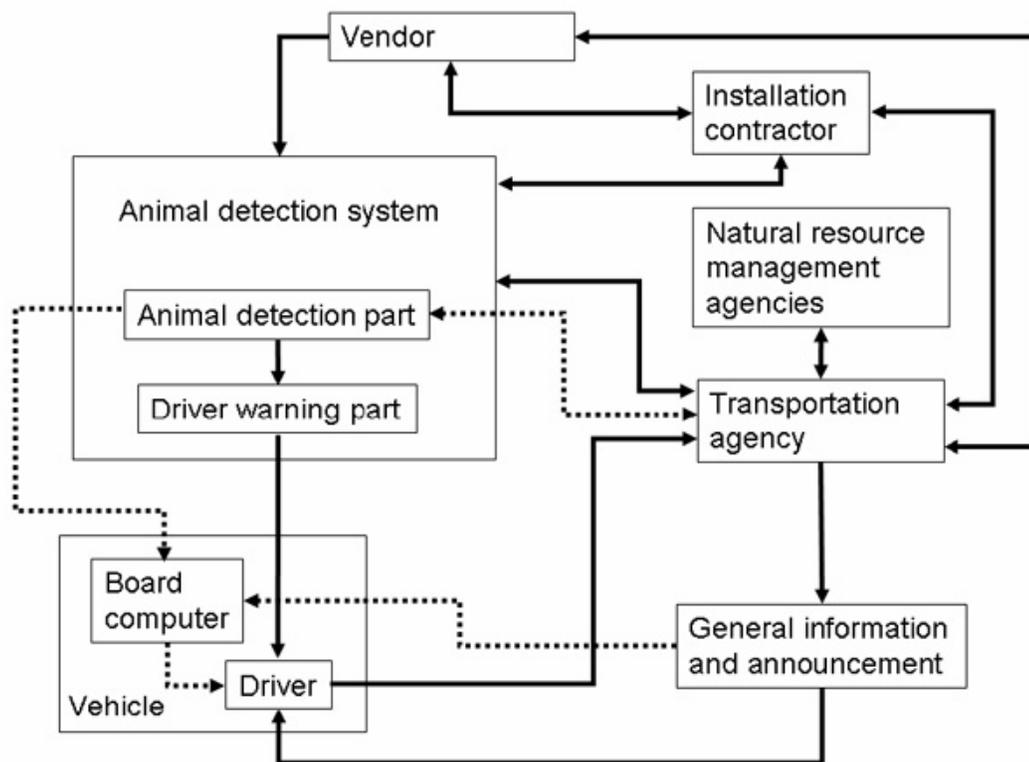
Figure 1: Concept of Operation.

A road-based animal detection system consists of two parts: the part that detects large animals as they approach the road, and the part that warns the drivers after detection has occurred (Figure 1). A transportation agency or natural resource management agency usually takes the initiative for site and species specific mitigation measures. Site selection is often based on accident reports and road-kill data for large animal species. The transportation agency and natural resource management agencies then decide on the appropriate approach; in this case an animal detection system. After a vendor is selected an animal detection system is designed, built and delivered by the vendor. An installation contractor then puts the system in place. Once the system is installed and working according to the agreed upon specifications, the transportation agency may operate and maintain the system. In some cases natural resource management agencies may assist with checking up on the system. Currently most systems have to be checked at the site regularly to verify that the system is indeed operating correctly. In some cases there is remote access to the detection data and system diagnostics through land-based phone lines, or cell or satellite phone. There may also be algorithms in place that screen the data continuously for unusual patterns that may indicate that there is a problem with the system or parts thereof. Once a problem with the system is detected a person may be notified through an automated system. Figure 1 shows the concept of operations for animal detection systems. Arrows indicate direction of output and processes. Solid lines indicate output and processes that exist already. Dotted lines indicate output and processes that may be developed in the future.

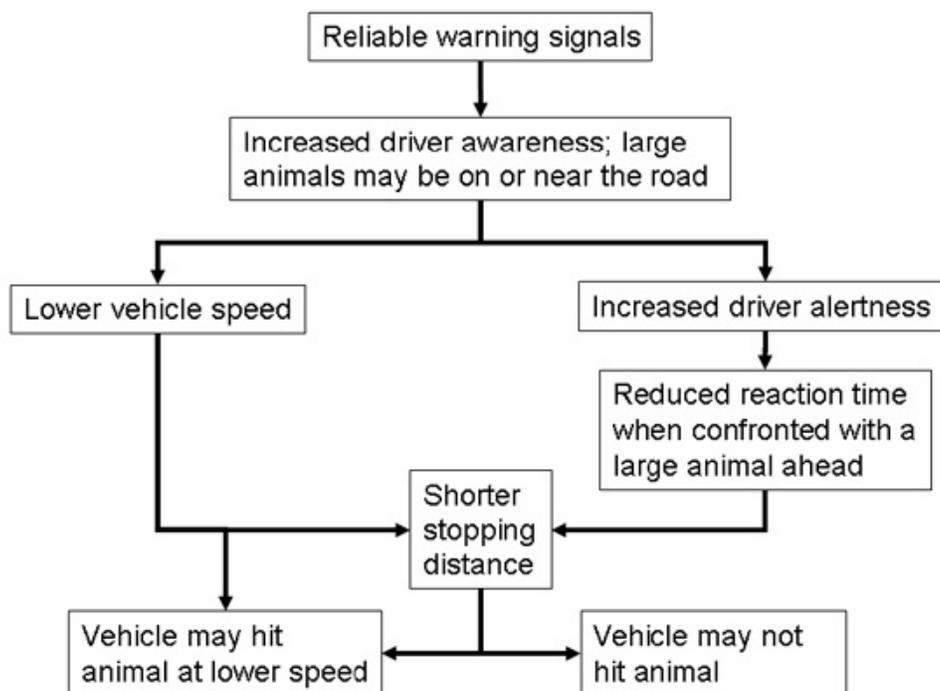
Figure 2: Warning signals and driver response.

Once an animal detection system reliably detects the target species and the warning signals and signs are activated, driver response determines how effective the system ultimately is in avoiding or reducing animal-vehicle collisions. Figure 2 splits driver response into two components: increased driver alertness and lower vehicle speed.

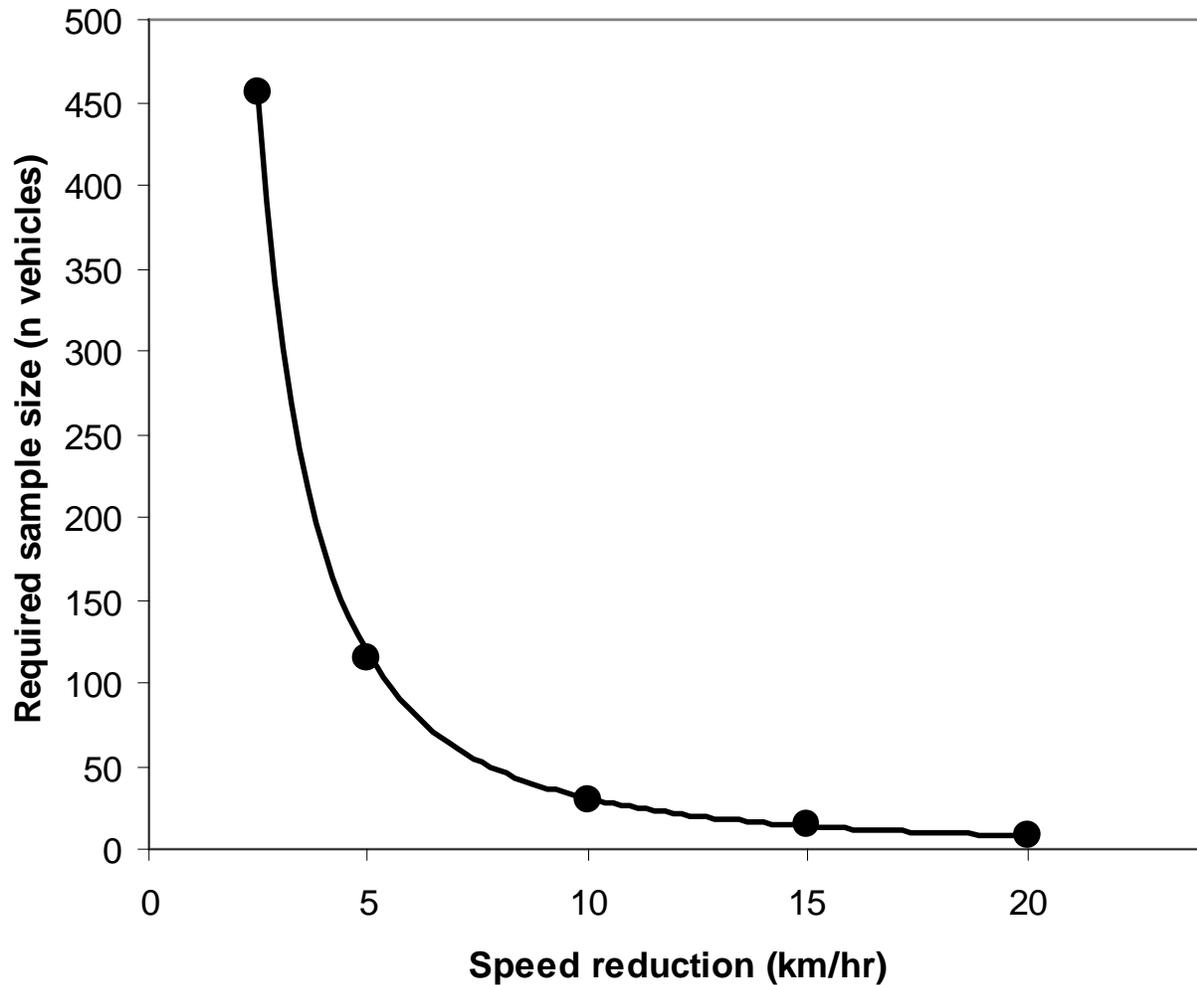
Figure 3: Sample size to detect speed reduction.

Figure 3: shows the sample size (number of vehicles) required to detect a certain reduction in vehicle speed. (1 sided t-test, $\alpha = 0.05$, power = 0.8). This power analysis is based on speed data from independently traveling passenger cars and combined trucks at the site along US Hwy 191, in Yellowstone National Park, Montana (Huijser et al., 2006a) (Figure 4): mean vehicle speed was 108.7 km/h, SD=15.2, n=52 (67.5 mi/h, SD=9.4) even though the posted speed limit is only 88 km/h (55 mi/h). There was no significant difference between the speed of passenger cars and combination trucks ($P=0.382$, 2-sided t-test), nor was there a significant difference in the speed between the two travel directions: passenger cars: $P=0.284$; combination trucks: $P= 0.944$ (2-sided t-test).

Since small reductions in vehicle speed are important, speed studies must have relatively large sample sizes. For example, in order to detect a substantial reduction in vehicle speed (≥ 5 km/h; ≥ 3.1 mi/h), a minimum of 115 vehicles per treatment is required (1 sided t-test, $\alpha = 0.05$, power = 0.8) (Figure 3:). This number is based on a power analyses conducted with speed data from the site along US Hwy 191 in Yellowstone National Park, MT (Huijser et al., 2006a). To detect smaller reductions in vehicle speed a much larger sample size is required. For example, in order to detect a reduction in vehicle speed of ≥ 2.5 km/h (≥ 1.6 mi/h), a minimum of 455 vehicles per treatment would be required (1 sided t-test, $\alpha = 0.05$, power = 0.8) (Figure 3:). Other sites may have different vehicle speeds and variation in speed. As a consequence other sites may require a higher or lower minimum sample size.

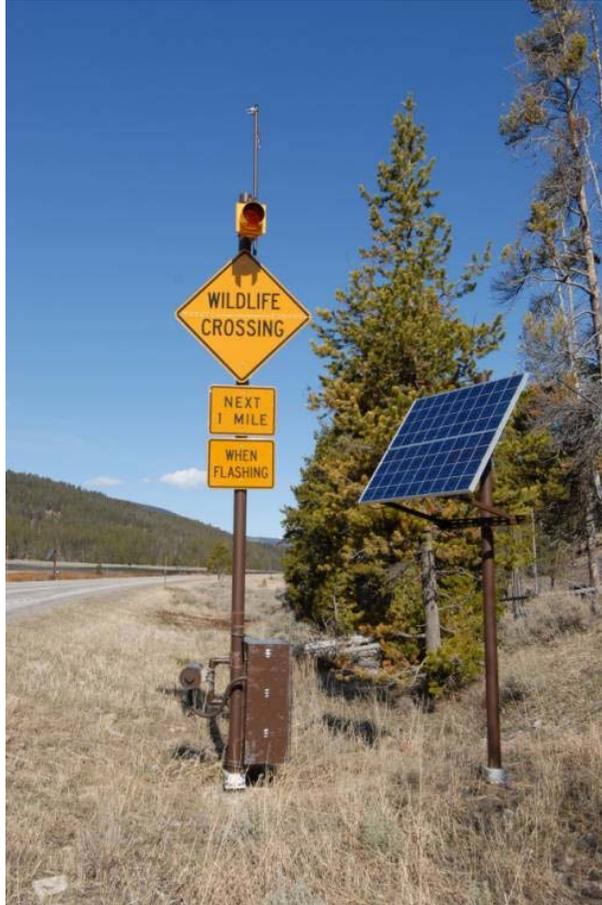
Figure 4: An animal detection system on U.S. Highway 191 in Yellowstone National Park (© Marcel Huijser).

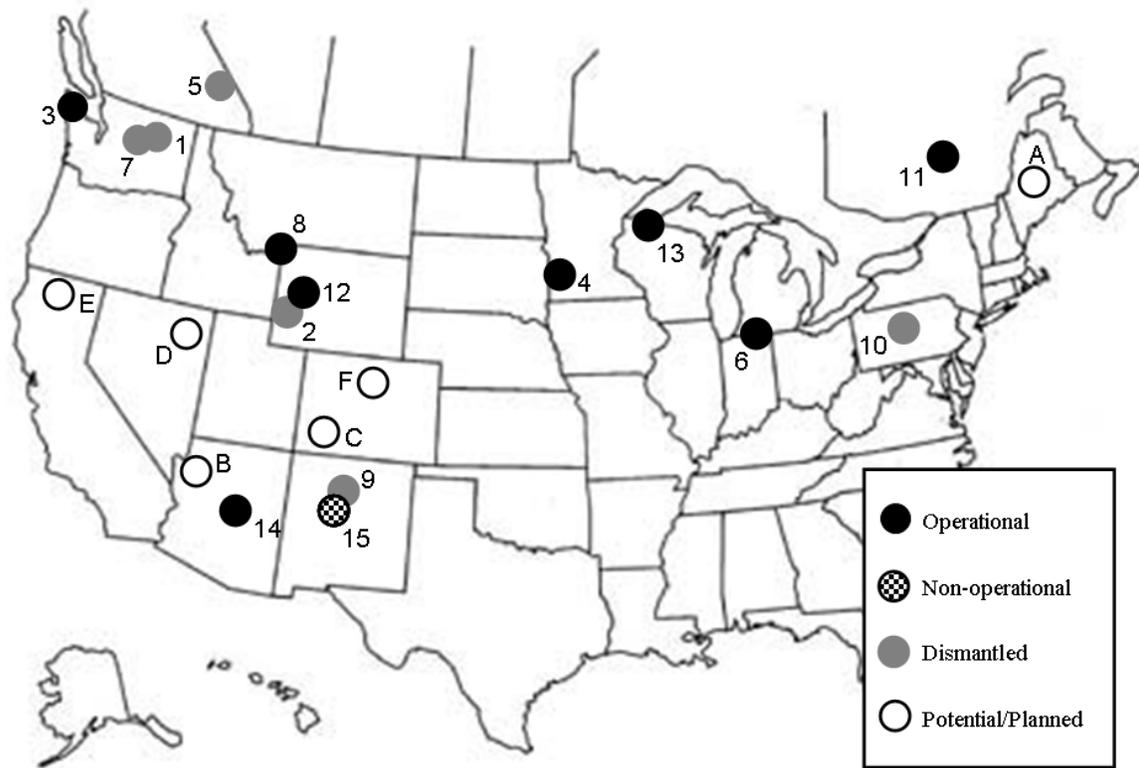
Figure 5: Location of animal detection systems in North America.

This section lists all animal detection systems and their study sites throughout North America as known to the authors (April 2008). In addition we included contact details for vendors (Appendix A), including of vendors that have not had their system installed along a roadside yet or that are based outside of North America. The authors identified 15 sites in North America that have or have had an animal detection system (Figure 5). In addition, there are at least 22 locations in Europe that have or have had an animal detection system (Huijser et al., 2006a). To the best of the authors' knowledge 8 of the sites in North America have a system that is currently in operation (as April 2008). A system at the 9th site is believed to have operational problems (Tijeras Canyon, New Mexico). On the remaining 6 sites the systems have been dismantled. In addition, to best of the authors' knowledge, there are 6 sites for which an animal detection system is planned (Figure 5). For additional information on the individual sites see Huijser et al. (2006a).

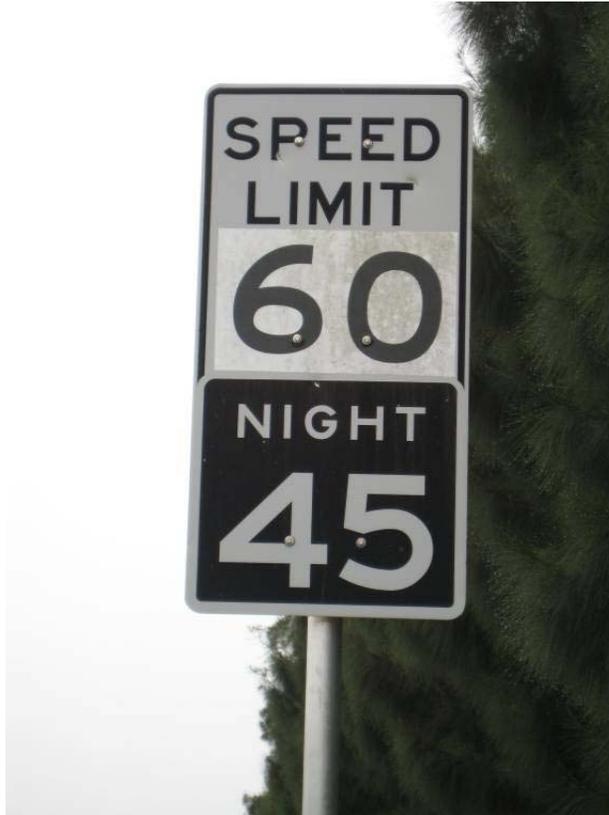
Figure 6: Reduced nighttime speed limit to protect the Florida panther along State Route 29 in southern Florida (© Marcel Huijser).

- On State Route 29 and U.S. Hwy 41 in southern Florida, the night speed limit has been lowered from 60 mi/h (97 km/h) to 45 mi/h (72 km/h) to reduce collisions with the Florida panther (*Puma concolor coryi*) (Figure 6). However, actual vehicle speeds are around 70-75 mi/h (113-121 km/h) during the day and 60-65 mi/h (97-105 km/h) during the night (Deborah Jansen, Big Cypress National Preserve, personal comment).

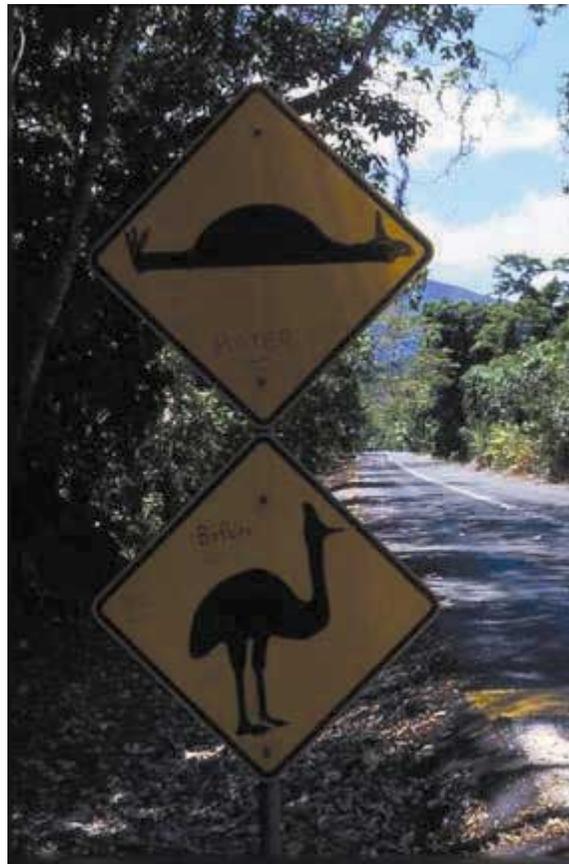
Figure 7: Speed bumps (lower right in picture) are used to reduce WVCs in Queensland, Australia (© Marcel Huijser). Please disregard graffiti on signs that made the speed bump look like a dead cassowary.

- Figure 7 shows an example of where speed bumps are used to reduce vehicle speed for cassowaries (*Casuarius casuarius*), a large bird species in Queensland, Australia. The top sign originally displayed a warning for a speed bump, but was vandalized with a black marker to depict a dead cassowary.

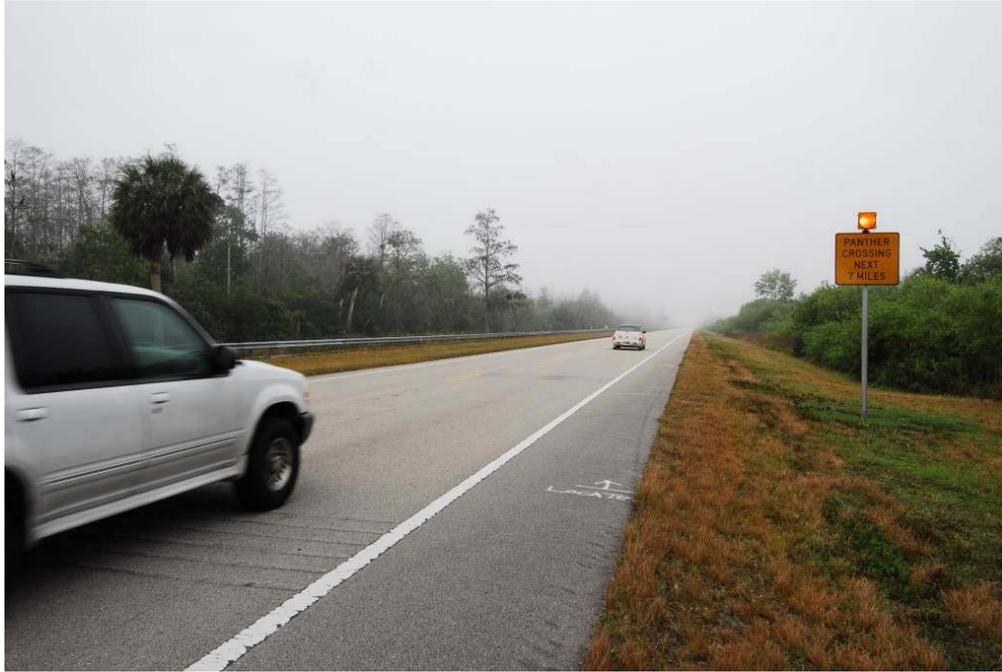
Figure 8: Patches of rumble strips accompany a panther warning sign along State Route 29 in southern Florida (© Marcel Huijser).

- In southern Florida, mitigation measures were installed including: 1) rumble strip patches in combination with 2) a black-on-yellow warning sign that reads "PANTHER CROSSING NEXT [X] MI" that has 3) a permanently activated flashing amber light installed on top of the warning sign (Figure 8). These mitigation measures were designed to reduce collisions with the Florida panther by increasing driver alertness and reducing vehicle speed.

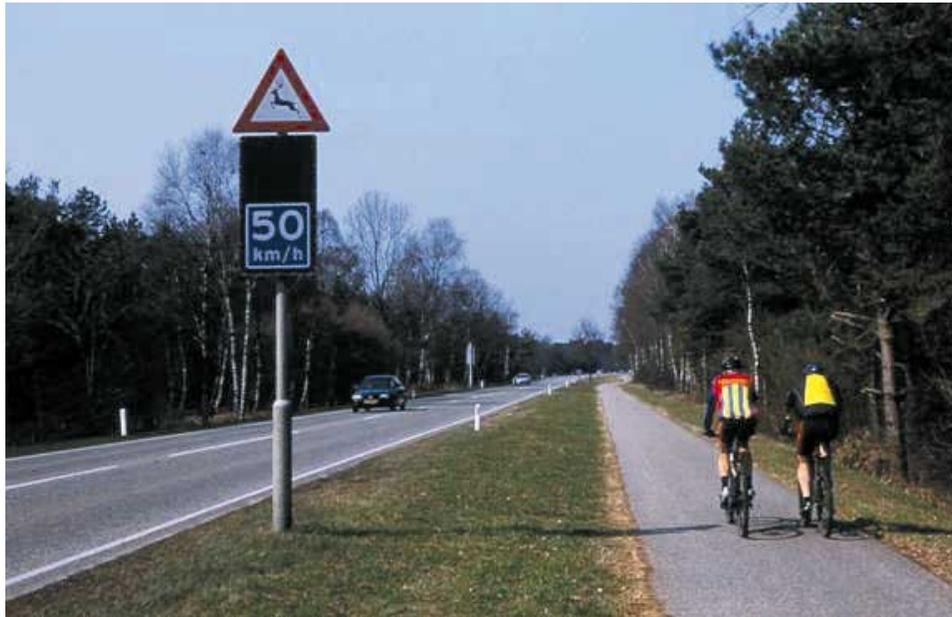
Figure 9: Advisory speed limits accompany a deer warning sign near ‘t Harde, The Netherlands (© Marcel Huijser). Note: The LED part of the warning sign is linked to an animal detection system, but the advisory speed limit reduction sign is always visible in daylight, regardless of the presence and detection of large animals.

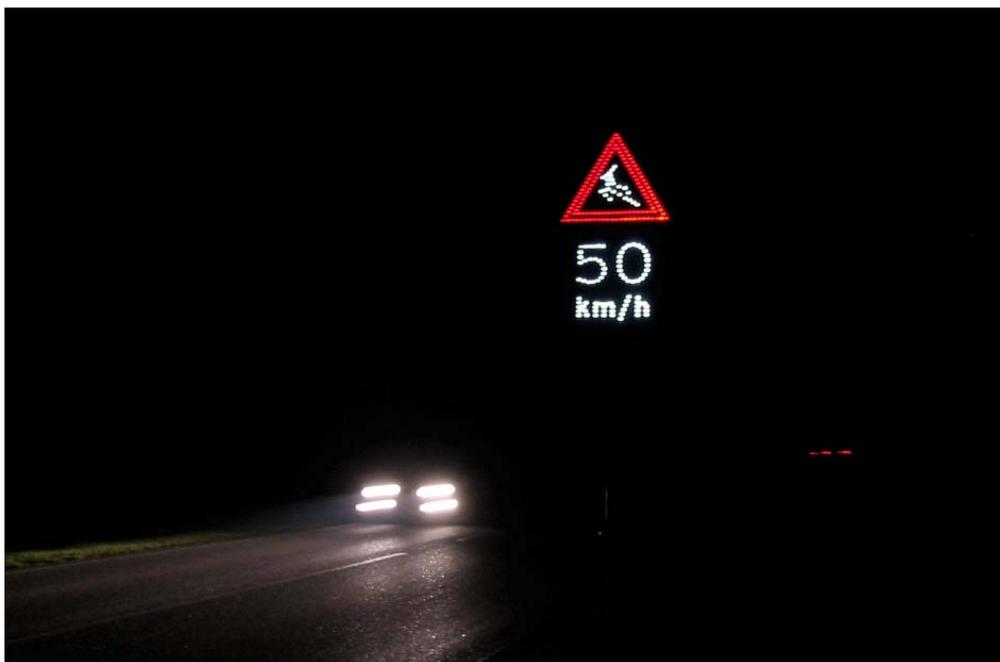
Figure 10: The same sign as shown in Figure 9 when triggered at night (© Marcel Huijser).

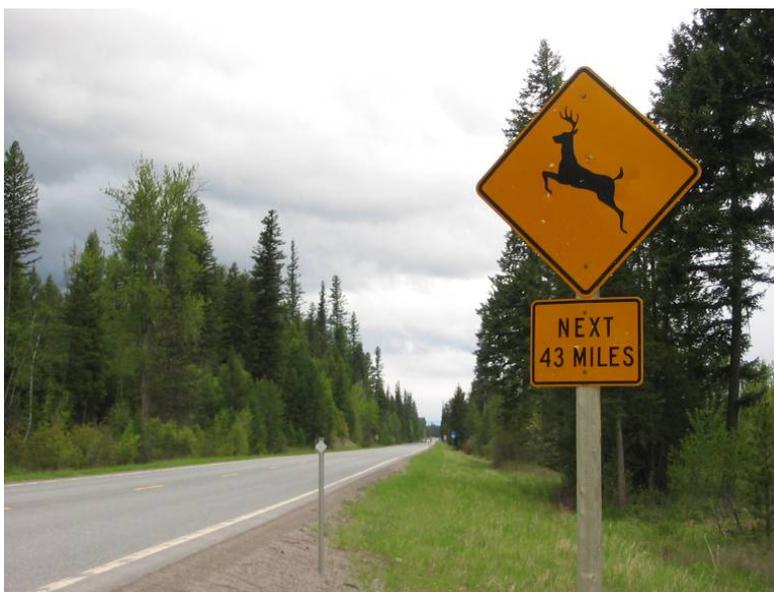
Figure 11: Standard deer warning sign on Highway 83 in Montana includes the length of the road section that the warning sign applies to (© Marcel Huijser).

The standard deer warning sign in the United States is a diamond-shaped panel with a black deer symbol on a yellow background. These signs are intended to inform drivers that the upcoming road section has a history of a higher-than-average number of deer-vehicle collisions. Sometimes signs also indicate the length of applicable road section (Figure 11).

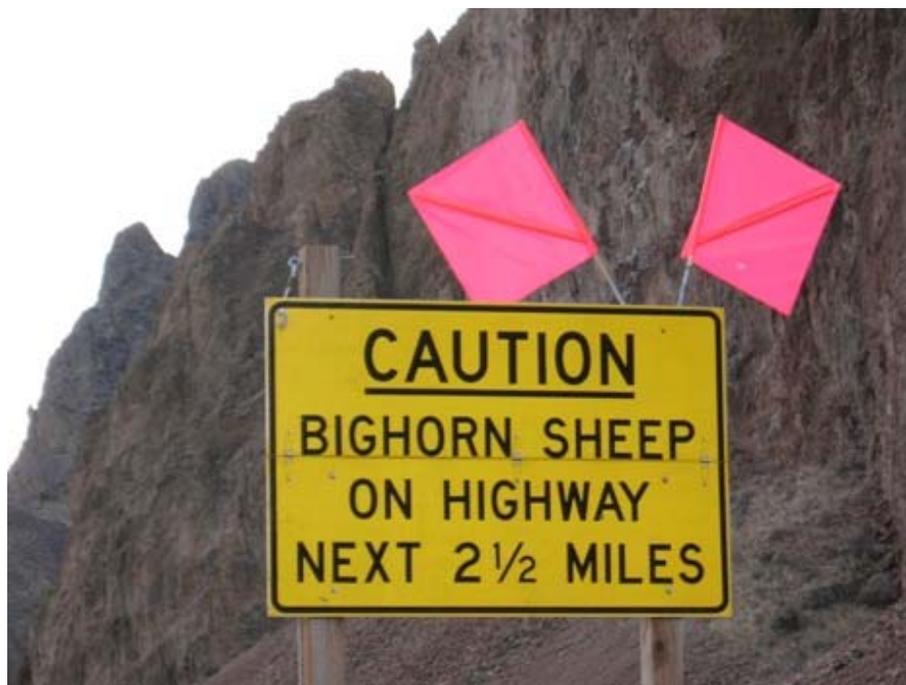
Figure 15: Large enhanced warning sign for bighorn sheep along State Highway 75 in Idaho (© Marcel Huijser).

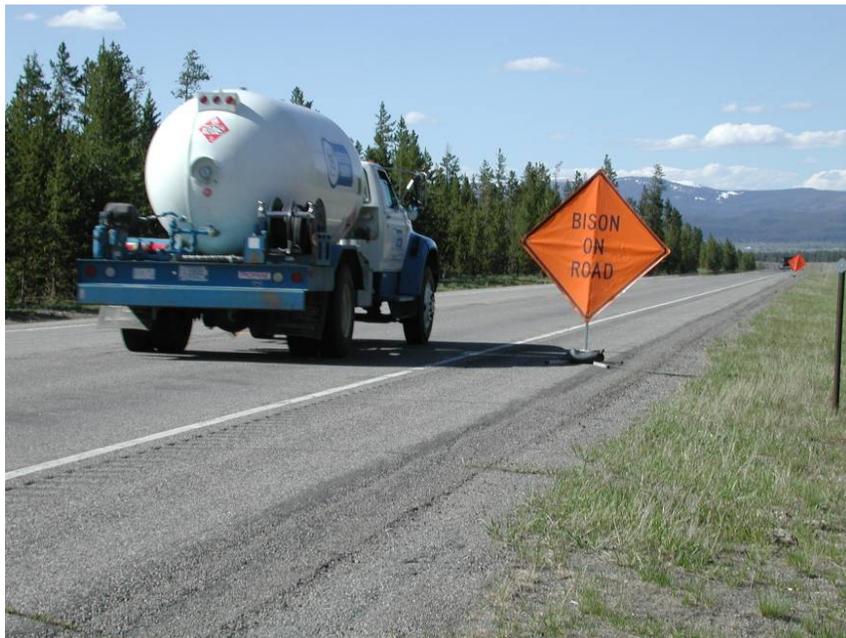
Figure 20: Seasonal warning signs for bison in Yellowstone National Park (WTI file photo).

Seasonal wildlife warning signs are designed to deliver time-specific messages to drivers. They are displayed at certain times of the year when animals cross the road most frequently, such as during a seasonal migration (Figures 20-22). Seasonal signs can be used for specific species for areas with a higher-than-average number of species-specific WVCs.

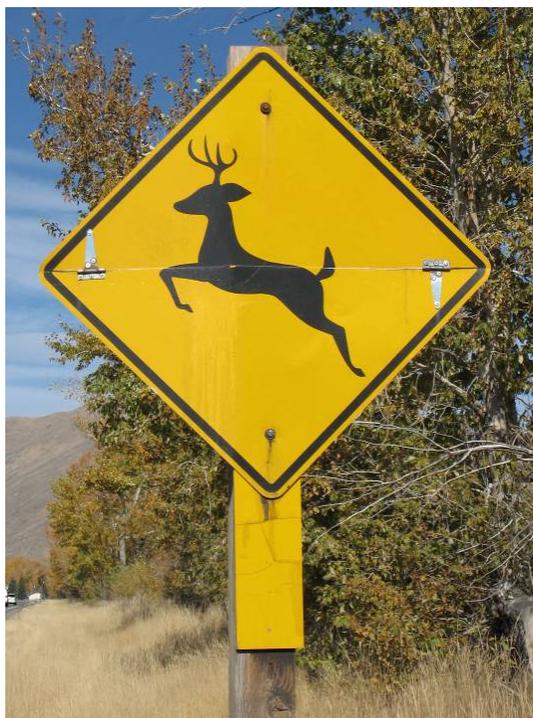
Figure 21: A permanent deer warning sign in Idaho has hinges, allowing for its seasonal use (© Marcel Huijser).

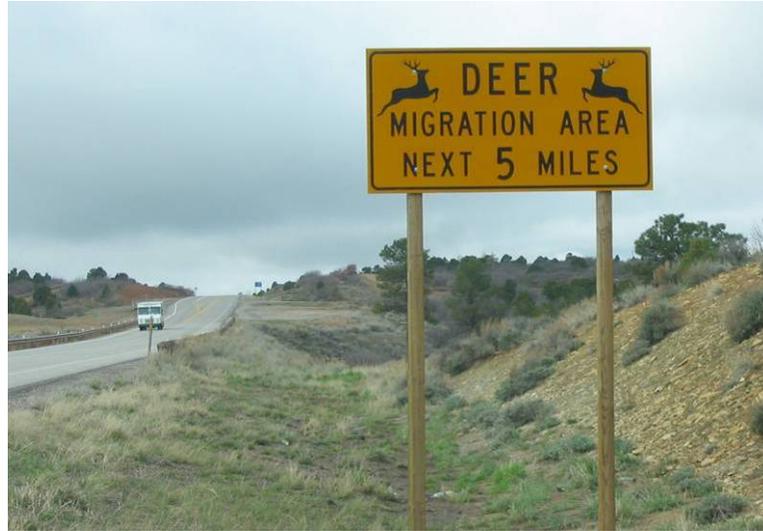
Figure 22: Seasonal deer migration sign in Utah (© Marcel Huijser).

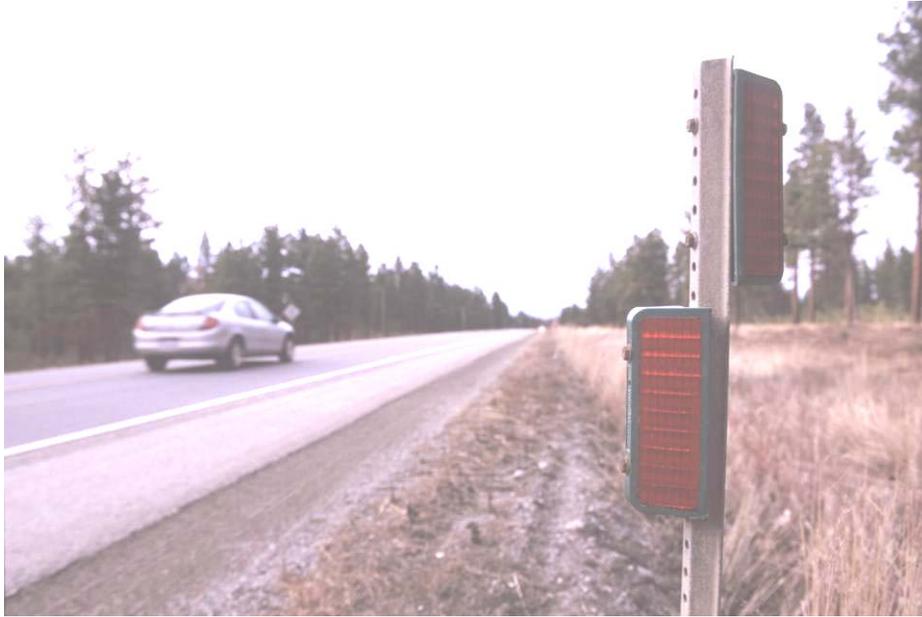
Figure 25: Deer reflector along Hwy 93 in British Columbia (© Marcel Huijser).

Deer mirrors and reflectors (Figure 25) are roadside installments intended to act as visual wildlife repellents. Mirrors directly reflect vehicle headlights off the roadway and into the surrounding right-of-way (Danielson & Hubbard 1998). Reflectors beam colored reflected light from headlights into roadside habitat (Swareflex, D. Swarovski & Co., Wattens, Austria, <http://www.swareflex.com/> (accessed 26 January 2007)) or onto the roadway itself (Strieter-Lite, Strieter Corp., Rock Island, Illinois, <http://www.strieter-lite.com/> (D'Angelo et al. 2006)).

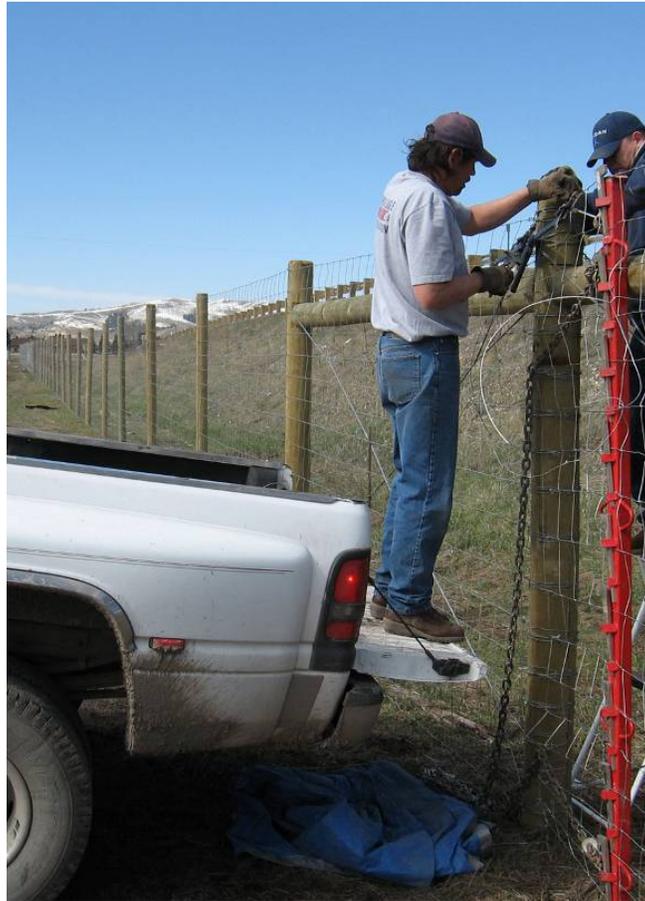
Figure 26: Wildlife fence along Interstate 90 near Bozeman, Montana (© Marcel Huijser).

typically consist of 2.0-2.4 m (6.5-8 ft) high wire mesh fence material. Several types of fence material are used, but page-wire or cyclone fence material is most common. Wooden or metal fence posts are typically used; the latter are particularly important when fencing over rock substrates. To keep other species from climbing over fences (e.g., cougars, bears), fences can be taller, mesh size can be smaller, and overhangs can be incorporated into the design (Jones and Longhurst 1958, Gloyne and Clevenger 2001) (Figure 29).

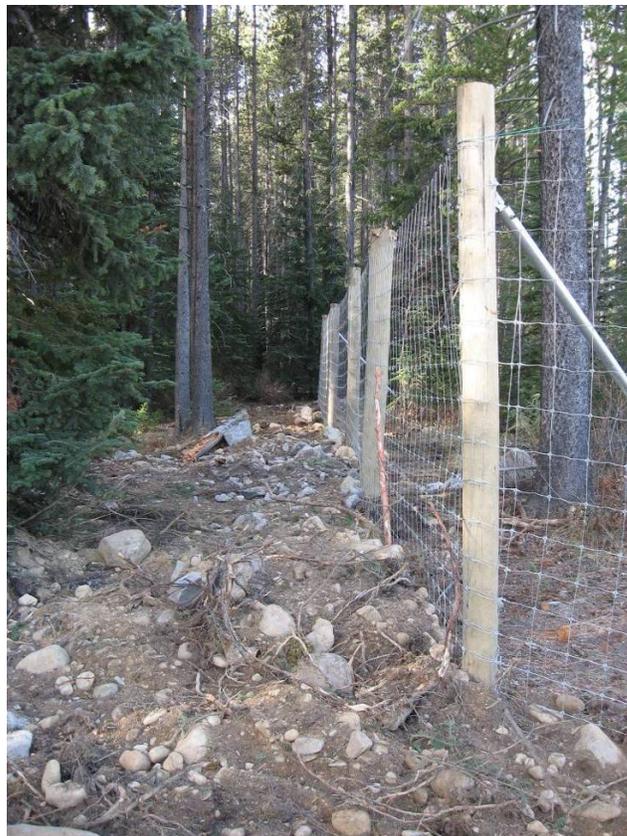
Figure 27: Wildlife fencing along the TransCanada Highway (© Marcel Huijser).

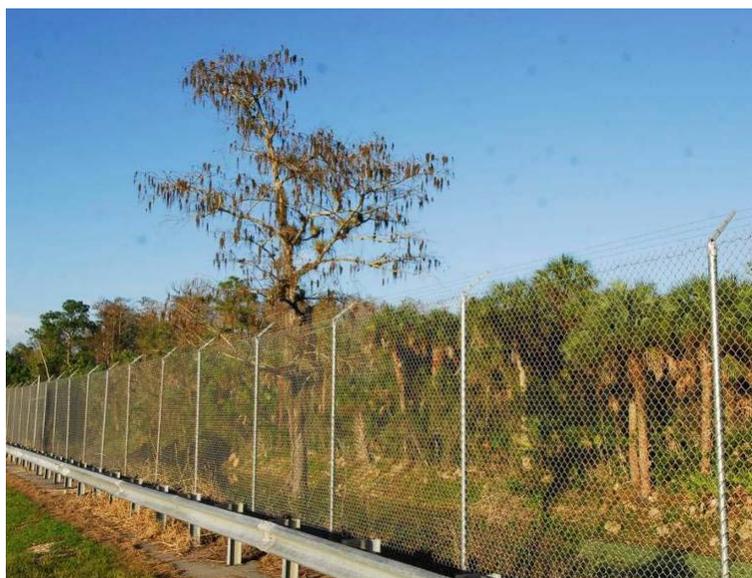
Figure 28: A 3.4 m high chain link fence along SR 29 in southern Florida designed to prevent Florida panthers from entering the roadway and to guide them toward underpasses (© Marcel Huijser).

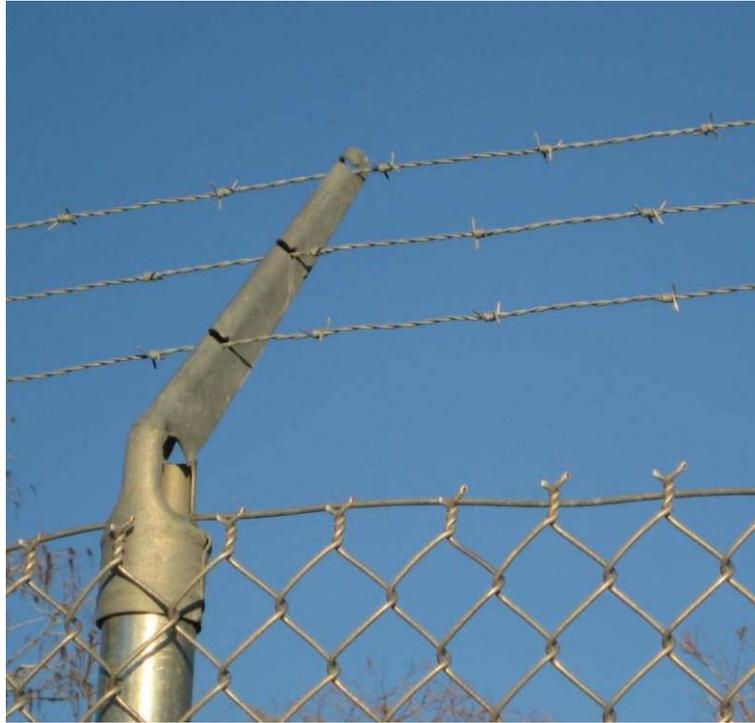
Figure 29: A 3.4 m high chain link fence along SR 29 in southern Florida was equipped with three strands of outriggered barbed wire to prevent Florida panthers from climbing the fence (© Marcel Huijser).

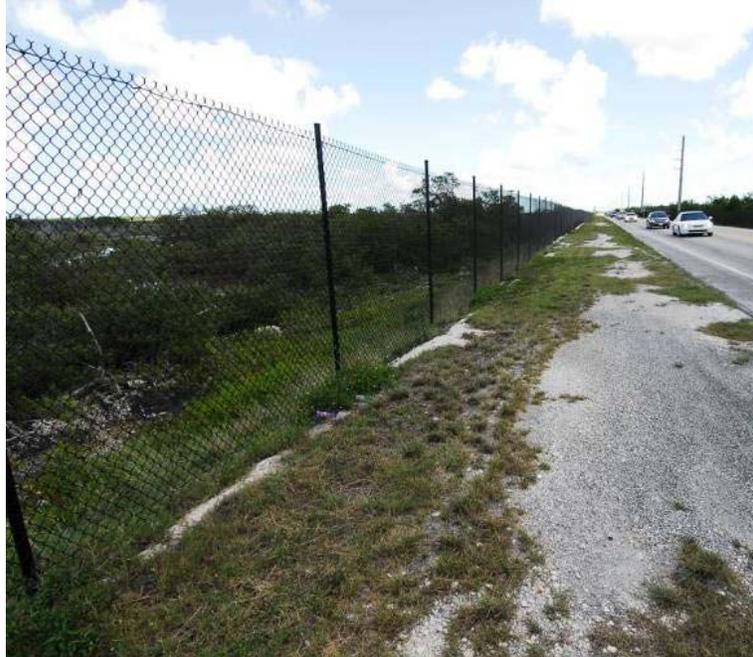
Figure 30: A 2.44 m (8 ft) high chain link fence along U.S. Hwy 1 on Big Pine Key, Florida, has been coated with plastic to make the fence blend in with its surroundings (© Marcel Huijser).

- Wildlife fencing can have a negative impact on landscape aesthetics; many people perceive tall wildlife fences as ugly. The Utah DOT has painted wire mesh fencing dark brown which camouflages the wire mesh to some extent. A chain link fence for Key deer on Big Pine Key in southern Florida (Figure 30) and a similar fence for the American crocodile and people along U.S. Hwy 1 between Florida City and Key Largo (Figure 31) have been coated with black plastic to reduce the impact of the fence on landscape aesthetics. However, camouflaging fencing because of landscape aesthetics may conflict with increasing risks for wildlife (see next bullet).

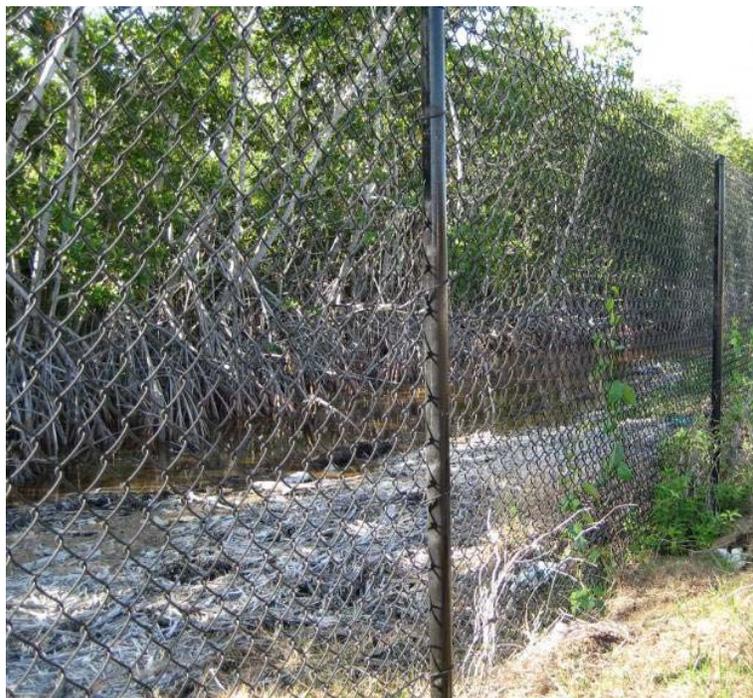
Figure 31: A 1.83 m (6 ft) high chain link fence along U.S. Hwy 1 between Florida City and Key Largo, Florida, has been coated with plastic to make the fence blend in with its surroundings (© Marcel Huijser).

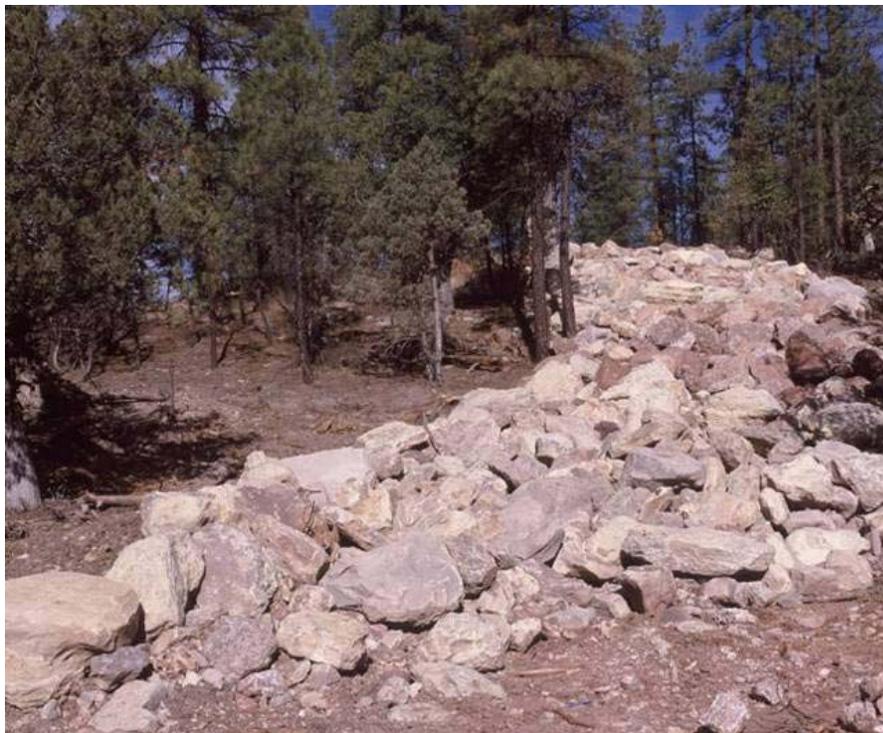
Figure 32: Large boulders placed in the right-of-way as a barrier to elk and deer along State Route 260 in Arizona (© Marcel Huijser).

- Boulders have been used for this purpose along State Route 260 in Arizona (Terry Brennan, U.S. Forest Service, personal communication; Norris Dodd, Arizona Game and Fish Department, personal communication) (Figures 32 and 33). The boulder barrier was not extended through areas with steep slopes, since it was thought that wildlife would not move through these steep areas. However, animals have traveled through these areas. The barrier is thought to be effective with exception of the gaps in the steep areas (Norris Dodd, Arizona Game and Fish Department, personal communication).

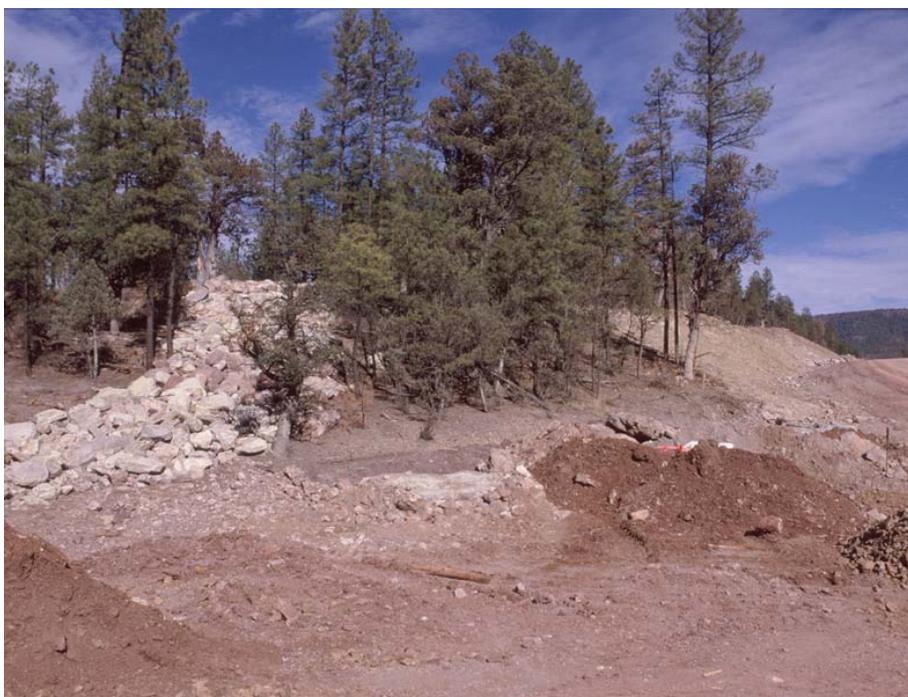
Figure 33: Large boulders placed in the right-of-way as a barrier to elk and deer with a view of State Route 260 (under construction) in Arizona (© Marcel Huijser).

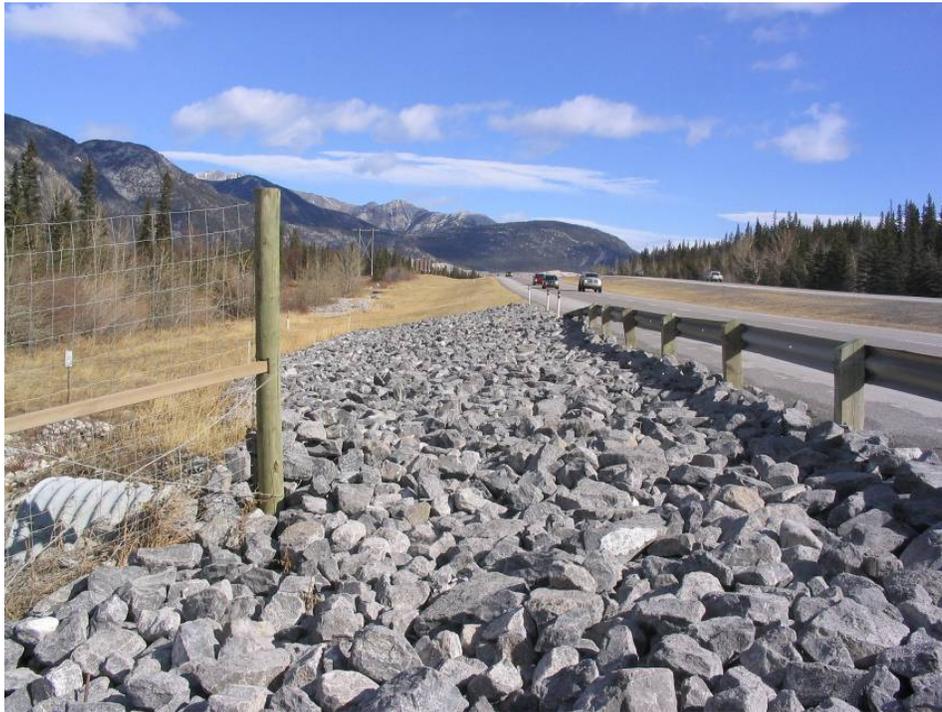
Figure 36: The boulder field at the fence end at Dead Man's Flats along the Trans-Canada Highway east of Canmore, Alberta (© Bruce Leeson).

To discourage ungulate species from entering the fenced sections of the Trans-Canada Highway in Alberta, rock impediments or boulder fields were placed at the ends of the fence between the roadway and the fence, as shown in Figure 36 (Clevenger et al. 2002a). Boulders, roughly the size of bowling balls, were laid out uniformly to create a boulder field. The boulders are thought to discourage animals, especially ungulates, from walking across them.

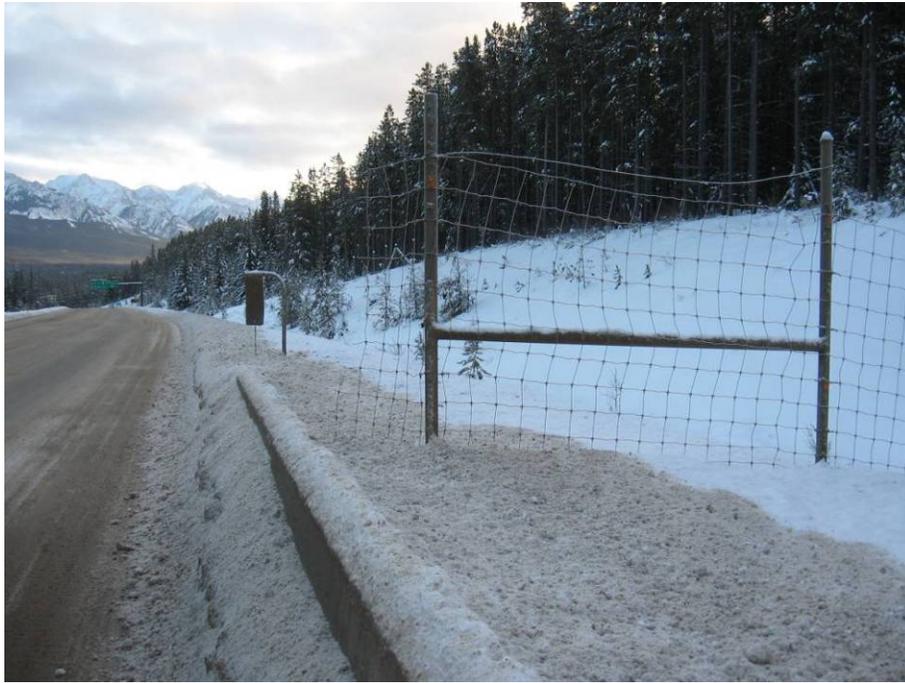
Figure 37. Fence end brought close to the road with a concrete barrier for safety along Hwy 93S in Banff National Park, just west of Castle Jct (© Marcel Huijser, WTI-MSU).

Alternatively, the fence end can angle towards the road and concrete barriers can prevent vehicles from crashing into the fence posts (Figure 37).

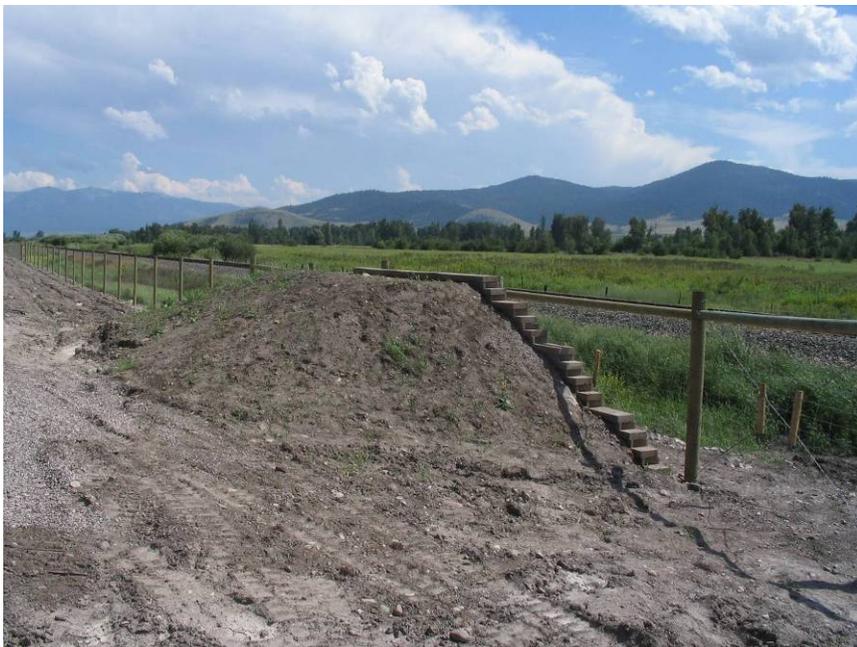
Figure 38: A jump-out along a 2.4 m (8 ft) high fence along U.S. Highway 93 in Montana (© Marcel Huijser).

Jump-outs or “escape ramps” are sloping mounds of soil placed against a backing material on the right-of-way side of the fence (Figure 38 and 39). The highway fence is tied in to the edges of the jump-out. Jump-outs are designed to allow animals caught between the fences to jump out of the right-of-way. At the same time, jump-outs should not allow animals to jump into the right-of-way area. Little is known about the appropriate height for jump-outs. The appropriate height of jump-outs is likely dependent on the main species of interest and the terrain (e.g., up-slope or down-slope), but they are typically 1.6-2.2 m (5-7 ft) in height.

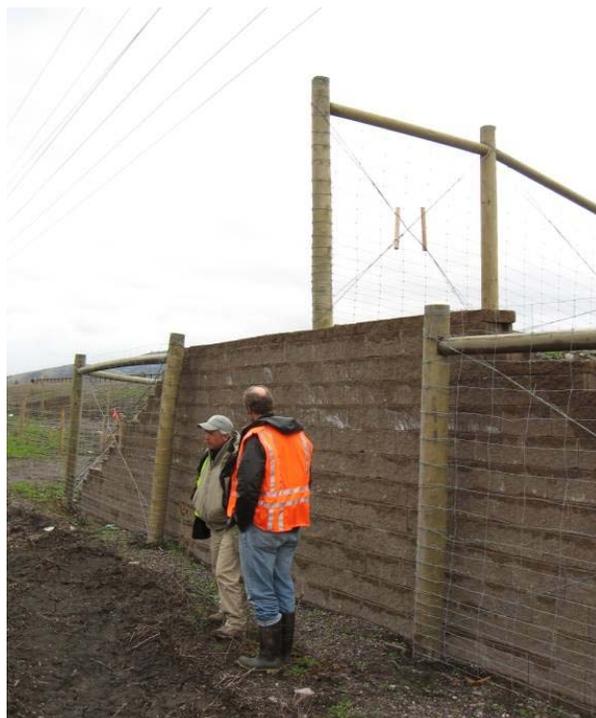
Figure 39: A jump-out along a 2.4 m (8 ft) high fence along U.S. Highway 93 in Montana (© Marcel Huijser).

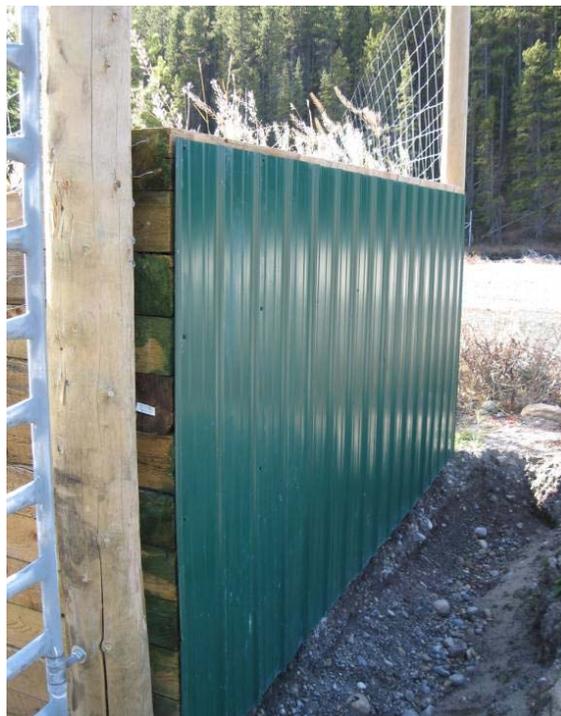
Figure 40: A jump-out along a 2.4 m (8 ft) high fence with smooth metal to prevent bears from climbing into the right-of-way along the Trans-Canada Highway, Lake Louise area, Banff National Park, Canada (© Marcel Huijser).

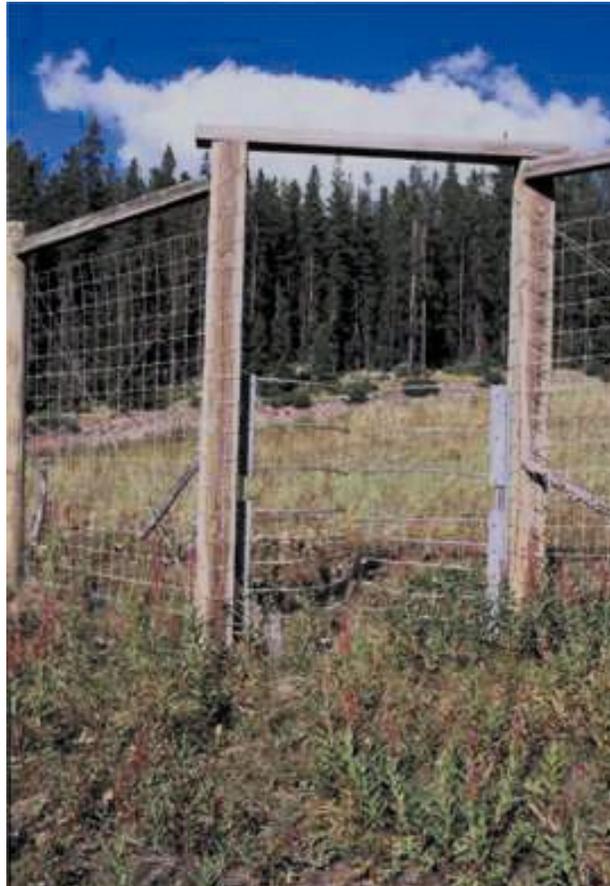
Figure 41: One-way elk gate in British Columbia, (© Marcel Huijser).

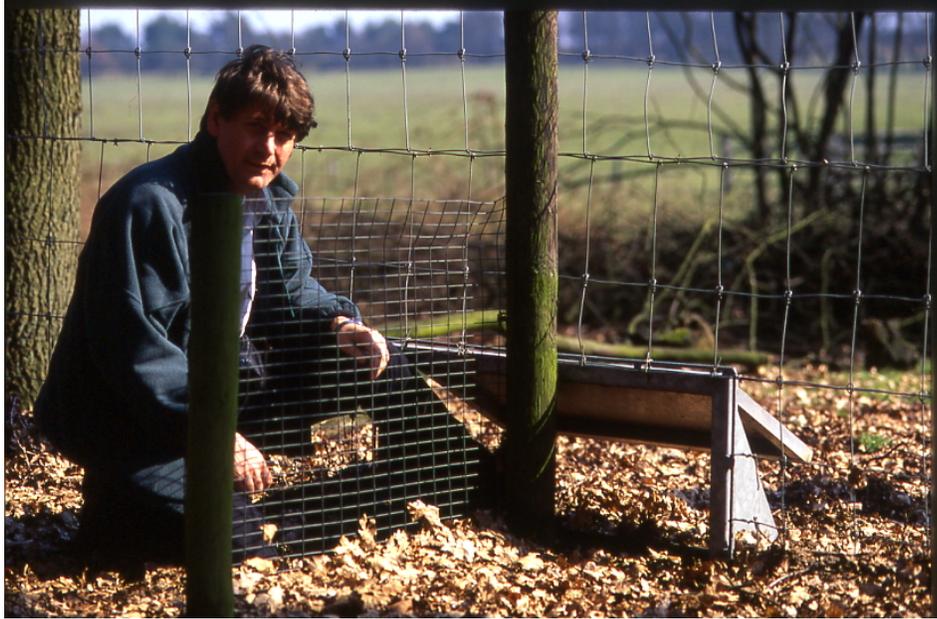
Figure 42: One-way Eurasian Badger gate, the Netherlands (© Marcel Huijser).

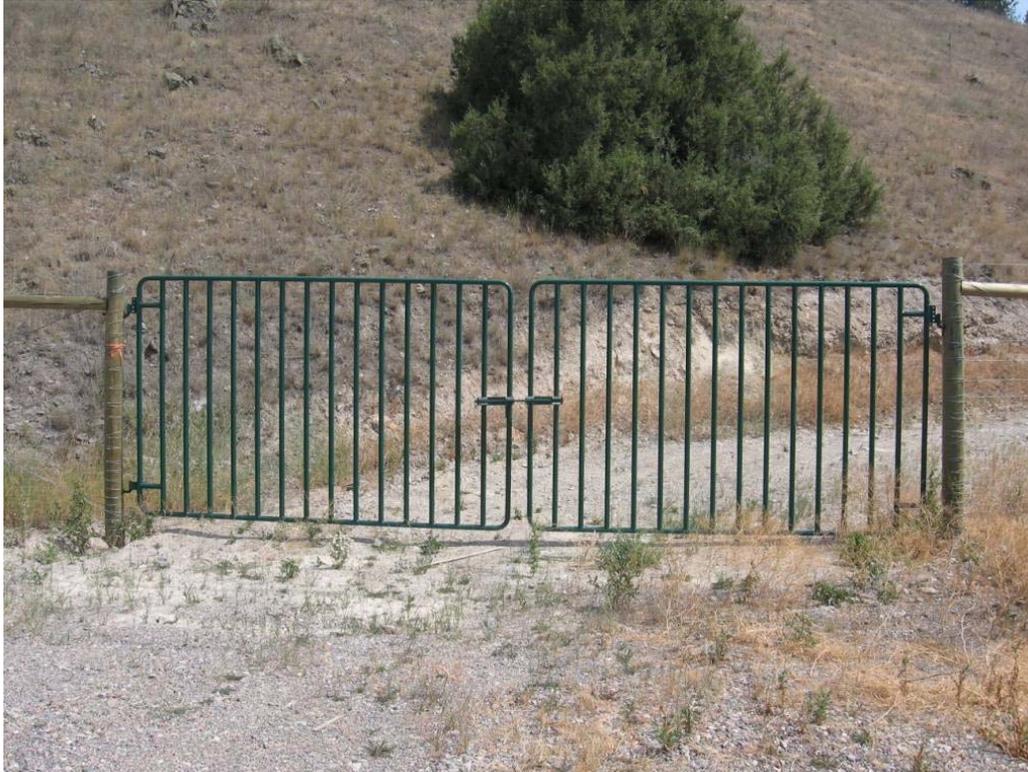
Figure 43: Gate on a low volume access road along U.S. Highway 93 in Montana (© Marcel Huijser).
