Wildlife-Vehicle Collision and Crossing Mitigation Measures: A Literature Review for Blaine County, Idaho

Marcel P. Huijser, PhD, Research Ecologist and
Angela V. Kociolek, MSc, Research Associate

Western Transportation Institute
College of Engineering
Montana State University

May, 2008

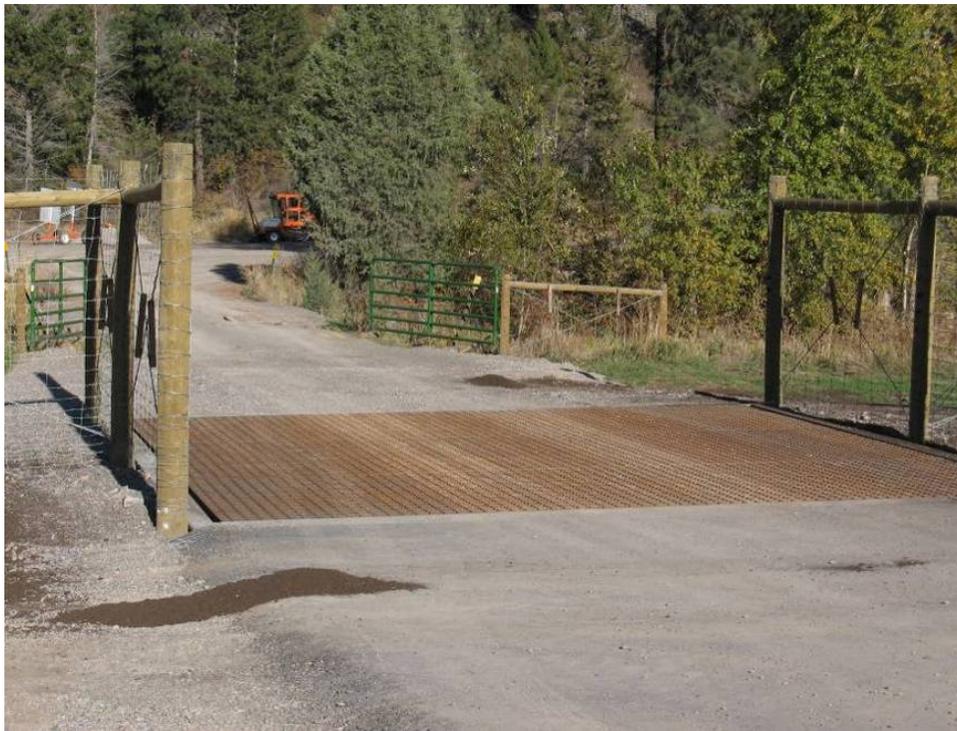
Figure 44: Wildlife guard along U.S. Highway 93 on the Flathead Indian Reservation, Montana (© Marcel Huijser).

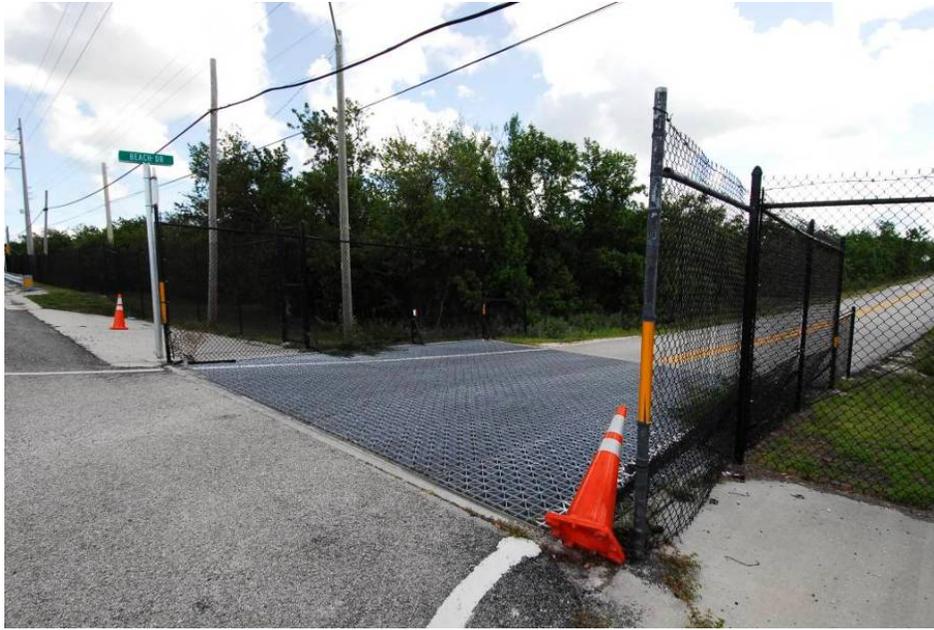
Figure 45: Wildlife guard along U.S. Highway 1 for Key deer on Big Pine Key, Florida (© Marcel Huijser).

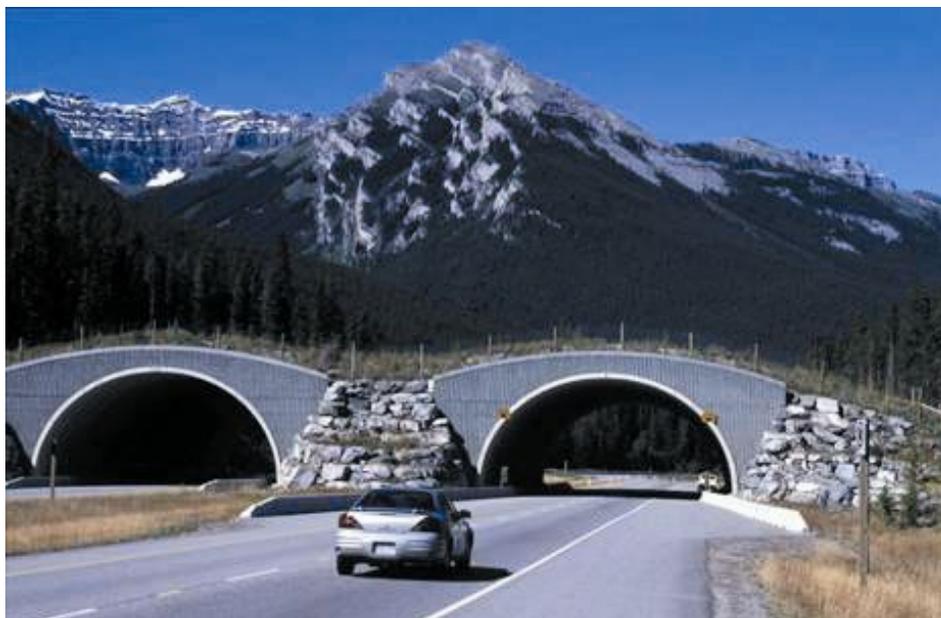
Figure 46: Wildlife overpass along the Trans-Canada Highway in Banff National Park, Alberta (© Marcel Huijser).

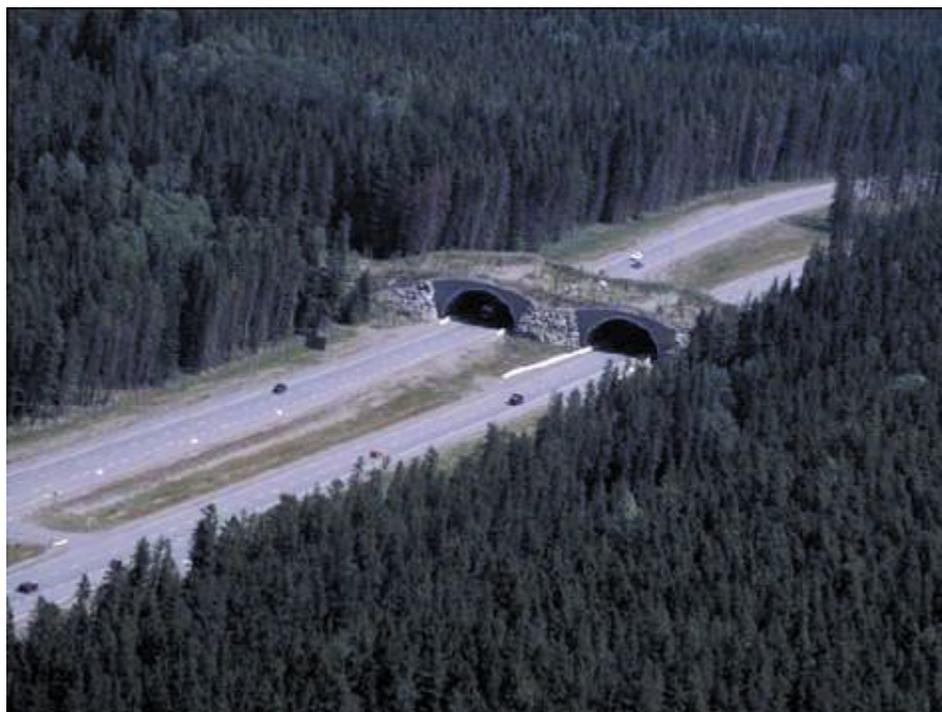
Figure 47: Red Earth Overpass on the Trans-Canada Highway (© Tony Clevenger).

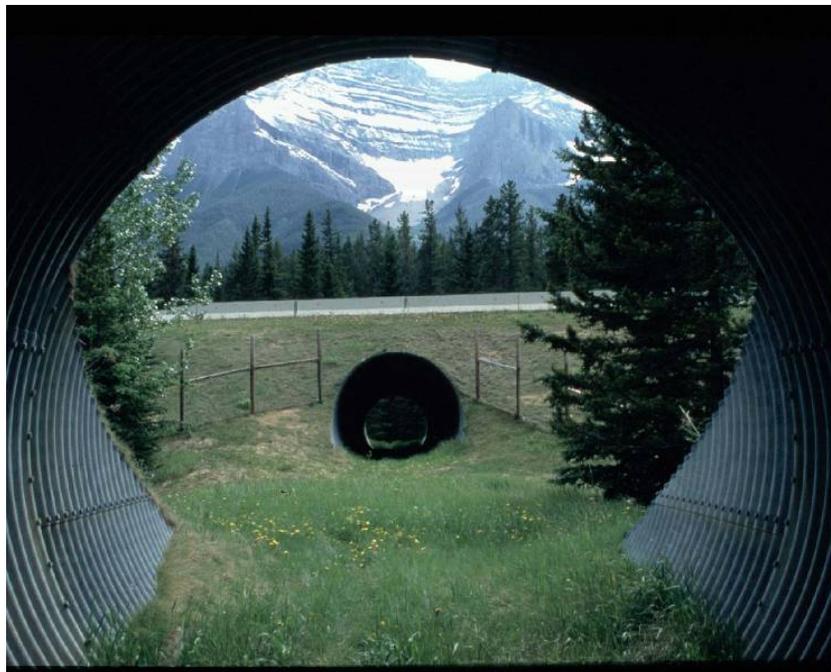
Figure 48: A large wildlife crossing culvert along the Trans-Canada Highway in Banff National Park, Alberta (© Tony Clevenger).

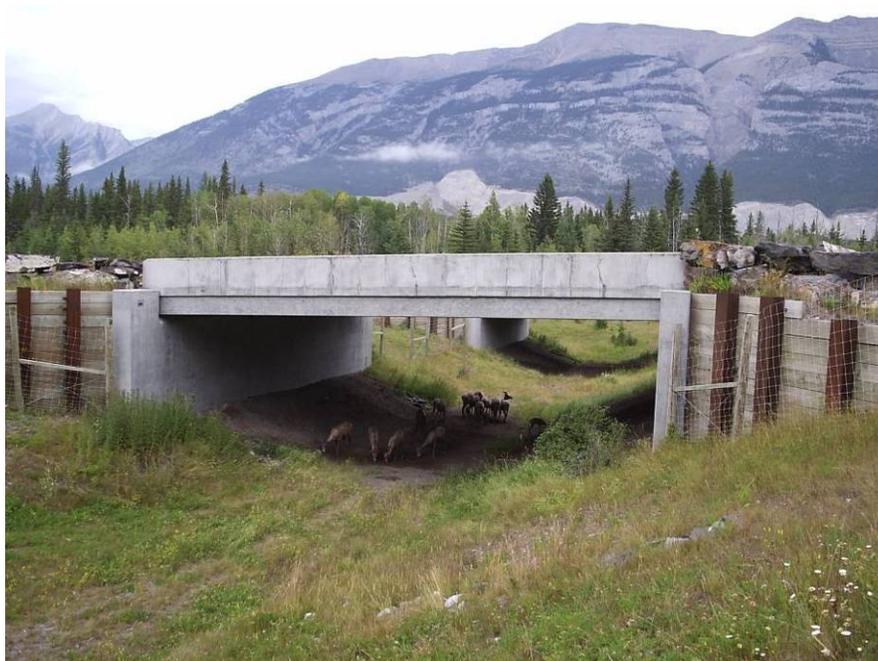
Figure 49. Bighorn sheep using an underpass along the Trans-Canada Highway near Canmore, Alberta (© Tony Clevenger).

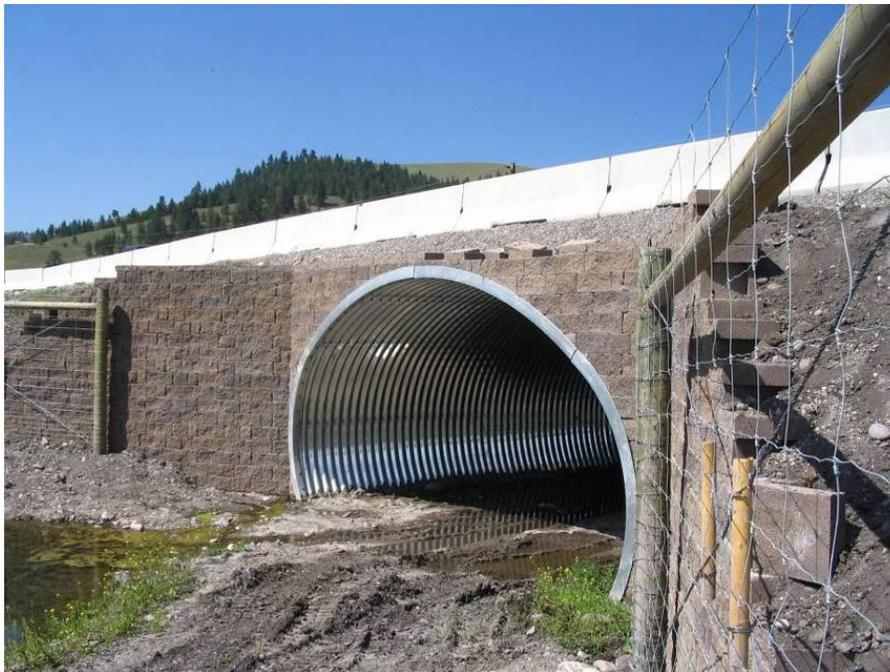
Figure 50: Wildlife underpass along U.S. Highway 93 on the Flathead Indian Reservation, Montana (© Marcel Huijser).

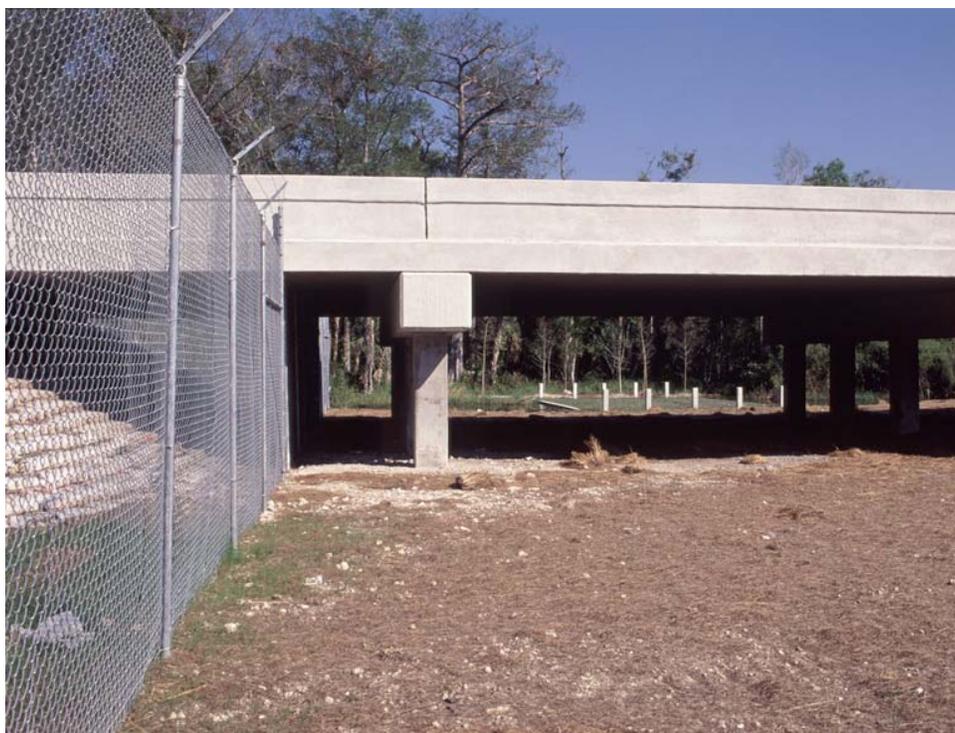
Figure 51: Underpass in southern Florida that allows for ecosystem processes (hydrology) as well as wildlife use, including the Florida Panther (© Marcel Huijser).

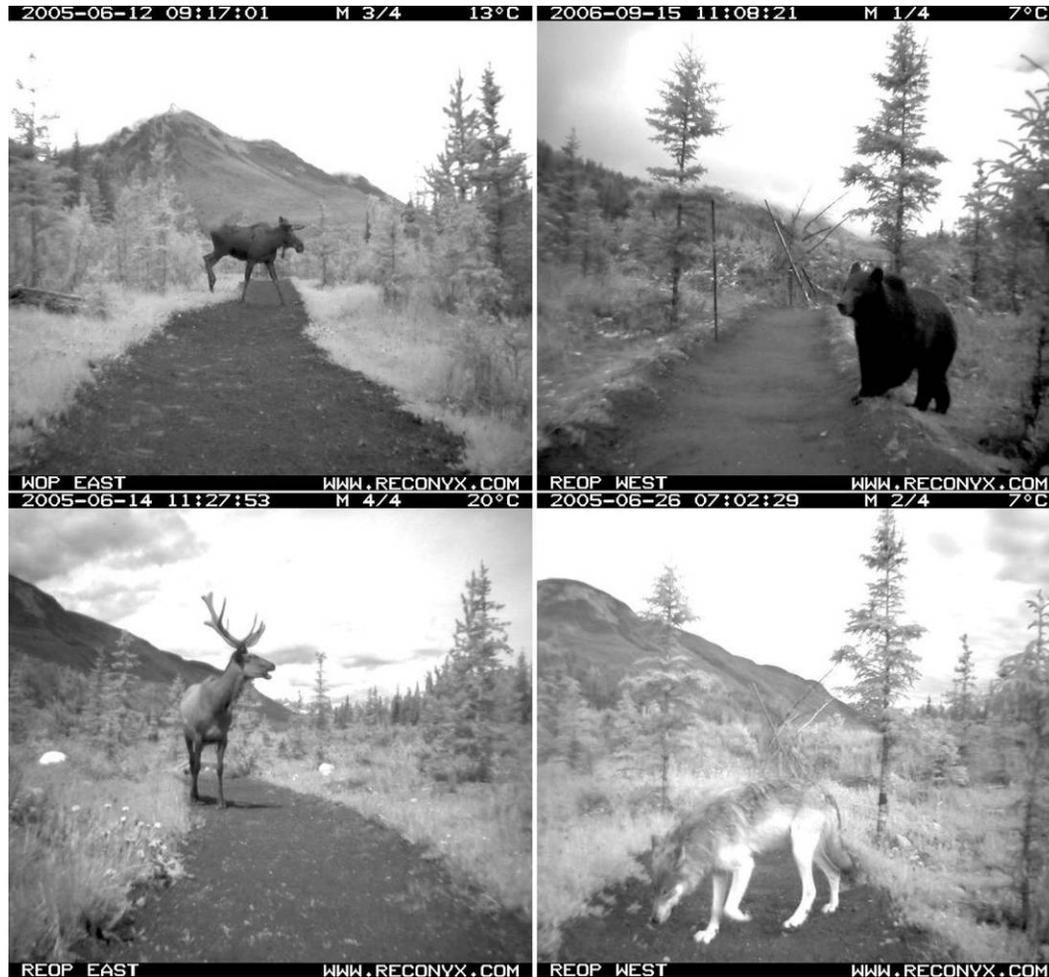
Figure 52: Wildlife use of wildlife overpasses on the TransCanada Highway in Banff National Park. Clockwise from upper left: moose, grizzly bear, gray wolf, and elk (© Tony Clevenger).

- Numerous species have been documented to regularly use 26 wildlife underpasses and two overpasses on the TransCanada Highway in Banff National Park. Almost 101,000 wildlife crossings have been recorded between 1996 and 2007 with almost 12,000 crossings at the overpasses. Species documented using underpasses include black bear, bobcat, cougar, coyote, deer, elk, fox, goat, grizzly bear, moose, bighorn sheep, and wolf. Species documented using overpasses include black bear, bobcat, cougar, coyote, deer, elk, fox, grizzly bear, moose, bighorn sheep, and wolf (Adam Ford, WTI, personal communication) (Figure 52). While Canada lynx and wolverine have also been observed using underpasses and while Canada lynx has been observed using an overpass, the

- In Banff National Park, Canada, grizzly bears, deer and elk tend to use overpasses to a greater extent than underpasses, while black bears and mountain lions tend to use underpasses more than overpasses (Clevenger et al. 2002a).
- Twenty-four underpasses along a 64 km (39.7 mi) long section of Interstate 75 in southern Florida were installed to allow for water flow and movement of animals, including the Florida panther (Foster and Humprey 1995).

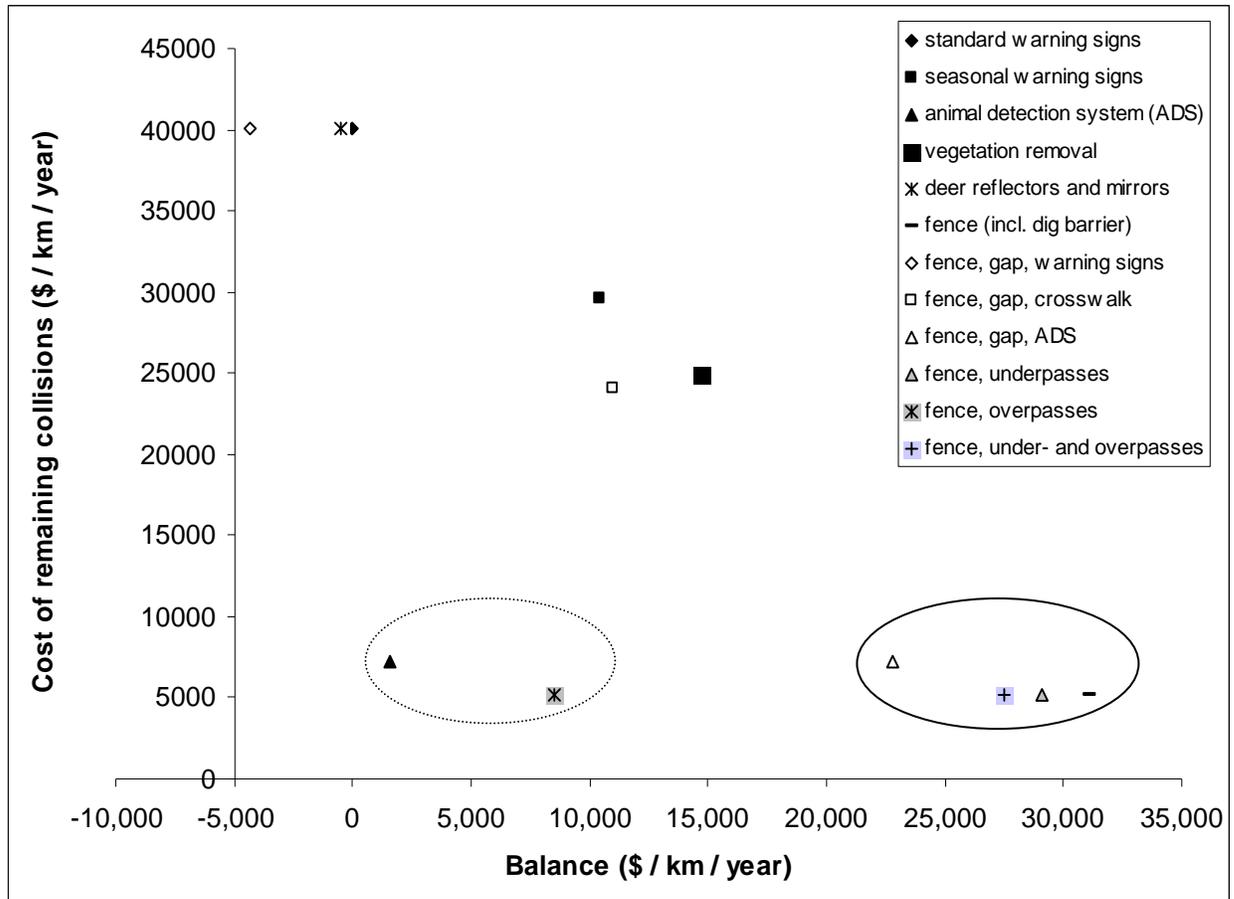
Figure 53: Balance and remaining costs for the different mitigation measures (further explanation in text).
