NCHRP 25-25, Task 113

ROAD PASSAGES AND BARRIERS FOR SMALL TERRESTRIAL WILDLIFE SPECIES

CASE STUDIES 1 & 2, OVERPASSES

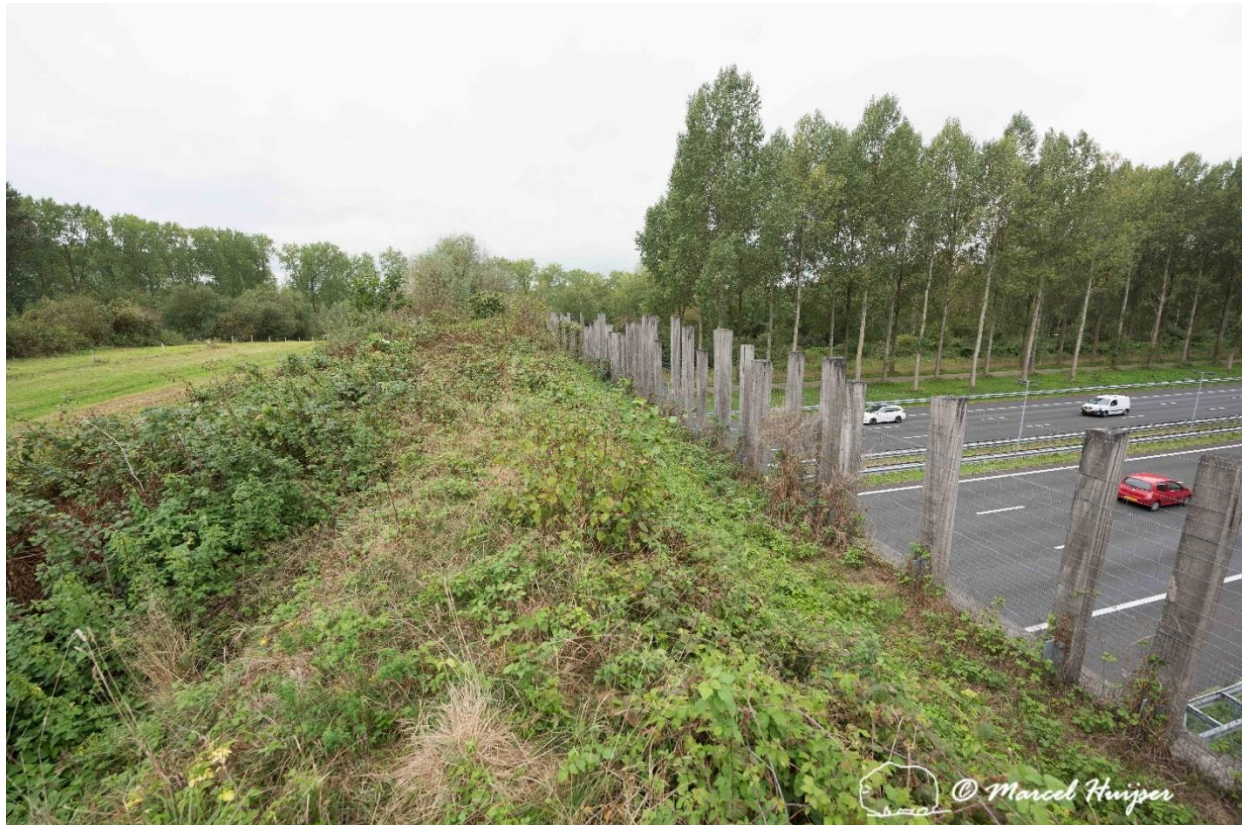
Figure 8: Wildlife overpass “Groene Woud,” across A2 motorway between Boxel and Best, The Netherlands.

This section features a wildlife overpass for which small animal species were among the target species (Figure 8). In this section, we illustrate the connection between identifying a species as a target species for a crossing structure, designing a structure for that target species, and evaluating the effectiveness of the structure in providing habitat connectivity for that target species (van der Grift et al. 2010).

Structure Dimensions: 50-m wide (164 ft), spans the A2 motorway for 65 m (213 ft), 100 m (328 ft) approach slope on west side, 85 m (279 ft) on east side.

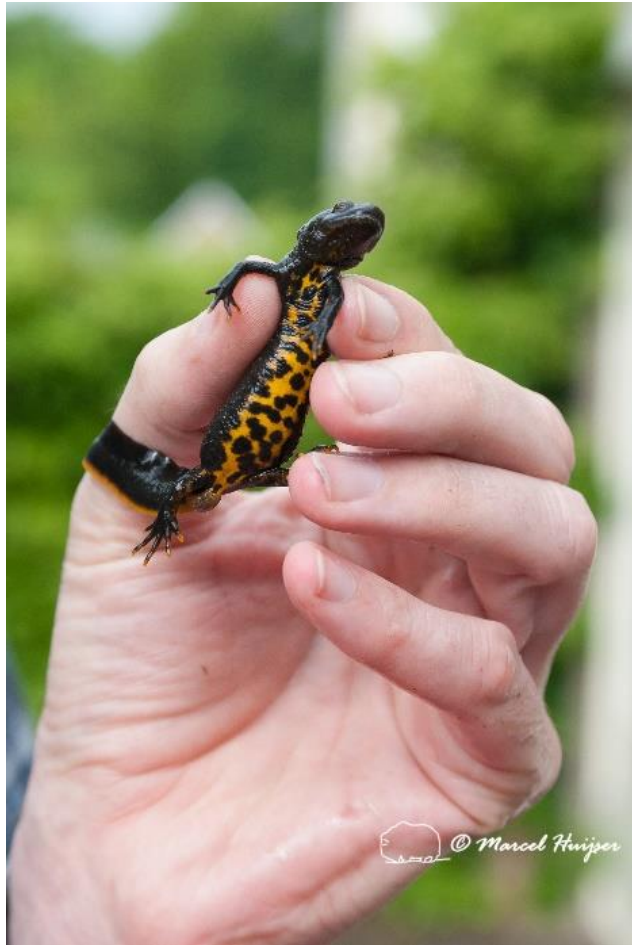
Figure 9: Great crested newts (*Triturus cristatus*) have unique patterns on their belly that can be used to identify individual animals in capture-mark-recapture experiments.

Target Species: The great crested newt (*Triturus cristatus*), an amphibian species, was explicitly named as one of the target species for this overpass (Figure 9). The overpass was at least partially designed for this species. Other target species include red deer (*Cervus elaphus*), Eurasian badger (*Meles meles*), and various insects, including butterfly species.

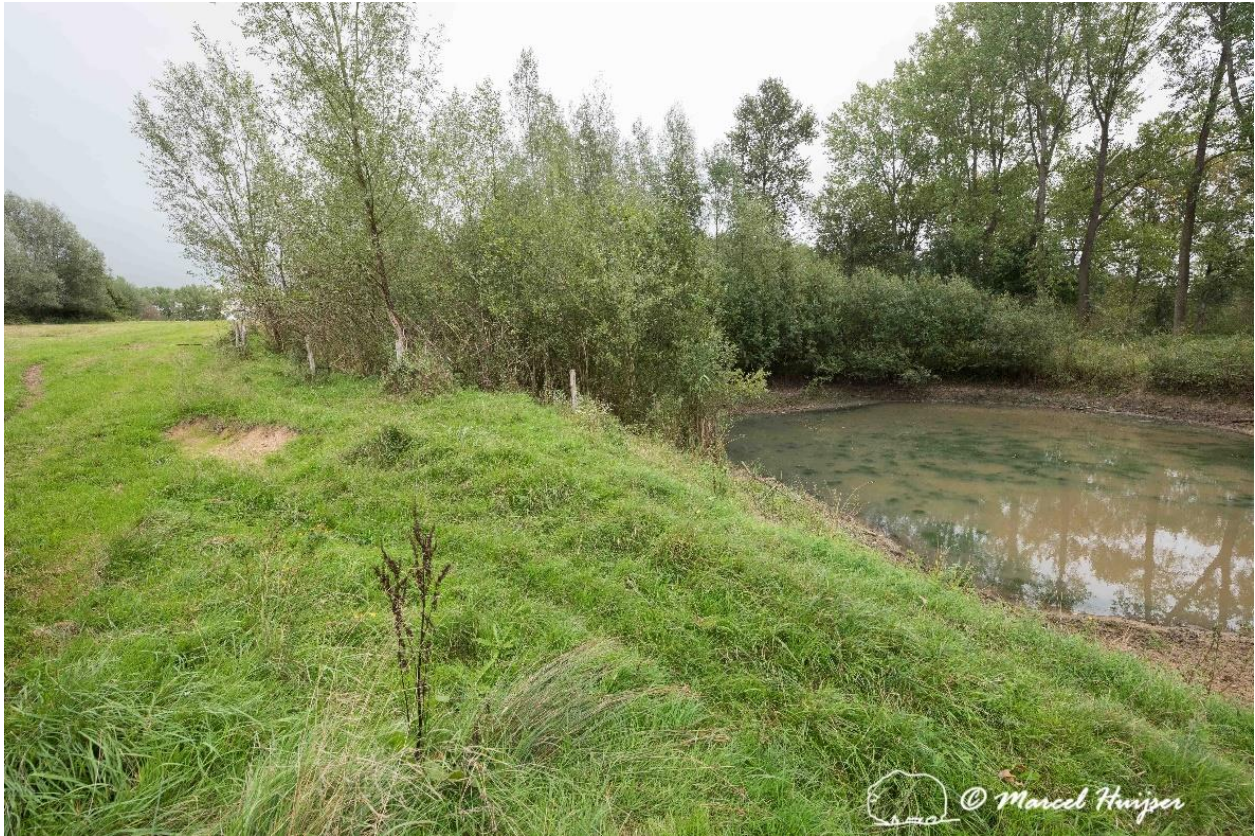
Figure 10: One of the larger pools on the approach of the overpass. Note that the banks are partially open (grass-herb vegetation) and partially covered with shrubs and trees.

- Small pools (“stepping stones,” about 30 cm (1 ft deep)) cascading and connecting to larger pools on either side of overpass (Figure 10 and 11).
- Water is kept above ground through lining and loam on the overpass.
- In dry periods, a pump pumps the water from one of the larger pools on the side overpass to the top of overpass. Then the water cascades (flows) back to the larger pools. In 2018, this pump was not working, illustrating that this pump system requires maintenance, which has been lacking.

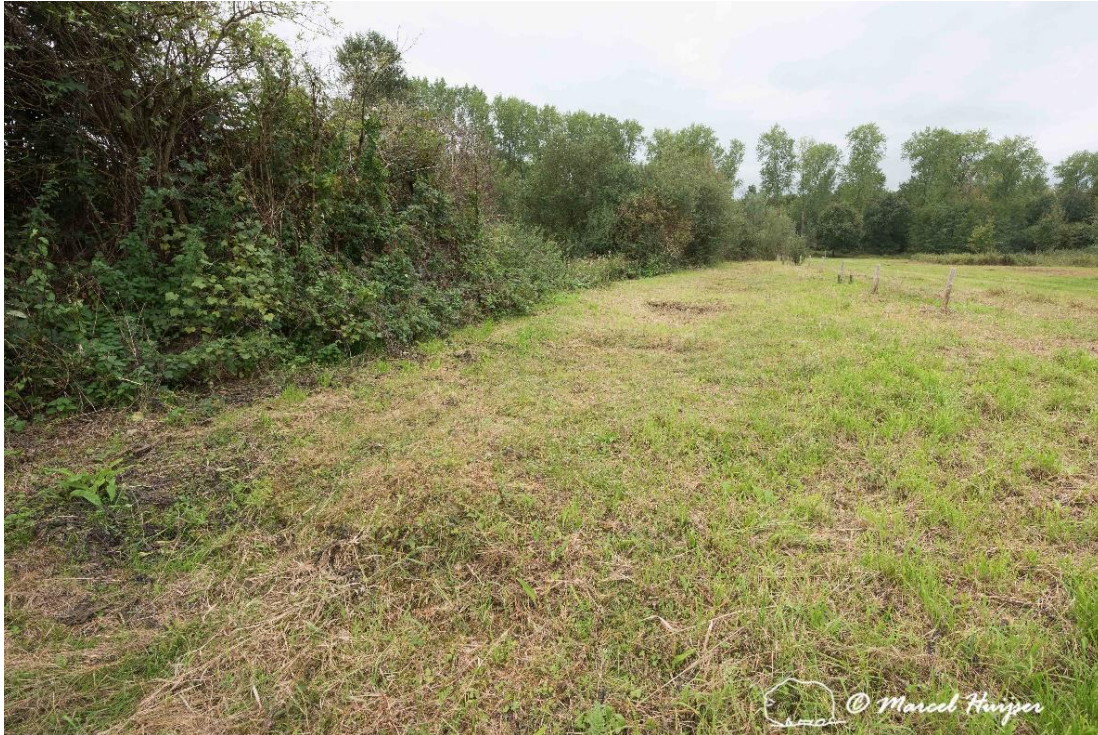
Figure 11: The wet zone is protected from cattle (used as a tool in nature management in the area) with a livestock fence (fence is on right side in the image). Note the small dams just above the center of the image that result in small pools during wetter times of the year. One of the berms is on the left side, at one of the outer edges of the overpass.

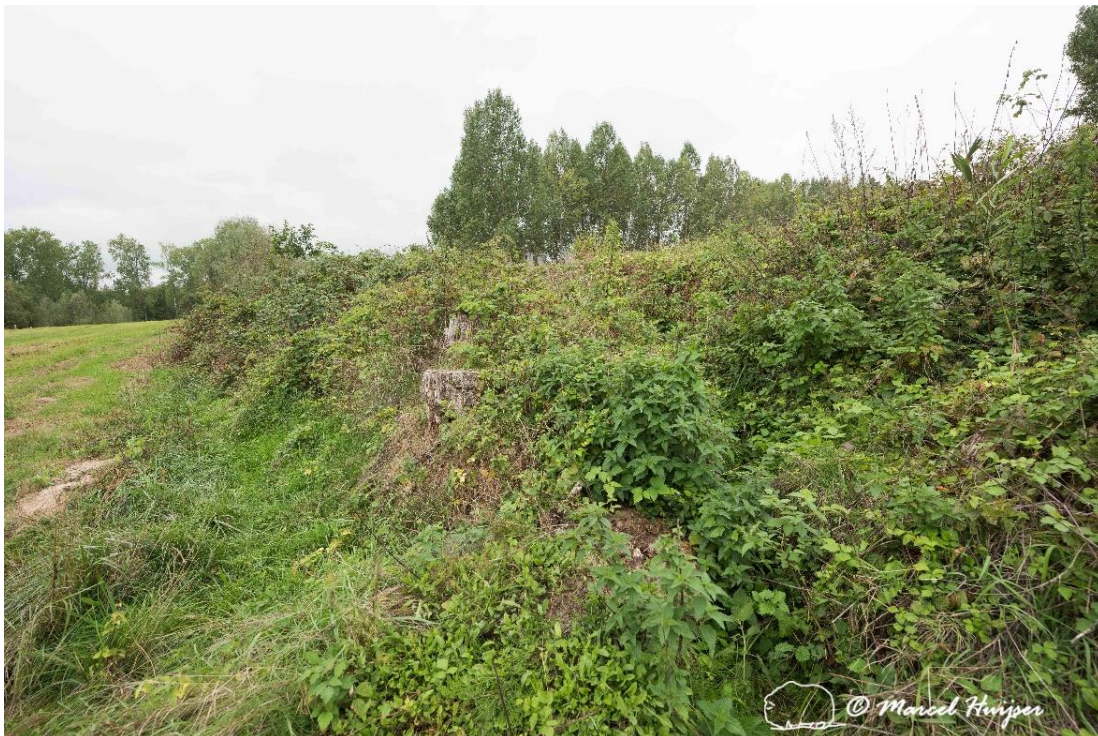
Figure 12: Detail of the berm in the dry zone. It consists of soil, root wads, shrubs (including thorny species such as bramble (*Rubus* spp.)).

Berms with soil, root wads, shrubs, and small trees line the two edges of the overpass to reduce visual and noise disturbance from traffic (Figure 12). These berms also provide cover for small animal species. There is about 38 meters (125 ft) of grass-herb vegetation between the two berms (total width of the overpass is 50 meters (164 ft)).

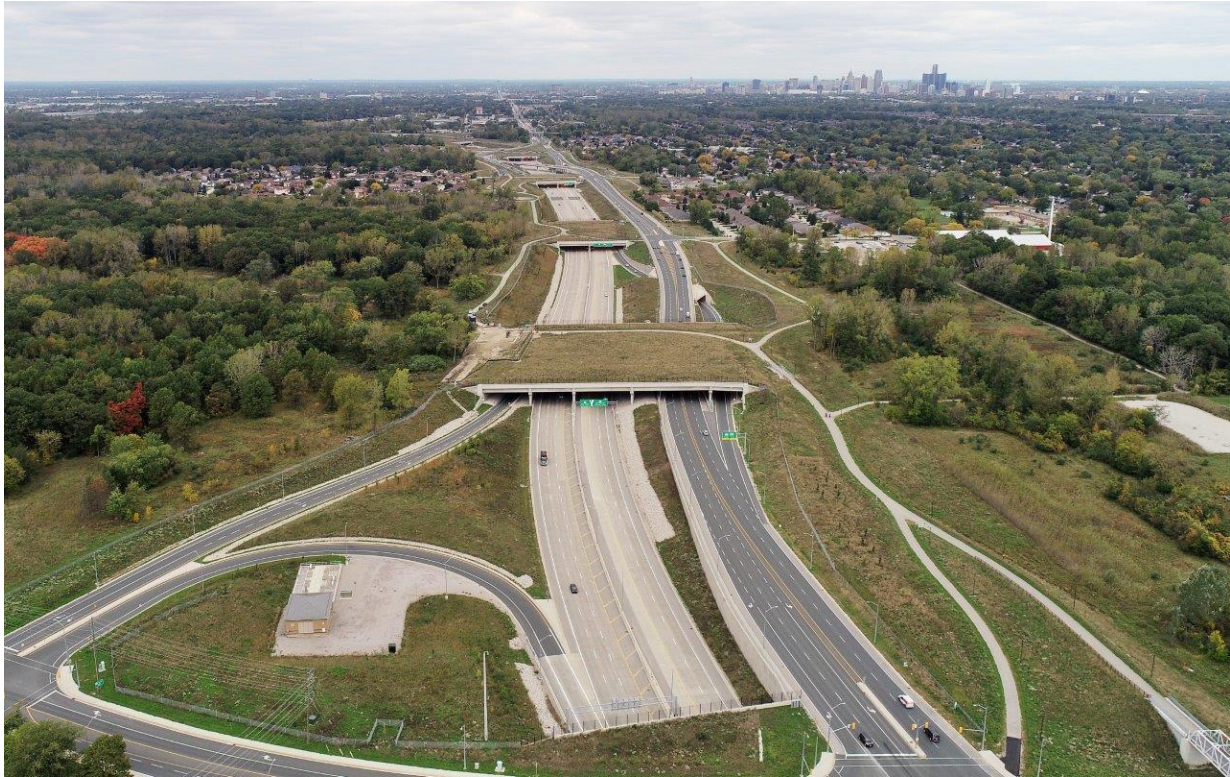
Figure 13: Aerial imagery of a wildlife overpass for snakes in Ontario showing bike path and the vegetation on top of the overpass connecting the habitat on the two sides of the highway. Photo Credit: Ministry of Transportation Ontario, Wood Environment & Infrastructure Solutions.

In addition to restoring and protecting 160 hectares of green space, several green overpasses were created as part of the project (Figure 13). One overpass in particular was built for two “Species at Risk” snakes: the rare Butler’s gartersnake (*Thamnophis butleri*) and Eastern fox snake (*Pantherophis gloydi*) (Figure 14). This overpass connects threatened Tallgrass Prairie habitat (Ontario Ministry of Transportation, 2019; Rt. Hon. Herb Gray Parkway 2019; <https://www.hgparkway.ca/>). The overpass is unique because there is a bicycle path that also has an underpass for snakes to reduce ‘trail-kill’ along the bike path (Figure 15, red circle). The effectiveness of the overpass and underpass system is currently being monitored using passive integrated transponder (PIT) tagging of snakes and radio-telemetry.

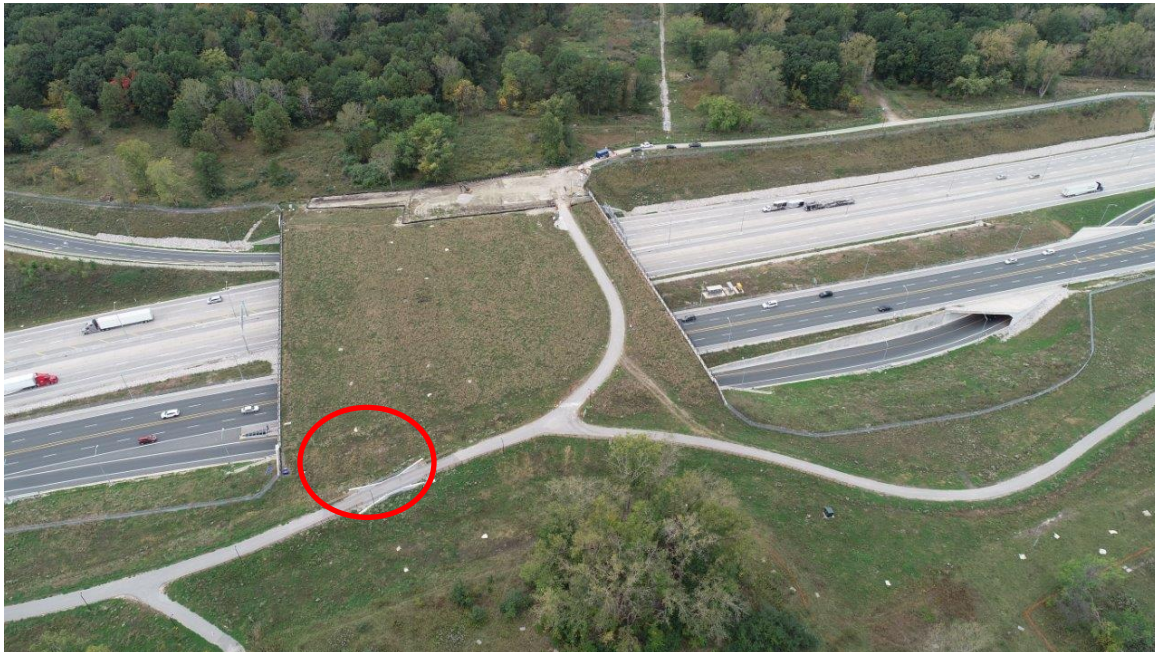
Figure 14: Aerial imagery of a wildlife overpass for snakes in Ontario showing a bike path and the location of an underpass on top of the overpass (red circle). The image also shows the vegetation on top of the overpass.

of the overpass connecting the tallgrass prairie habitat on the two sides of the highway. Photo Credit: Ministry of Transportation Ontario, Wood Environment & Infrastructure Solutions.

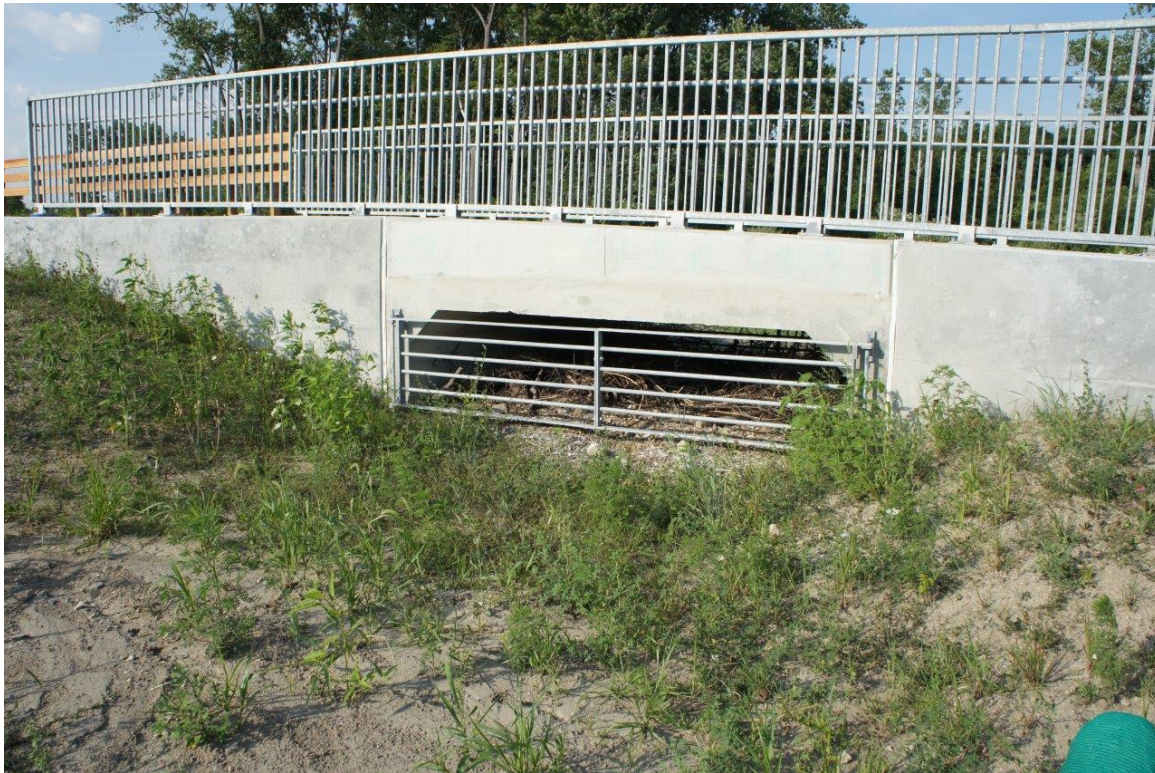
Figure 15: Detail of the underpass for snakes under a bicycle path on top of the wildlife overpass in Windsor, Ontario. Photo Credit: Ministry of Transportation Ontario, Wood Environment & Infrastructure Solutions.
