# **Review of Proposed Bighorn Sheep Mitigation Measures Along Montana Hwy 200, East of Thompsonfalls, Montana**

Western Transportation Institute  
College of Engineering  
Montana State University – Bozeman

A report prepared for the  
Montana Department of Transportation  
2701 Prospect Drive,  
Helena, Montana

May 23, 2013

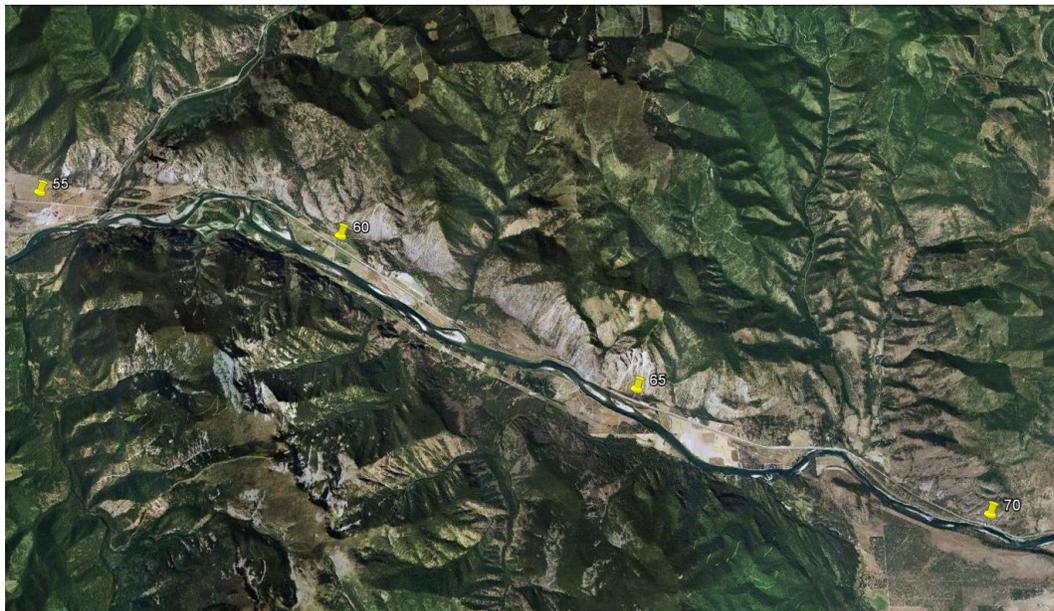
**Figure 1: Montana Highway 200 between mile reference posts 55.0 and 70.0, east of Thompsonfalls, MT, USA.**

Currently much of the road section between mile reference post 55 and 70 is relatively narrow, windy, has short sight distances and is located at the bottom of steep rocky slopes (Figure 1). The railroad and the Clark Fork River parallel MT Hwy 200 on the south side. In several sections there is a rock fence between MT Hwy 200 and the railroad to stop rocks that may be falling from the slopes on the north side of the road. Some wildlife, including bighorn sheep are killed on the railroad.

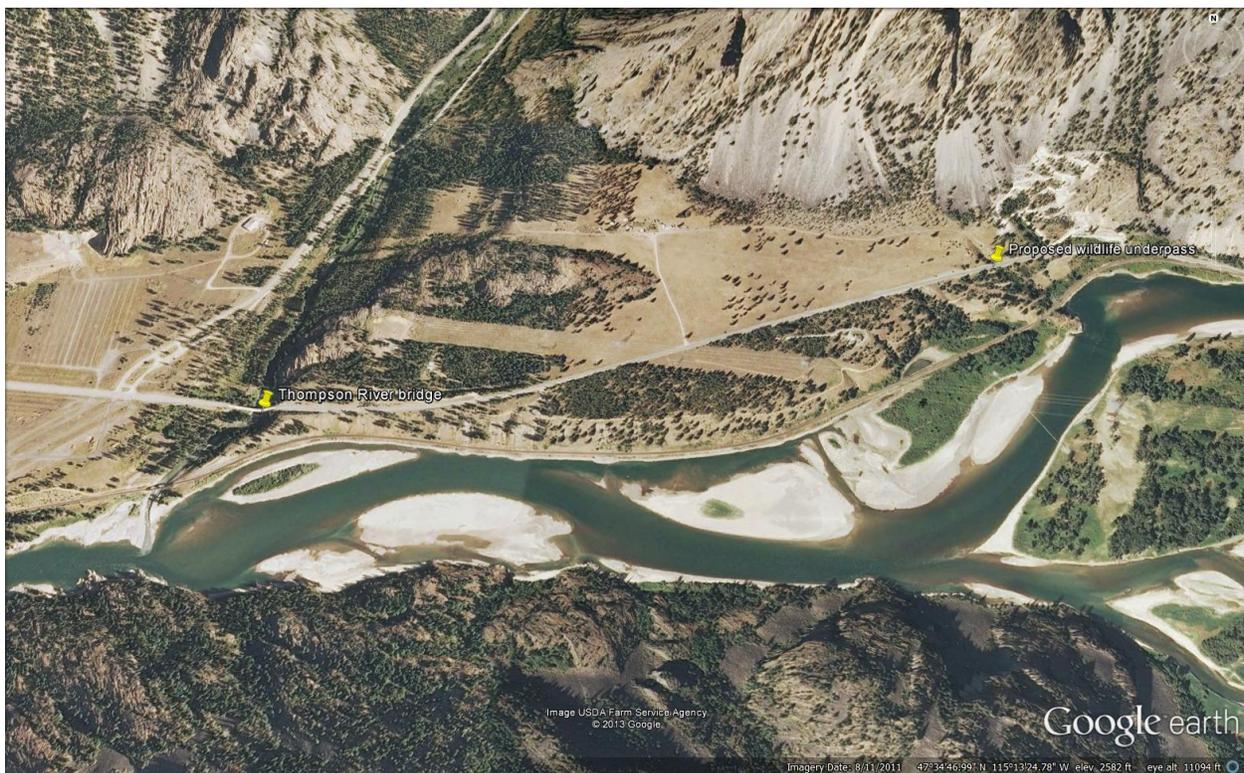
**Figure 5: The two proposed safe crossing opportunities for wildlife along MT Hwy 200, east of Thompsonfalls, MT.**

The proposed highway reconstruction project includes measures aimed at reducing collisions with the bighorn sheep while also providing safe crossing opportunities for bighorn sheep and other wildlife species in the area. In particular, the current plans for the section between mile reference posts 55.9 and 59.1 include wildlife fencing, wildlife barriers (gates or wildlife guards) at access roads, and safe crossing opportunities for large mammals (i.e. bridge across Thompson River, and a 30 ft (9.15 m) wide, 11 ft (3.35 m) high bridge with reinforced soil abutments approximately 1.3 miles (~2.1 km) to the east) (Pat Basting, Personal communication, Montana Department of Transportation) (Figure 5).
