# **Wildlife Data Collection and Potential Highway Mitigation along State Highway 75, Blaine County, Idaho**

Western Transportation Institute  
College of Engineering  
Montana State University

Board of Blaine County Commissioners  
206 First Avenue South, Suite 3000  
Hailey, Idaho 83333

May, 2008

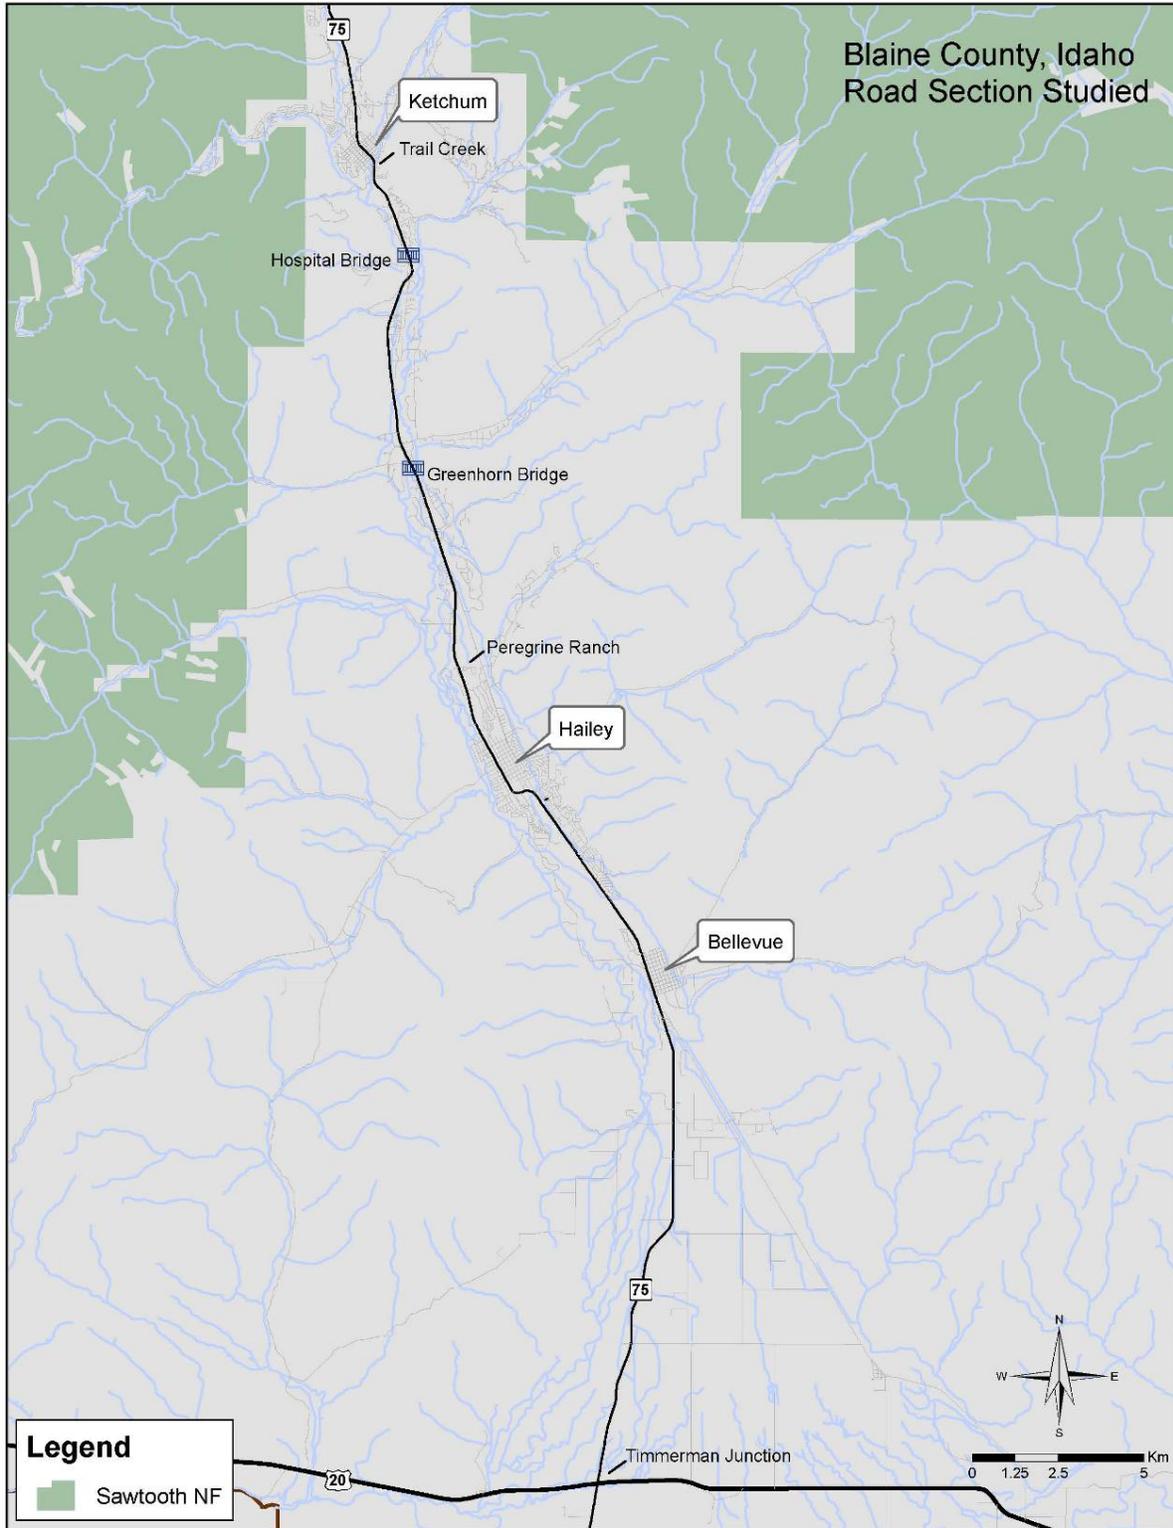
**Figure 1: The 26 mile long road section of SH 75 under study. The road section starts at Timmerman Junction (junction with Highway 20) at the south end, and ends at the Trail Creek Bridge in Ketchum. In addition, the map shows the location of two bridges across the Big Wood River that may be used by large mammals as a wildlife underpass.**

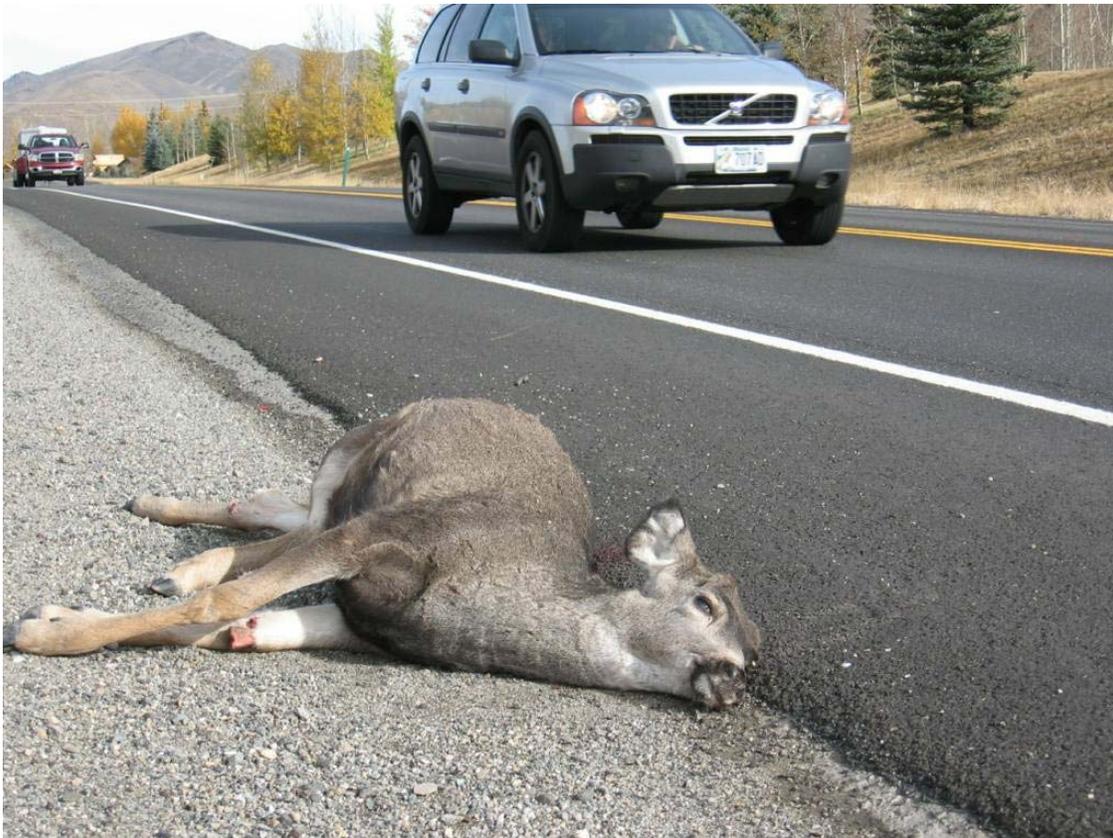
**Figure 6: Road-killed mule deer along SH 75 (© Marcel Huijser, WTI-MSU).**

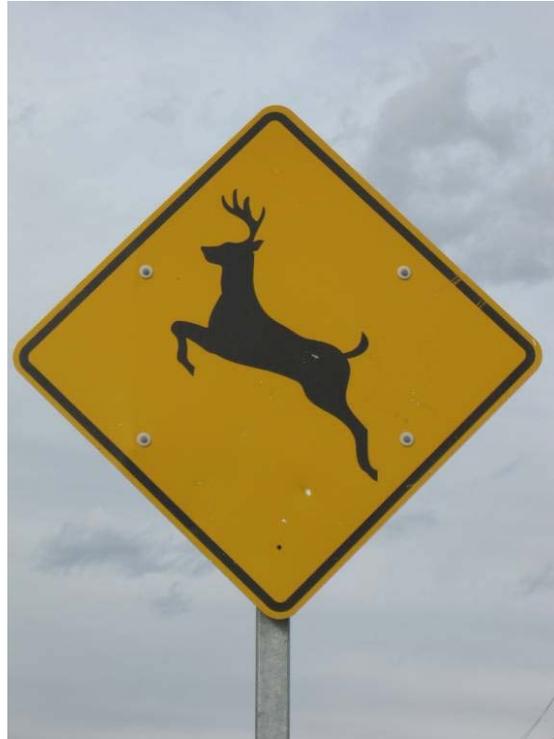
**Figure 7: Standard deer warning sign along SH 75**

Warning signs for large mammals have been installed between Timmerman Jct and Ketchum (Figure 7 through 11). As part of this project the Western Transportation Institute at Montana State University made an inventory of all warning signs for large mammals and speed limit signs on the road section under study (Figure 12 and 13). Wildlife warning signs are unlikely to be effective though (see review in Huijser et al., 2007a; b) and the current level of WVCs is considered too high by Blaine County, ITD, Idaho Department of Fish and Game, and the public, despite the presence of the warning signs.

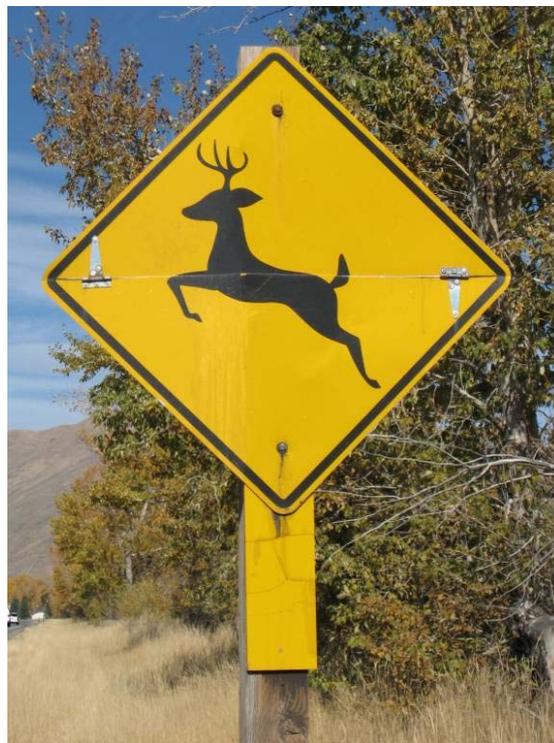
**Figure 8: Standard deer warning sign with hinges (option to display only in certain seasons) along SH 75 (© Marcel Huijser, WTI-MSU).**

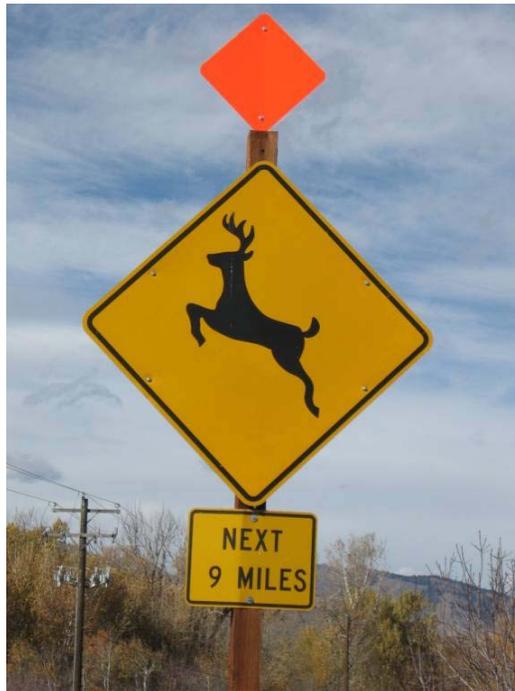
**Figure 9: Enhanced (orange square) deer warning sign along SH 75 with distance indication (© Marcel Huijser, WTI-MSU).**

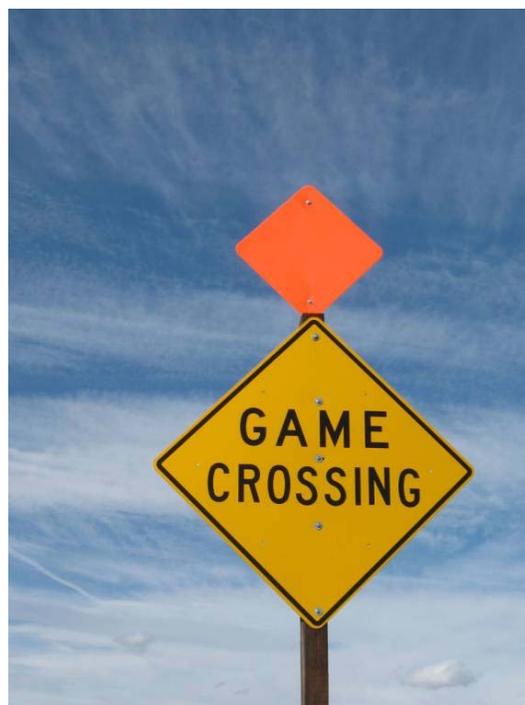
**Figure 10: Enhanced (orange square) game warning sign along SH 75 (© Marcel Huijser, WTI-MSU).**

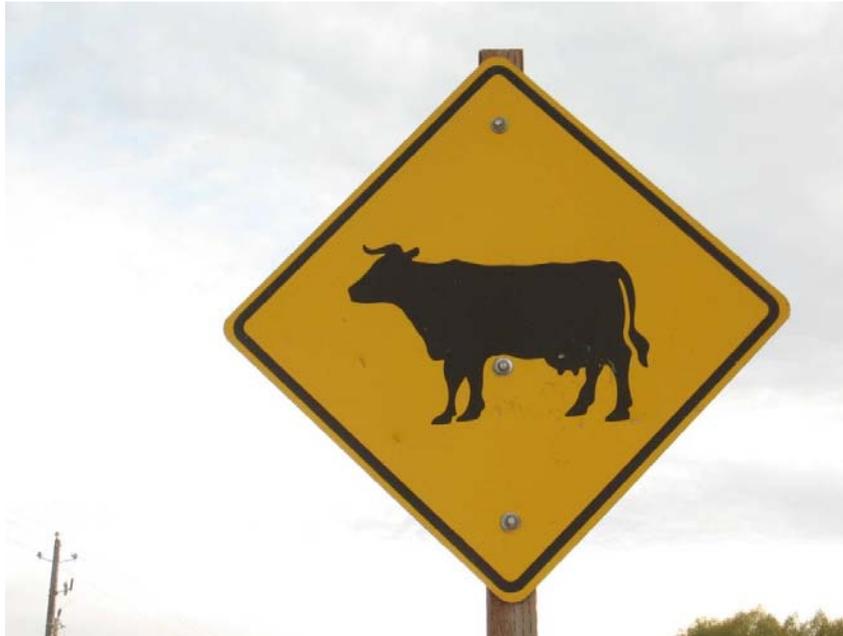
**Figure 11: Cattle warning sign along SH 75 (© Marcel Huijser, WTI-MSU).**

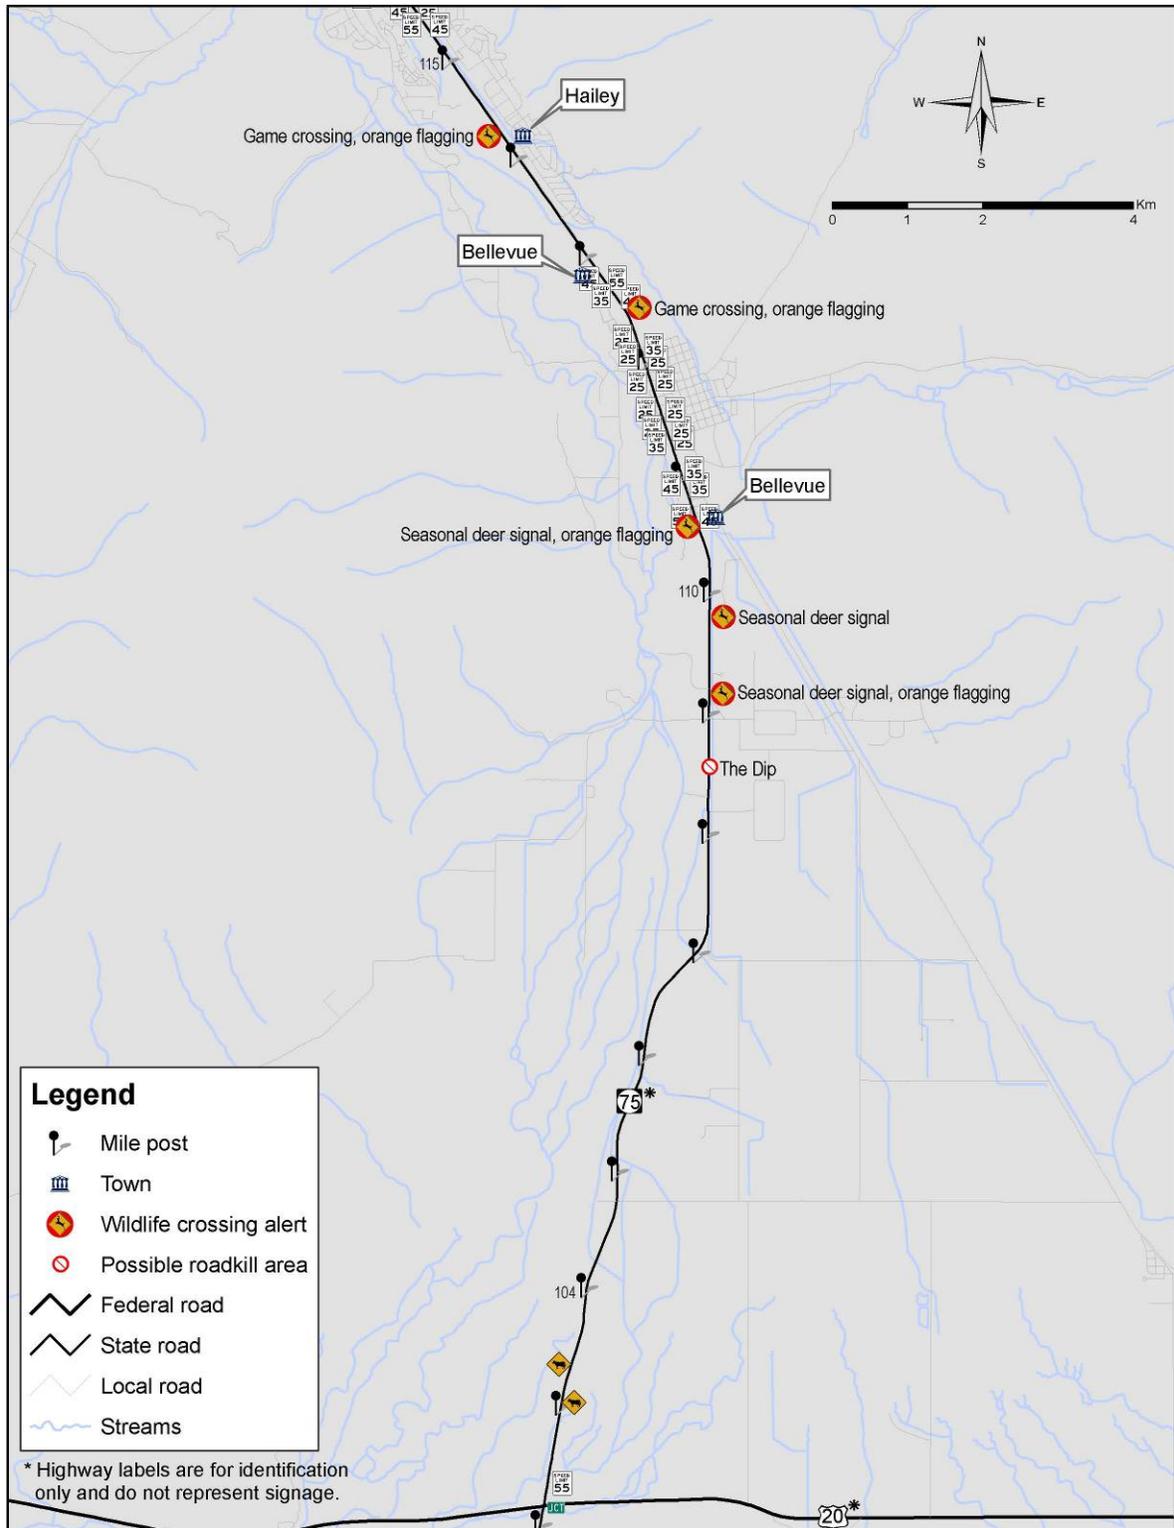
Figure 12: All large mammal warning signs and speed limit signs along the section of SH 75 under study (southern half). Road signs on the left side of the road are for south bound traffic, road signs on the right side of the road are for north bound traffic.

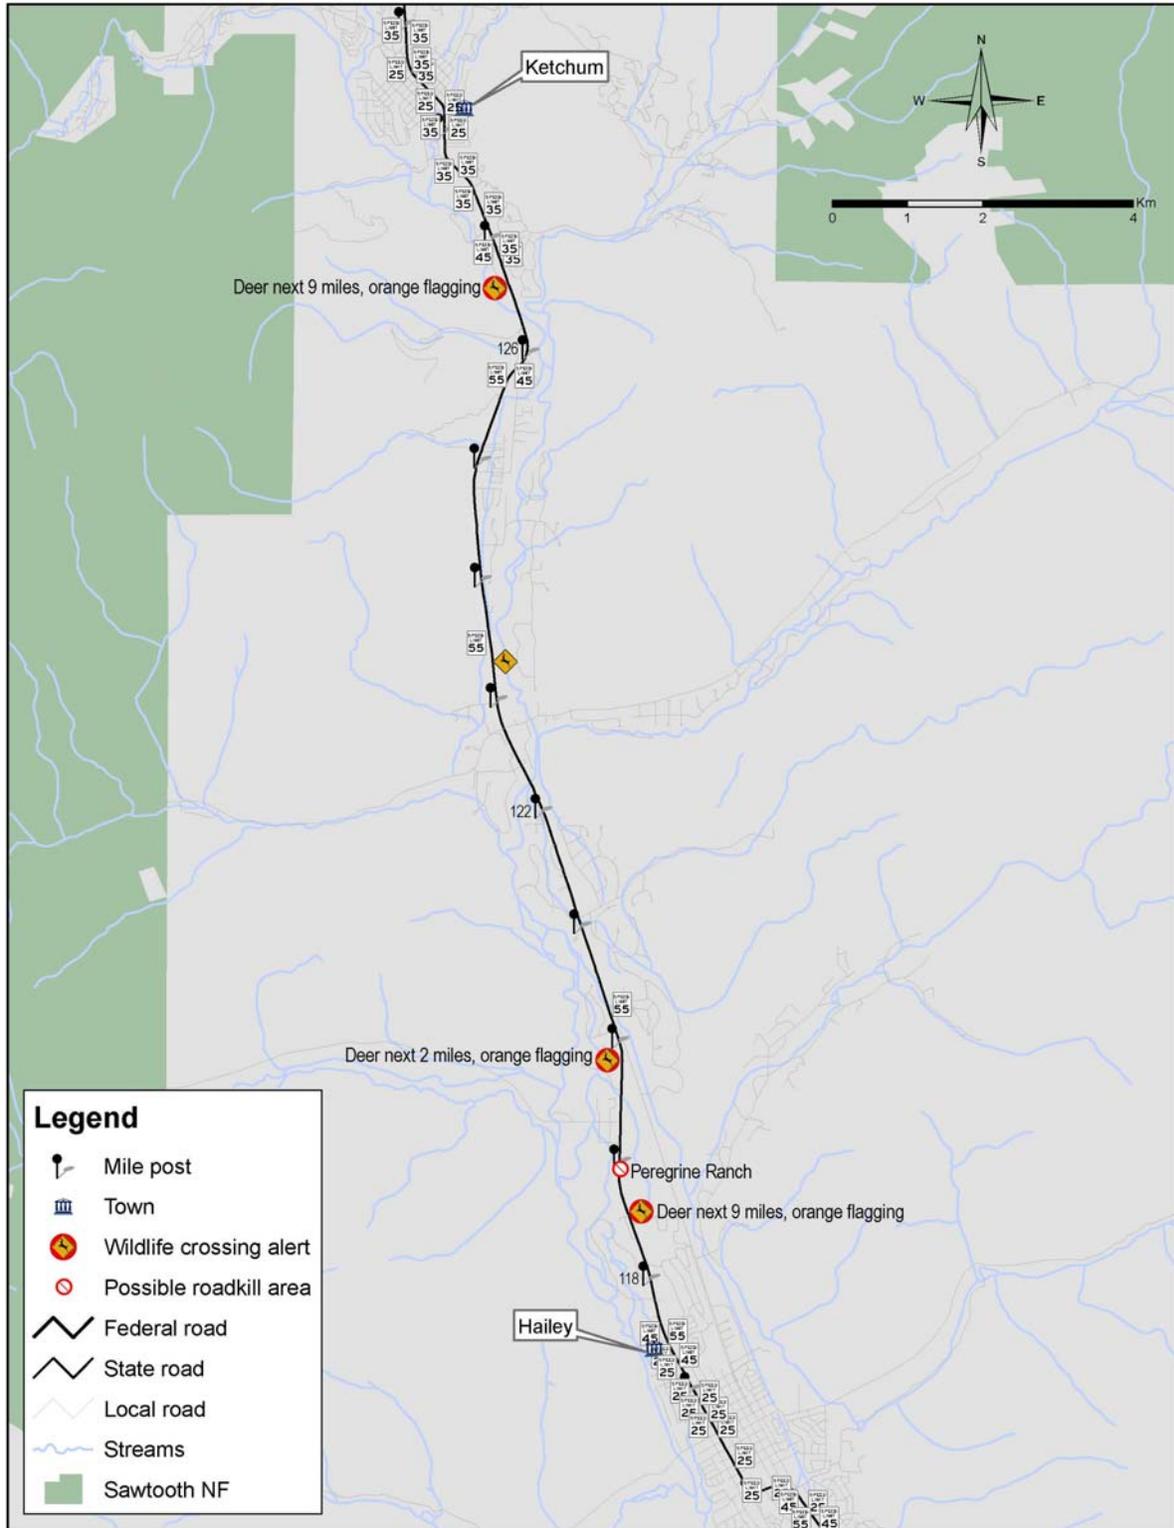
Figure 13: All large mammal warning signs and speed limit signs along the section of SH 75 under study (northern half). Road signs on the left side of the road are for south bound traffic, road signs on the right side of the road are for north bound traffic.

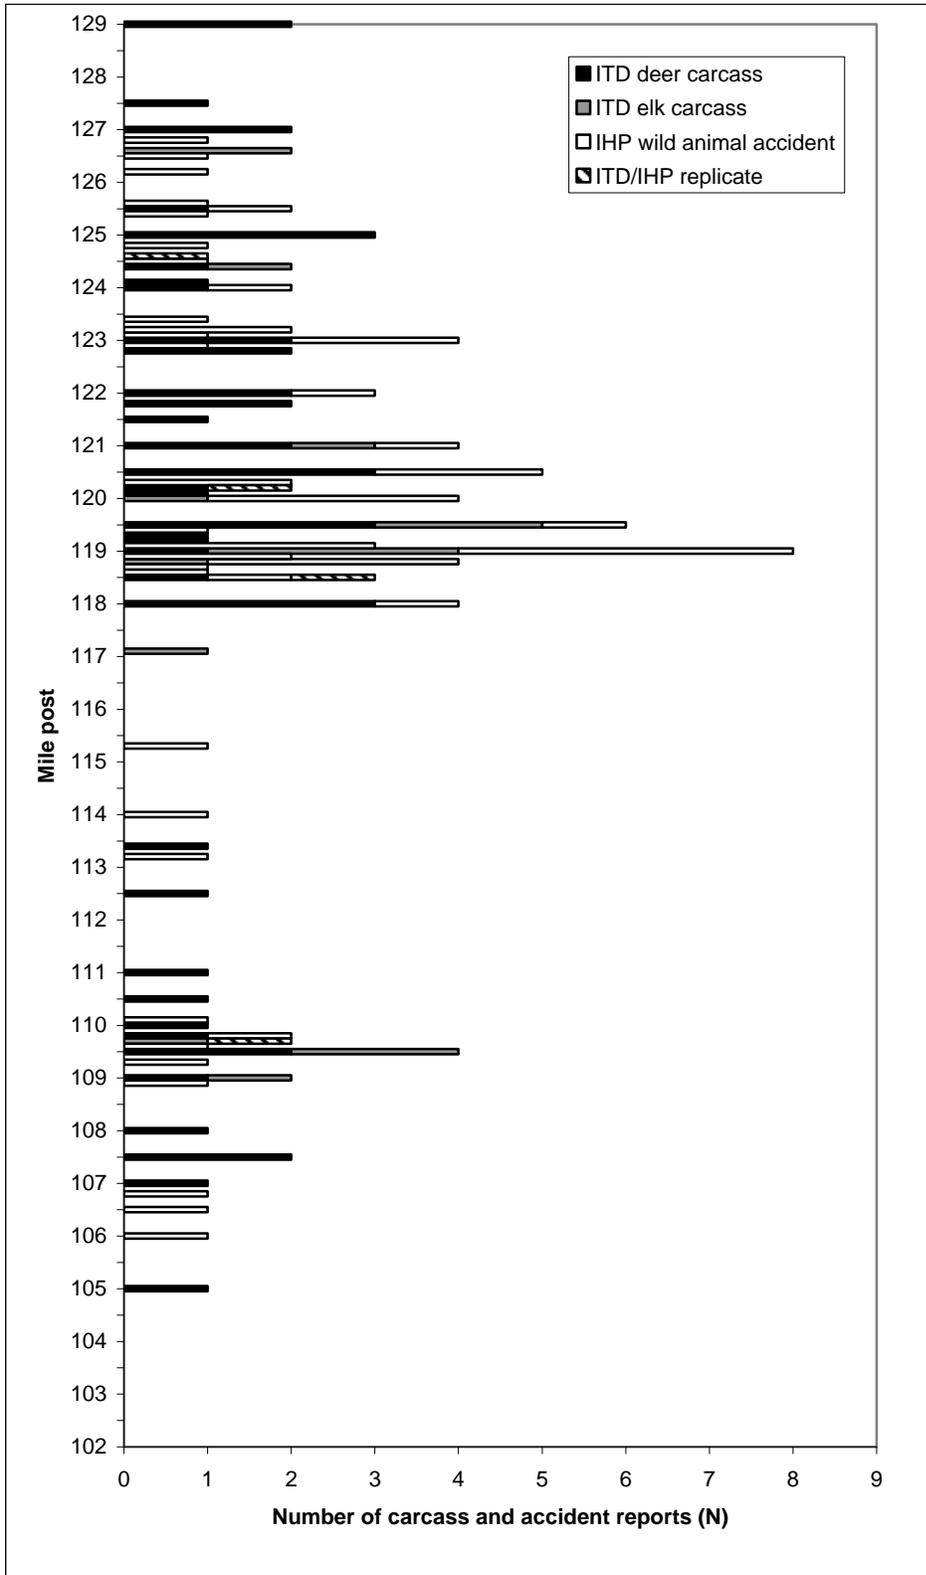
Figure 16: Locations of historic WVC reports by one-tenth of a mile (Total n = 126) (Data provided by ITD and IHP).

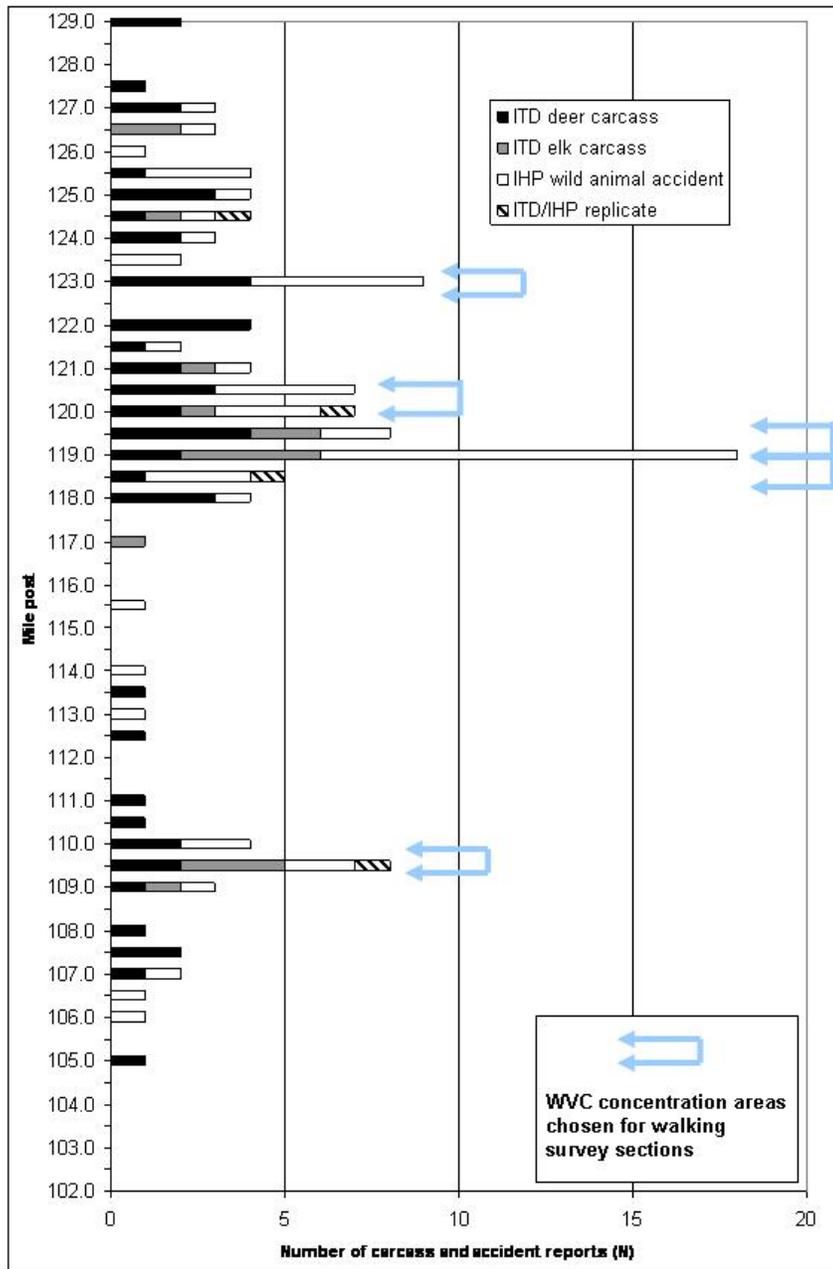
Figure 17: Locations of historic WVC reports aggregated to .5 miles (Total n = 126) (Data provided by ITD and IHP).

In order to more easily define the road sections (maximum length of .5 miles) with the highest concentration of historic WVCs, all reports were aggregated to the closest whole number or .5 mile post (Figure 17). If the mile post location was at .1, .2, .8 or .9 mile, it was merged with nearest whole number mile post. If the mile post location was at .3, .4, .6 or .7 mile, it was merged with the .5 mile post.

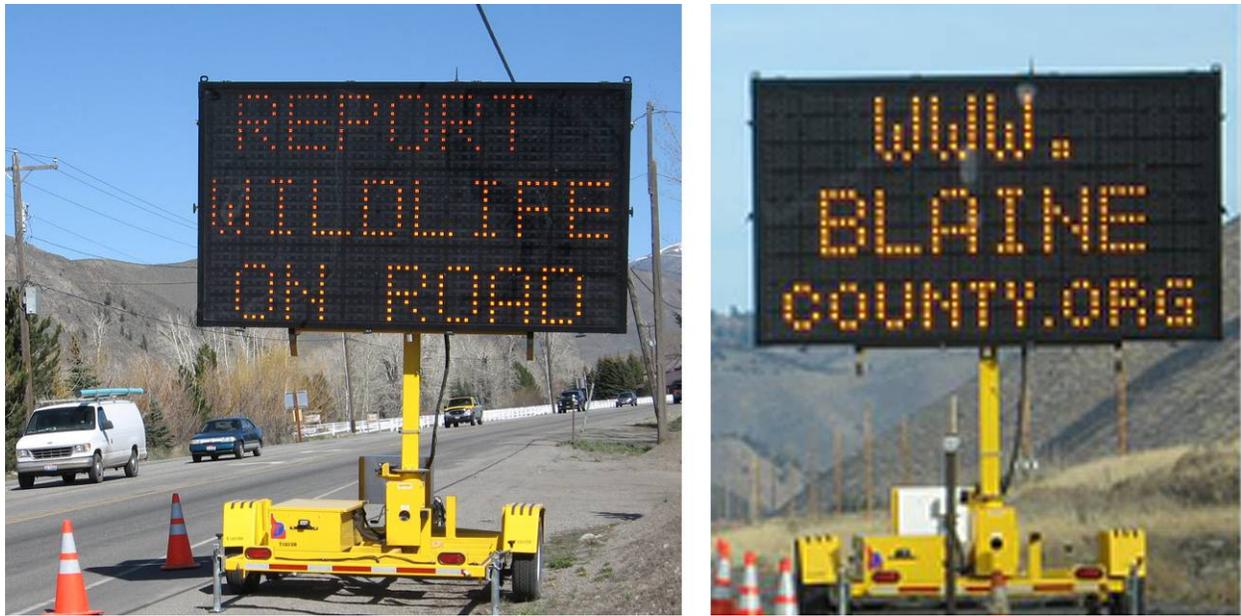
**Figure 30: Two rotating screens of the variable message sign deployed by ITD (© Angela Kociolek, WTI-MSU).**

On March 12, 2007, WTI and Blaine County issued a press release to the media stating that wildlife reporting website was online. In April, June and November, 2007, ITD deployed a variable message sign (VMS) to advertise the website for at least seven consecutive days (Table 2). The VMS rotated between two screens, the first of which requested the public to report wildlife on road the second of which directed them to the website (Figure 30).

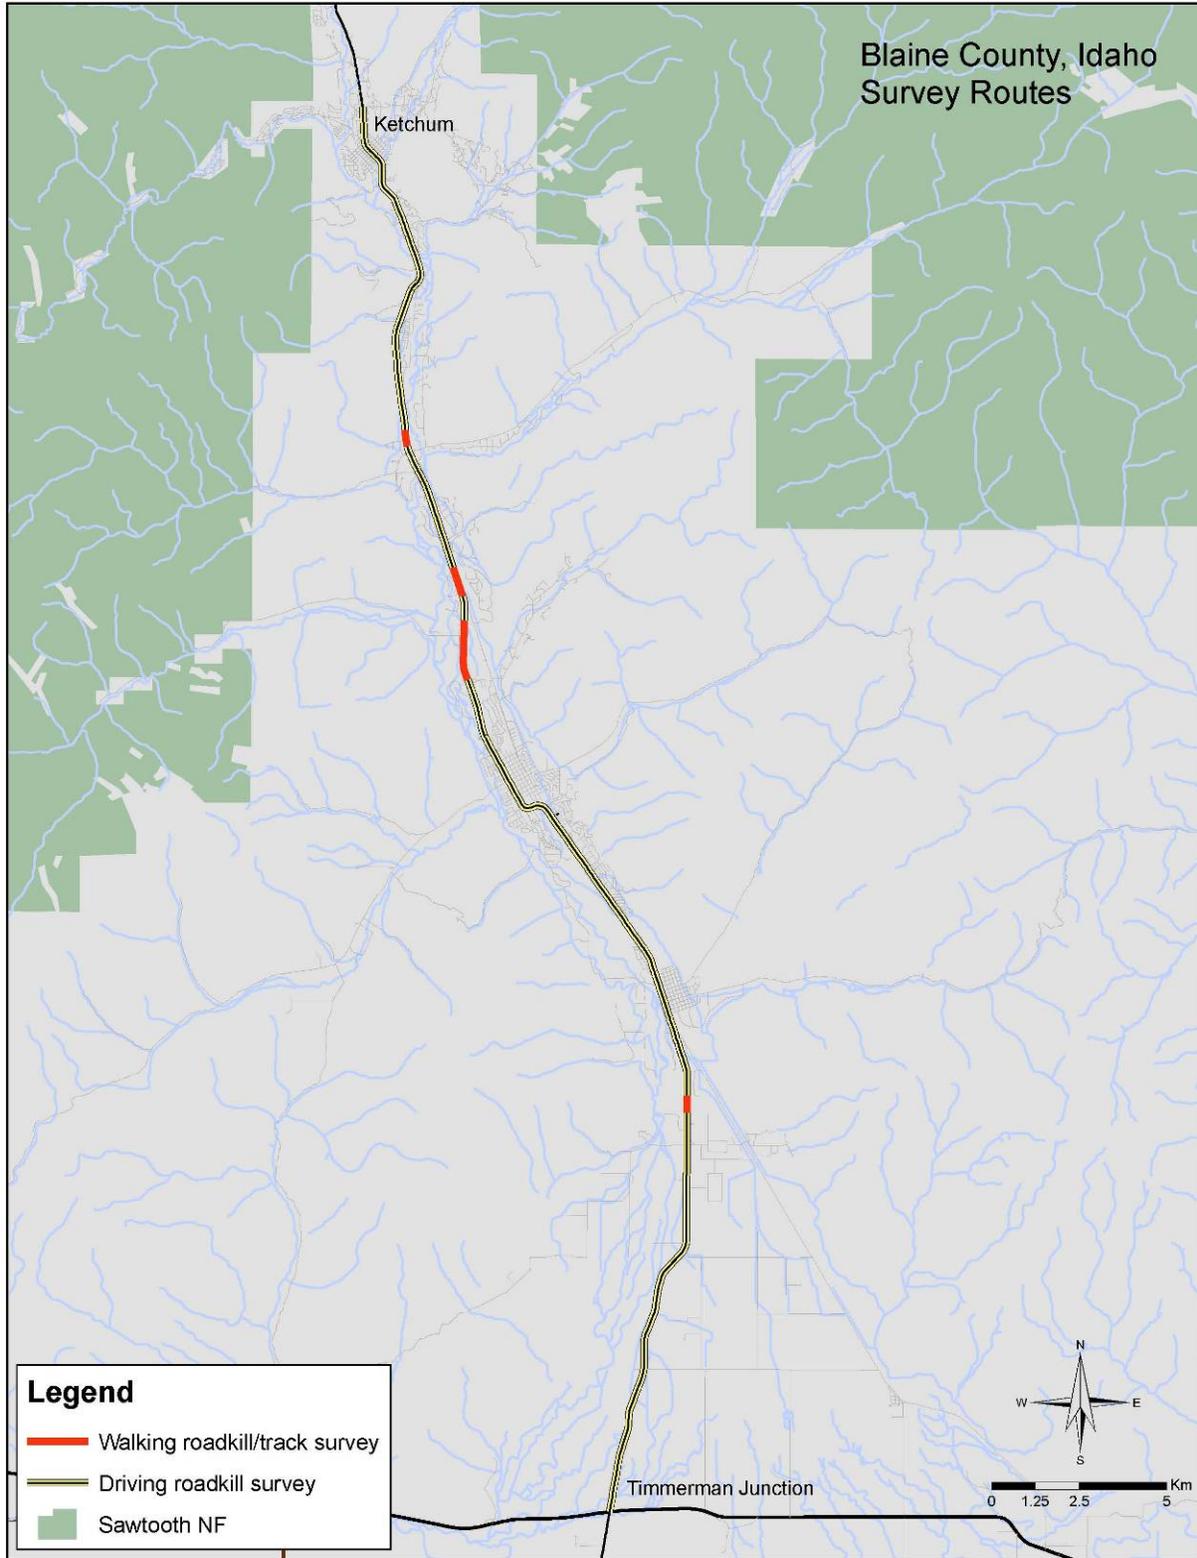
**Figure 35: Map of road mortality driving and walking survey routes. Note that road mortality walking survey sections are the same as the snow tracking section to be discussed in Section 4.1.**

For safety reasons, surveys generally began after 9 am to avoid morning commuter traffic. A flashing amber light was mounted to the top of the vehicle and a hard hat and safety vest was worn when walking along the roadway. The 26 mi long road section was driven by the observer in both directions. The road section extended from Timmerman Junction (mile post 102.1) to Saddle Road just north of Ketchum (milepost 129.2) (Figure 35). Saddle Road was chosen as a convenient and safe turn around point. The initial direction of driving surveys alternated between heading north and south each day. The five road sections with the highest concentration of historic WVCs, as determined from the analysis of historic ITD carcass and IHP accident data (see section 2.3), were selected for walking surveys. The maximum length of each walking section was 0.5 miles. Walking surveys were conducted in the right-of-way on both sides of the road while facing traffic (Figure 35 - 36).

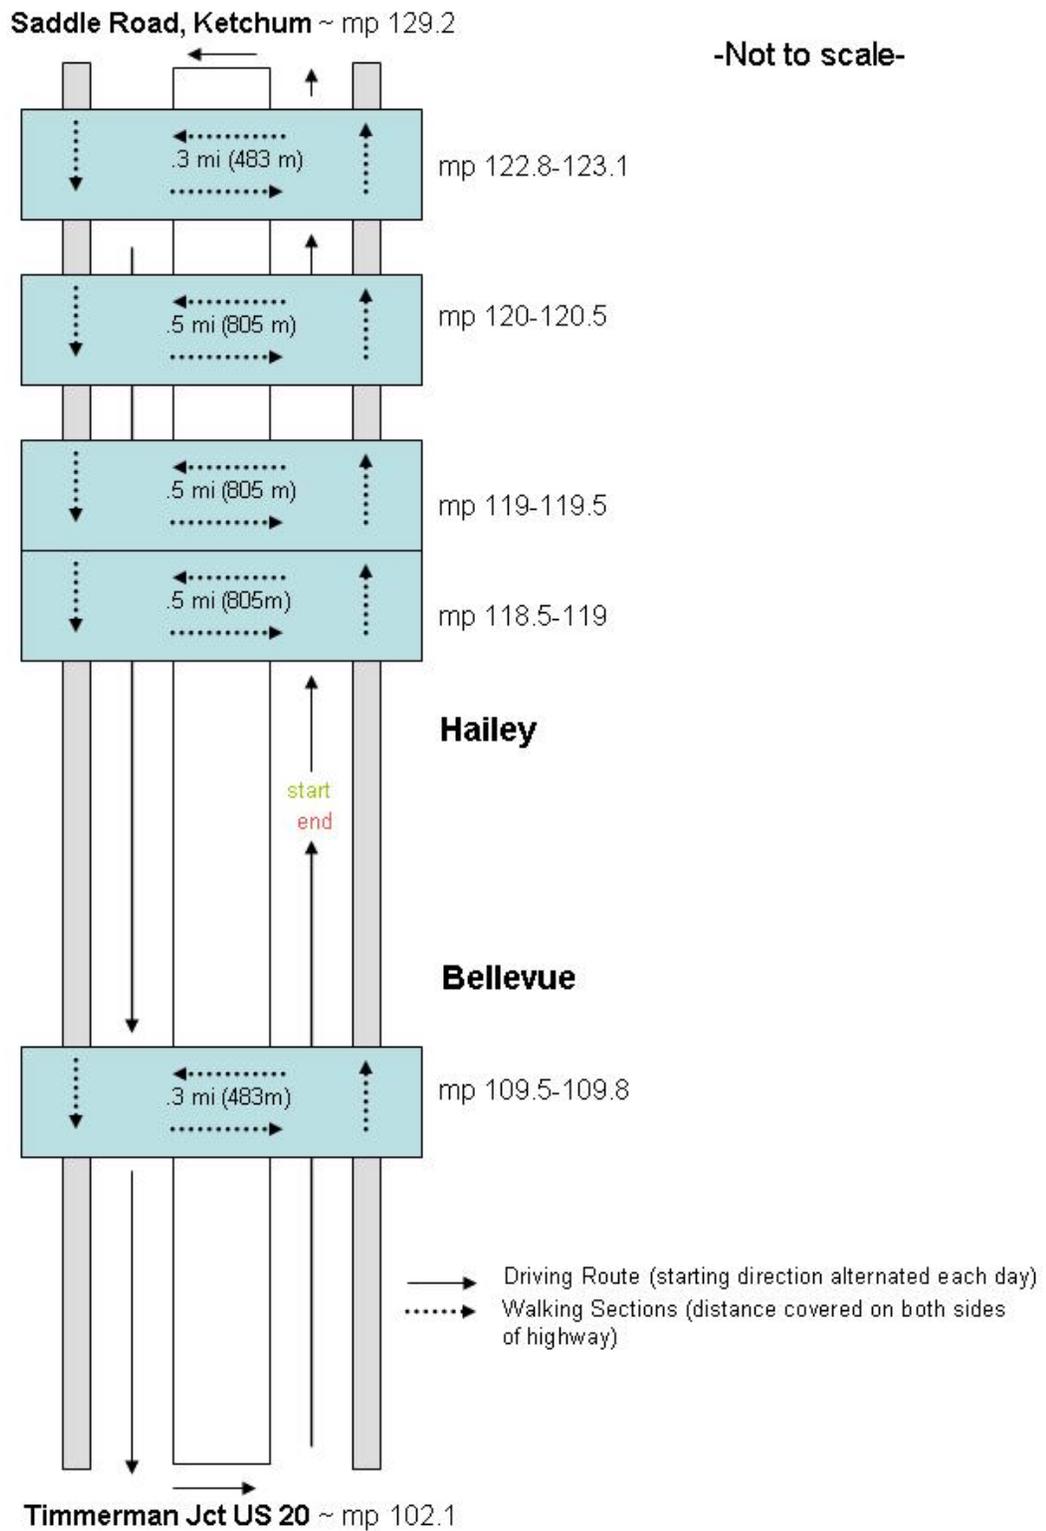
**Figure 36: Schematic presentation of the driving and walking road mortality survey routes.**

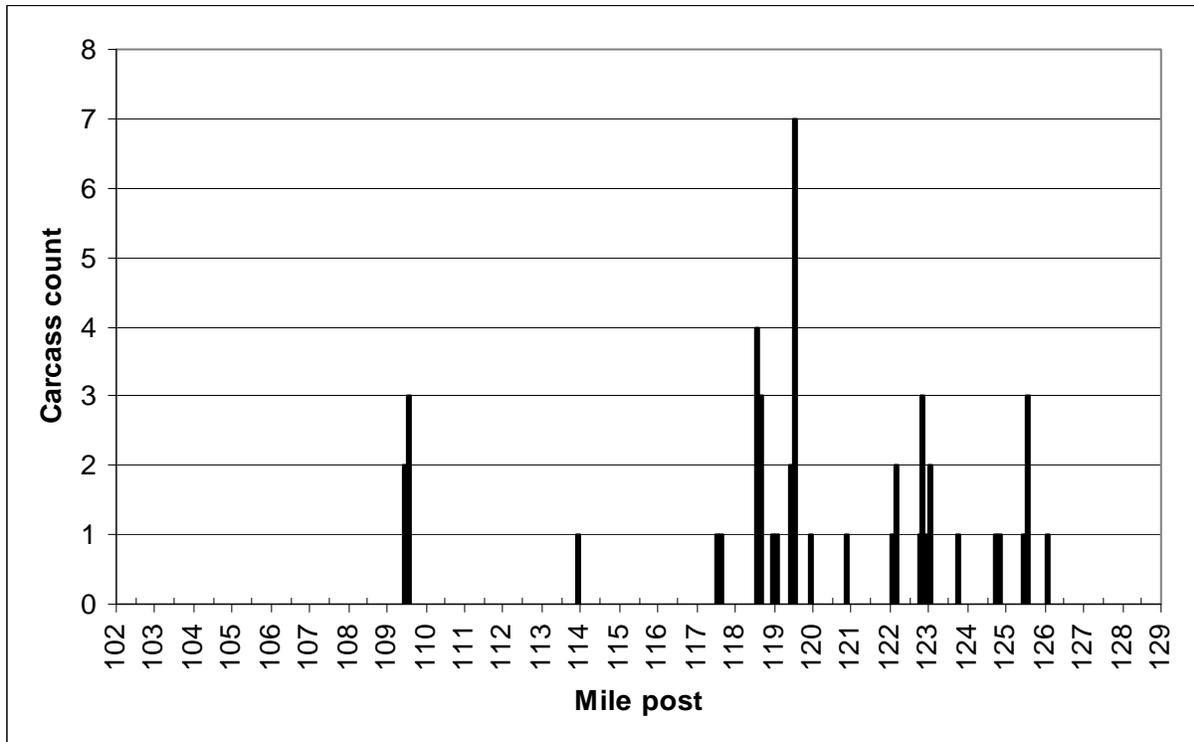
Figure 42: Distribution of mule deer and elk road mortality combined detected during WTI surveys by .1 mile. (Total n =46).

All ungulate road kills detected during WTI surveys were found between MP 109.0 - 126.0 with the highest concentration found between MP 118.5-119.6 (Figures 42 and 43). Four out of five current (WTI) road mortality concentration areas match those found in the historical data (ITD and IHP) as defined in Section 2.3 (Figure 44). These current data confirm that historical data was useful in determining the locations of WVC concentration areas.

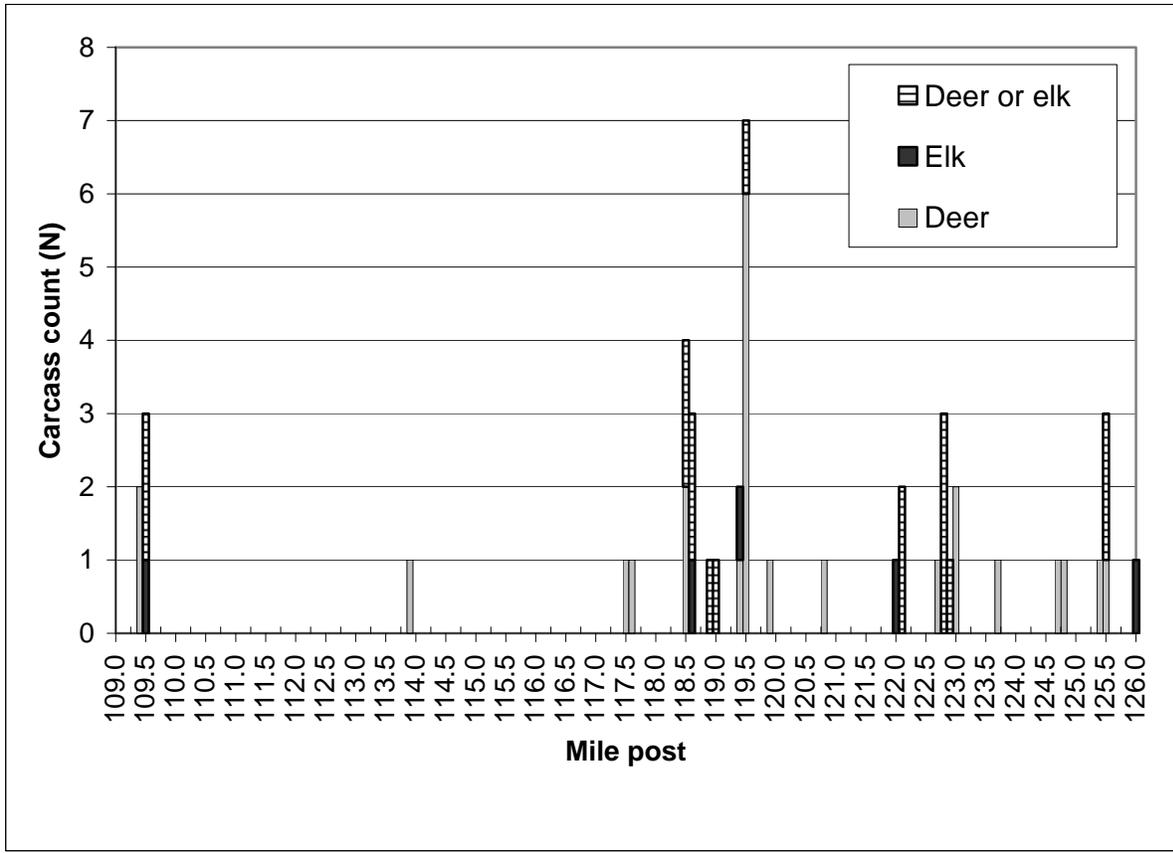
Figure 43: Distribution of mule deer and elk road mortality in subsection of study area between MP 109.0-126.0. (Total n = 46).

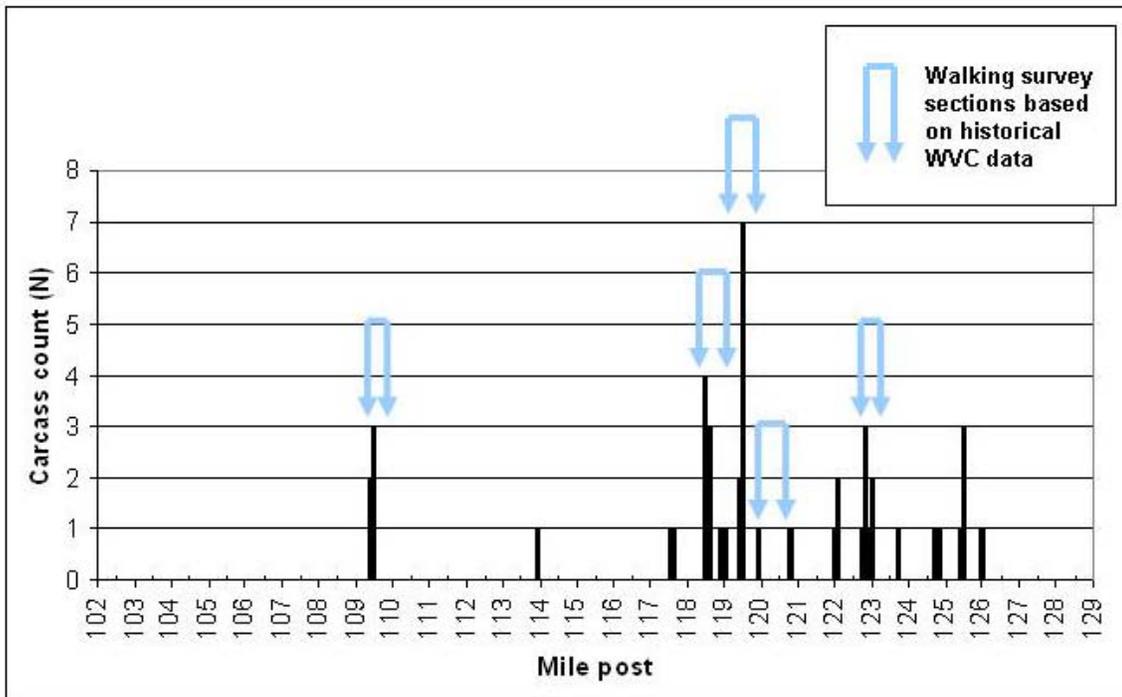
**Figure 44: Current road mortality concentration areas compared to historical concentration areas.**

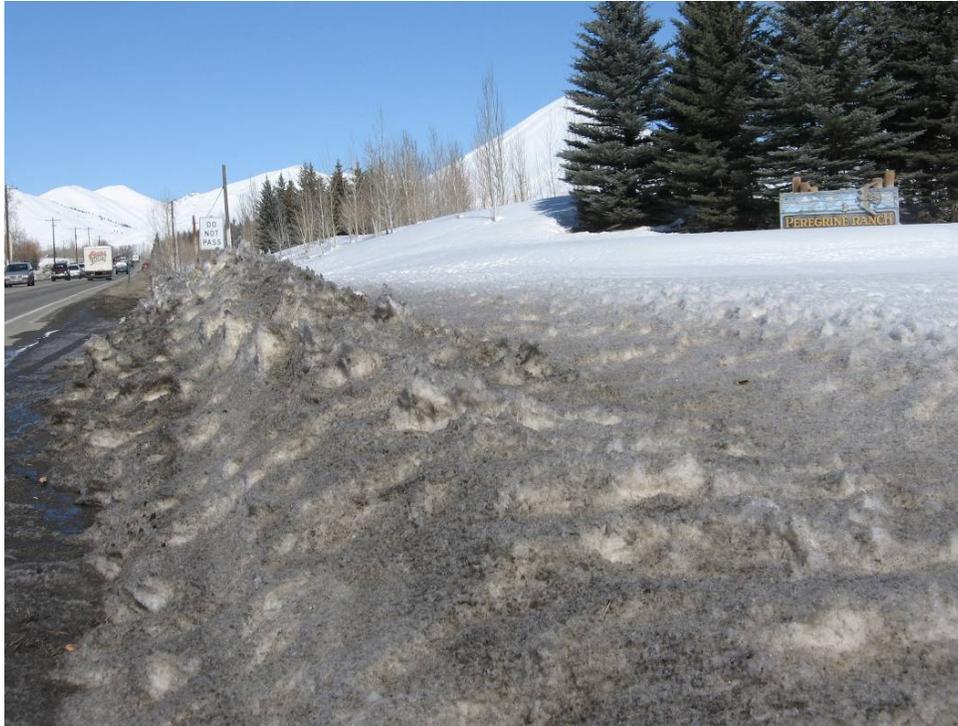
**Figure 46: Fallen snow and mounds of plowed snow have the potential to hide carcasses (© Angela Kociolek, WTI-MSU).**

During the course of WTI surveys, it was found that environmental factors, including fallen snow, vegetation height, late season vegetation camouflaging color affected the surveyor’s ability to detect carcasses (Figures 46-48). Despite the use of an amber warning light and because of much of the study area is comprised of only two lanes, it was necessary to maintain a certain minimum driving speed and not intervene with the flow of traffic. Therefore, sometimes speed was greater than 50 mi/h which may have also limited the surveyor’s ability to detect carcasses.

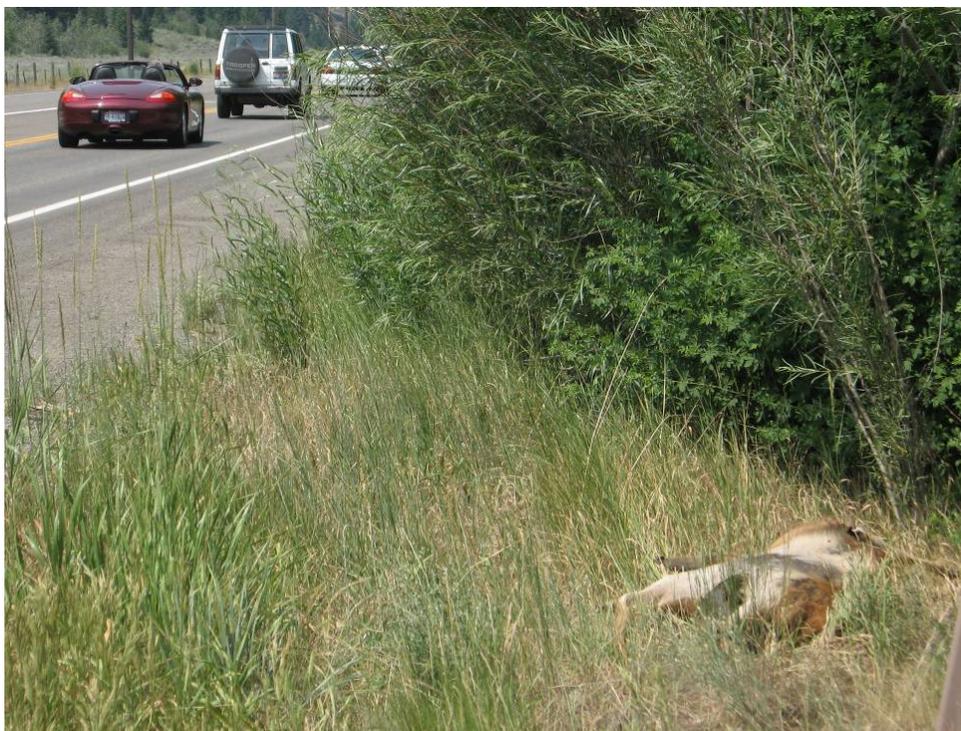
**Figure 47: This mule deer carcass was missed during a driving survey on at least one day; vegetation height from the perspective of the road and the need to maintain speed in the flow of traffic probably affected detection ability in this case (© Angela Kociolek, WTI-MSU).**

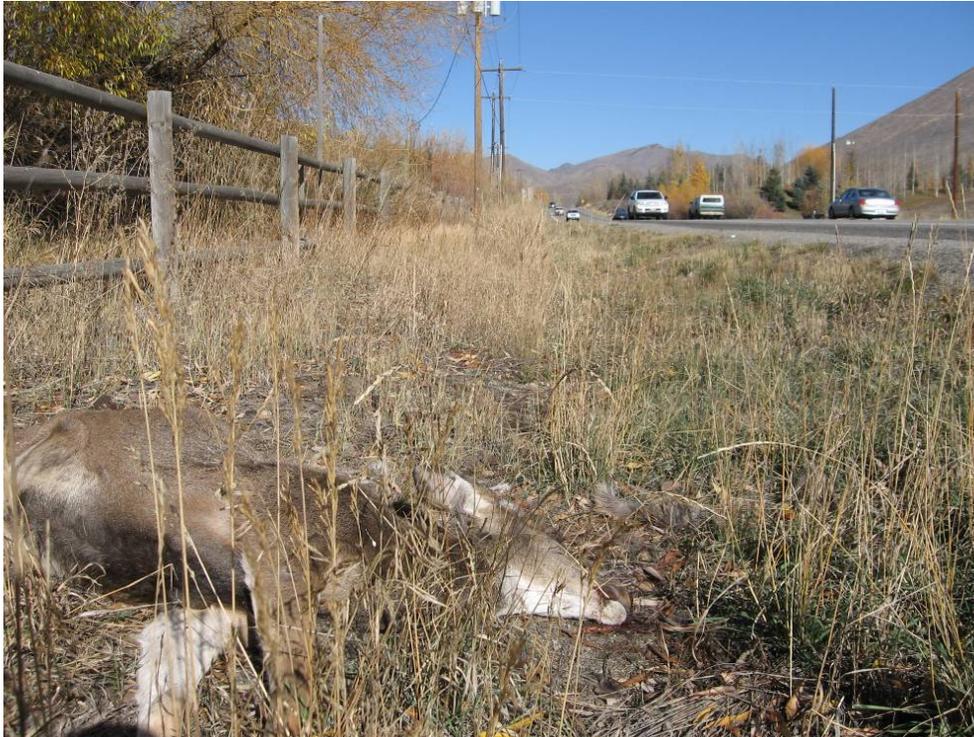
**Figure 48: The color of the dried grass matched the coat of this mule deer so well that this carcass was not detected during the driving survey but happened to be within a walking survey section (© Angela Kociolek, WTI-MSU).**

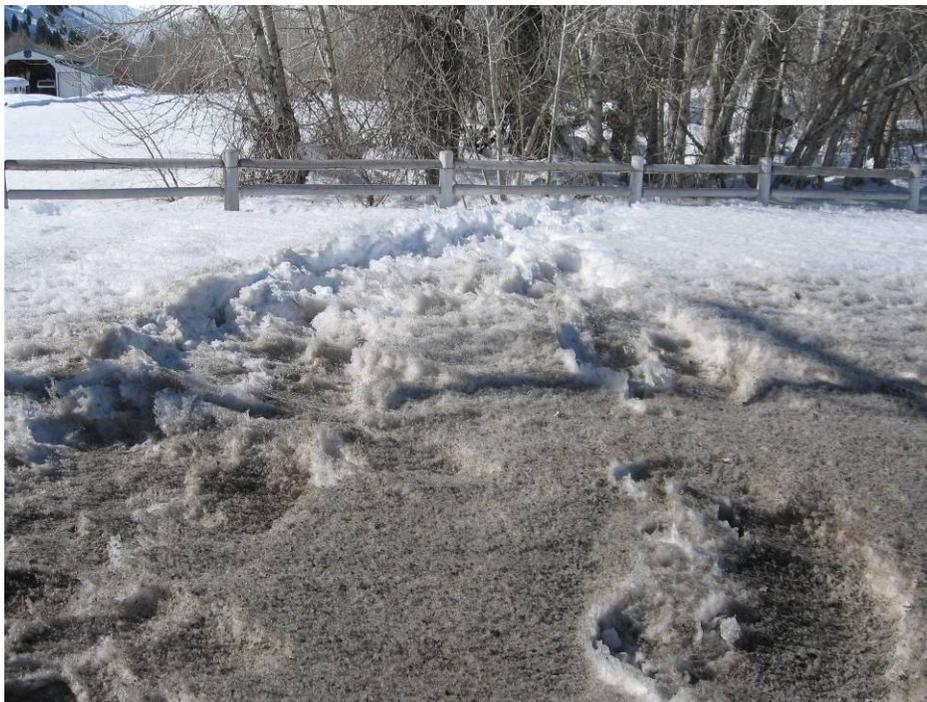
**Figure 49: Multiple elk tracks in the vicinity of MP 119.0.**

Deer, elk and canid, probably coyote, tracks were observed. In some cases, tracks from a single animal were observed. In other cases, it was clear that several animals passed in a particular location, sometimes stepping in each others tracks (Figure 49). The observations of deer and elk tracks were summarized in Table 6.
