# **Wildlife Data Collection and Potential Highway Mitigation along State Highway 75, Blaine County, Idaho**

Western Transportation Institute  
College of Engineering  
Montana State University

Board of Blaine County Commissioners  
206 First Avenue South, Suite 3000  
Hailey, Idaho 83333

May, 2008

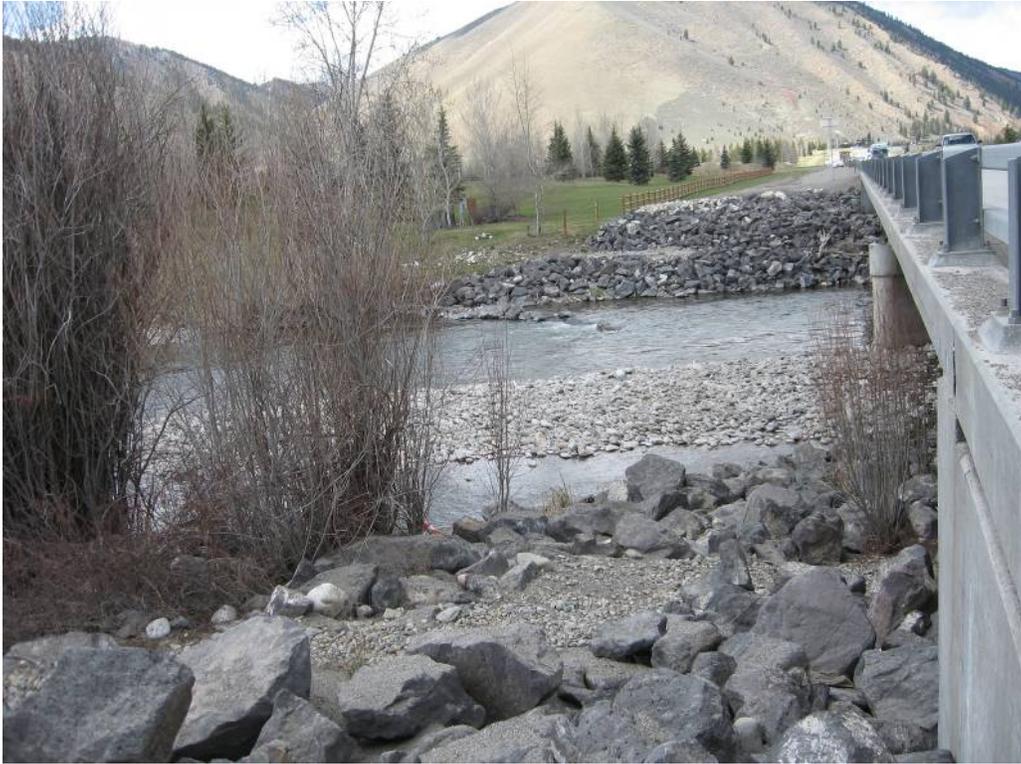
**Figure 53: Vicinity of west side of Greenhorn Bridge looking north (© Angela Kociolek, WTI-MSU).**

In April 2007, four monochrome Reconyx PM35 remote infrared trigger cameras were deployed under the Greenhorn Bridge (Figures 53-55) and Hospital Bridge (Figures 56-58), one on each side of the structure (Figure 59). The purpose of the cameras was to document potential wildlife crossings under these two bridges, in lieu of crossing SH 75 at grade. Cameras were mounted into the wall inside theft deterrent camera boxes with cable and locks and informational stickers were affixed to the boxes (Figures 60-63).

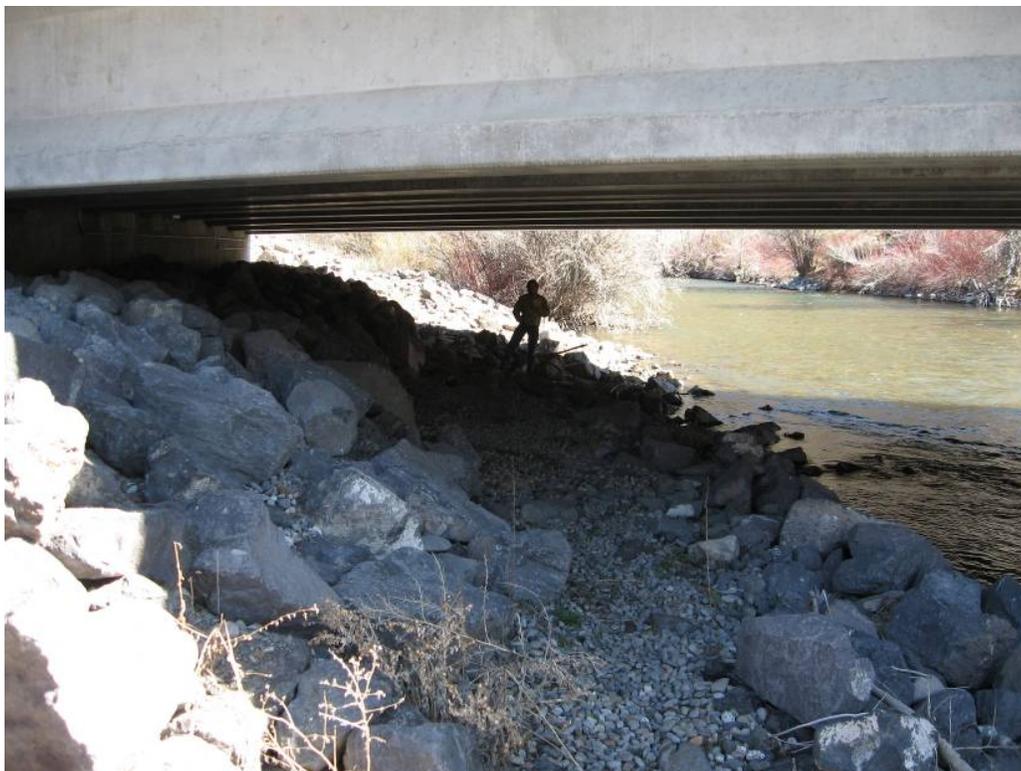
**Figure 54: View of the south side of the Greenhorn Bridge looking west (© Angela Kociolek, WTI-MSU).**

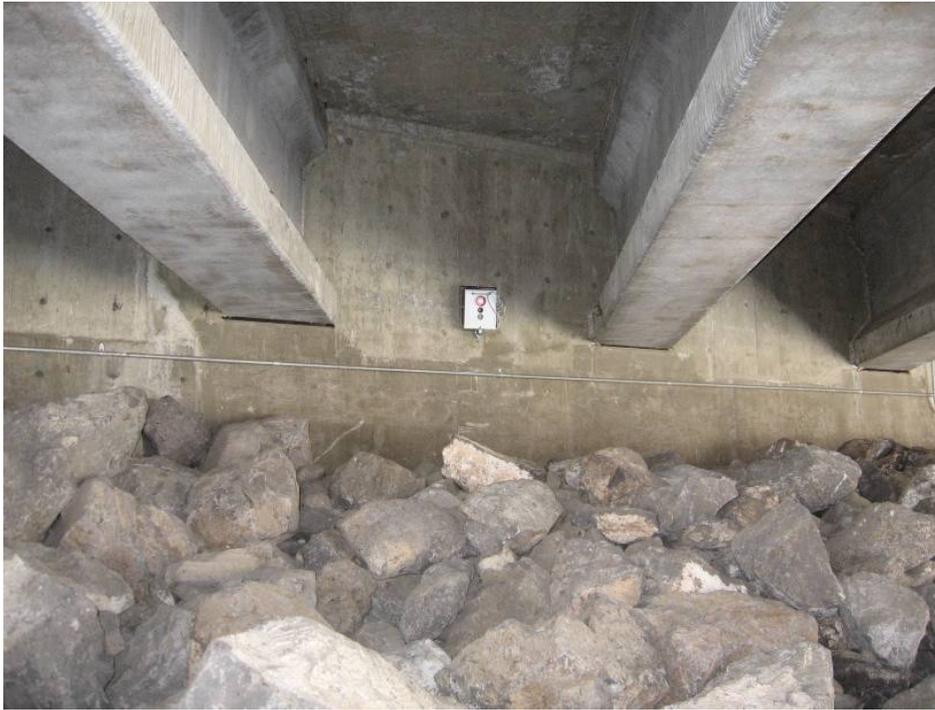
**Figure 55: Camera mounted under Greenhorn Bridge (© Angela Kociolek, WTI-MSU).**

Mule deer appeared to use the area beneath the bridges to cross the highway corridor (Figure 67). Mule deer were most often detected lingering at the southern Hospital Bridge undercrossing presumably to lick minerals that dripped through seams from the road surface above onto the sandy substrate below (Figure 68-70). Note orientation of seams above sandy substrate in Figure 55.

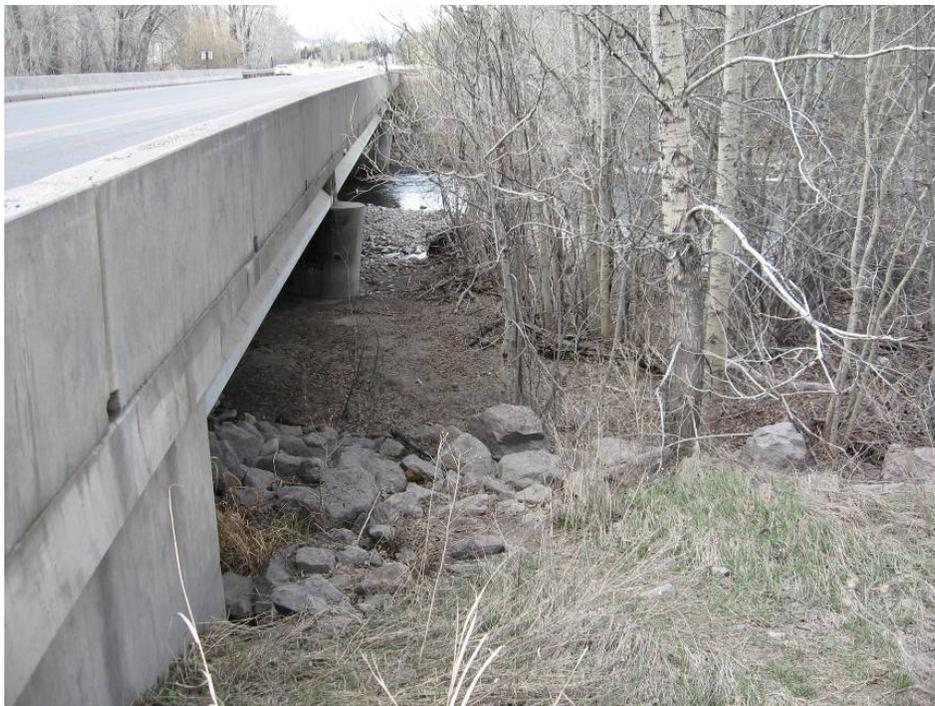
**Figure 56: Vicinity of east side of Hospital Bridge looking north. Note seams in bridge above sandy substrate where mule deer were often seen presumably licking minerals – discussed later (© Angela Kociolek, WTI-MSU).**

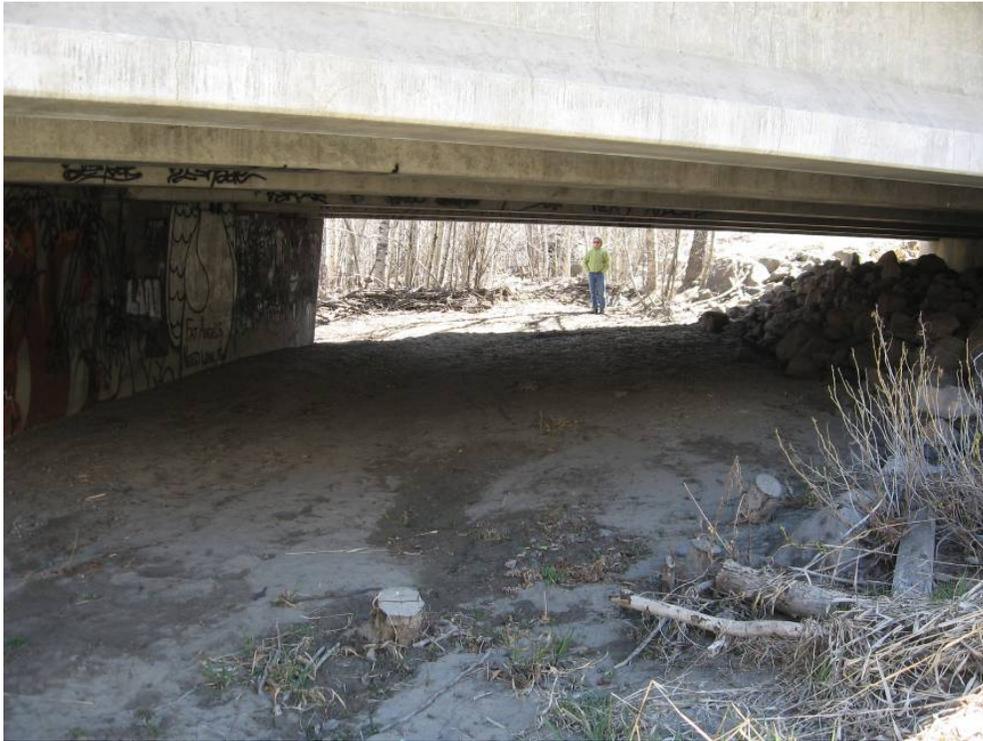
**Figure 57: View of south side of Hospital Bridge looking east (© Angela Kociolek, WTI-MSU).**

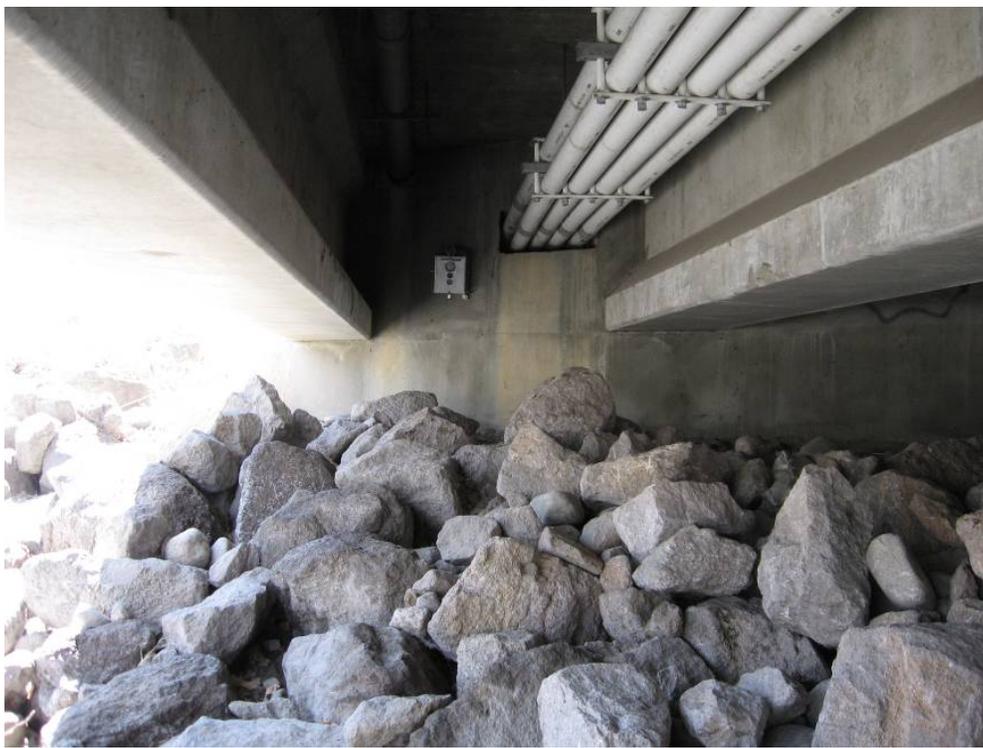
**Figure 58: Camera mounted under Hospital Bridge (© Angela Kociolek, WTI-MSU).**

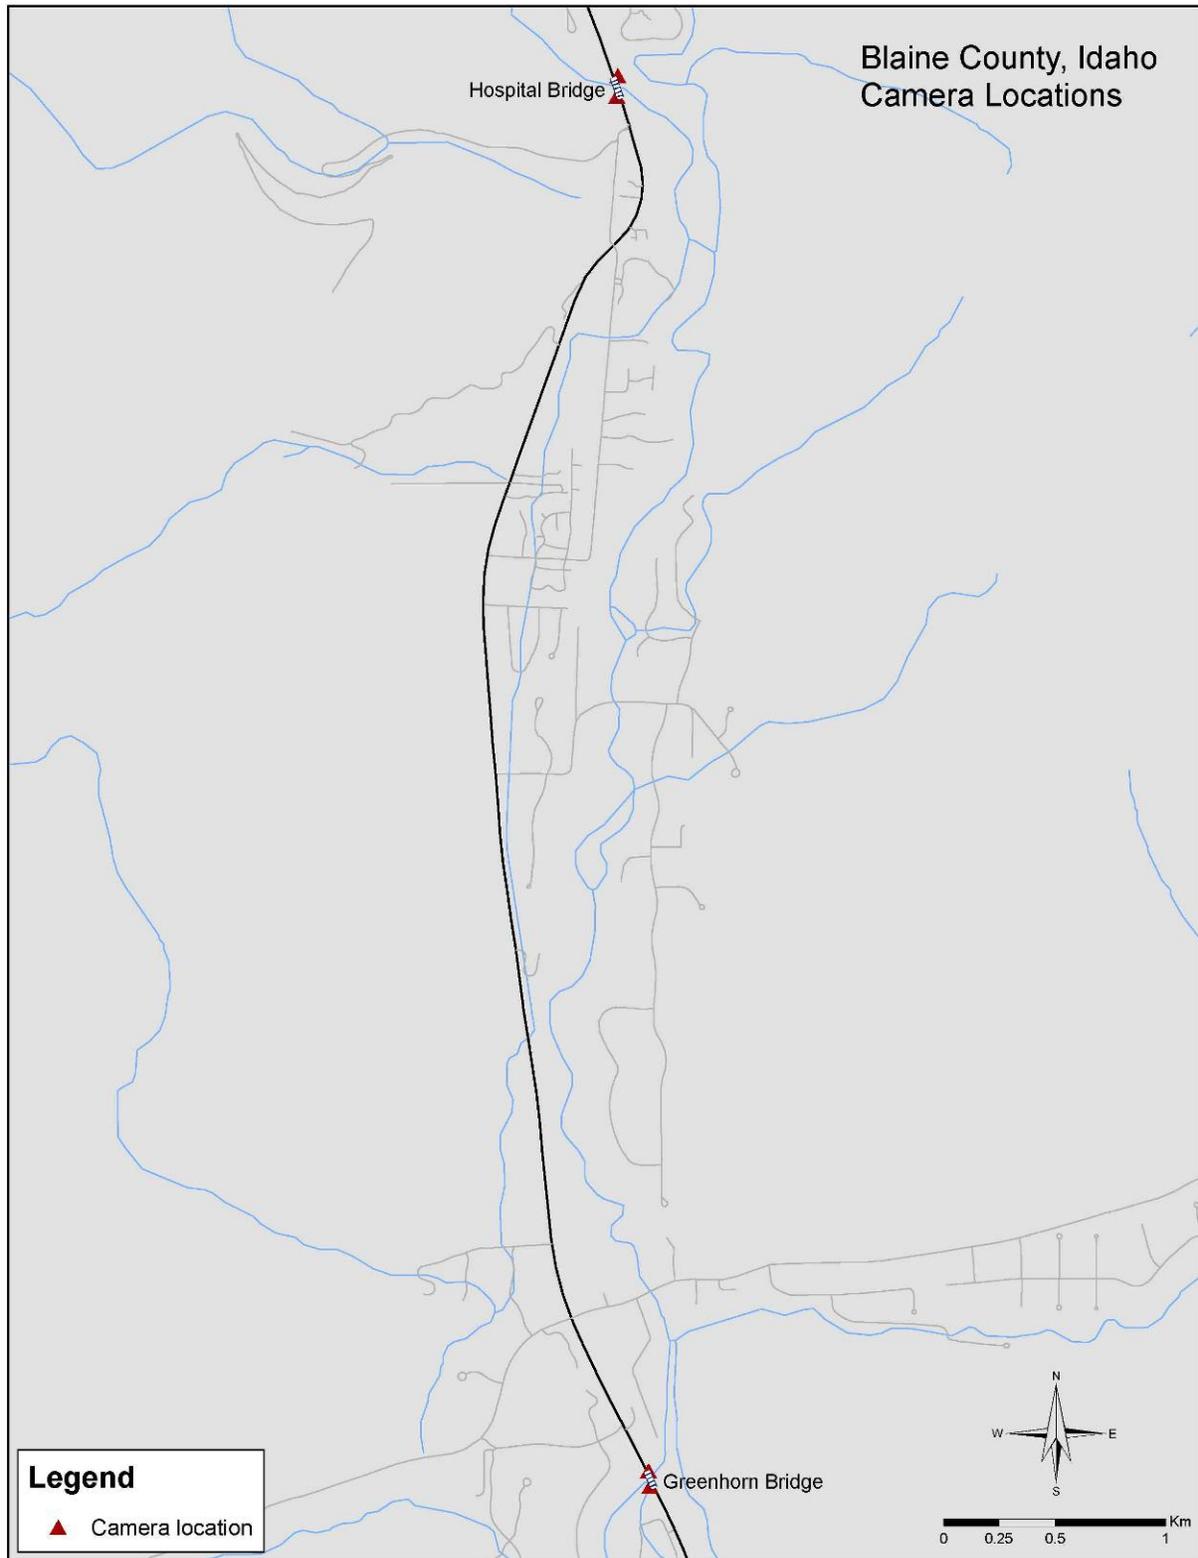
Figure 59: Map of camera locations (4 in total) under the two bridges across the Big Wood River.

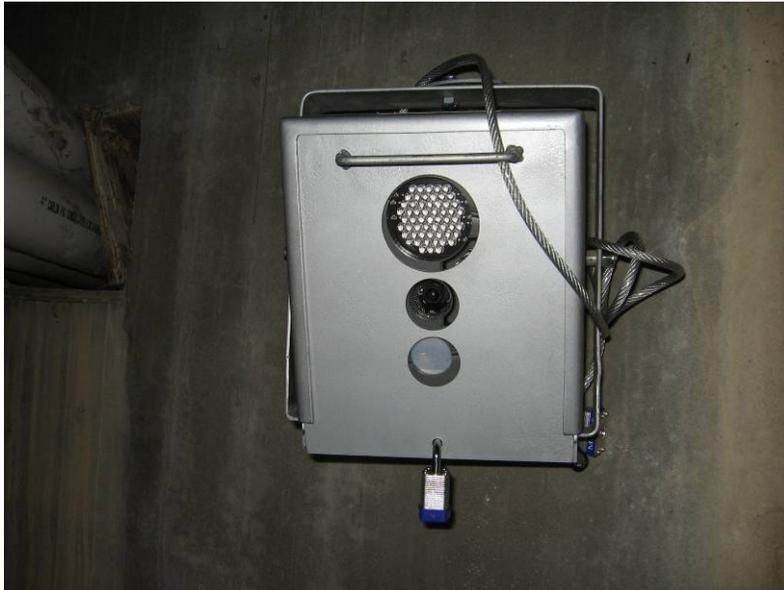
Figure 60: Front view of mounted camera (© Angela Kociolek, WTI-MSU).

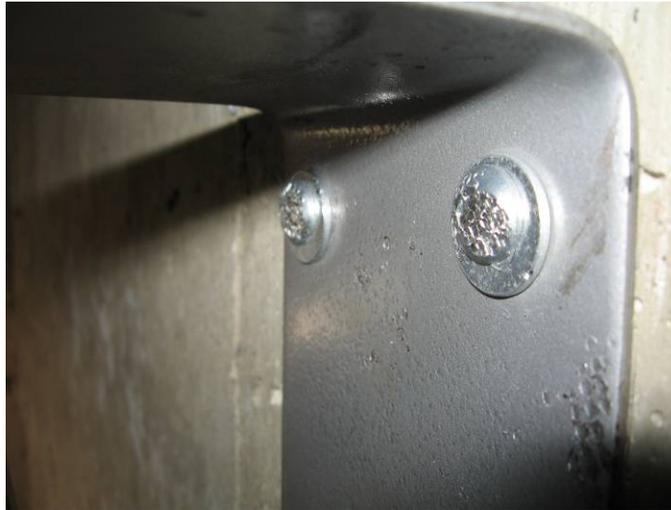
Figure 62: Close-up of bolting mechanism (© Angela Kociolek, WTI-MSU).

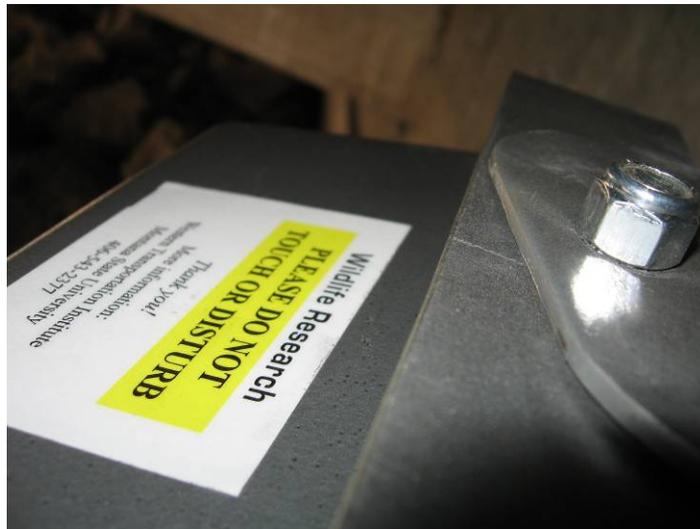
Figure 63: Informational sticker on camera box (© Angela Kociolek, WTI-MSU).

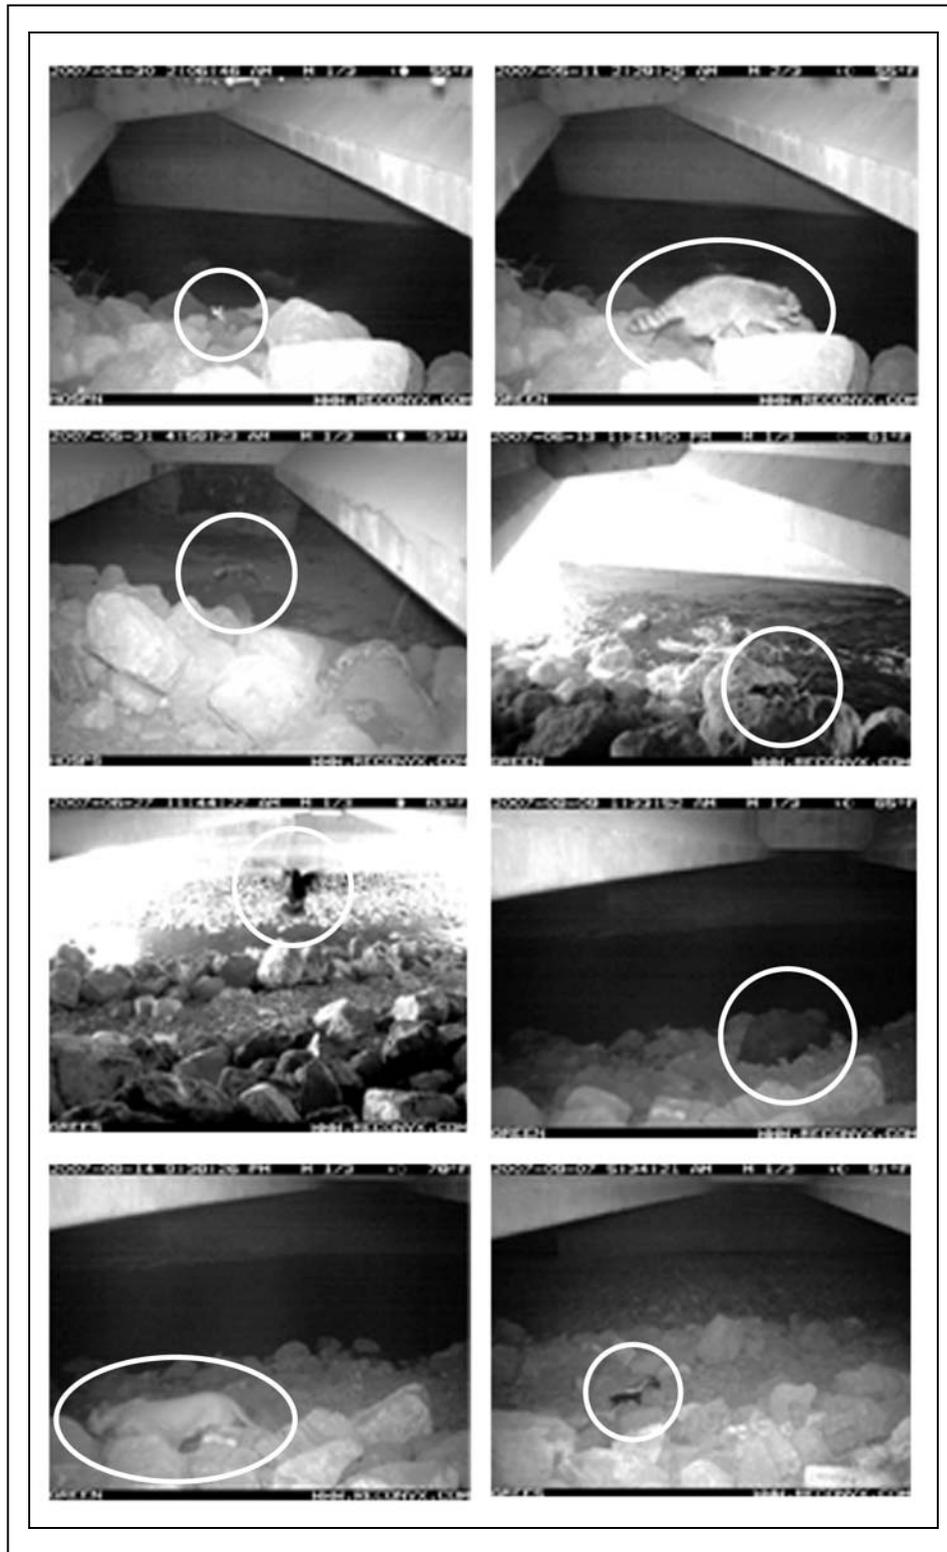
Figure 66. Clockwise from upper left: pine marten, raccoon, squirrels, black bear striped skunk, mountain lion, birds, red fox and other animals (not shown) were documented under the Greenhorn and/or Hospital Bridges (© WTI-MSU).

Humans and domestic animals accounted for 59% of all triggers while wildlife accounted for 32% (Figure 64). Nine percent of the triggers were unknown. There were 695 wildlife triggers, 129 of which were mule deer and 10 of which were deer but it is unknown whether they were mule deer or white-tailed deer. Flying animals, including bats and birds, triggered the cameras most, followed by deer (Figure 65). Cameras confirmed that a variety of wildlife cross under SH 75 along the Big Wood River corridor (Figure 66).

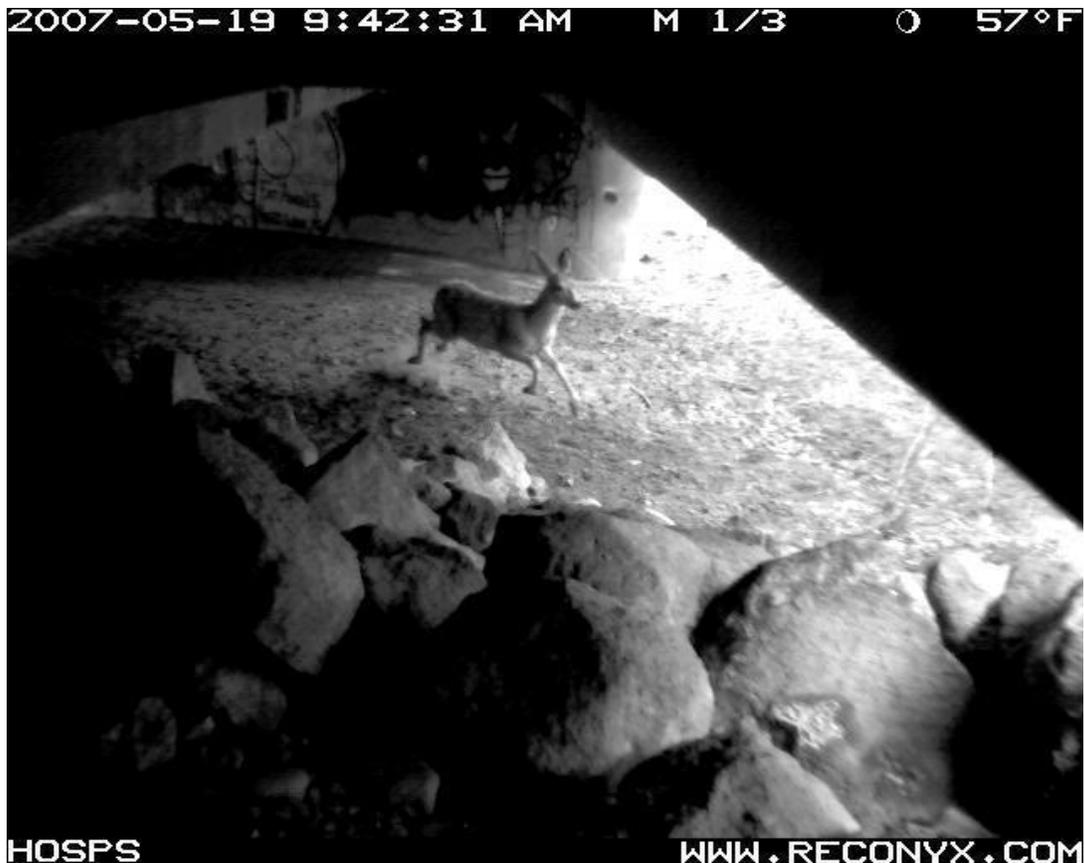
Figure 67: Mule deer running west to east under the south side of the Hospital Bridge on May 19, 2007 at 9:42am (© WTI-MSU).

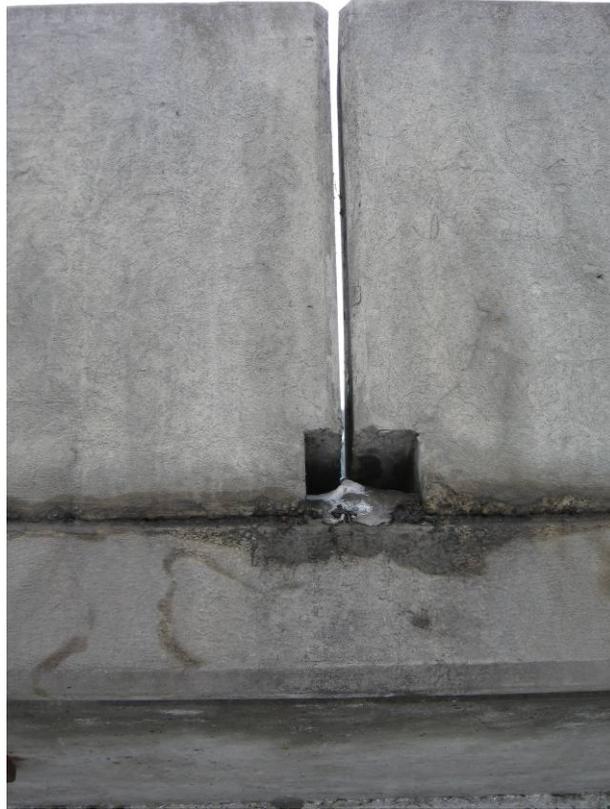
Figure 68: Seams in bridge concrete allow run off that settles on sandy substrate below (© Angela Kociolek, WTI-MSU).

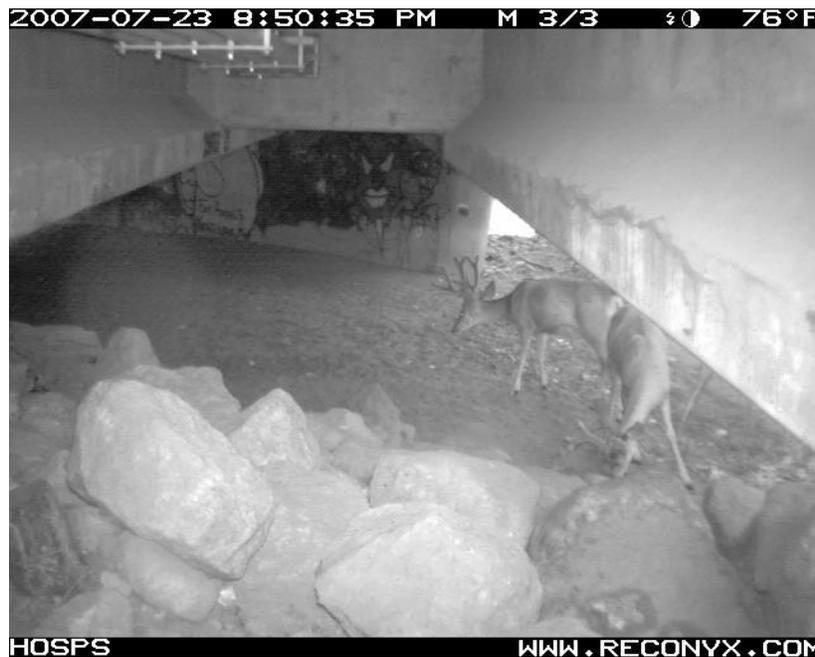
Figure 69: Mule deer presumably mineral licking under south side of Hospital Bridge on July 23, 2007 at 8:50 pm (© WTI-MSU).

In an attempt to separate mineral licking events from crossing events, a cut off time of ten minutes was used in the analysis. Mineral licking activity resulted in lingering under the bridge sometimes for an hour or longer. Obvious crossing activity, on the other hand, usually happened within seconds. Sixty percent of all deer events resulted in a stay of ten minutes or more (Figure 71). Sixty-one percent of deer events that lasted ten minutes or more did not appear to result in a complete crossing (Figure 72). In contrast, of those deer events that lasted less than ten minutes, 38% did not appear to result in a complete crossing (Figure 73). Deer appeared to cross in both directions (east to west and west to east). Four (8%) of the less than ten minute events, were inconclusive regarding whether or not a crossing took place.

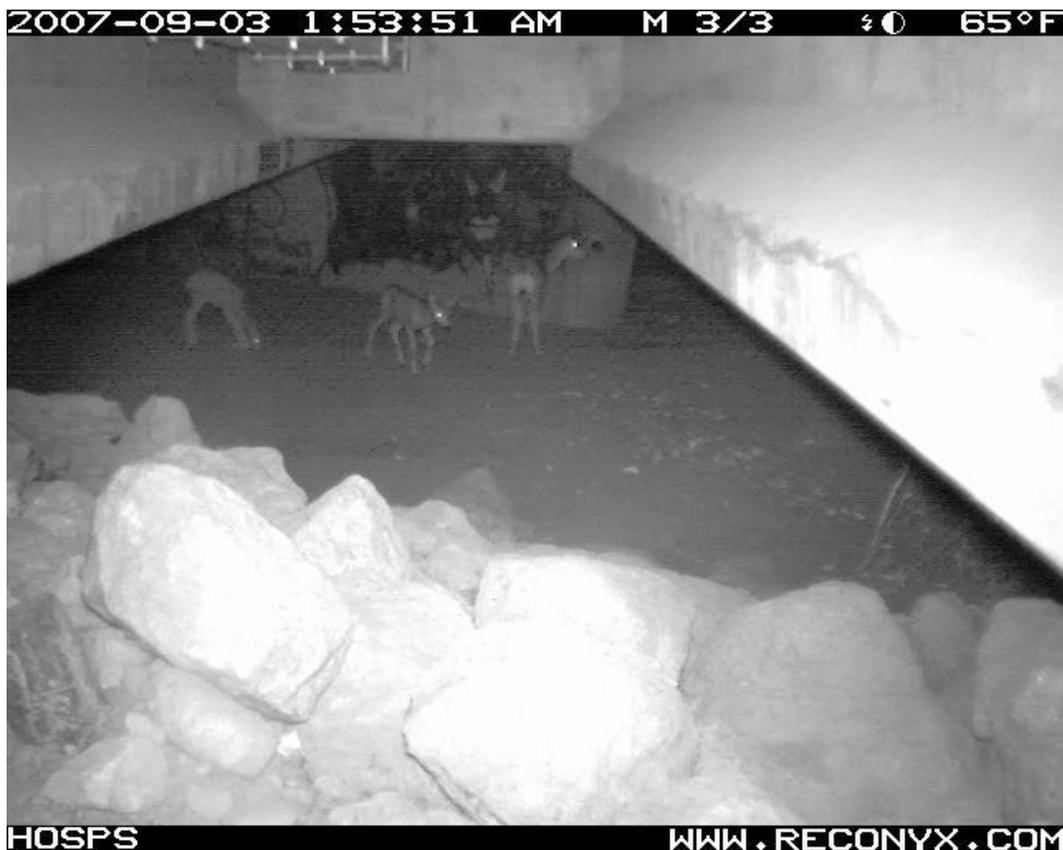
**Figure 70: Three mule deer lingering under south side of Hospital Bridge on September 3, 2007 at 1:53 am (© WTI-MSU).**

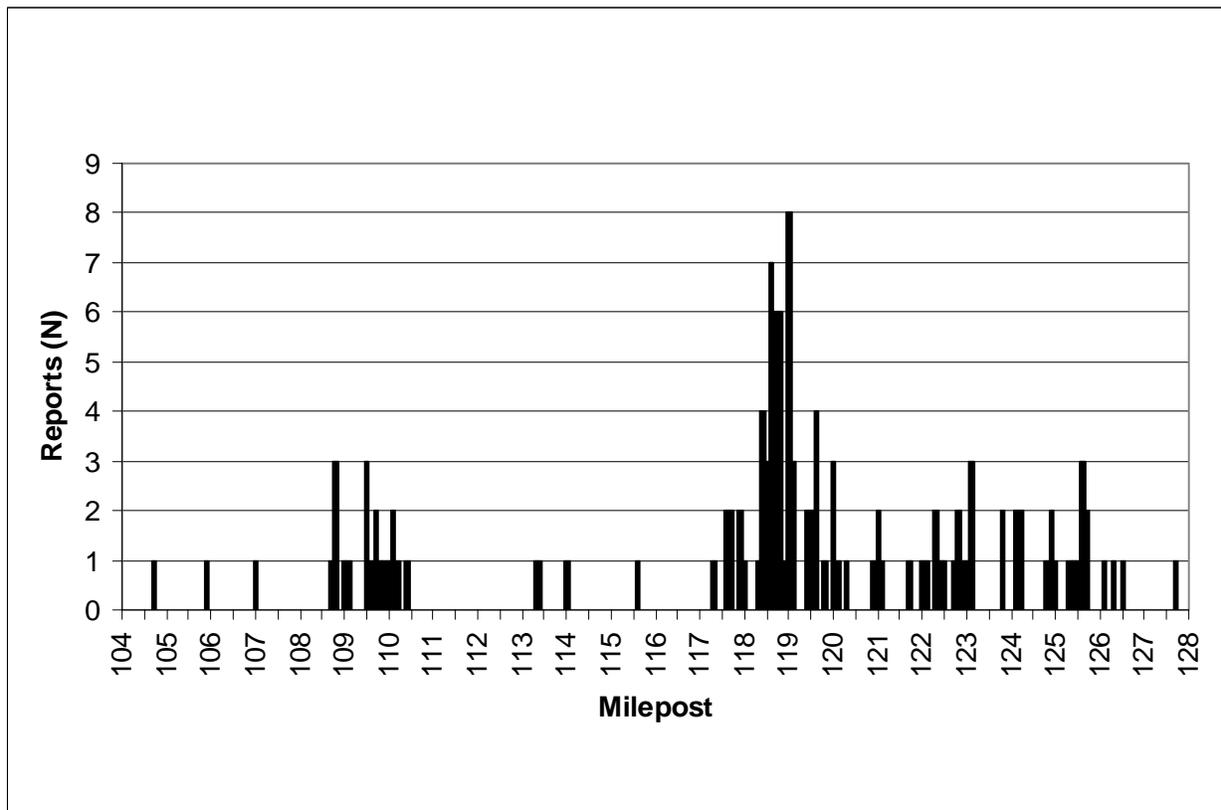
Figure 82: Spatial distribution of all carcass reports made during study period (Data provided by ITD, IHP, WTI and the public) (Total n = 128).

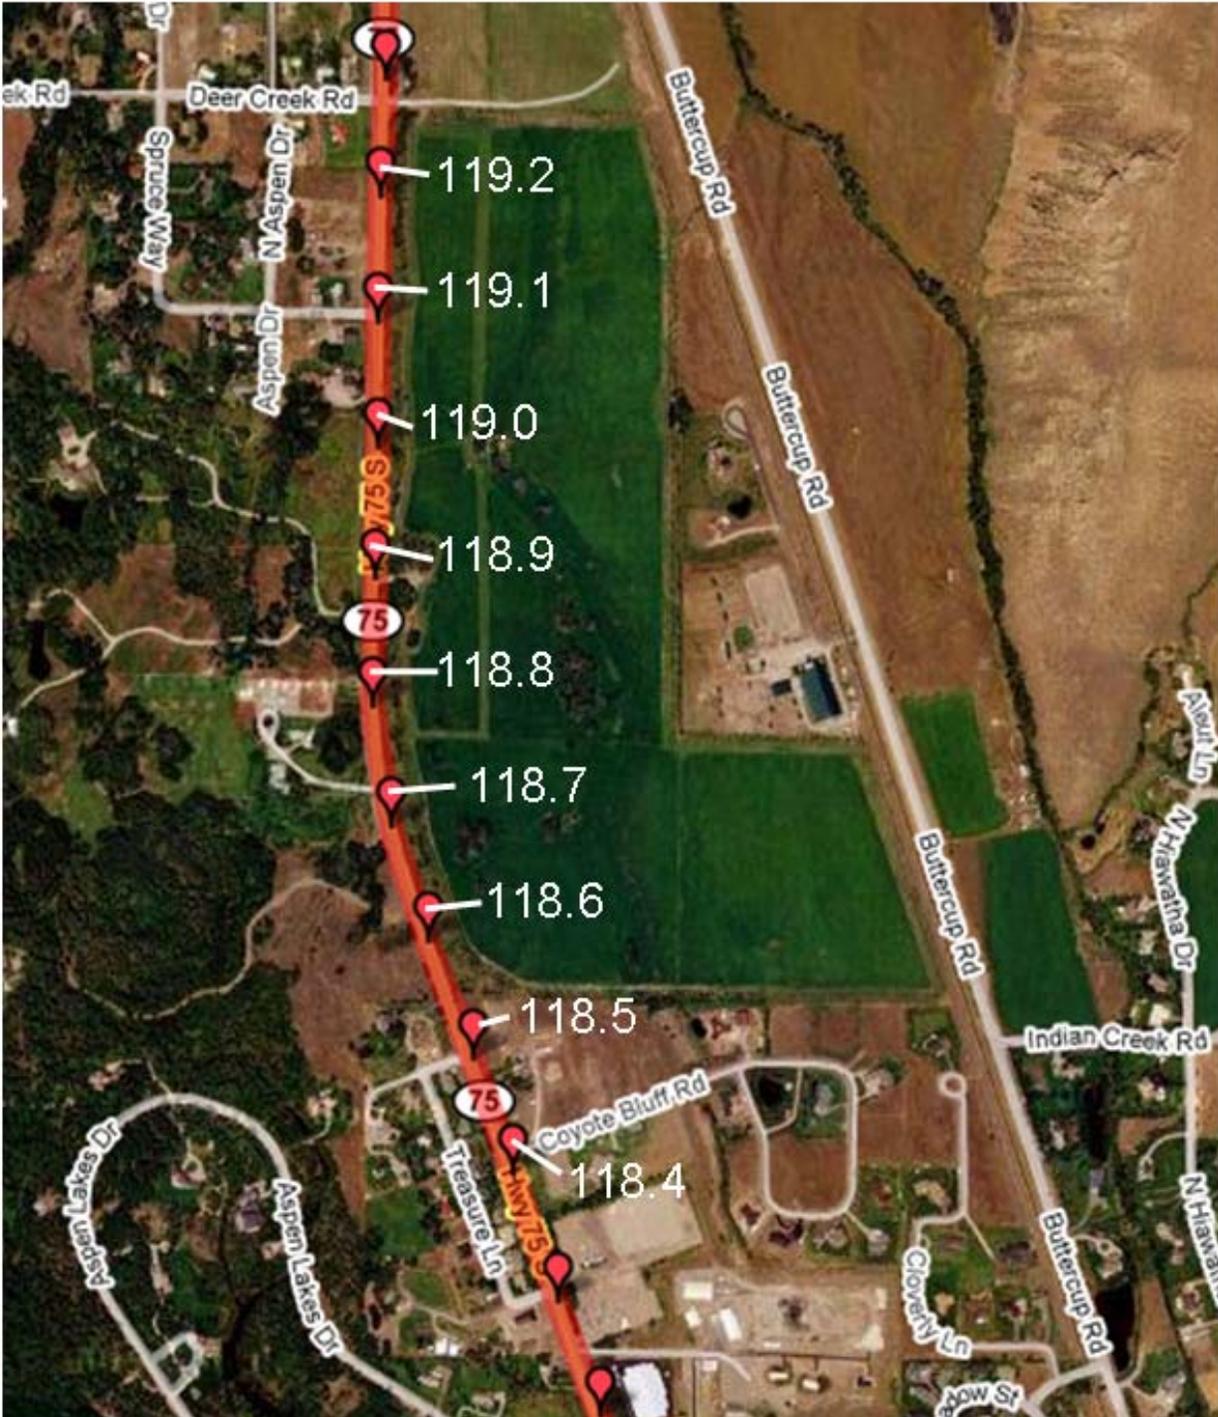
Figure 83: An aerial image of S.H. 75, just north of Hailey, between mi posts 118.4 and 119.2.

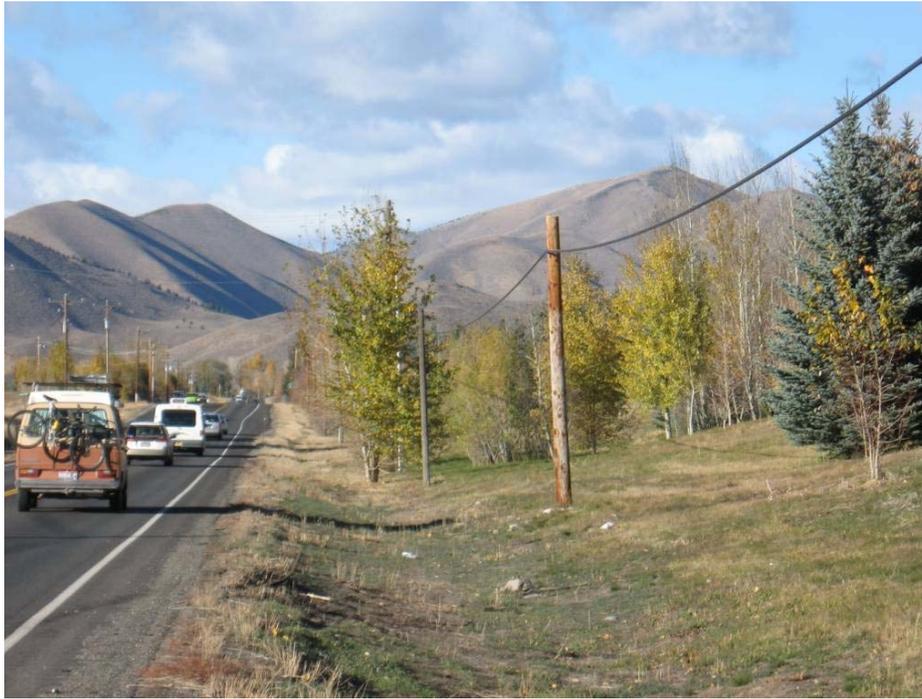
**Figure 84: View of the right-of-way, east side of S.H.75, about at mi post 119.0 (north of access road to meadows) looking north (© Marcel Huijser, WTI-MSU).**

Sites B and C in Table 10 stand out as the two road sections [maximum 500 m (.3 miles in length)] that might benefit most from an animal detection system based on the number of reported collisions with deer and elk. These two road sections were further evaluated with regard to the potential installation of an animal detection system (Table 11). Because the sections are adjacent to each other the authors of this report decided to treat the two road sections as one. The southern edge is just north of mi post 118.4, just north of the intersection with Coyote Bluff Rd (Figure 83). For practical reasons the northern edge was extended until just south of the first access road past 119.1 (Deer Creek Rd) at about mi post 119.25 (Figure 83). Figures 84-89, and especially Appendix A, show the road, right-of-way and the surrounding landscape in the area.

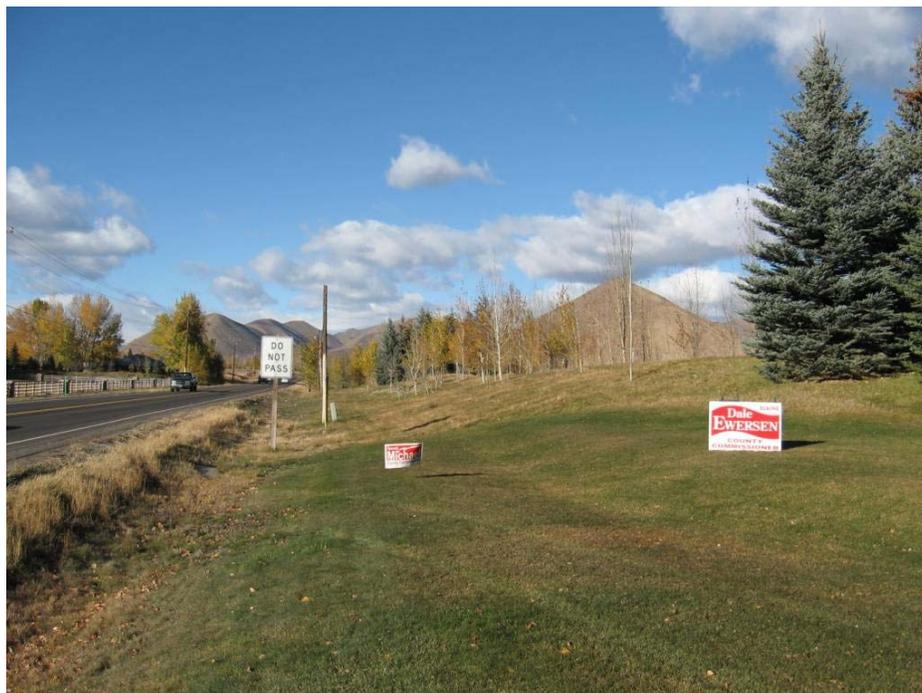
**Figure 85: View of the right-of-way, east side of S.H.75, about at mi post 118.9 (access road to meadows), looking north (© Marcel Huijser, WTI-MSU).**

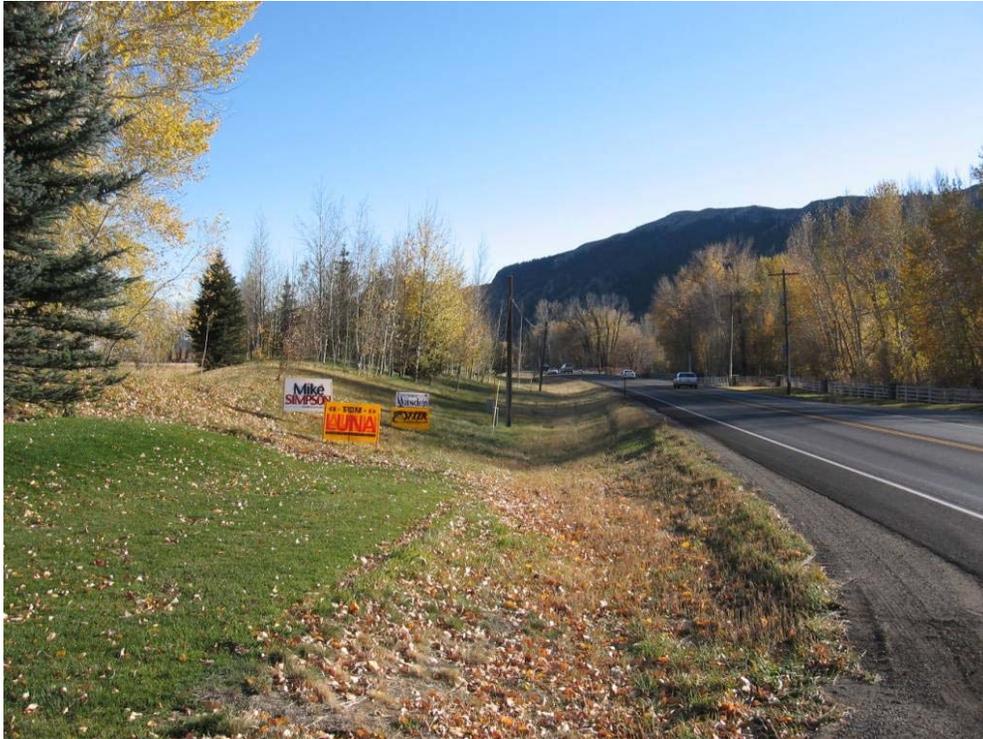
**Figure 86: View of the right-of-way, east side of S.H.75, about at mi post 118.9 (access road to meadows), looking south (© Marcel Huijser, WTI-MSU).**

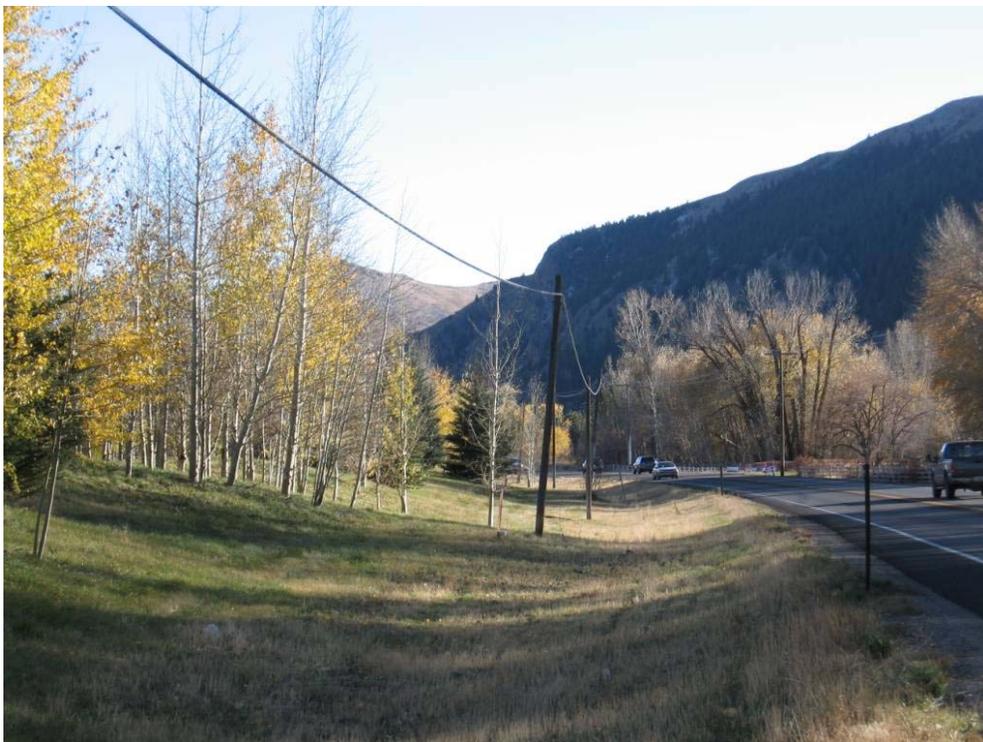
**Figure 87: View of the right-of-way, east side of S.H.75, about at mi post 118.8, looking south (© Marcel Huijser, WTI-MSU).**

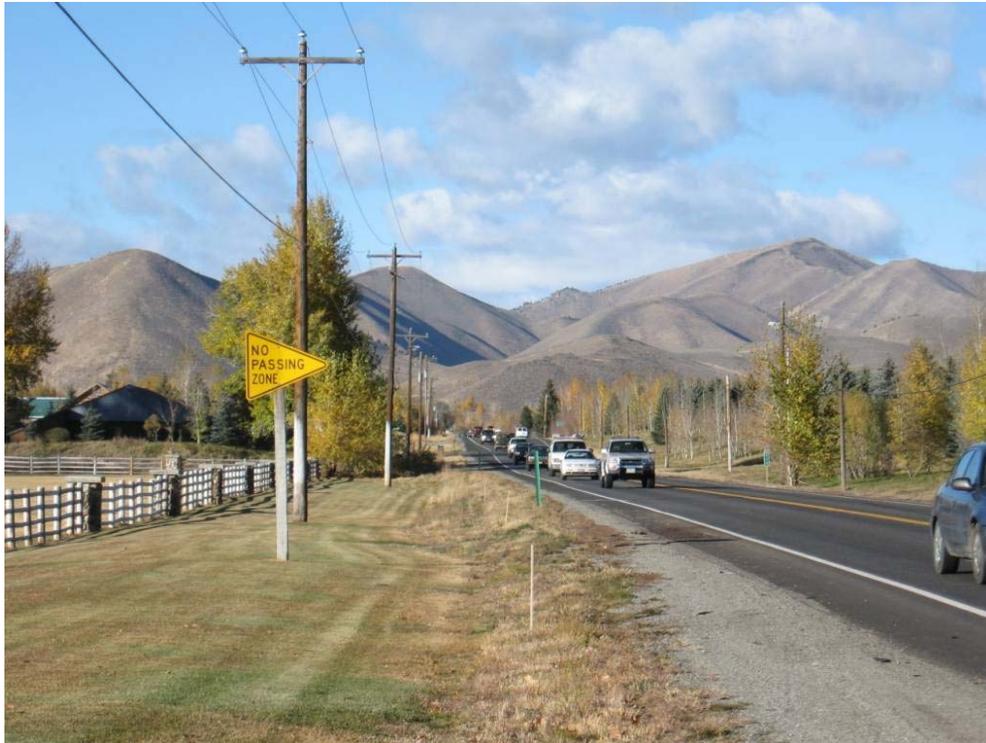
**Figure 88: View of the right-of-way, west side of S.H.75, about at mi post 118.85, looking north (© Marcel Huijser, WTI-MSU).**

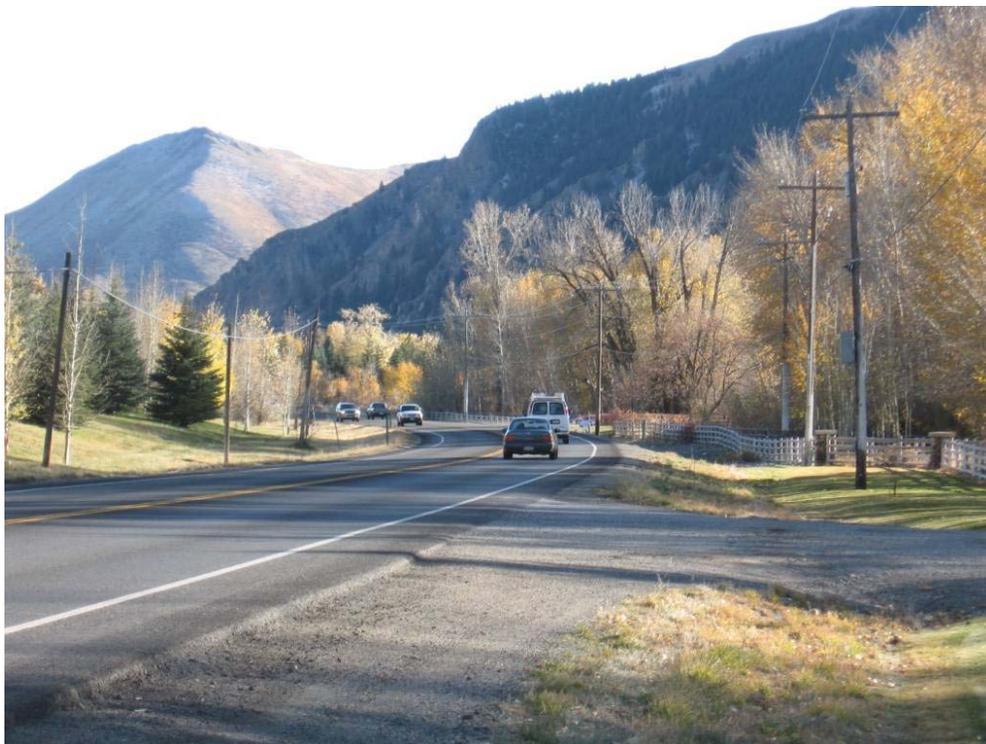
**Figure 89: View of the right-of-way, west side of S.H.75, about at about mi post 118.85, looking south (© Marcel Huijser, WTI-MSU).**

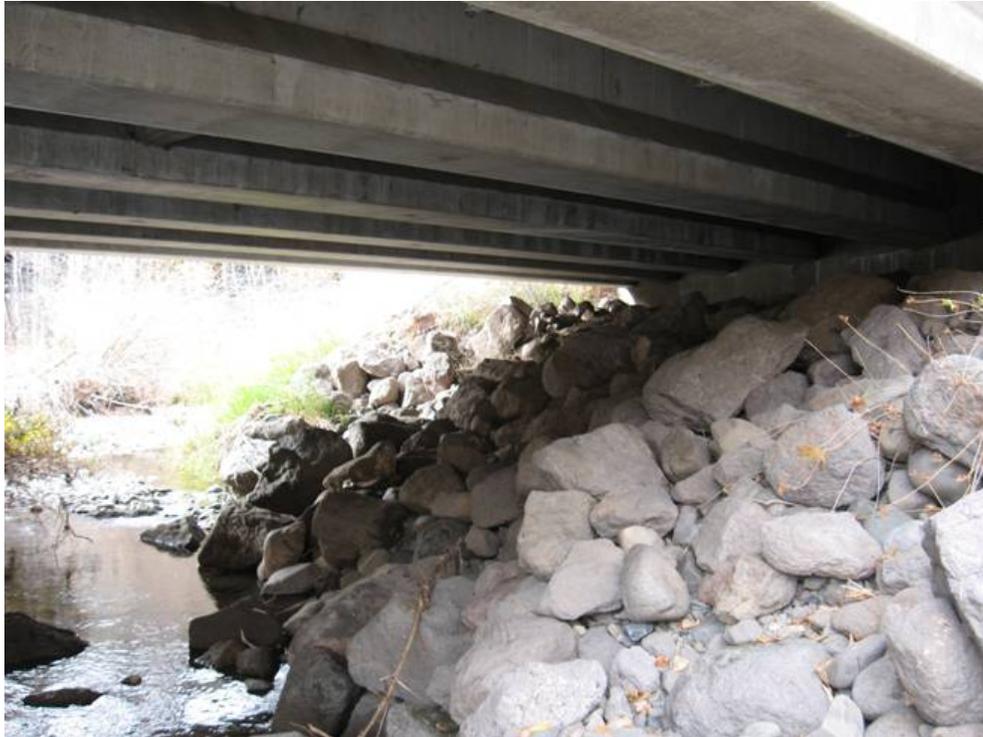
**Figure 90: Riprap representative of the north banks under both bridges; deer were rarely documented on the north sides (© Marcel Huijser, WTI-MSU).**

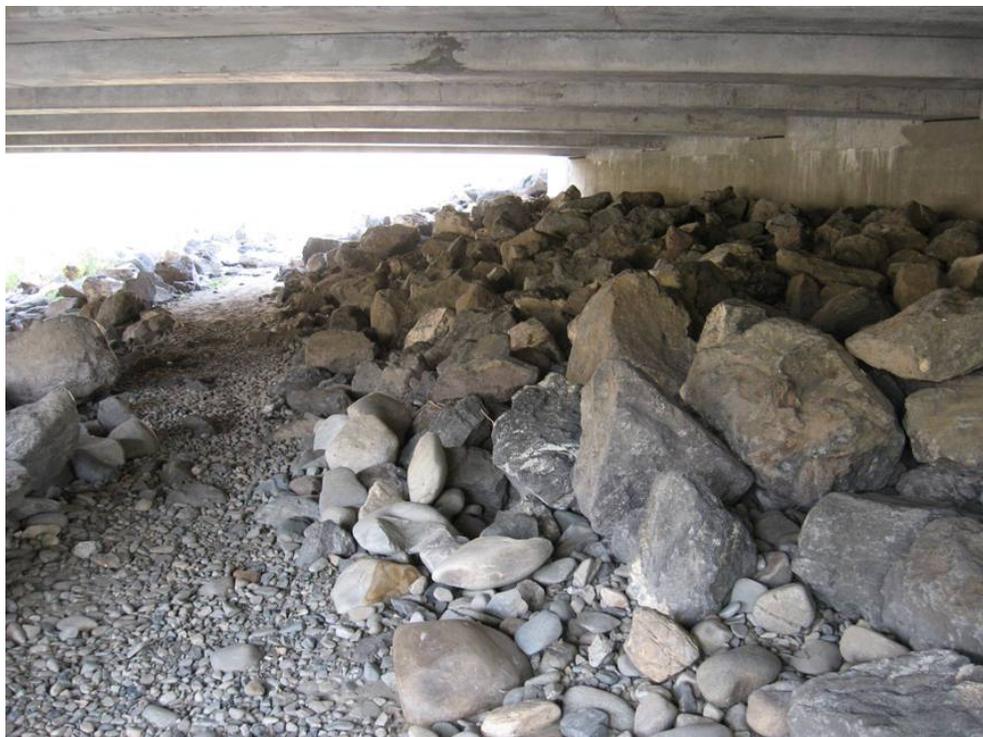
**Figure 91: A trail has been cleared from riprap on the south bank of the Greenhorn bridge; deer have been observed crossing under the bridge here (© Marcel Huijser, WTI-MSU).**
