NDOT Research Report

Report No. 701-18-803 TO 6 Part 2

**TPF-5(358)
PART 2 - WILDLIFE BARRIERS: THE
EFFECTIVENESS OF ELECTRIFIED BARRIERS
TO KEEP LARGE MAMMALS OUT OF FENCED
ROAD CORRIDORS**

September 2022

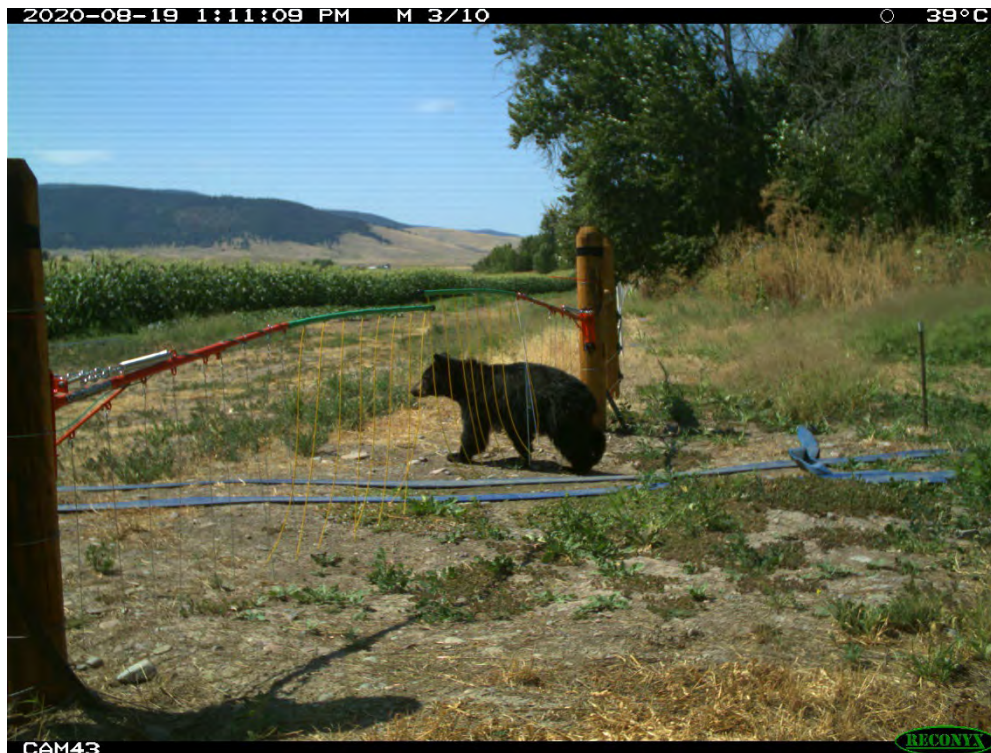
Figure 13: Black bear accessing the melon patch at a bump gate at access point 4, entering in between the vertical electrified wires. The black bears tended to choose the location where the space between the vertical wires was widest, at the transition of the orange and green parts of the horizontal pole.

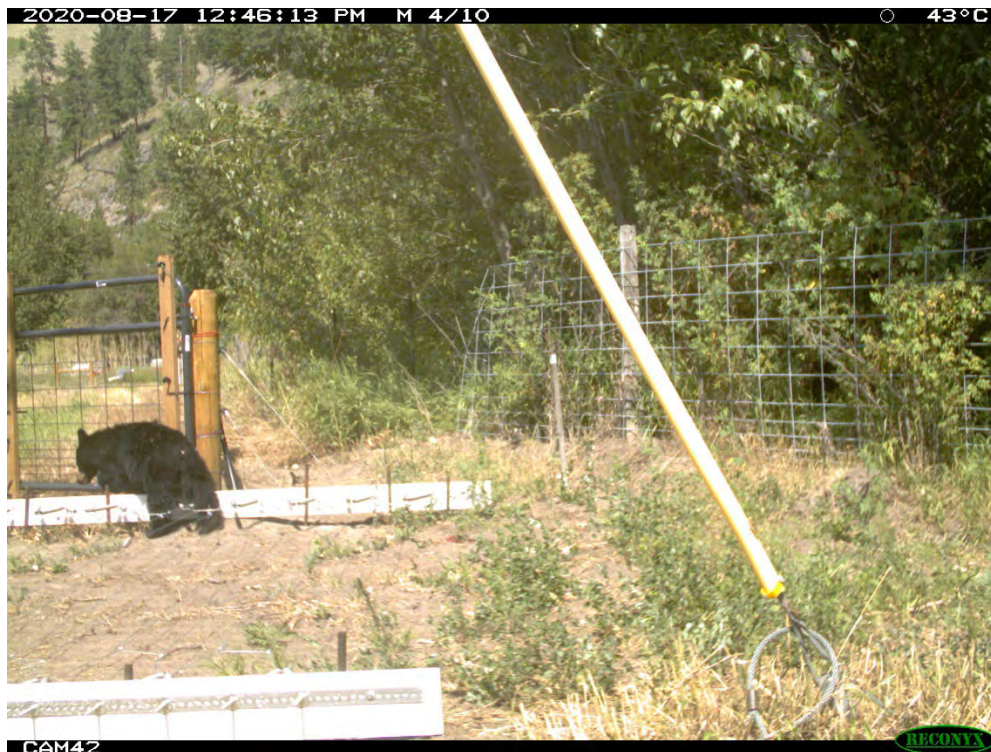
Figure 14: Black bear bypassing most of the wires above the ground and taking advantage of the space between the wires and the electrified gate on the side (1st out of 3 intrusions). Note that the electric wires on the side of the barrier (to the right of the bear) only cover the side partially.

above the ground (Figure 12). All 3 intrusions involved a bear bypassing most of the wires by coming in or leaving from the side (Figures 14-16).

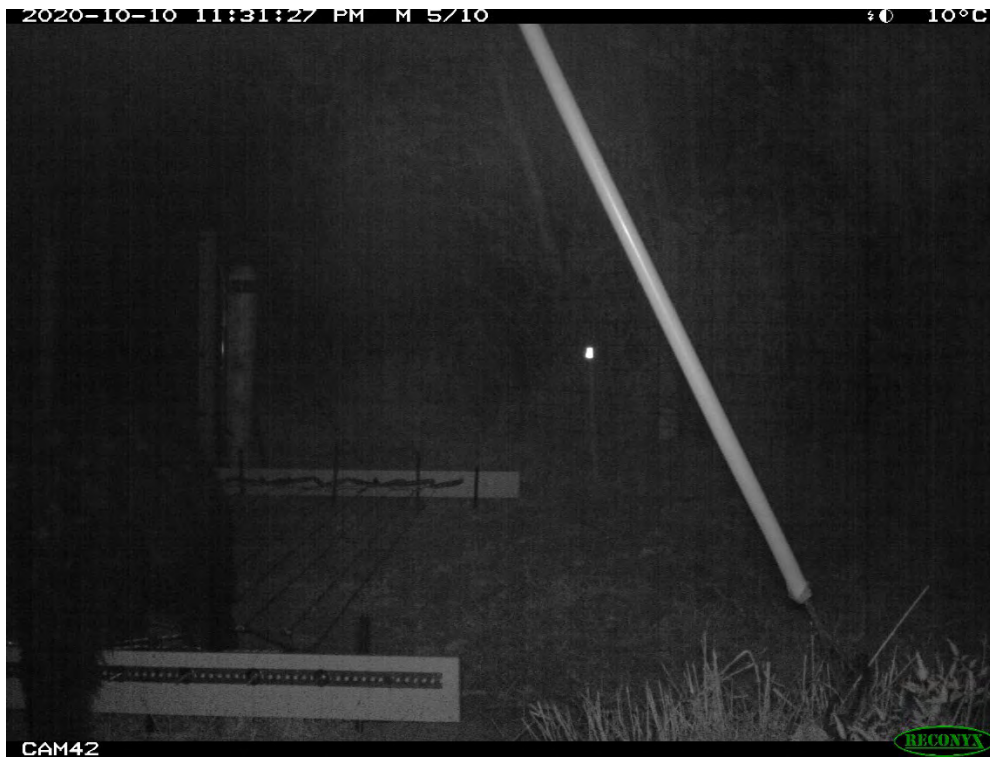
Figure 15: Black bear bypassing most of the wires above the ground by taking advantage of the partial electric fence on the side of the barrier (2nd out of 3 intrusions).

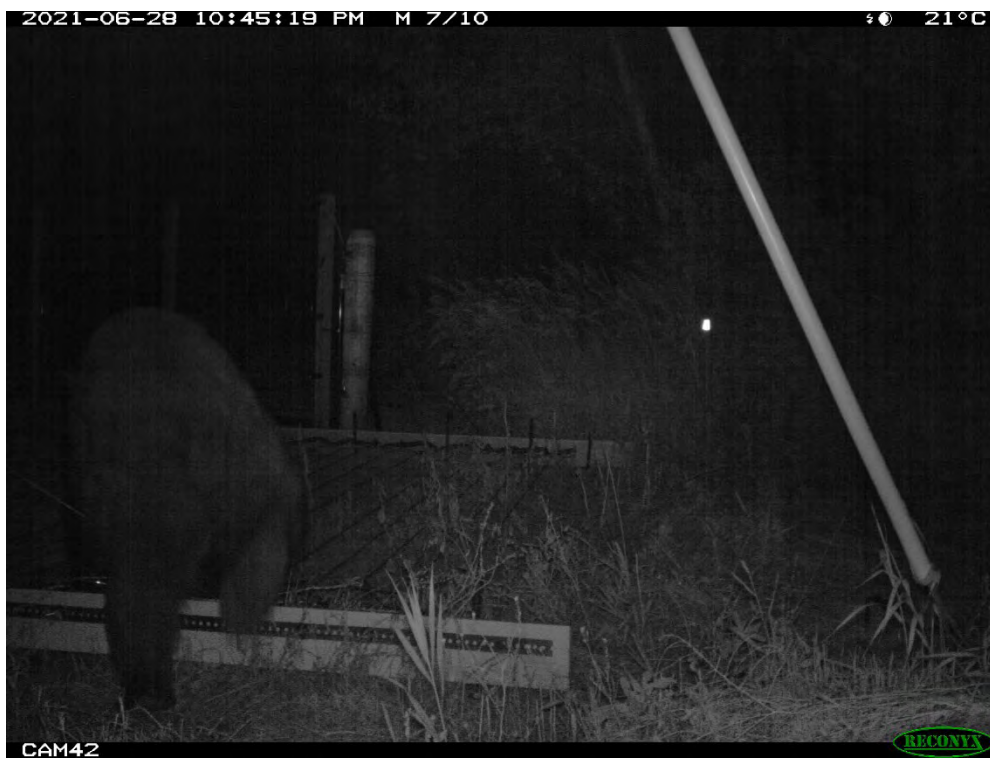
Figure 16: Black bear bypassing most of the wires above the ground by taking advantage of the partial electric fence on the side of the barrier (3rd out of 3 intrusions).

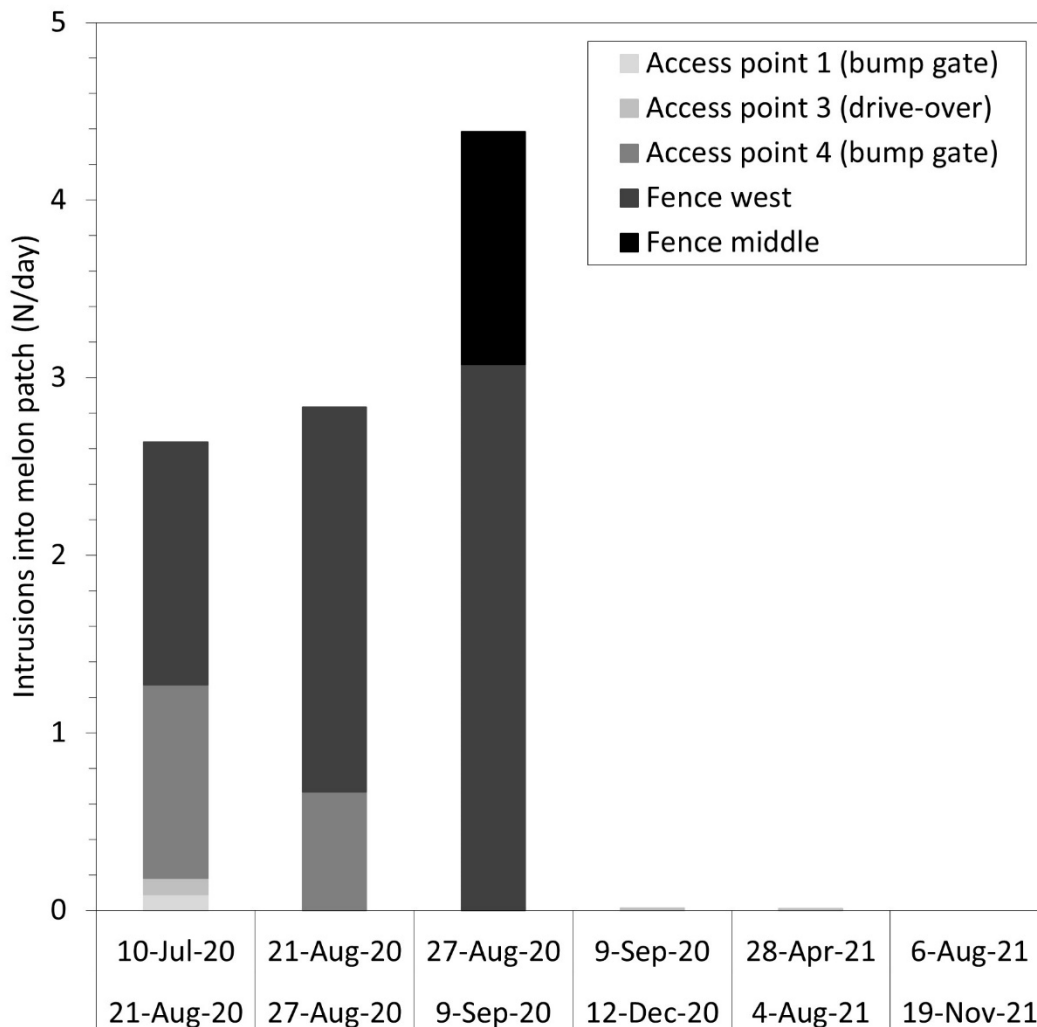
Figure 17: The number of black bear intrusions per day into the melon patch during different periods. Note: No intrusions were reported at access point 2 (swing gate) and “fence east”.

At the 7 locations that were monitored with a camera, the number of black bear intrusions into the melon patch varied between about 2.5 and 4.5 per day during much of the 2020 harvest season (Figure 17). Access point 4, the non-modified bump gate adjacent to the Jocko river, and “fence west” accounted for the vast majority of the intrusions. After conductive netting was attached to the bump gate at access point 4, black bear pressure increased on “fence west”, and also “fence middle” (Figure 18-20). After fence modifications on 9 September 2020, almost no bears were able to enter the melon patch. There were only 2 black bears that entered after that date, and both did so through largely bypassing the drive-over wires at access point 3. The researchers did not have any evidence that black bears entered the melon patch at any other location that was not monitored with a camera. The total number of black bears was highest in August through October (Figure 21). The total number of black bear observations at any of the 7 locations monitored with a camera, regardless of which side of the fence or electrified barriers the bears were on, was 95% lower in 2021 (N=24) than in 2020 (N=527).

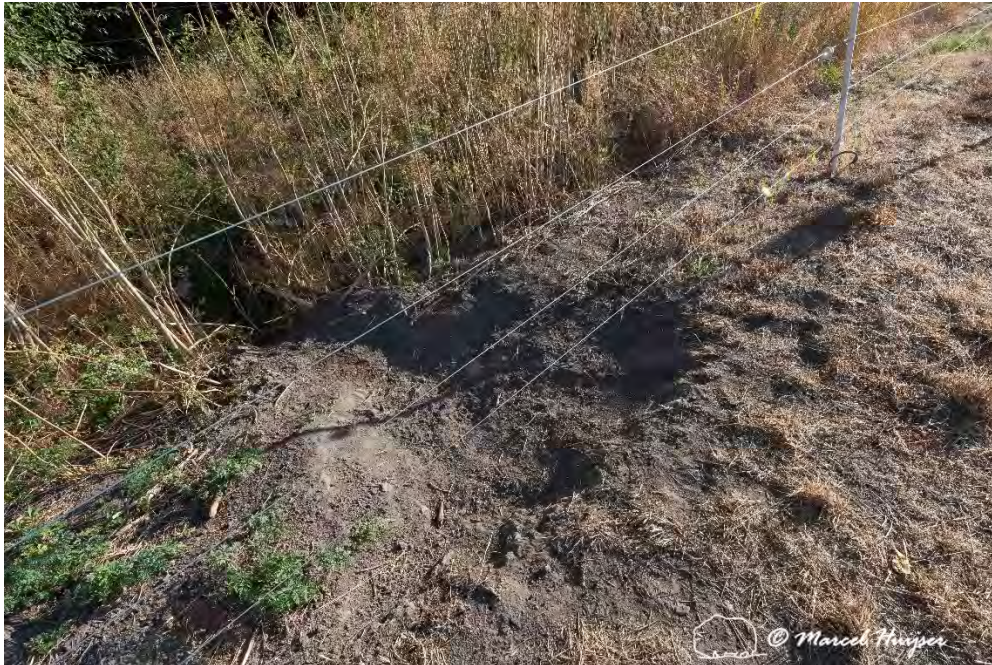
Figure 18: In some places black bears dug under the fence.

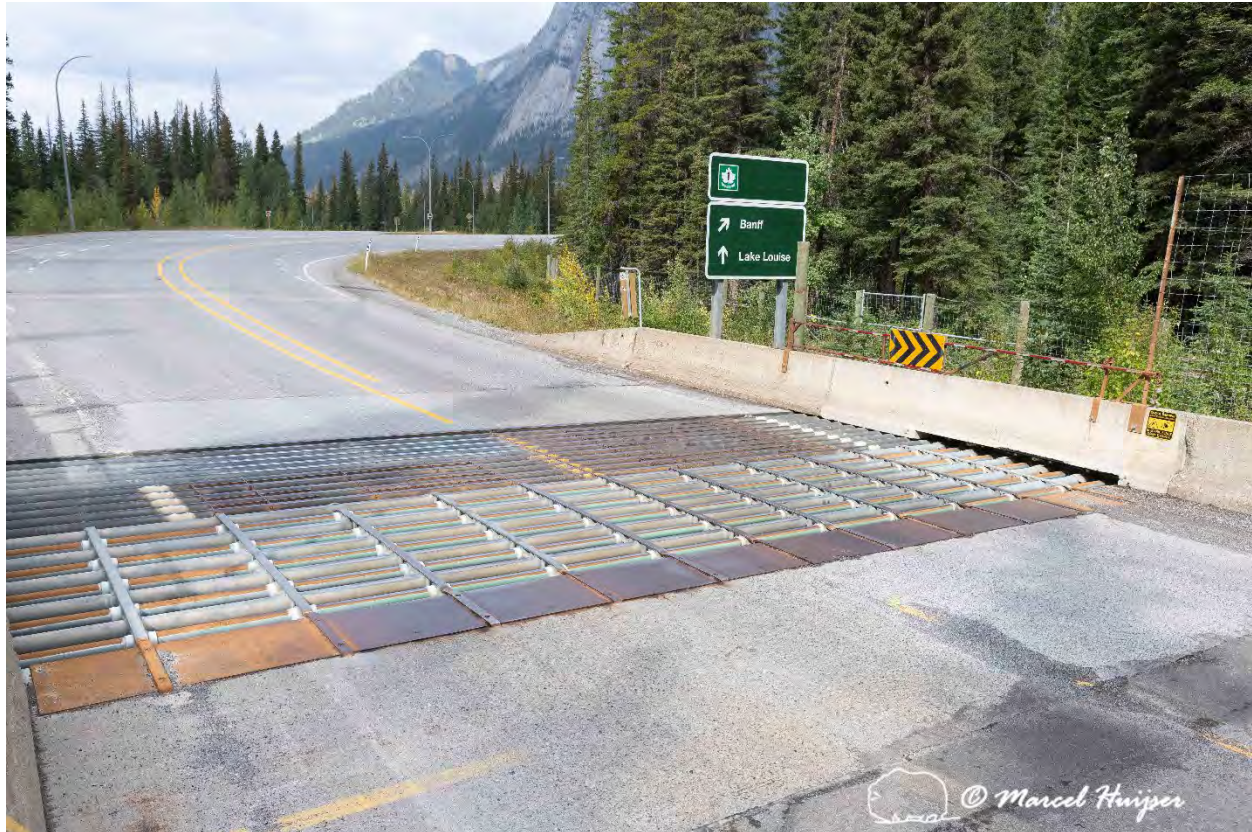
Figure 26: Electrified barrier, Sunshine Road, Banff National Park, Canada.

The barrier was briefly fully operational 8-20 October 2020, but a snowplow damaged the grounding plate as the protective strips had not been installed yet. After that, the damaged grounding plate was removed which meant that the animals were less likely to receive a full shock (variable conductivity of the pavement) or they would only be delivered a full shock after making contact with both a positive and negative bar. The grounding plate was reinstalled (with protective strips) at the end of September 2021 (personal communication Dan Rafla, Parks Canada).

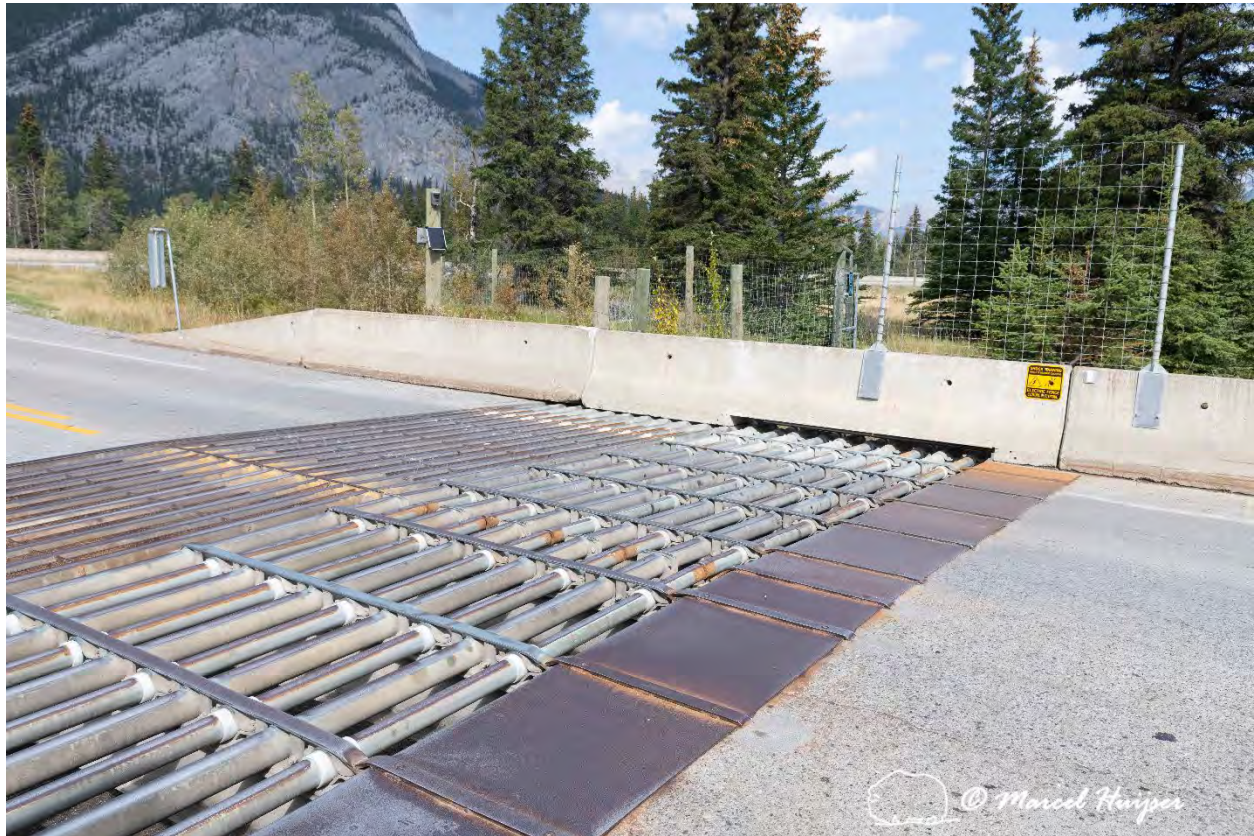
Figure 27: Electrified barrier, Compound Road, Banff National Park, Canada.

The barrier at Compound Road is constructed similar to the one at Sunshine Road (Figure 27). This barrier did not receive a grounding plate (with protective strips) until the end of September 2021 (personal communication Dan Rafla, Parks Canada).

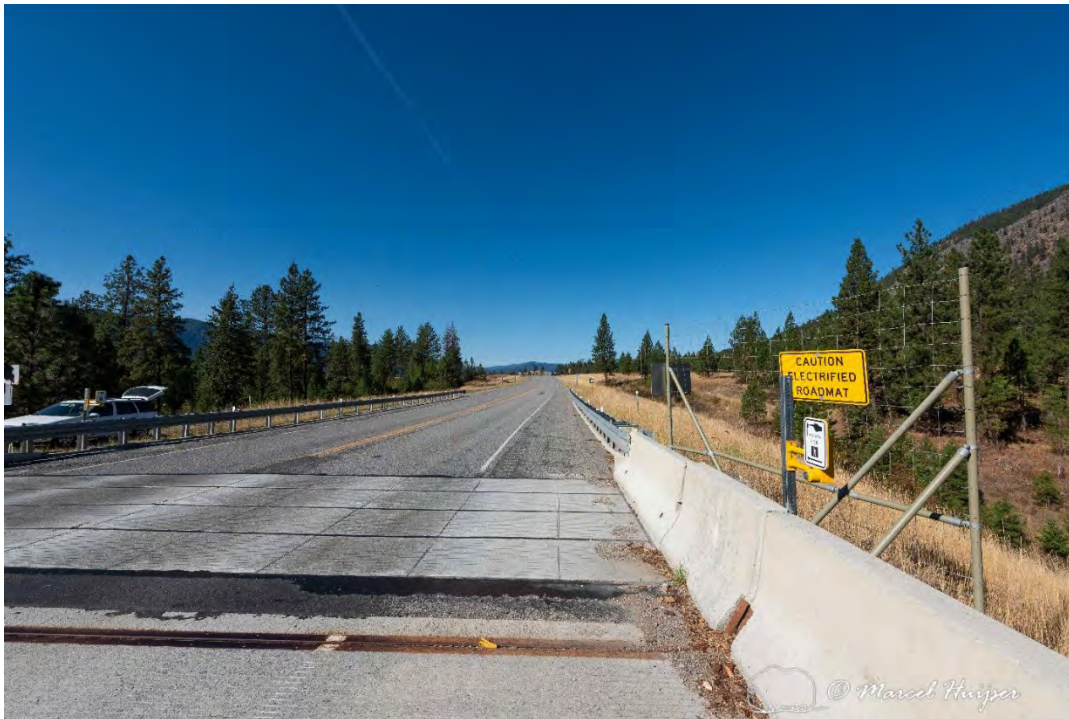
Figure 32: The electrified barrier at the west fence-end. Note that the bridge directly connects to the electrified barrier.

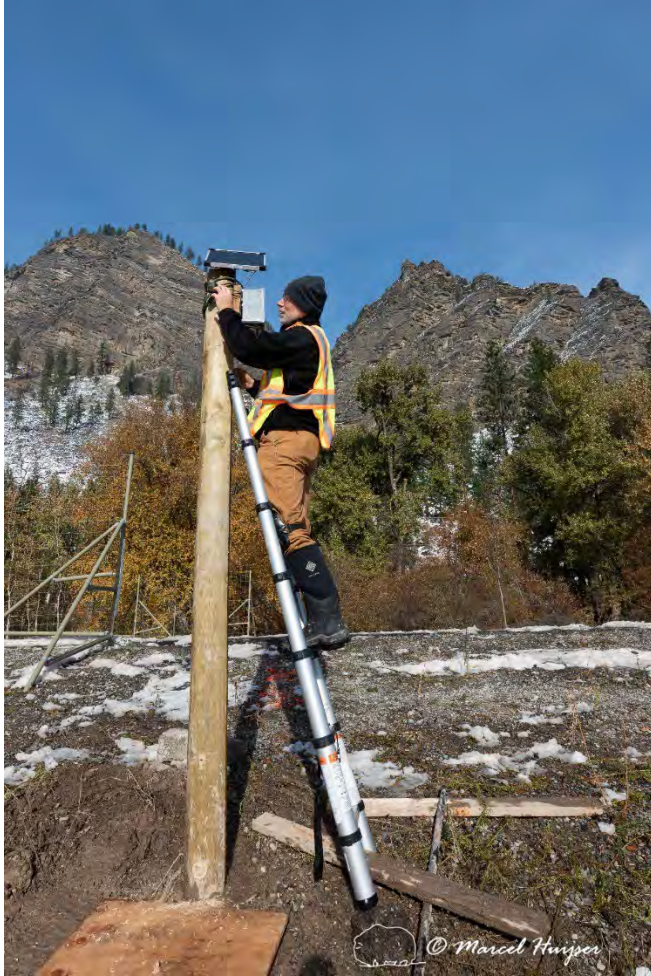
Figure 36: The camera, battery box and solar panel installed on a designated newly installed post at the eastern electrified barrier.

The west and east electrified barrier each had a trail camera installed (HyperFire 2 Professional Covert IR) (Figures 35, 36). To accommodate the heavy use of the cameras associated with the traffic volume (about 2,000 potential camera triggers per day on average), the cameras were customized with an external power. This allowed the cameras to be powered through a solar panel and associated battery. In addition, high-capacity memory cards (64 GB) were used. The cameras were checked, and the memory cards were exchanged about once a month. The camera at the west fence-end was installed 30 September 2020. The camera at the east fence-end required a new post for which a right-of-way encroachment permit was obtained from MDT on 8 October 2020. The post and camera were installed on 27 October 2020.

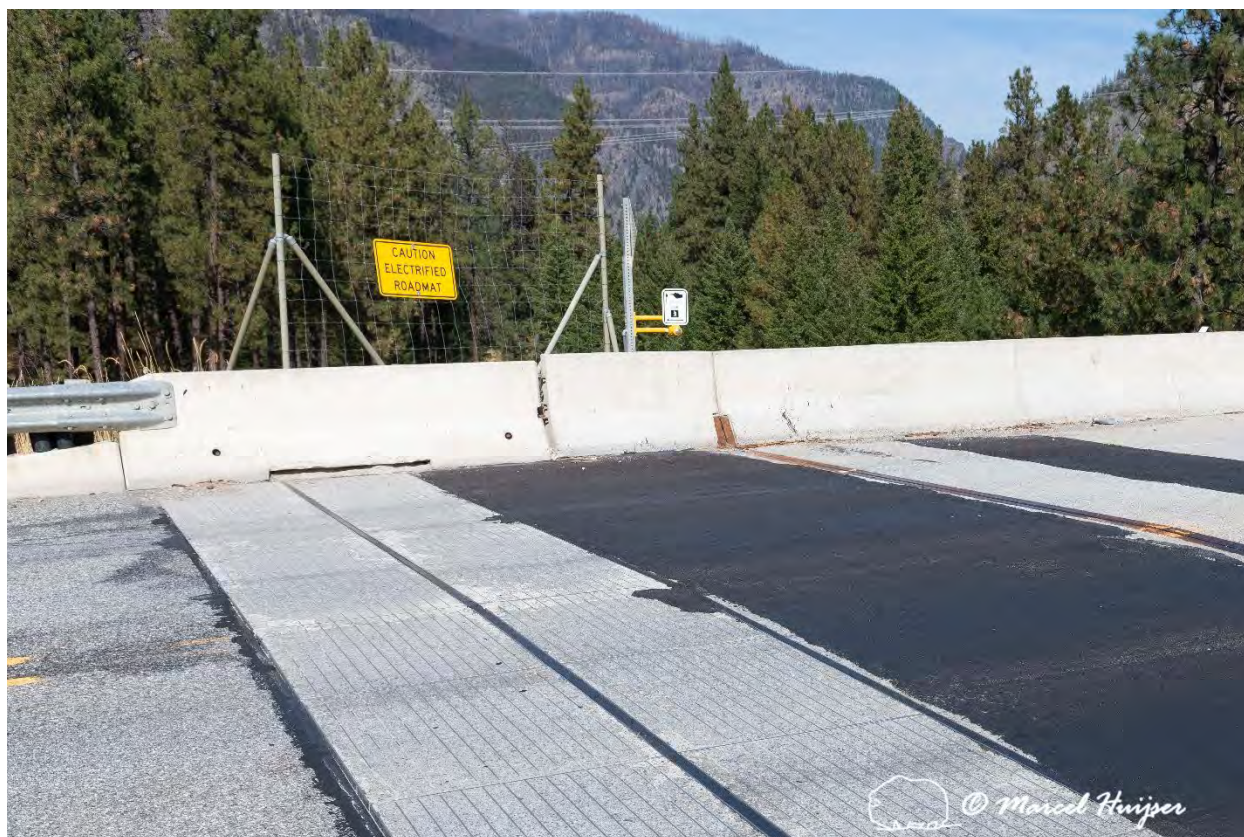
Figure 38: The crumbling concrete at the western electrified barrier was covered in asphalt.
