# **Evaluation of the Reliability of an Animal Detection System in a Test-Bed**

Final Report

Western Transportation Institute  
College of Engineering  
Montana State University – Bozeman

California PATH program – UC Berkeley

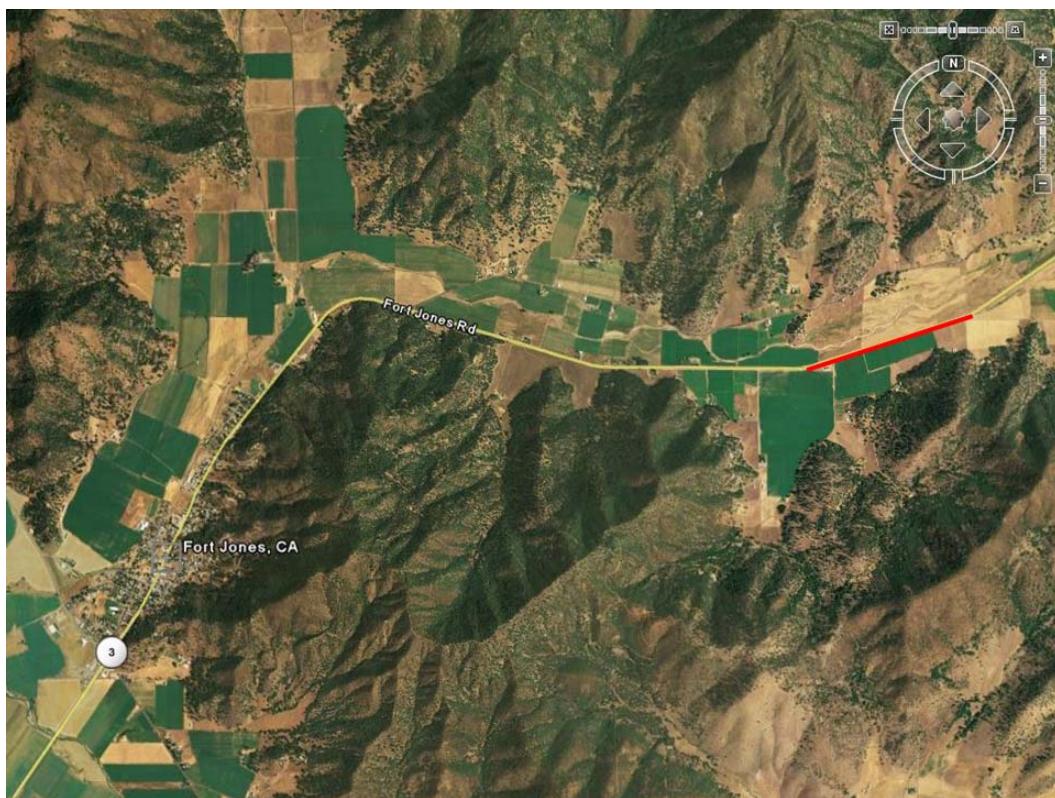
**Figure 1. The road section (in red, about 0.8 mi (1.3 km) long) of the location of an animal detection system along Hwy 3 (Ft. Jones Rd.) near Ft Jones, CA.**

Originally, an animal detection system was scheduled to be installed along Hwy 1, near Orick, CA (Cody & Huijser, 2005). However, that site was abandoned and, after review by PATH and discussion with WTI-MSU, a new site was selected: an about 1.3 km (0.8 mi) long section of Hwy 3 (Ft. Jones Rd.), near Ft Jones, CA (Figure 1).

Below is a brief description of the site near Ft Jones, CA, where the animal detection system was installed in the summer of 2009. The road section near Ft. Jones was primarily selected because of its history of collisions with black-tailed deer (*Odocoileus hemionus columbianus*) and the interest of California Department of Transportation (CALTRANS) District 2 personnel in the project.

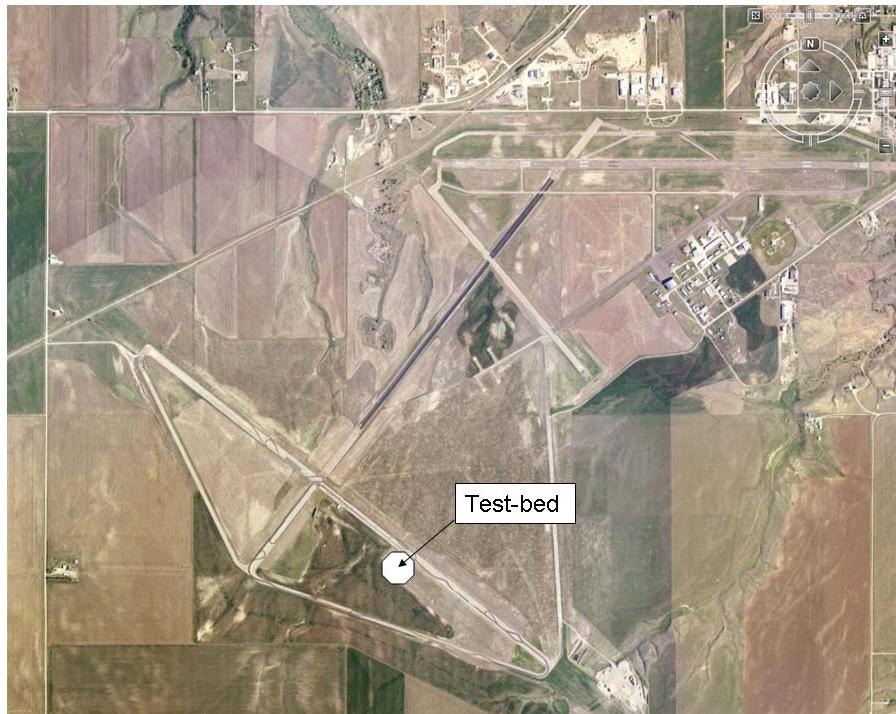
**Figure 2.** The location of the test-bed along a former runway at the Lewistown Airport in central Montana. The current municipal airport is located on the upper right of the photo.

The RADS test-bed is part of the TRANSCEND cold region rural transportation research facility and is located along a former runway at the Lewistown Airport in central Montana (Figure 3.1). The test-bed location experiences a wide range of temperatures, and precipitation ranges include mist, heavy rain, and snow; the topography is flat, and the rocky soil does not sustain much vegetation that may obstruct the signals transmitted or received by the sensors. The test-bed consists of an animal enclosure, space for multiple animal detection systems, and six infrared cameras with continuous recording capabilities (Figures 2 through 5). The distance covered by the system tested for this project was 91 m (300 ft) (from the left to the right side of the enclosure). The animal enclosure includes shelter, water, and an area alongside the fence that was designated for feeding. These three resources are located in different parts of the enclosure to maximize animal movement through the detection areas.

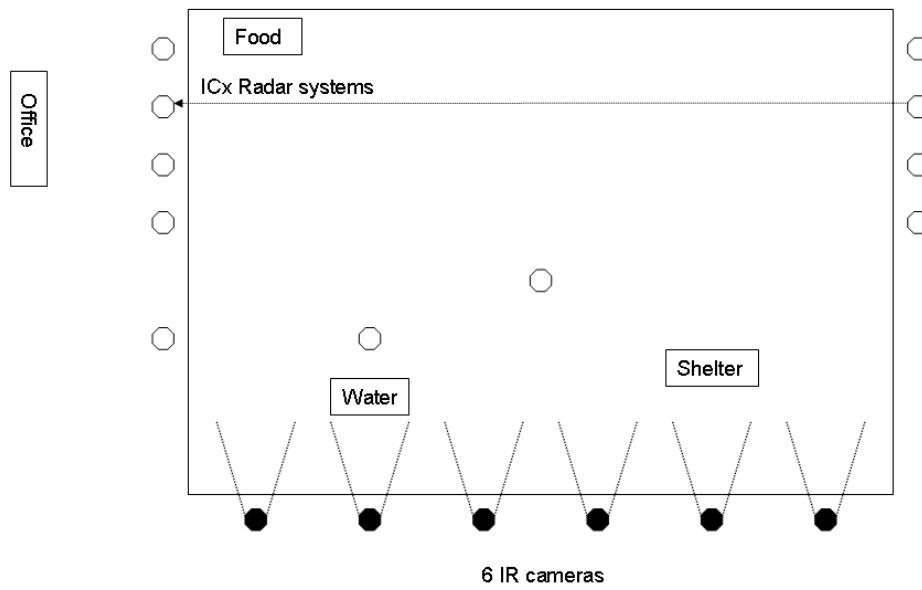
**Figure 3.** Test-bed design including an animal enclosure, the animal detection system tested for this project (open circles represent poles on which sensors can be attached), the six infrared (IR) cameras aimed at the enclosure from the side (solid circles), and the office with data recording equipment. The arrow shows the direction towards which the transmitter is pointed.

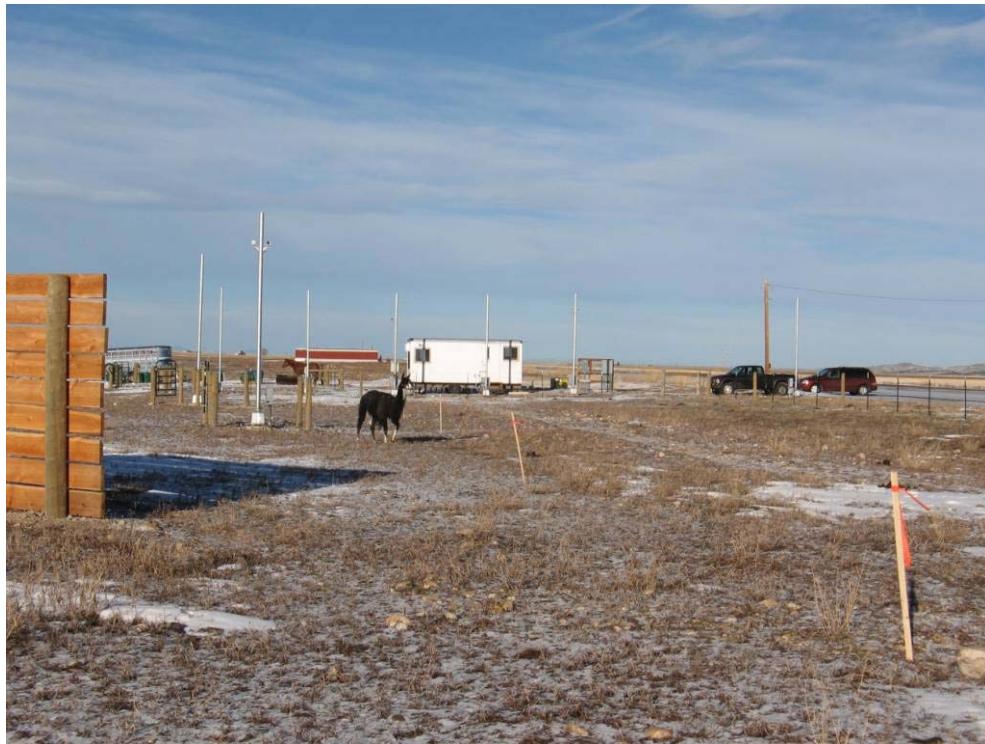
**Figure 4.** The test bed with the remote office, poles on which sensors can be attached, the shelter, and a llama (Photo: Marcel Huijser, WTI/MSU).

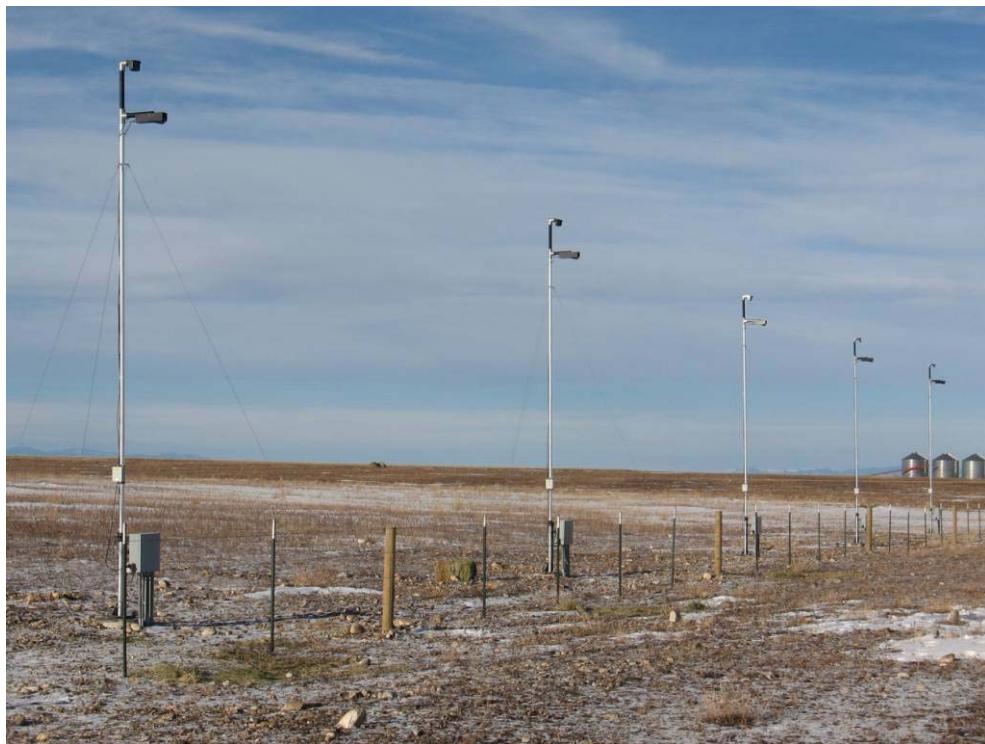
**Figure 5.** The infrared cameras that monitor animal movements in the enclosure (Photo: Marcel Huijser, WTI/MSU).

The six infrared cameras (Fuhrman Diversified, Inc.) were installed perpendicular to the detection system. These cameras and a video recording system record all animal movements within the enclosure continuously, day and night. The RADS III animal detection system saved its individual detection data with a date and time stamp. These data were compared to the images from the infrared cameras, which also had a date and time stamp, to investigate the reliability of the system.

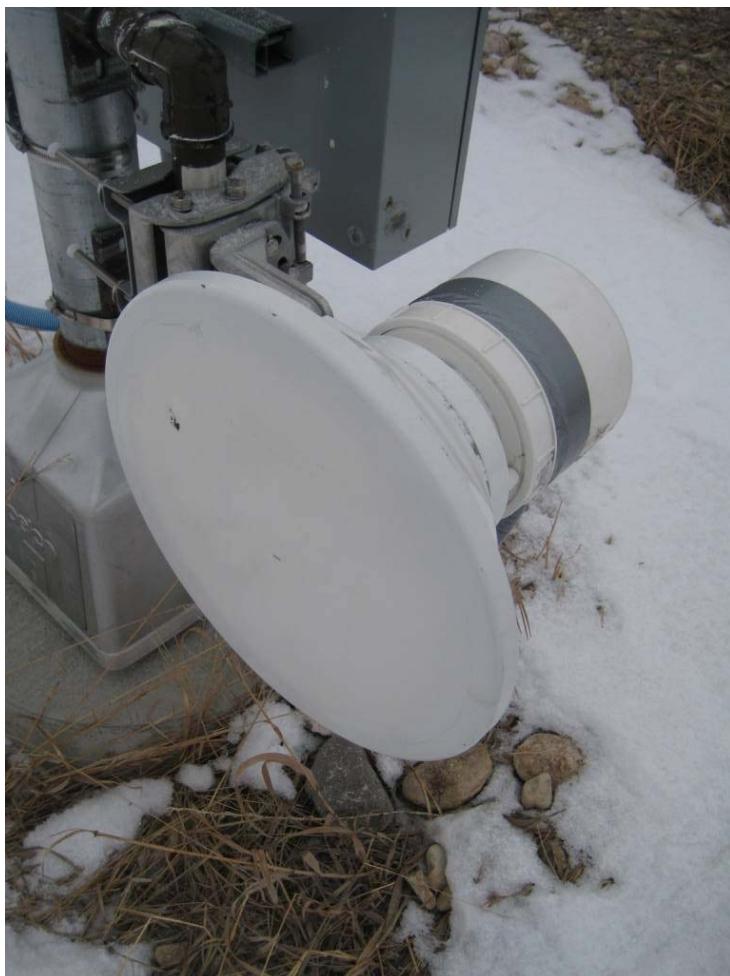
**Figure 6. The receiver of the third generation break-the-beam system manufactured by ICx Radar Systems. Note: the transmitter looks similar to the receiver.**

The system tested for this project is a microwave radio signal break-the-beam system manufactured by ICx Radar Systems (Scottsdale, Arizona (formerly Sensor Technologies and Systems, Inc.). The system is the third generation of this detection technology (RADS III) (Figure 6). Previous generations (RADS I and RADS II) were evaluated for their reliability in an earlier project (Huijser et al., 2009c). The RADS III is the exactly the same detection technology as was installed near Ft Jones, CA, in September 2009. The delivery of the system for the test site in Lewistown, MT was delayed and the equipment was not received until 24 September 2009. Certain parts were not functional and were shipped back to the manufacturer for repair and replacement. Functional equipment was received on 14 December 2009, and the system was successfully installed in Lewistown, MT on 16 December 2009. The center of the beam was set at about 73.7 cm (29 inches) above the ground. However, because of rises and depressions in the terrain, the center of the beam was estimated to have varied between 71.1 and 76.2 cm (28-30 inches) above the ground. Setting the center of the beam lower may have resulted in false positives as a result of the grass-herb vegetation in the enclosure.

The RADS III system transmits microwave radio signals (around 35.5 GHz). These signals are received by a sensor on the other end, and whenever an animal or object passes between the sensors, the signal is reduced. If certain thresholds are met, the reduction in signal strength results in a detection. The detection line is the line between the transmitter and receiver sensors where the break-the-beam systems should detect large animals. The detection line was marked with cones just adjacent to the actual detection line to prevent interference with the microwave radio signal (Figure 7). The cones were visible on the images from the individual cameras. For the RADS III system the detection line is 40.6 cm (16 in) wide consistently (Pers. com. Lloyd Salsman, ICx Radar Systems). In addition, RADS III has a wider detection area 4.5 m (15 ft) close to the sensors (Pers. com., Lloyd Salsman, ICx Radar Systems).

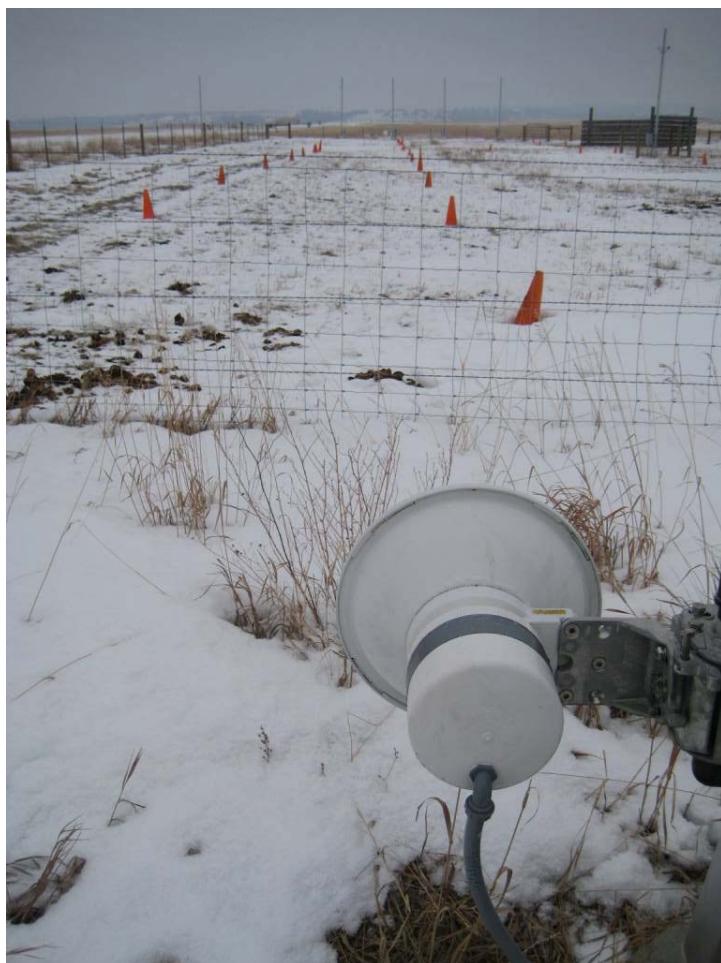
**Figure 7. The detection line was marked with cones to be able to record the position of the animals (Photo: Marcel Huijser, WTI/MSU).**
