# NCHRP 25-25, Task 113

## ROAD PASSAGES AND BARRIERS FOR SMALL TERRESTRIAL WILDLIFE SPECIES

### CASE STUDY 7, CONCRETE BARRIERS FOR SMALL ANIMALS

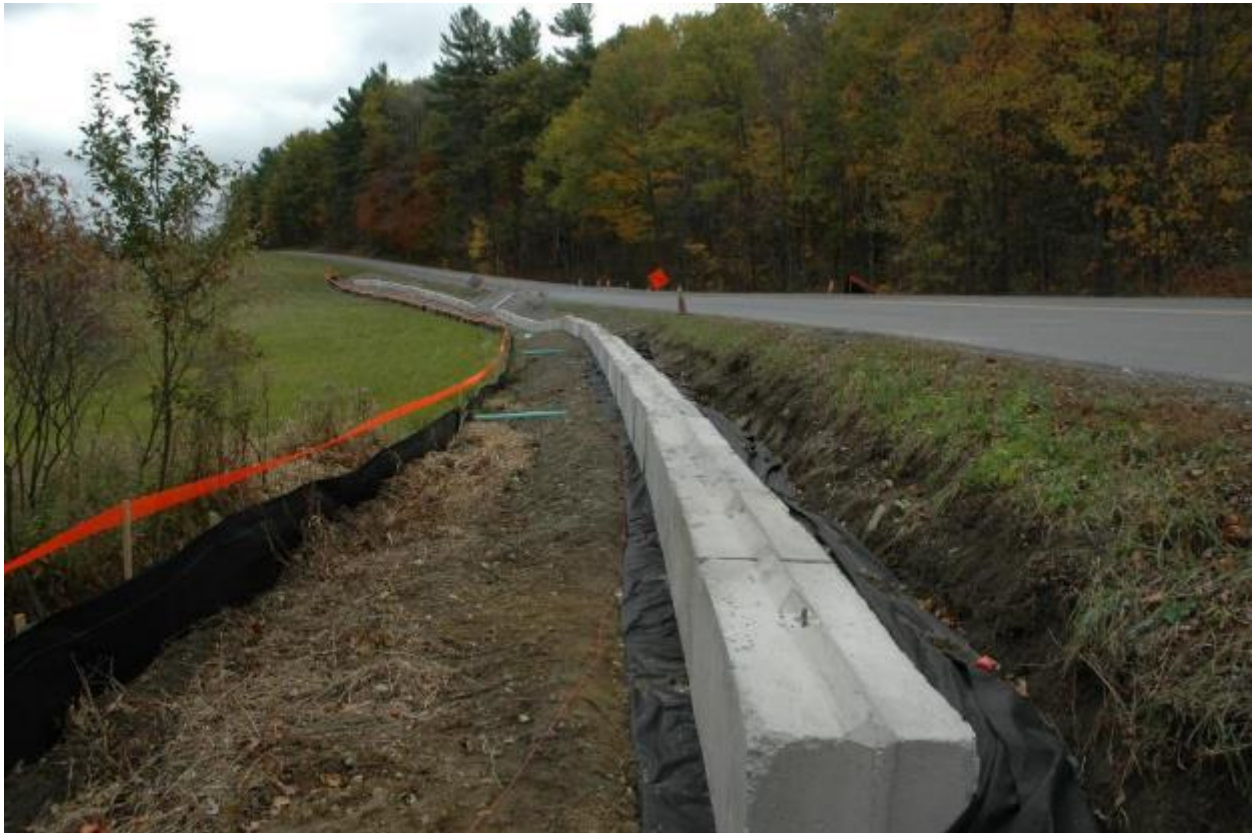
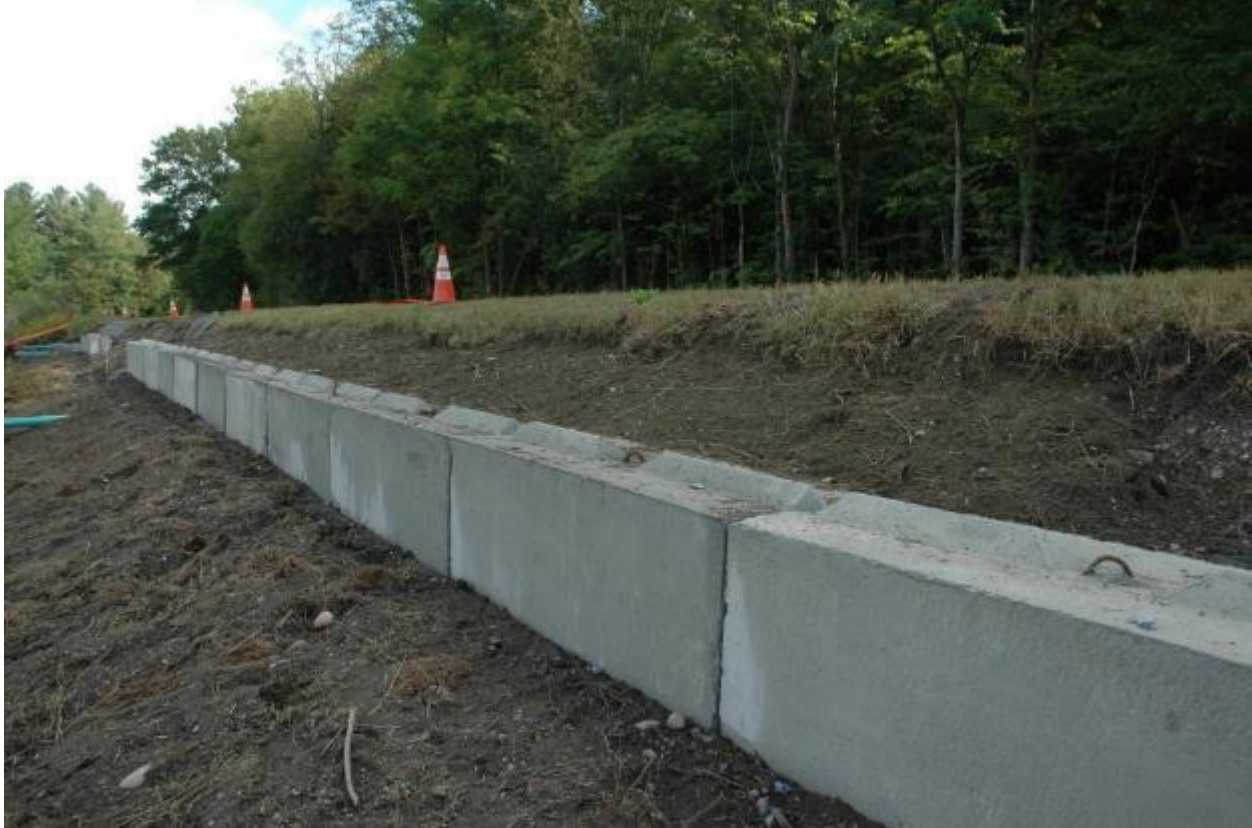
**Figure 3:** Installation (top) and completion (bottom) of a barrier wall for amphibians made from concrete waste blocks on Monkton Road, Vermont. Photo Credit: Chris Slesar, Monkton Conservation Commission.

**Barrier Specifications:** Keyed waste blocks with lifting loops were used that were not as expensive as the concrete used for crossing structures (Figure 3). These structures are 2 feet high by 2 feet deep by 4 feet long. Drainage from under and behind the blocks was built in to prevent movement of the blocks during the winter. The southernmost crossing structure has 228 feet of guide-walls on the upland side of

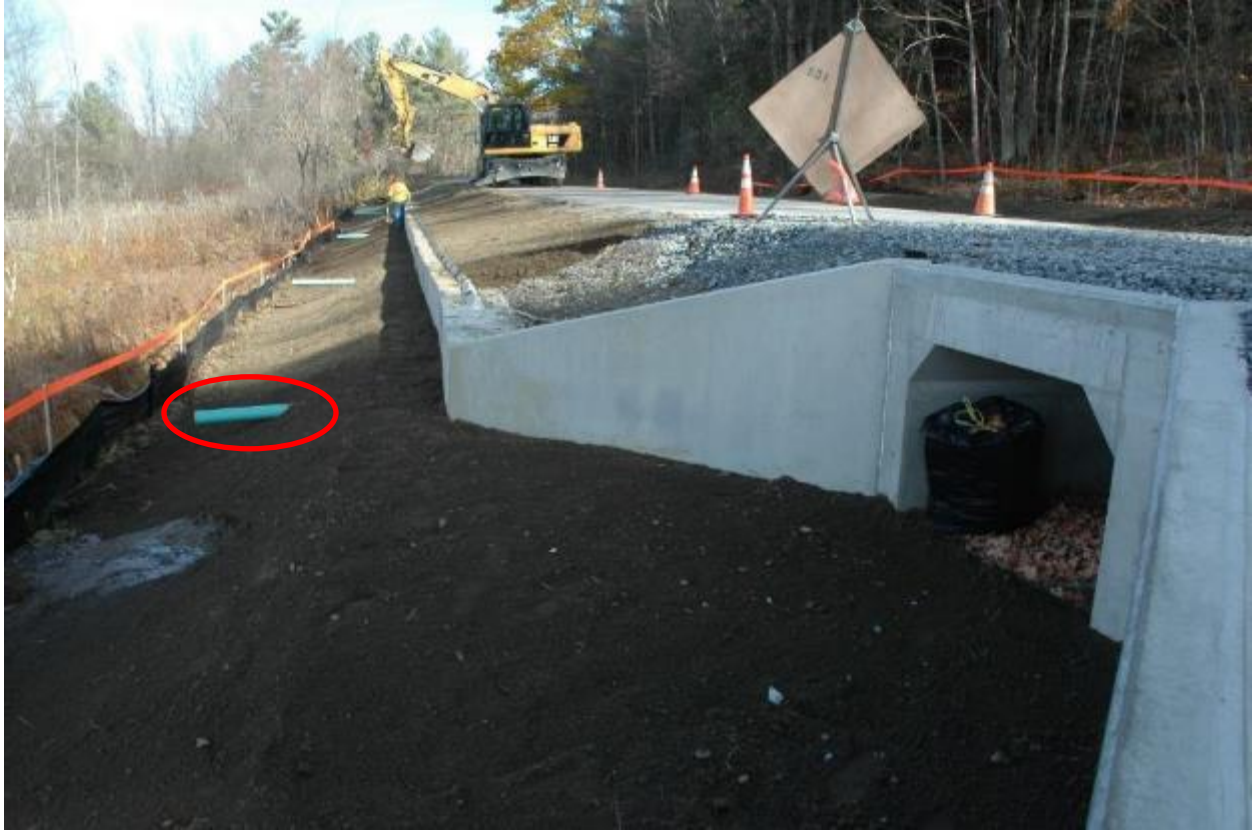
**Figure 4:** Concrete guide-walls used to funnel amphibians into the bottomless underpass and drainage pipes (red circle) inserted underneath the guide-wall. Photo Credit: Chris Slesar, Monkton Conservation Commission.

- Installed a drainage mechanism behind and under concrete walls (Figure 4)
- Added a plastic high density polyethylene (HDPE) curved piece at the fence-end to redirect amphibians away from road (Figure 5)
- Added cover objects every 6 feet along the barrier wall and in the tunnels
- Inserted slotted manhole covers at the top to allow additional light (Figure 6 and Figure 7)
- Used foam to seal off cracks between concrete blocks in the guide-wall

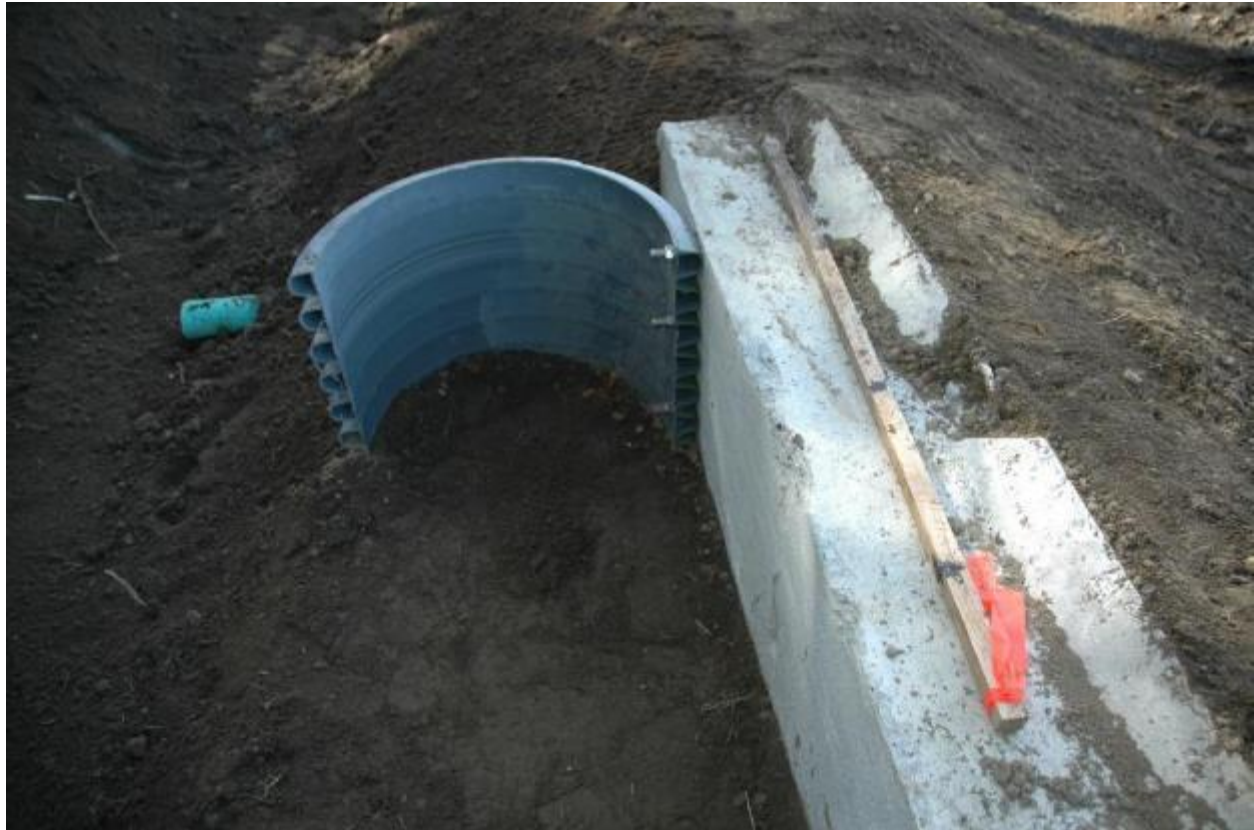
**Figure 5:** Plastic corrugated HDPE pipe used at barrier end to redirect amphibians away from the road.  
*Photo Credit: Chris Slesar, Monkton Conservation Commission.*

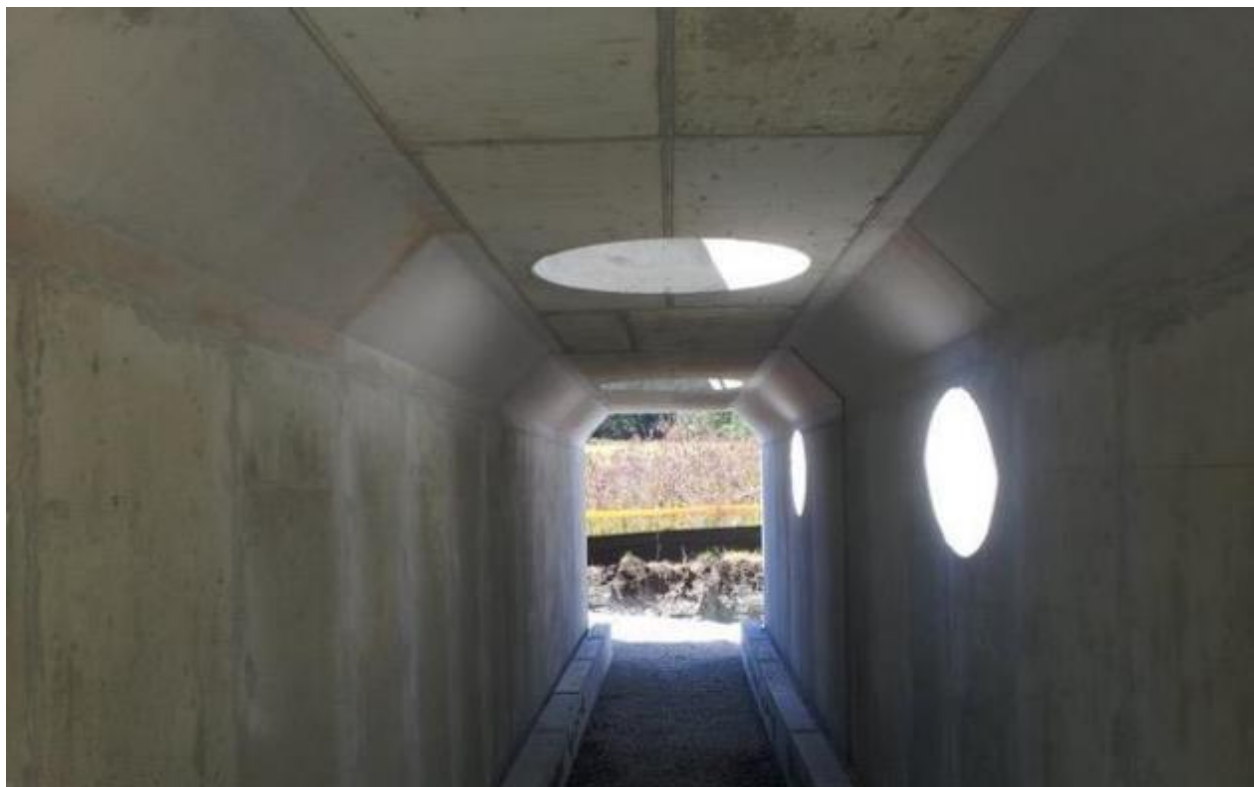
**Figure 6:** *Light shining into underpass through manhole cover. Note sandy bottom. Photo Credit: Stephen Pilcher with permission from James Andrews, Vermont Reptile and Amphibian Atlas.*

**Crossing Structure Specifications:** Pre-cast bottomless box culverts 8 feet high by 8 feet wide (2.4 meters high by 2.4 meters wide) with a natural substrate floor that mimicked the natural contours of the landscape but were raised enough so that water from the ditches did not drain through them. When the amphibians are walking downhill to the wetlands, they cross through a ditch and up a slight rise before the downward slope is continued through the culvert. Drainage from the road is maintained with drainage ditches and other below grade drainage culverts, so that the two amphibian crossing structures remain dry. To allow light, two slotted manhole covers were installed in the ceilings of each culvert.

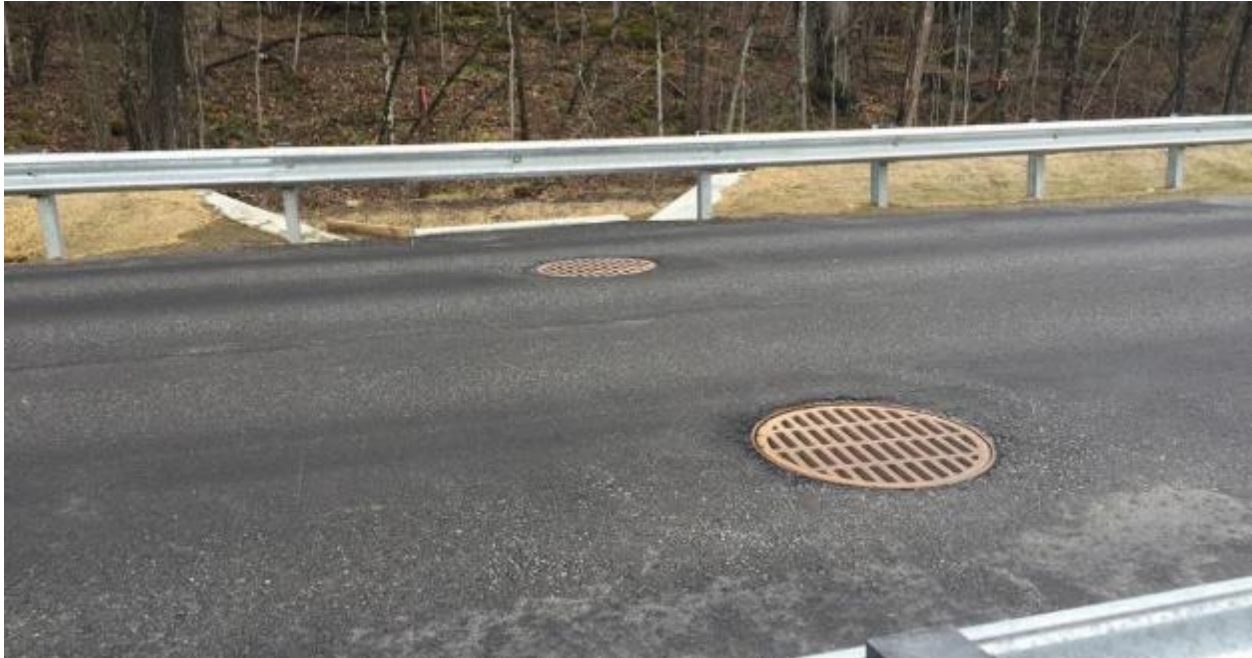
**Figure 7:** *Manhole covers on-top of the road to allow light into the underpass. Chris Slesar, Monkton Conservation Commission.*

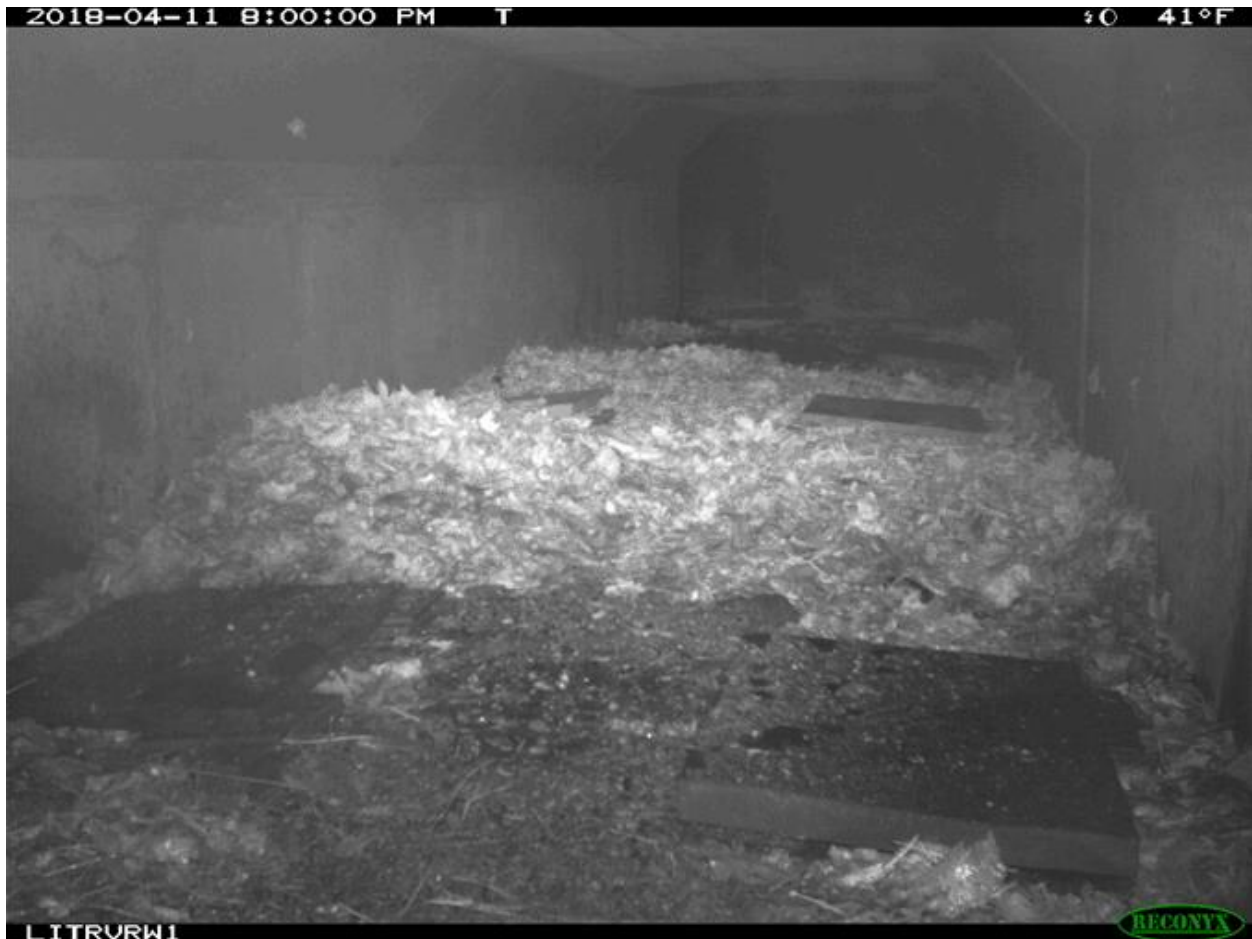
**Figure 8:** Figure shows the inside of the underpass with cover objects; it is actually a video (.gif) that shows amphibians moving through. Video Credit: Chris Slesar, Monkton Conservation Commission.

**Effectiveness in Providing Connectivity:** Monitored the underpasses with cameras to take pictures every minute from dusk to dawn during the spring migration period. Both before and after mitigation installation. Shown passage by thousands of amphibians and many small mammal species (Figure 8).
