Evaluation of an Animal Warning System Effectiveness

**California PATH Research Report
UCB-ITS-PRR-2010-22**

Final Report for Task Order 6604

EVALUATION OF AN ANIMAL WARNING SYSTEM EFFECTIVENESS

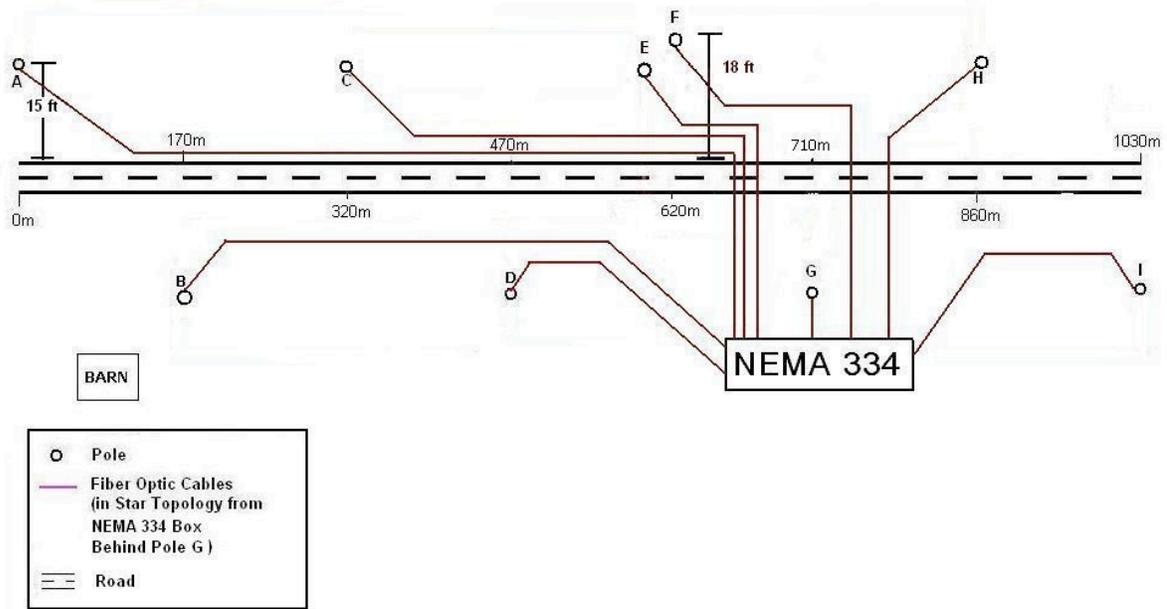
Diagram 1: A diagram of fiber optic roadside LAN layout

Each pole on the site is provided with its own network link and an industrial network switch and media converter. Because the poles are so far apart, the network links between poles are made with fiber optic cable, while the connections to networked components on the pole are made with category 5 or better twisted pair copper cabling. The power to each pole can be controlled independently. The switch and many other components run on 12 volt power. Below is a diagram of fiber optic roadside local area network of LAN.

The network connections between poles are made in a star configuration so each pole has an independent connection to the network, with a concentrating switch located with the PAWS computer in the roadside cabinet.

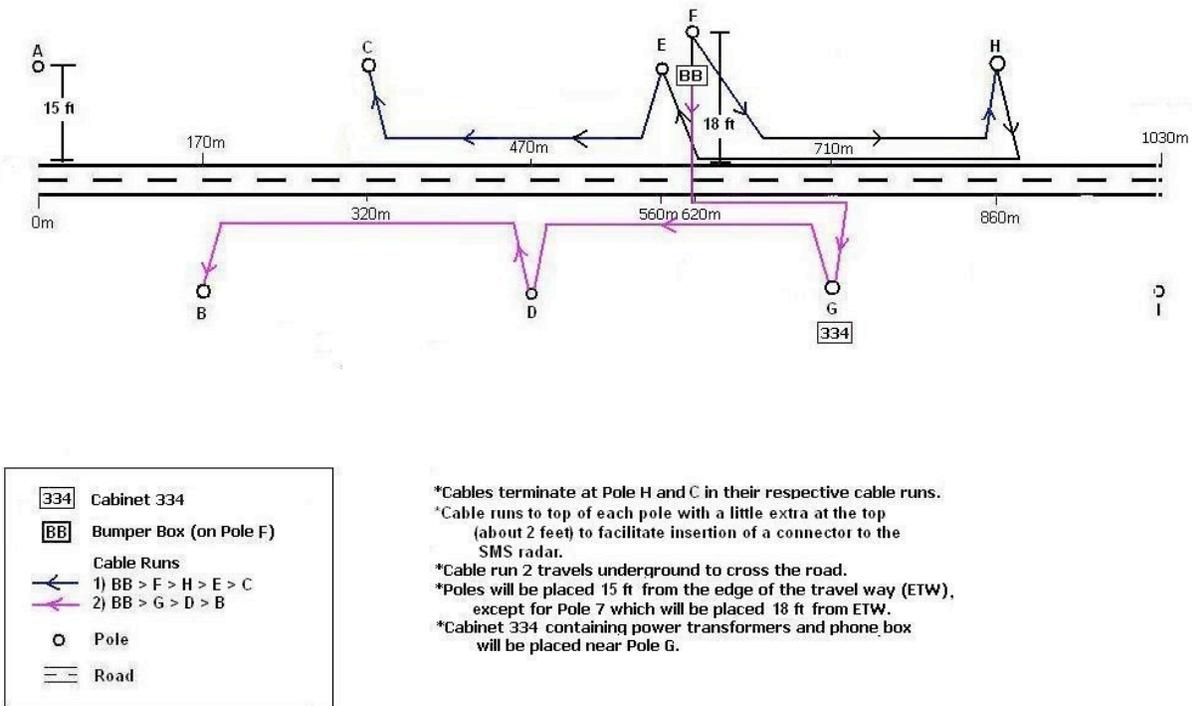
Diagram 2: A diagram of specialized “CAN” bus cables layout for SMS radars

The SMS radars are connected by a specialized “CAN” bus network, with special hardware that concentrates the messages and repeats them (“bumper boxes”) in particular locations at the site. The messages are eventually all received in a single bumper box that converts the data into a single stream in the site coordinate system. This data stream is sent over an Ethernet interface to the PAWS computer via the same fiber/twisted pair network described above. Below is a diagram of Specialized “CAN” bus cables for SMS radars.

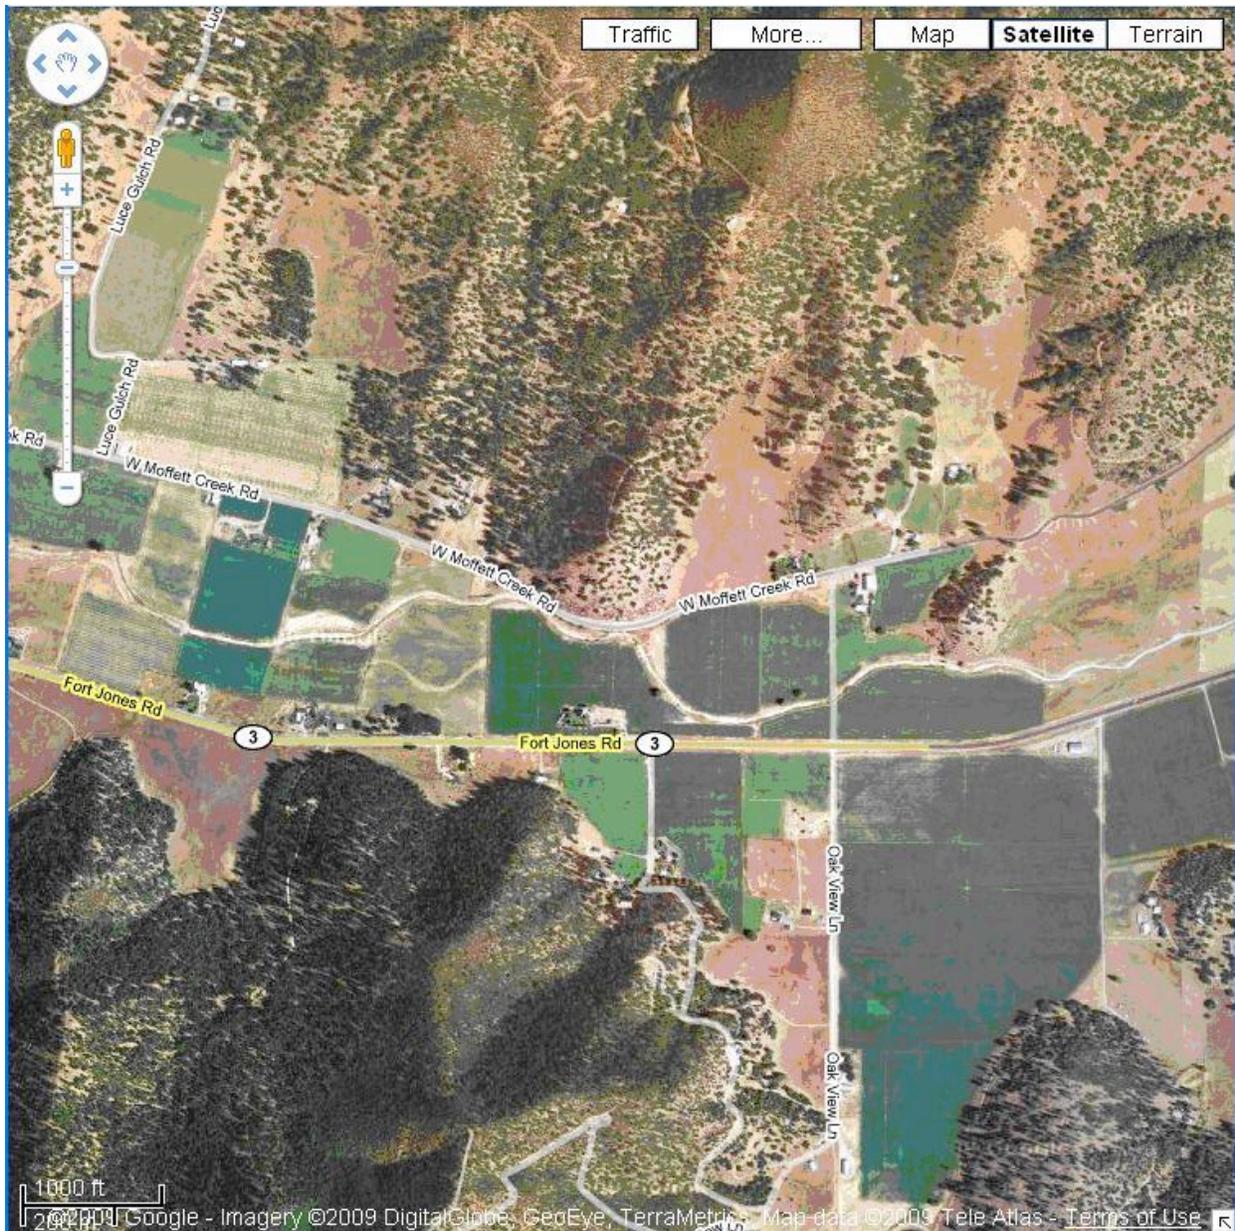
Figure 1: An aerial picture of the study site on SR-3 near of Fort Jones

This study site is in an area where a local herd of deer cross SR-3 all year long and the local Caltrans maintenance crew has been picking up carcasses every month for a long time now. It stretches about 1,030 meters and it is between post miles 36.6 and 37.3 of SR-3. District 2's maintenance crew have installed a post mile marker paddles every 1/10 of mile for the whole 5 mile corridor of SR-3 that lay north of Fort Jones. The site's topology and road geometry made this site a perfect location to install the animal and vehicular detection systems. Below is an aerial picture of the study site.

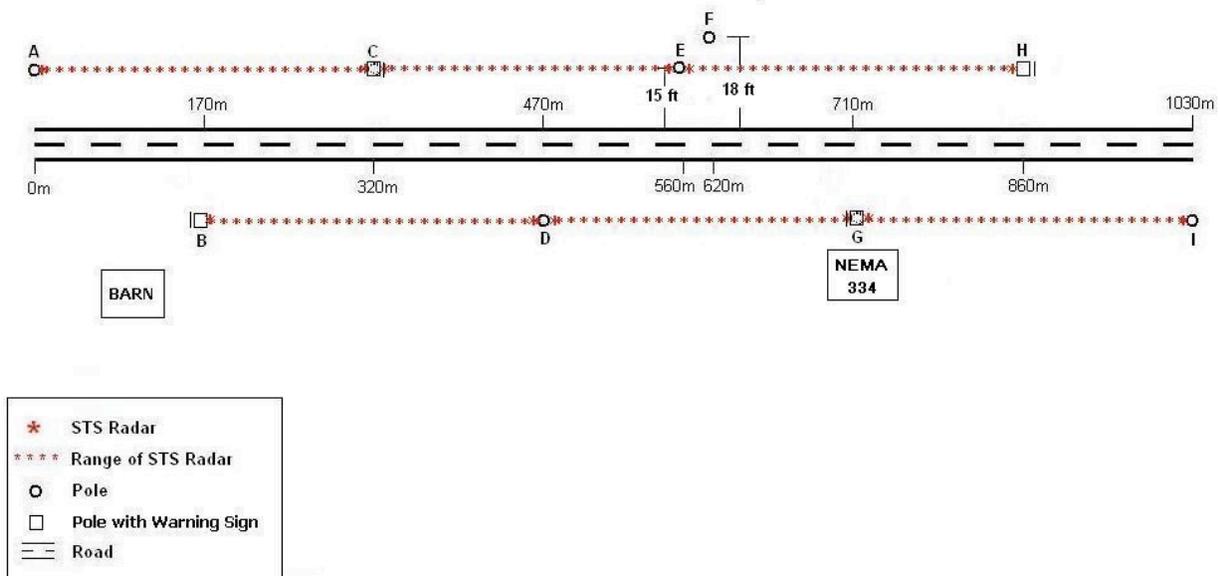
Diagram 3: A diagram of RADS system layout

The RADS system was installed and calibrated in September of 2009 with the help of an ICx support engineer. The acceptance tests were done by PATH staff on location. There are six breakaway beams that are established with three beams on each side of the roadway. Below is a diagram of the RADS.

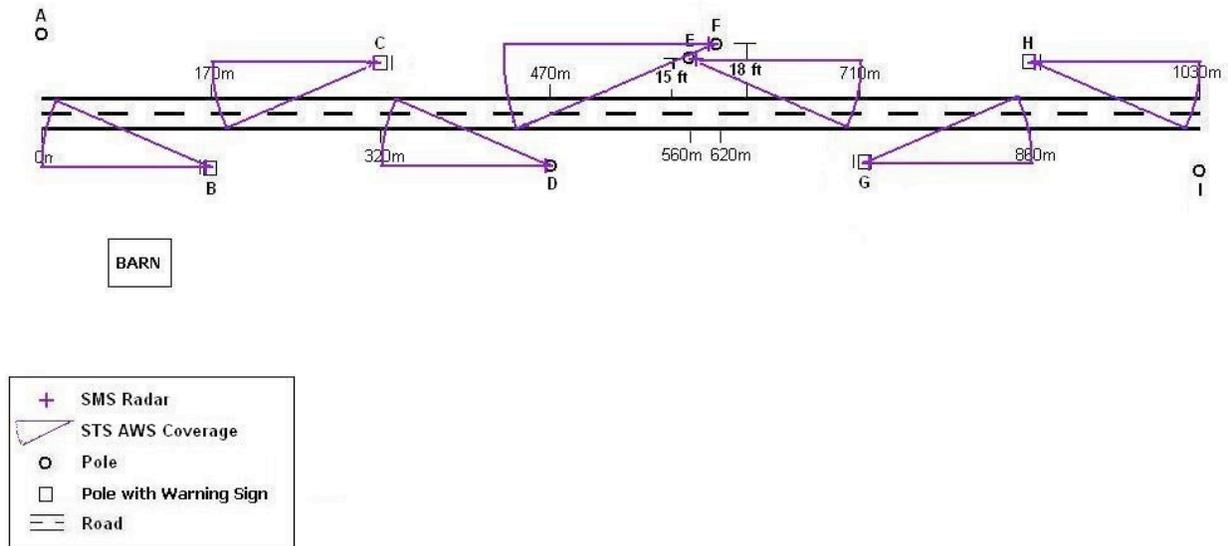
Diagram 4: A diagram of SMS radars layout

The SMS radar system was installed and calibrated in September of 2009 with the help of a SMS support engineer. The acceptance tests were done by PATH staff on location. There are seven SMS radars with three one side of the road and four on the other. This configuration was used to maximum the coverage of these radars given the number of available poles as well topography and geometry of the study site. Below is a diagram of the SMS radars.

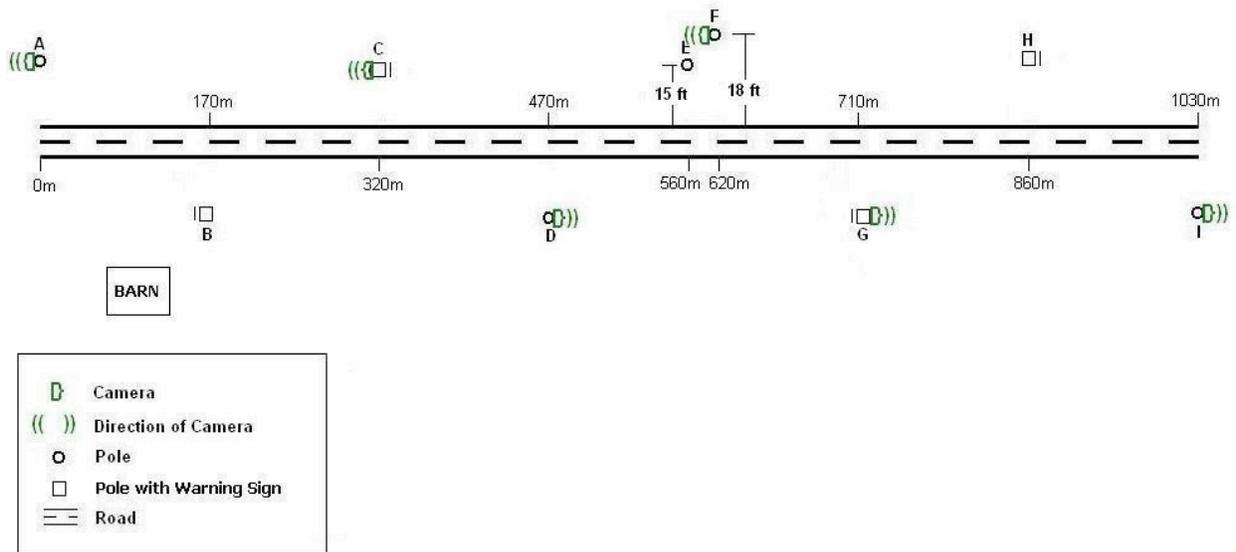
Diagram 5: A diagram of Omcon video cameras layout

The Omcon video cameras were installed and calibrated in September of 2009. The acceptance tests were done by PATH staff on location. There are six Omcon videos with three on each side of the road. This configuration was used to maximum the coverage of these videos given the number of available poles as well topography and geometry of the study site. Below is a diagram of the Omcon video cameras.

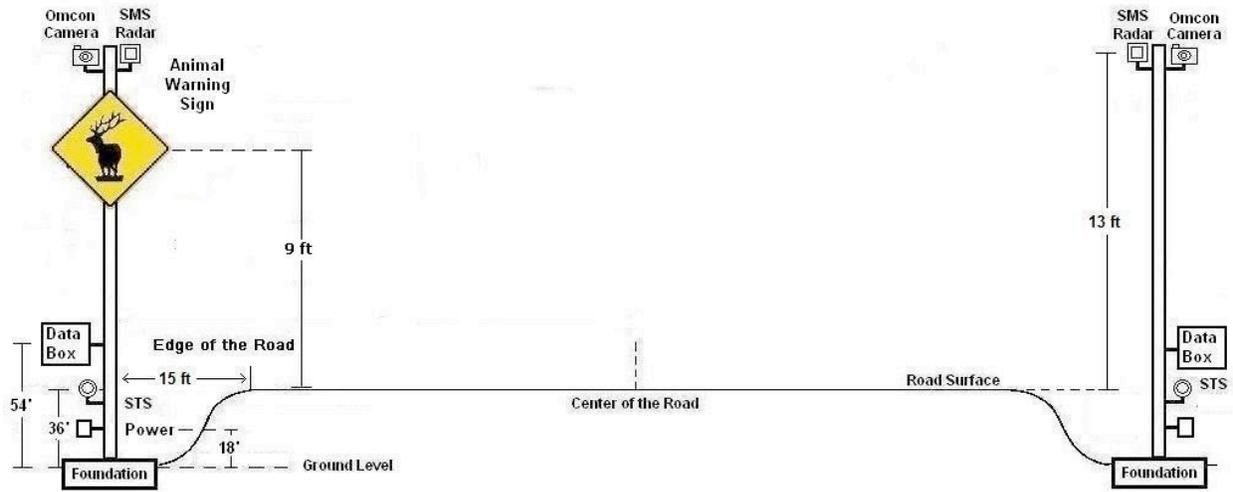
Figure 2: Typical pole installation side-view

Figure 2 below shows a typical side view of the pole installations.

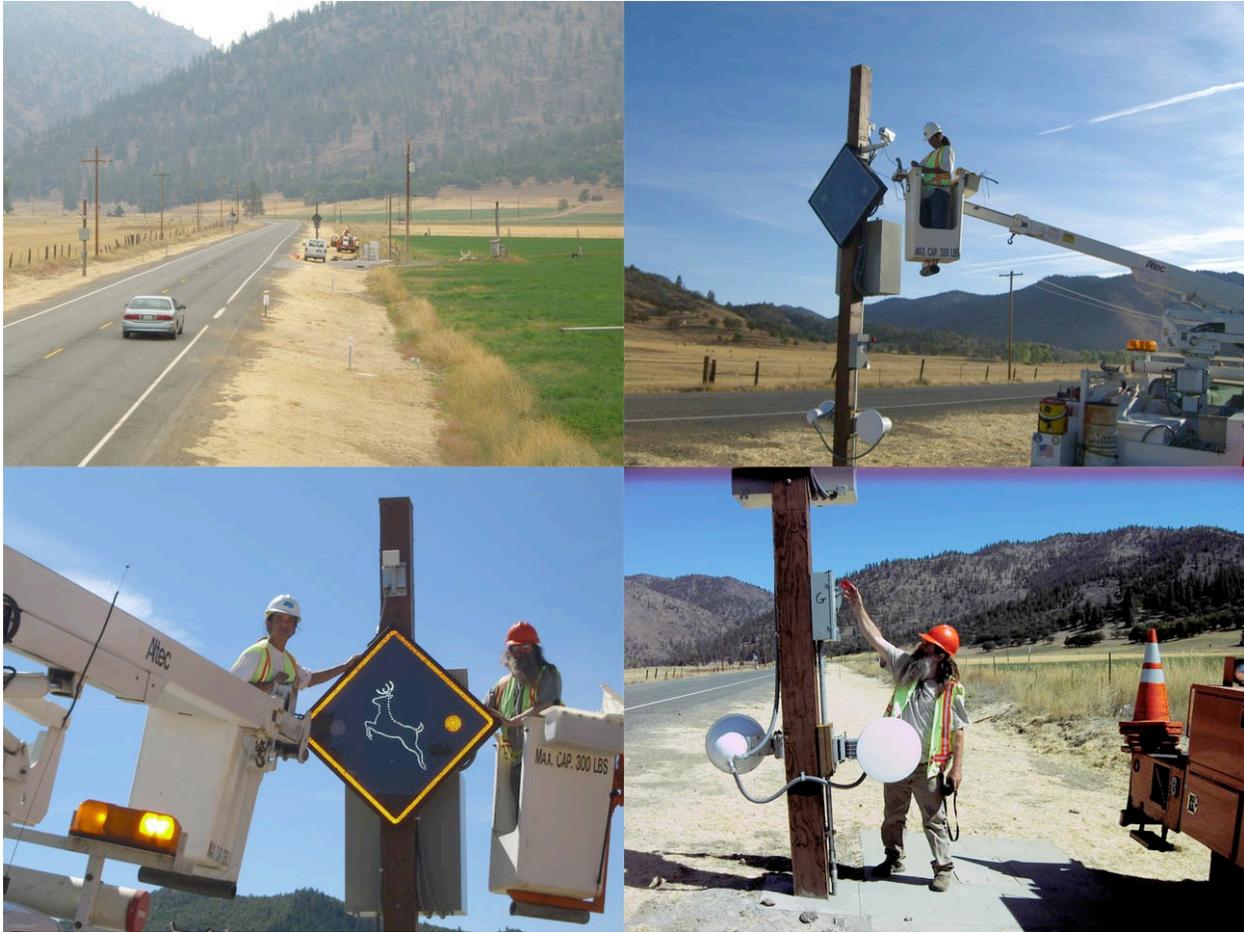
Figure 3: A picture of system installation

Figure 3 shows a picture of system installation.

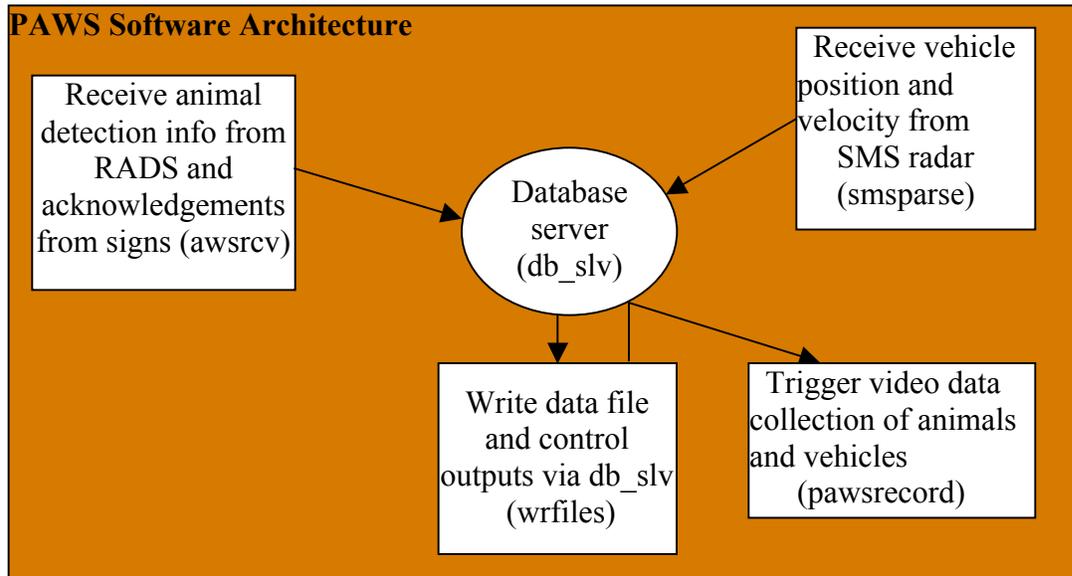
The PAWS data acquisition system is based on a publish/subscribe data pool system developed at PATH for other transportation purposes. A data server is created; it serves as a buffer for data coming in from the animal warning system and SMS radar, and as a trigger source for controls and data going out to wrfiles and pawsrecord (Figure A1).

Figure A1: Schematic of PAWS data acquisition software and control

Database clients subscribe to the data server by requesting a connection using a database variable defined by an arbitrary unique number selected by the programmer. Only one instantiation of a given database variable is allowed. The client may read, write, or both to this variable, as may other database clients. The variable is usually associated with a C structure containing fields important to a task, such as range, velocity, length, and ID of an SMS radar target. The client may also set a trigger with the database: when any field in the database variable's structure changes, the data server sends a trigger to the client, which then can read the new value in realtime and handle the trigger.

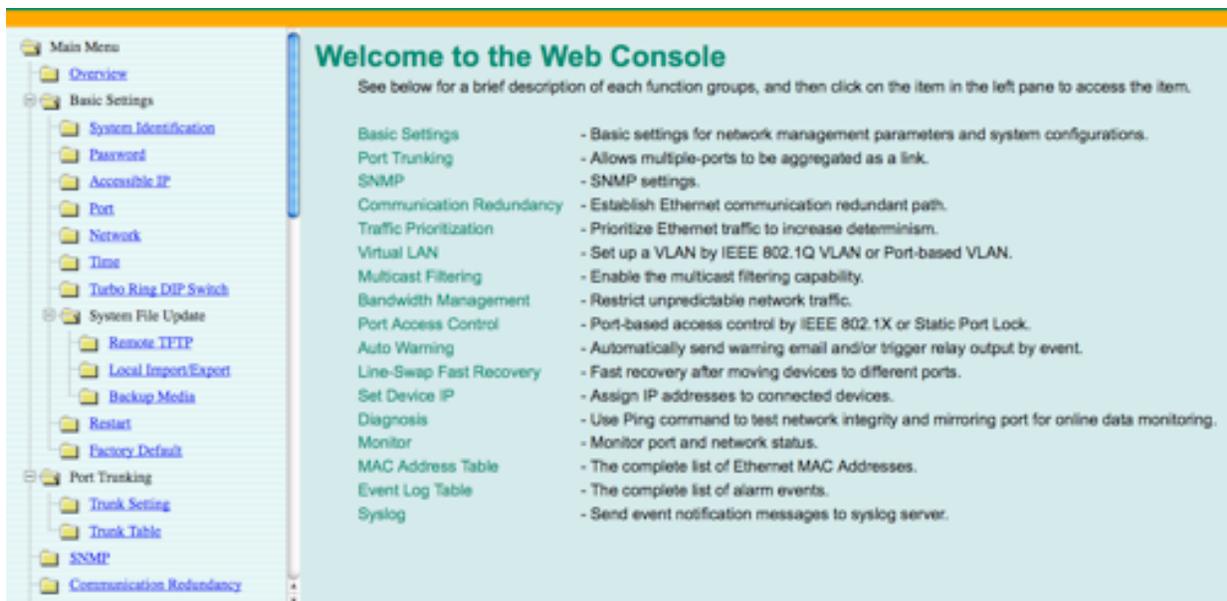
Managed network switches were chosen when the project's network infrastructure was designed. Managed network switches provide a lot of diagnostic information that is not typically available in non-managed network switches, as can be seen in Figure A2.

Figure A2: Switch Management Menu

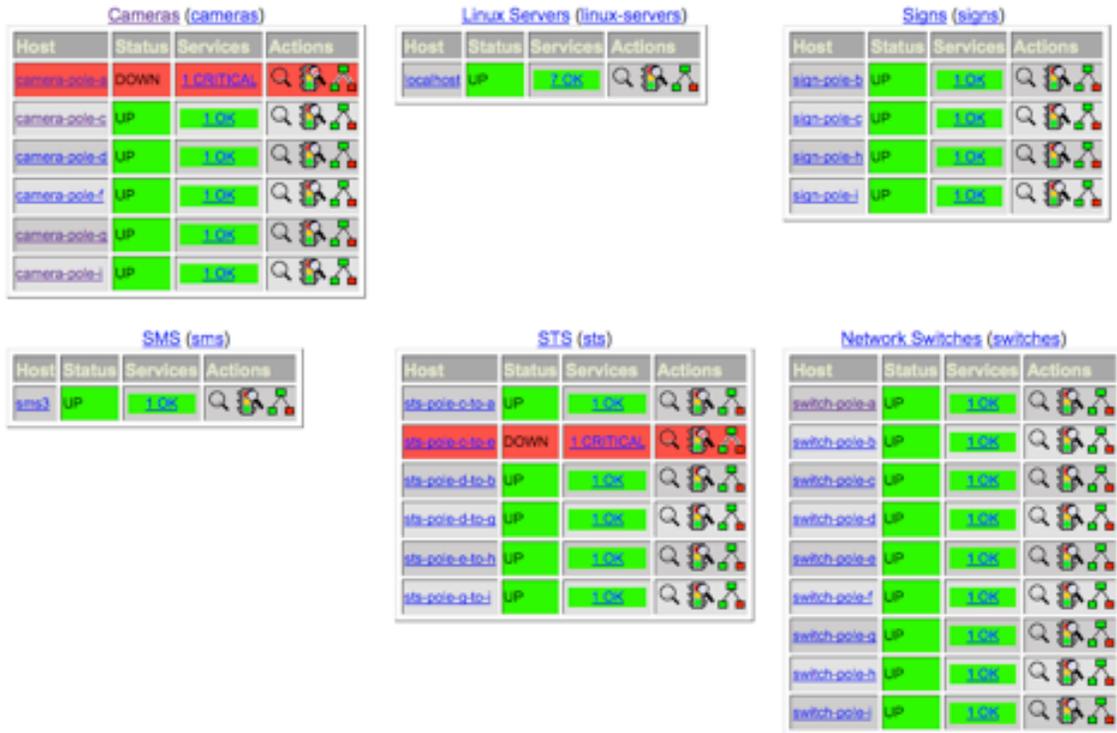
For PAWS we want to know whether or not all the networked components are online and we want to know the general health of the PAWS data collection computer. Figure A3 is a screen shot of a Nagios webpage that provides an overview of the health of each individual component in its component group. Figure A4 is a screen shot of a Nagios webpage that provides detailed host information of PAWS computer.

Figure A3: Nagios overview by component group

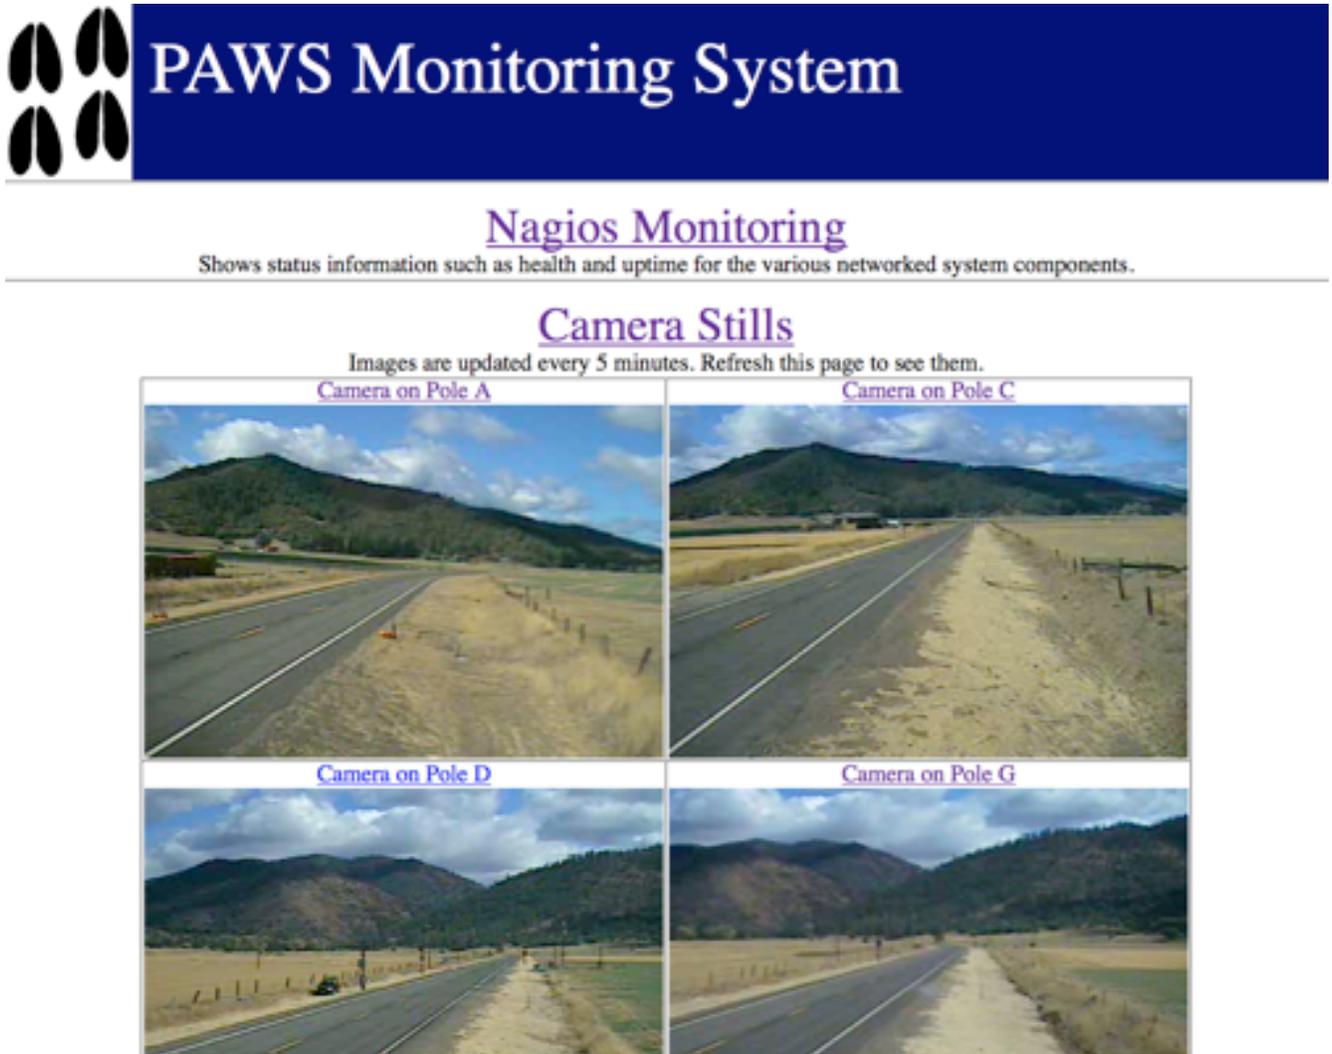
The website provides links to Nagios and displays the most recent still images recorded from each camera. Figure A6 below provides a sample of still images.

Figure A6: PAWS Monitoring Website

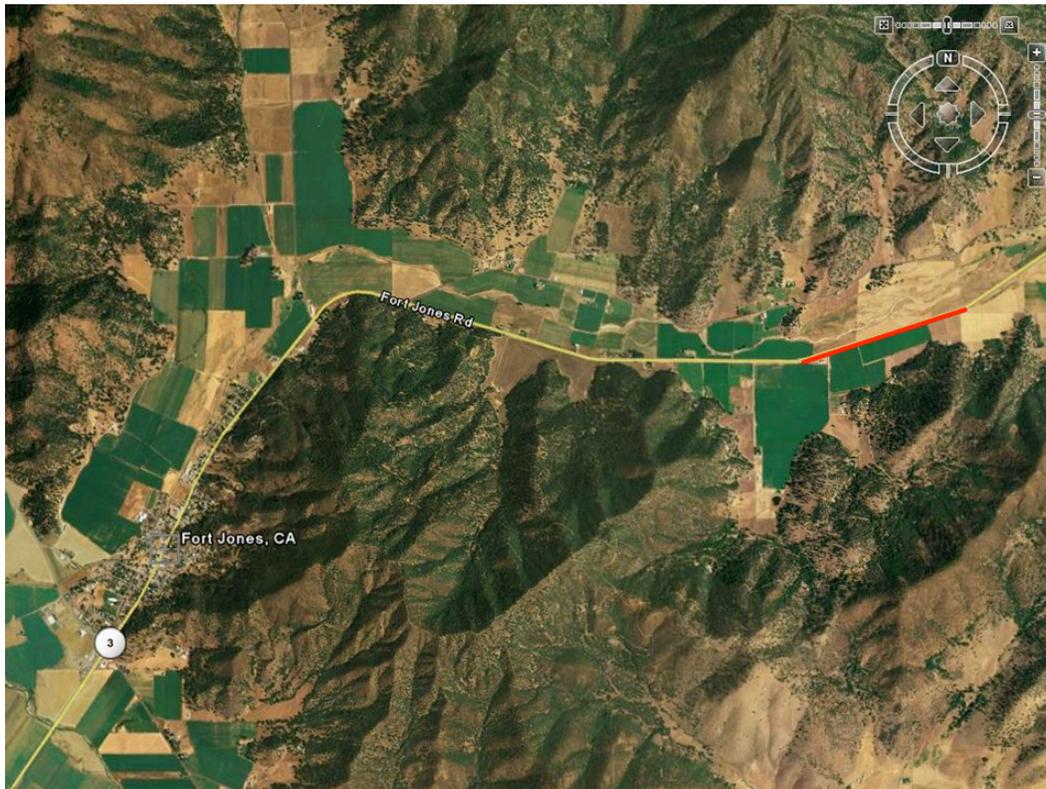
Figure 1. The road section (in red, about 0.8 mi (1.3 km) long) of the location of an animal detection system along Hwy 3 (Ft. Jones Rd.) near Ft Jones, CA.

Originally, an animal detection system was scheduled to be installed along Hwy 1, near Orick, CA (Cody & Huijser, 2005). However, that site was abandoned and, after review by PATH and discussion with WTI-MSU, a new site was selected: an about 1.3 km (0.8 mi) long section of Hwy 3 (Ft. Jones Rd.), near Ft Jones, CA (Figure 1).

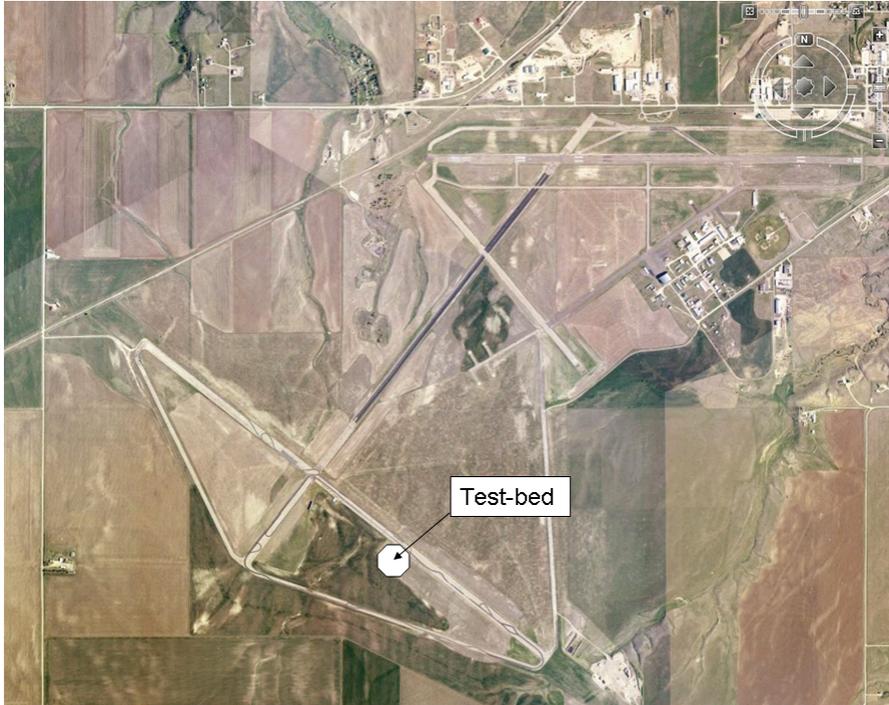
Figure 2. The location of the test-bed along a former runway at the Lewistown Airport in central Montana. The current municipal airport is located on the upper right of the photo.

The RADS test-bed is part of the TRANSCEND cold region rural transportation research facility and is located along a former runway at the Lewistown Airport in central Montana (Figure 3.1). The test-bed location experiences a wide range of temperatures, and precipitation ranges include mist, heavy rain, and snow; the topography is flat, and the rocky soil does not sustain much vegetation that may obstruct the signals transmitted or received by the sensors. The test-bed consists of an animal enclosure, space for multiple animal detection systems, and six infrared cameras with continuous recording capabilities (Figures 2 through 5). The distance covered by the system tested for this project was 91 m (300 ft) (from the left to the right side of the enclosure). The animal enclosure includes shelter, water, and an area alongside the fence that was designated for feeding. These three resources are located in different parts of the enclosure to maximize animal movement through the detection areas.

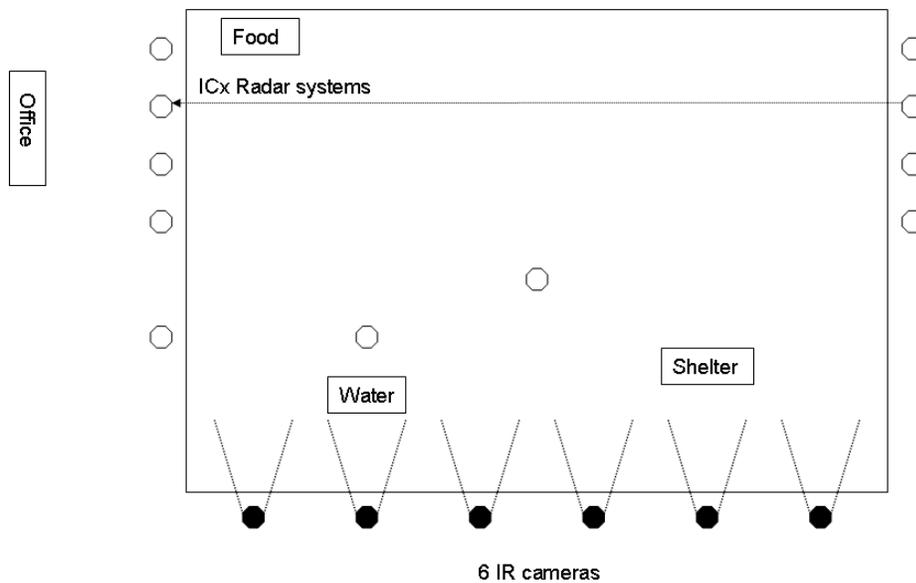
Figure 3. Test-bed design including an animal enclosure, the animal detection system tested for this project (open circles represent poles on which sensors can be attached), the six infrared (IR) cameras aimed at the enclosure from the side (solid circles), and the office with data recording equipment. The arrow shows the direction towards which the transmitter is pointed.

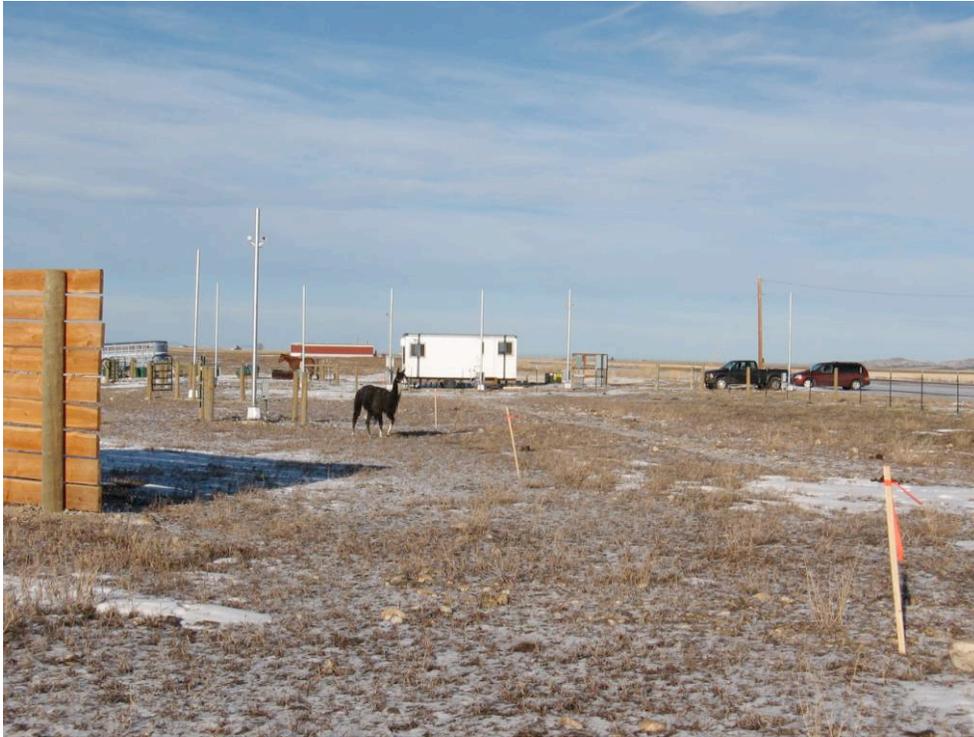
Figure 4. The test bed with the remote office, poles on which sensors can be attached, the shelter, and a llama (Photo: Marcel Huijser, WTI/MSU).

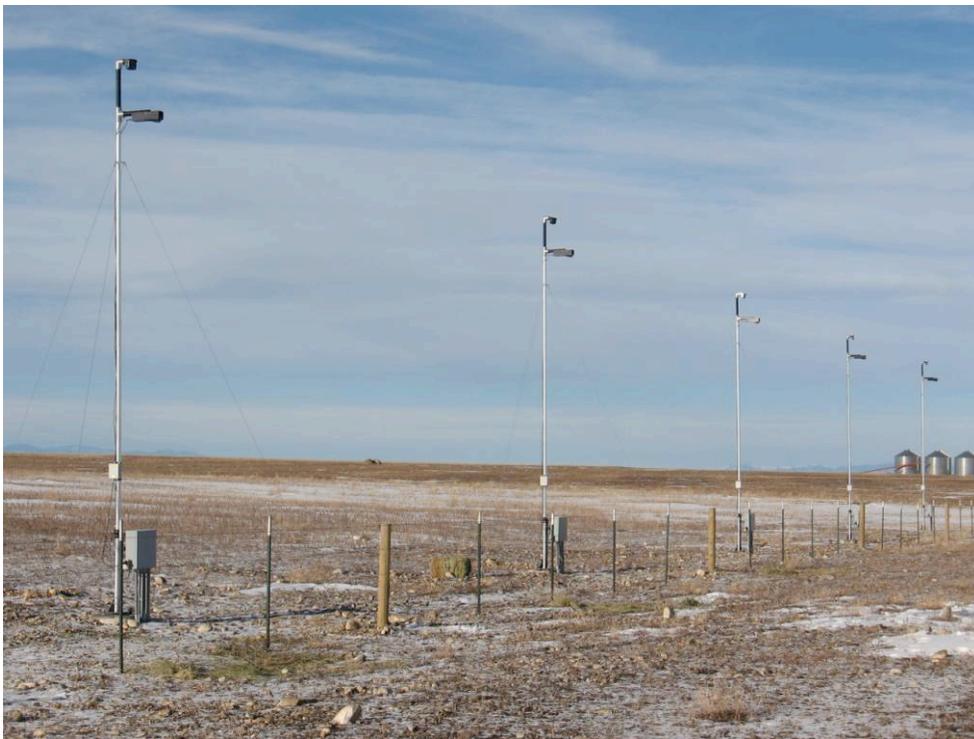
Figure 5. The infrared cameras that monitor animal movements in the enclosure (Photo: Marcel Huijser, WTI/MSU).

The six infrared cameras (Fuhrman Diversified, Inc.) were installed perpendicular to the detection system. These cameras and a video recording system record all animal movements within the enclosure continuously, day and night. The RADS III animal detection system saved its individual detection data with a date and time stamp. These data were compared to the images from the infrared cameras, which also had a date and time stamp, to investigate the reliability of the system.

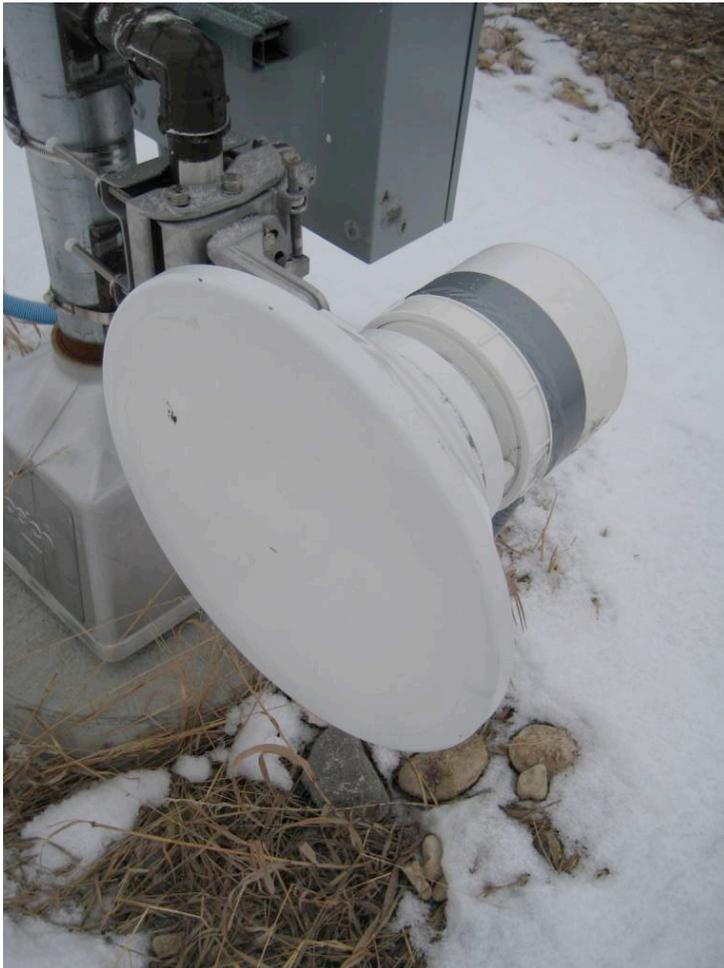
Figure 6. The receiver of the third generation break-the-beam system manufactured by ICx Radar Systems. Note: the transmitter looks similar to the receiver.

The system tested for this project is a microwave radio signal break-the-beam system manufactured by ICx Radar Systems (Scottsdale, Arizona (formerly Sensor Technologies and Systems, Inc.)). The system is the third generation of this detection technology (RADS III) (Figure 6). Previous generations (RADS I and RADS II) were evaluated for their reliability in an earlier project (Huijser et al., 2009c). The RADS III is the exactly the same detection technology as was installed near Ft Jones, CA, in September 2009. The delivery of the system for the test site in Lewistown, MT was delayed and the equipment was not received until 24 September 2009. Certain parts were not functional and were shipped back to the manufacturer for repair and replacement. Functional equipment was received on 14 December 2009, and the system was successfully installed in Lewistown, MT on 16 December 2009. The center of the beam was set at about 73.7 cm (29 inches) above the ground. However, because of rises and depressions in the terrain, the center of the beam was estimated to have varied between 71.1 and 76.2 cm (28-30 inches) above the ground. Setting the center of the beam lower may have resulted in false positives as a result of the grass-herb vegetation in the enclosure.

The RADS III system transmits microwave radio signals (around 35.5 GHz). These signals are received by a sensor on the other end, and whenever an animal or object passes between the sensors, the signal is reduced. If certain thresholds are met, the reduction in signal strength results in a detection. The detection line is the line between the transmitter and receiver sensors where the break-the-beam systems should detect large animals. The detection line was marked with cones just adjacent to the actual detection line to prevent interference with the microwave radio signal (Figure 7). The cones were visible on the images from the individual cameras. For the RADS III system the detection line is 40.6 cm (16 in) wide consistently (Pers. com. Lloyd Salsman, ICx Radar Systems). In addition, RADS III has a wider detection area 4.5 m (15 ft) close to the sensors (Pers. com., Lloyd Salsman, ICx Radar Systems).

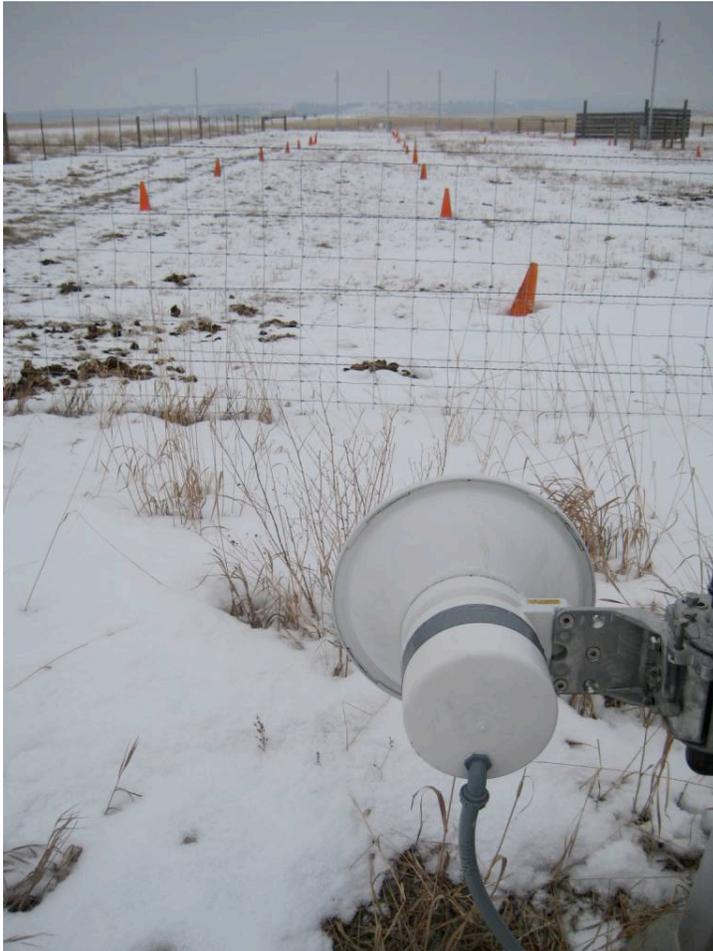
Figure 7. The detection line was marked with cones to be able to record the position of the animals (Photo: Marcel Huijser, WTI/MSU).

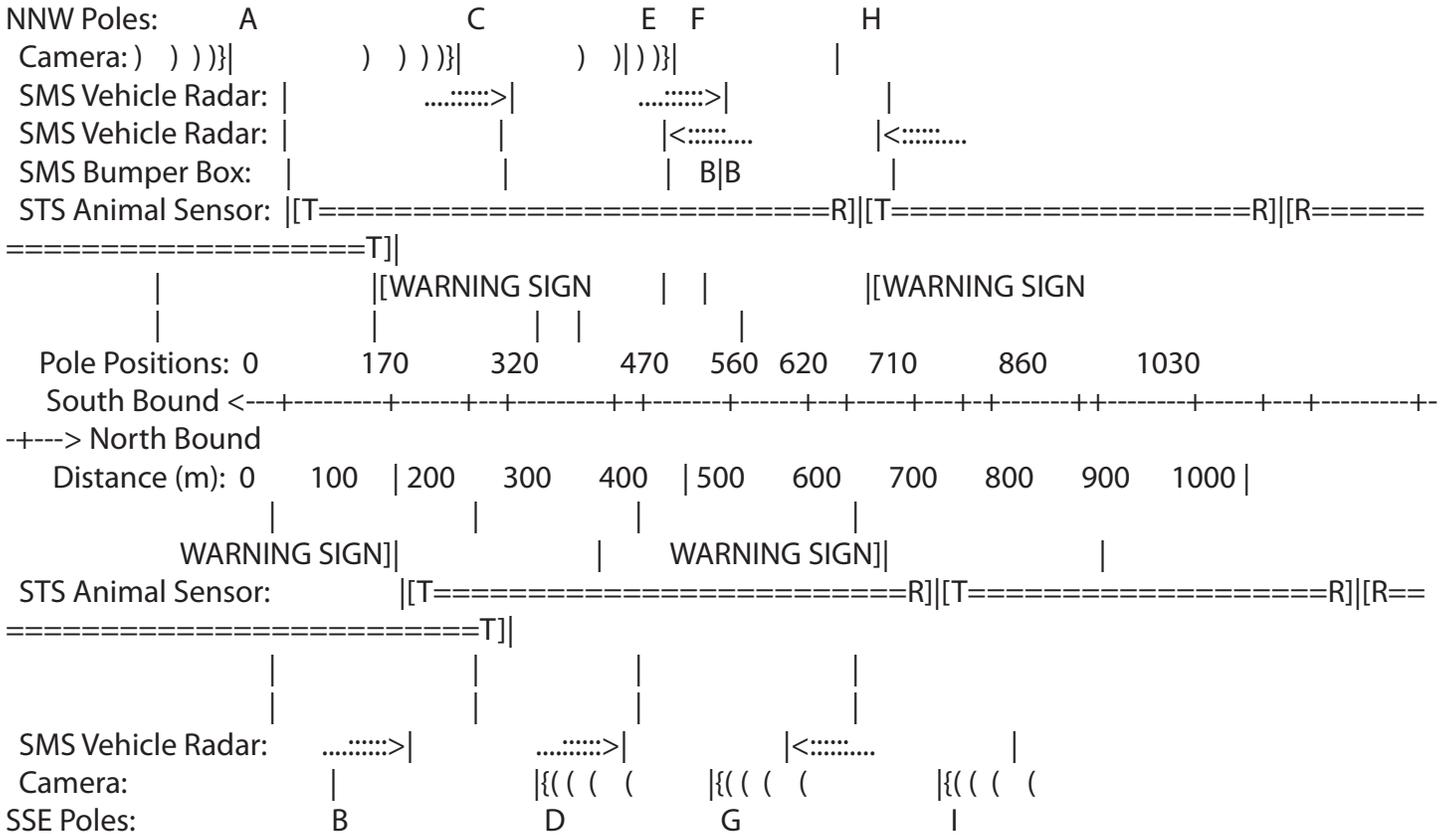
SENSOR LAYOUT

CAN BUS 1 (BumperBox(F) > SMS(F) > SMS(H) > SMS(E) > SMS(C))

CAN BUS 2 (BumperBox(F) > Tunnel > SMS(G) > SMS(D) > SMS(B))
