Exploration of Opportunities to Address the Impacts of Roads and Traffic on Wildlife Around Rocky Flats National Wildlife Refuge

FINAL REPORT

Prepared by
Marcel P. Huijser, PhD
James S. Begley, MSc
Western Transportation Institute
Montana State University

November, 2023

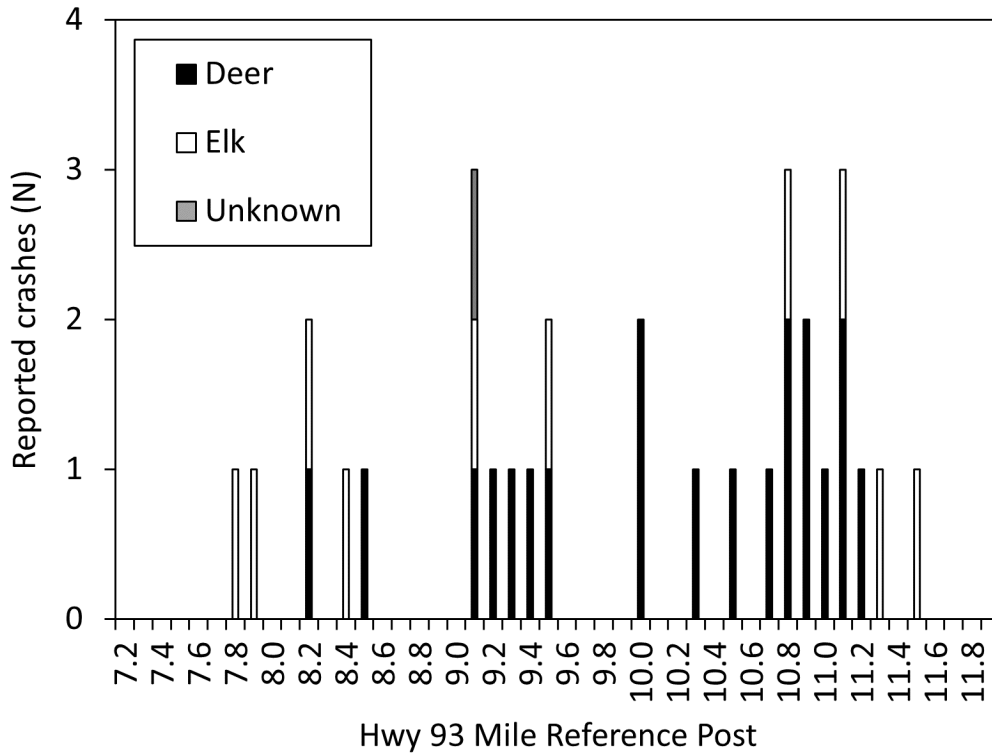
Figure 3: The number of reported crashes with animals along Hwy 93 between mile reference post 7.2 (Junction with Hwy 72, Coal Creek Canyon Rd.) and 11.9 (Junction with Hwy 128).

Along Hwy 93, deer and elk crashes were most abundant between mile reference posts 9.1-9.5 and between 10.7 and 11.3 (Figure 3). Along Hwy 128, deer and elk crashes were most abundant at mile reference post 2.0 and 3.9 (Figure 4). Along Indiana St., deer and elk crashes were most abundant south of the junction with Hwy 128 (Figure 5).

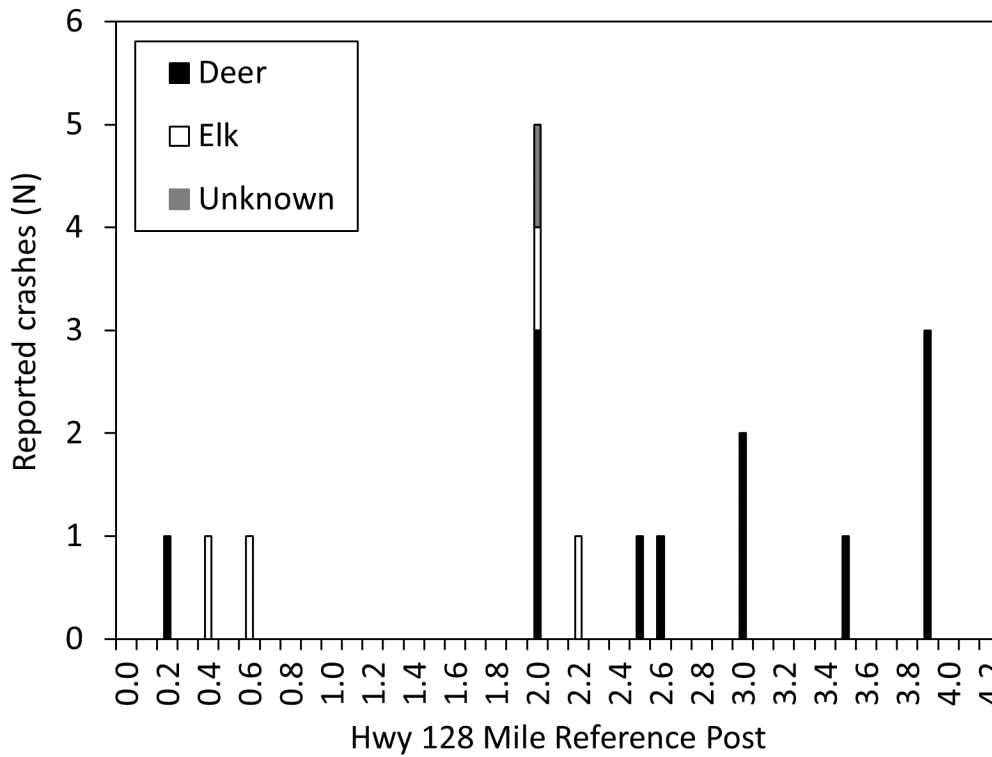
Figure 4: The number of reported crashes with animals along Hwy 128 between mile reference post 0.0 (Junction with Hwy 93) and 4.2 (Junction with Indiana St.).

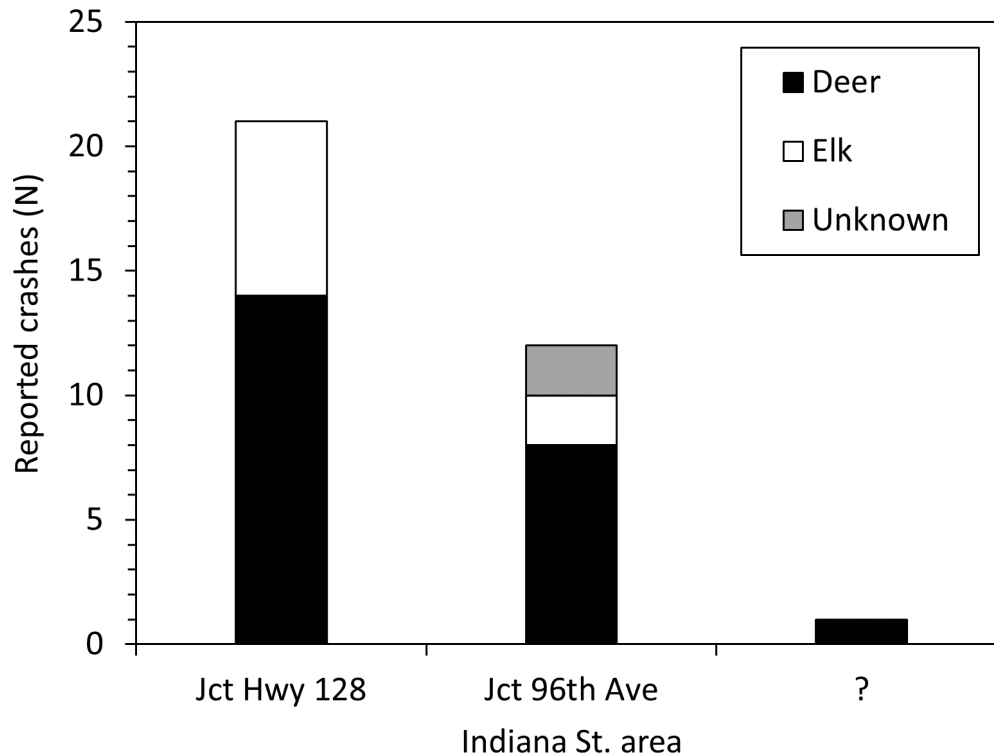
Figure 5: The number of reported crashes with animals along Indiana St. in 2 areas: South of Junction with Hwy 128 (north end), and around the Junction with W 96th Avenue (south end).

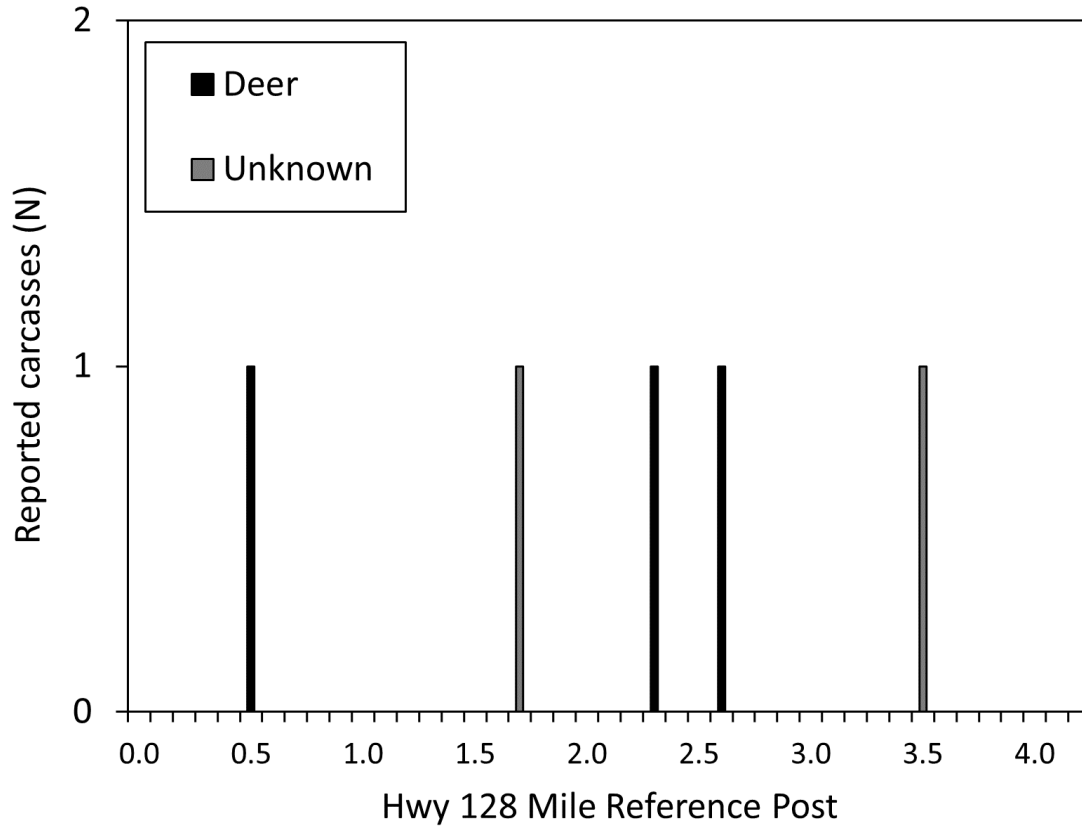
Figure 9: The number of reported carcasses with animals along Hwy 128 between mile reference post 0.0 (Junction with Hwy 93) and 4.2 (Junction with Indiana St.).

Along Hwy 93, deer and elk carcasses were most abundant at mile reference post 10.0 and between 11.0 and 11.2 (Figure 8). Along Hwy 128, the number of recorded carcasses was low and deer and elk crashes did not have a particular concentration (Figure 9).

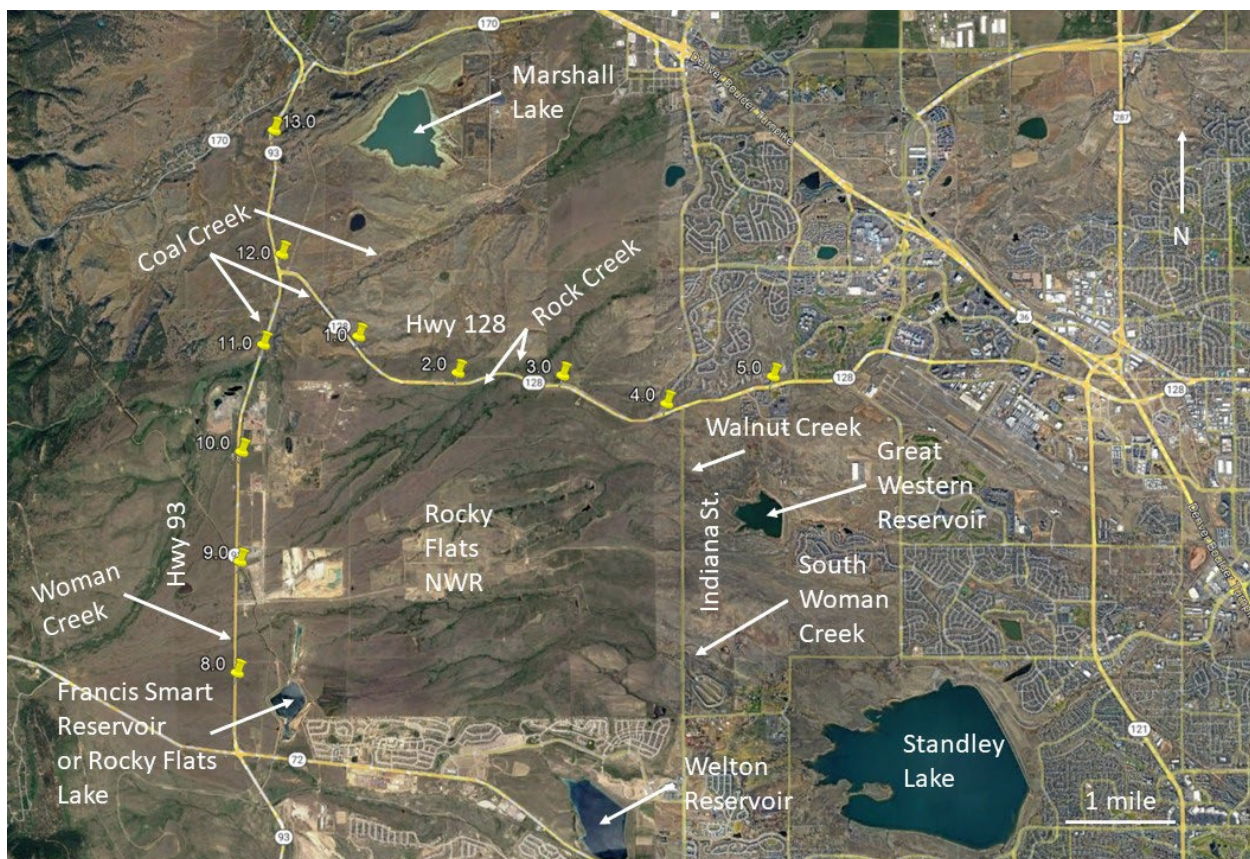
Figure 14: Map of Rocky Flats National Wildlife Refuge showing highways and associated mile reference points, creek crossings and water bodies.

The Refuge is surrounded by roads to the west, north, and east, and has developments just beyond its southern boundary (Figure 14). Hwy 93 has an estimated Annual Average Daily Traffic Volume (AADT) of about 18,000 vehicles, Hwy 128 about 4,200 vehicles, and Indiana St. about 7,000 vehicles (Michael Baker International 2016, CDOT 2023). There are several water bodies in the area that are likely important to ungulates, especially during the dry summer months (Figure 14). The area mostly consists of dry grassland with some shrubs and trees along some of the creeks (Figure 15, 16).

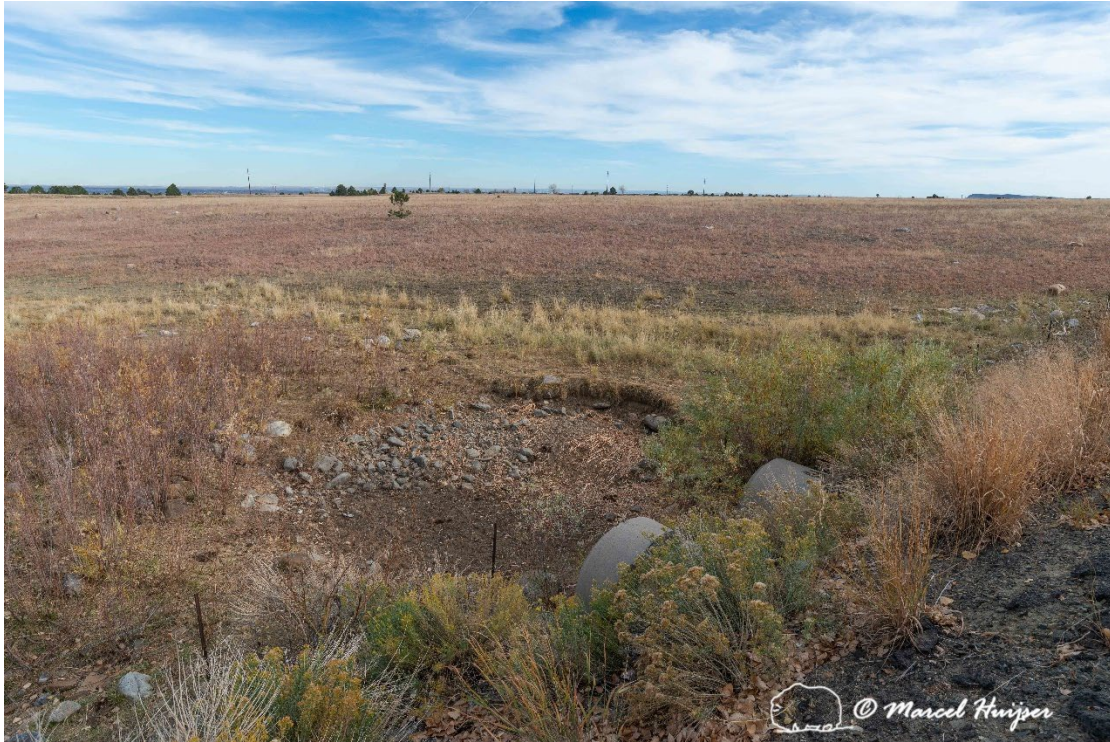
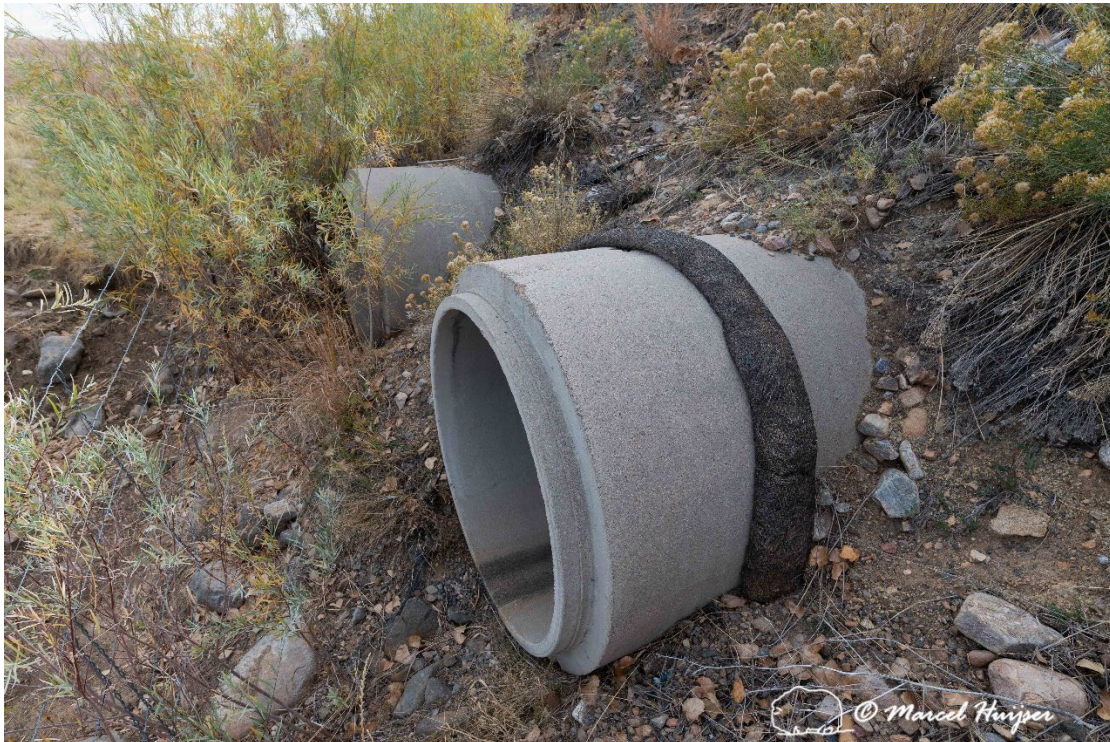
Figure 17: Double culvert, Woman Creek (Hwy 93, mile reference post 8.40), east side, outflow.

Figure 18: Double culvert, Woman Creek (Hwy 93, mile reference post 8.40), east side, outflow.

The crossing for Woman Creek along Hwy 93 (mile reference post 8.40) consists of a double culvert (Figure 17, 18).

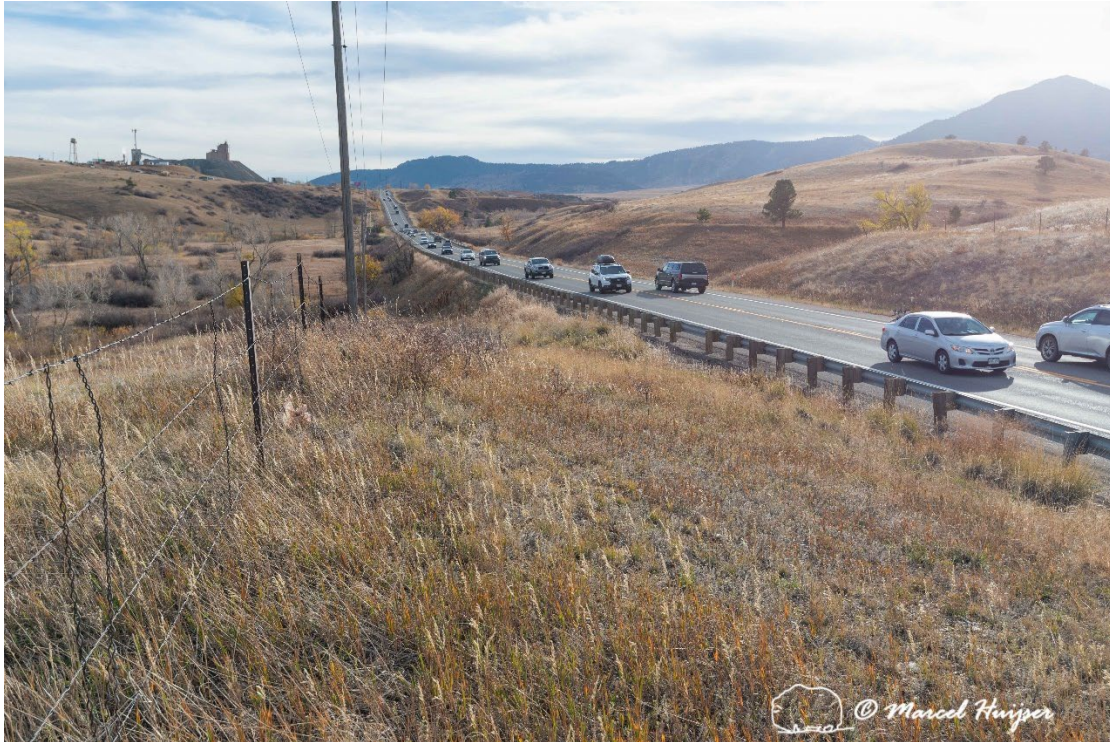
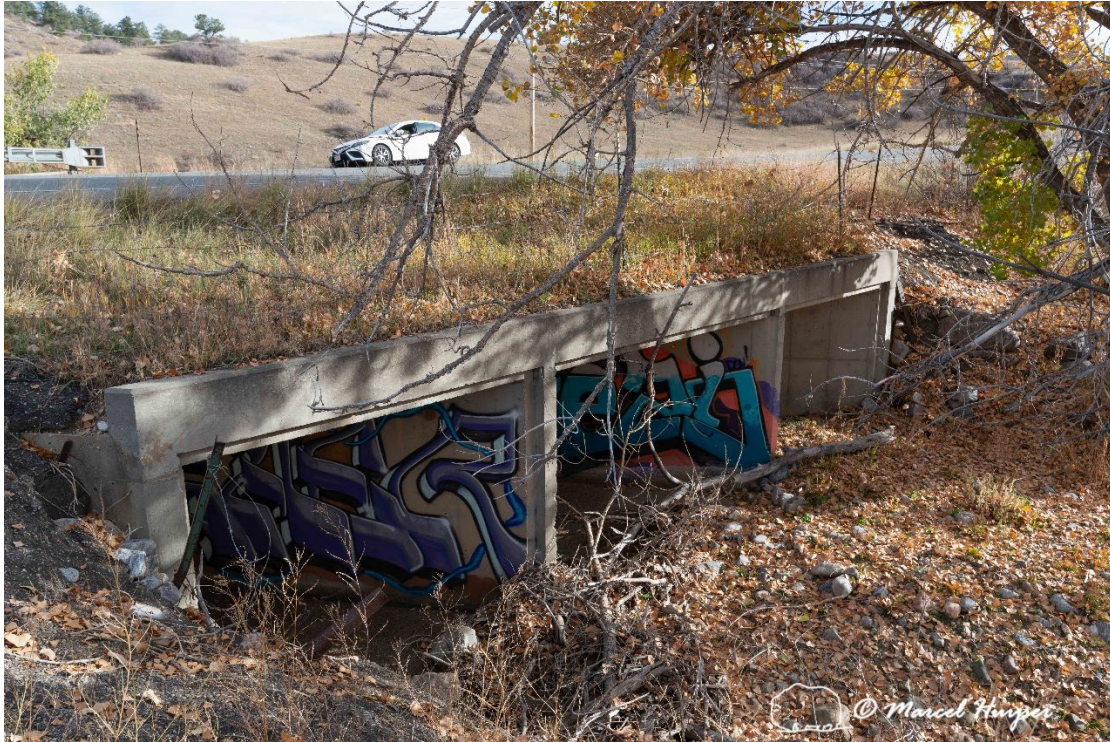
Figure 19: Surroundings, Coal Creek (Hwy 93, mile reference post 10.95), east side, looking south.

Figure 20: Divided box culvert, Coal Creek (Hwy 93, mile reference post 10.95), west side, inflow.

Figure 21: Surroundings, Coal Creek (Hwy 93, mile reference post 10.95), east side, outflow.

The crossing for Coal Creek along Hwy 93 (mile reference post 10.95) consists of a divided box culvert (Figure 19, 20, 21).

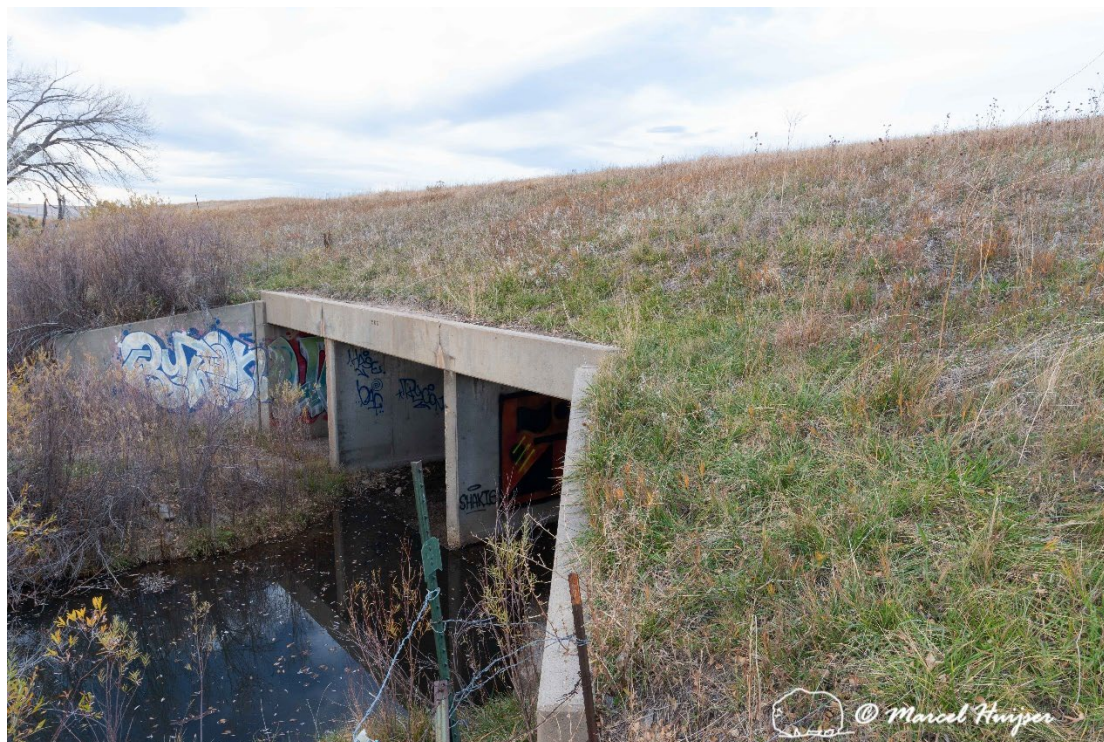
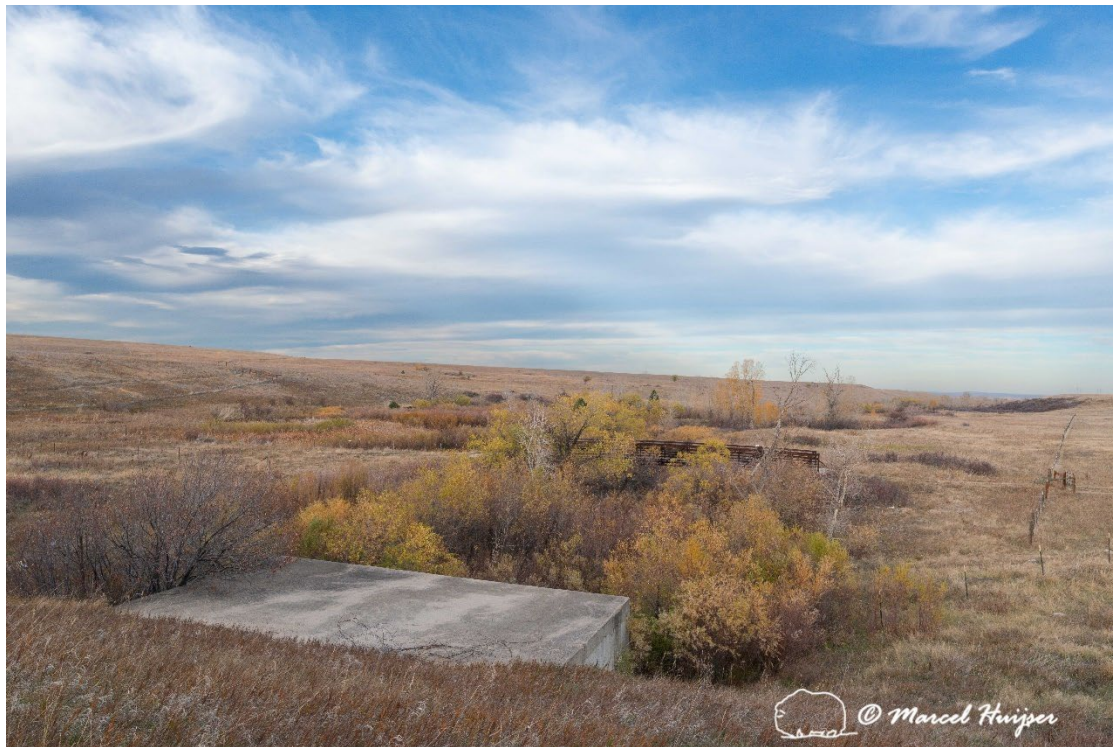
Figure 22: Divided box culvert, Coal Creek (Hwy 128, mile reference post 0.47), south side, inflow.

Figure 23: Divided box culvert, Coal Creek (Hwy 128, mile reference post 0.47), north side, outflow.

The crossing for Coal Creek along Hwy 128 (mile reference post 0.47) consists of a divided box culvert (Figure 22, 23).

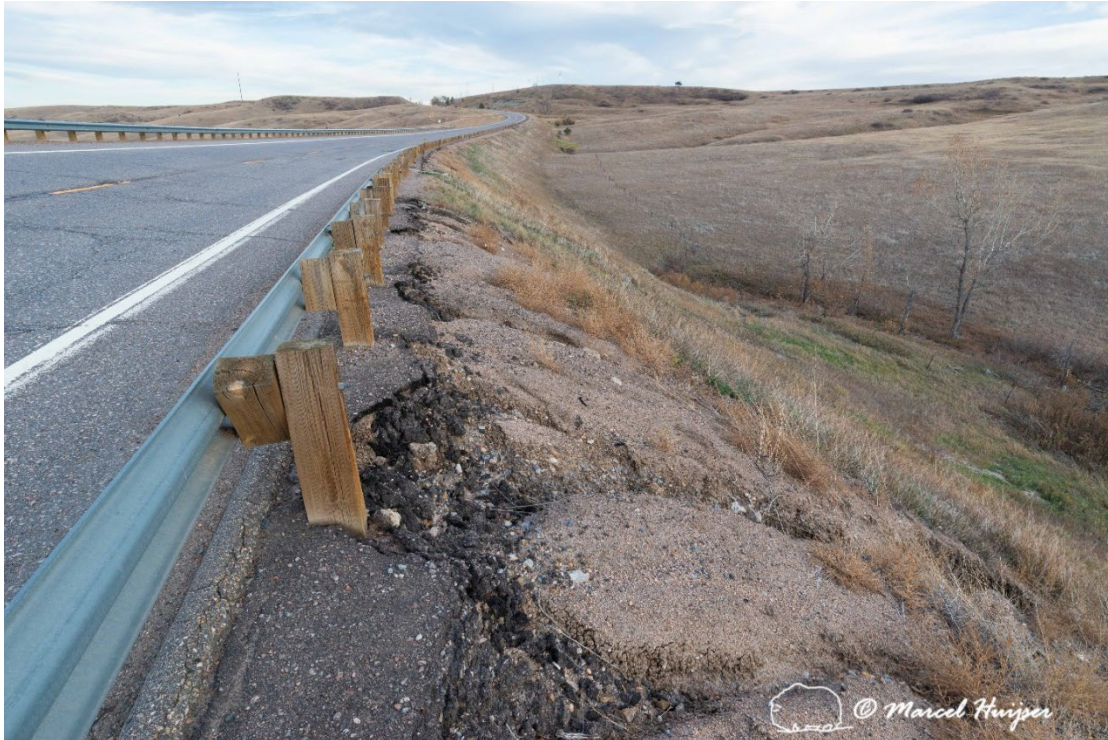
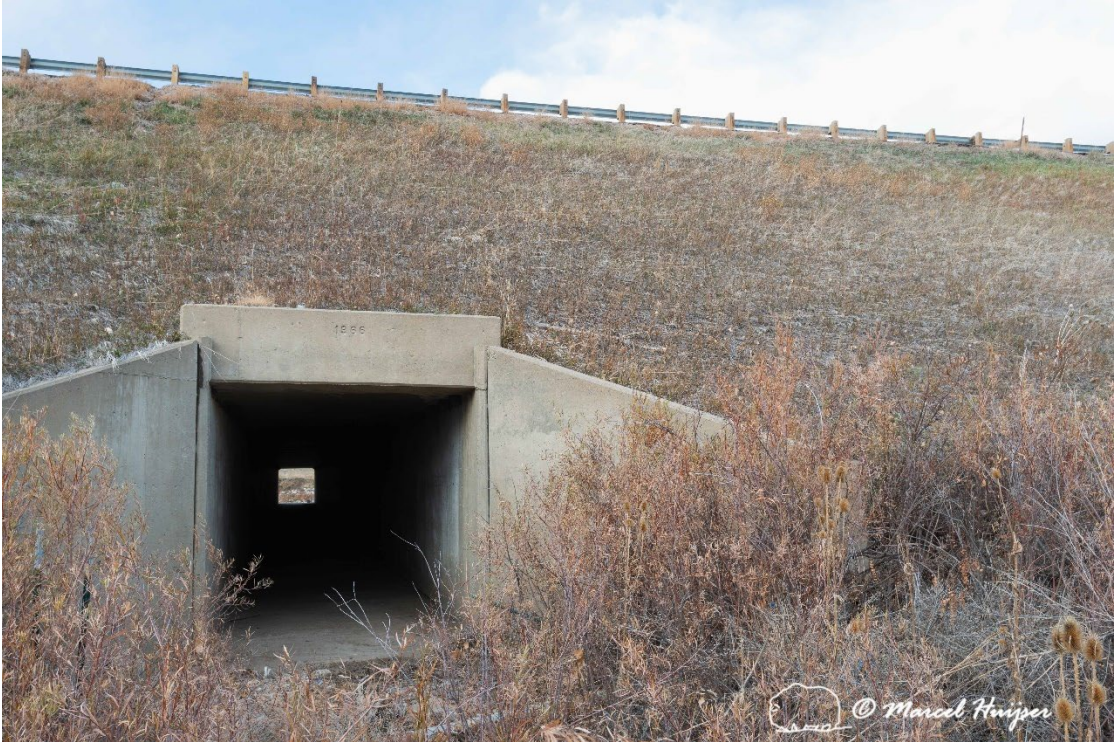
Figure 24: Surroundings, Rock Creek (Hwy 128, mile reference post 2.54), south side, looking east.

Figure 25: Surroundings, Rock Creek (Hwy 128, mile reference post 2.54), south side, inflow.

The crossing for Rock Creek along Hwy 128 (mile reference post 2.54) consists of a box culvert (Figure 24, 25).

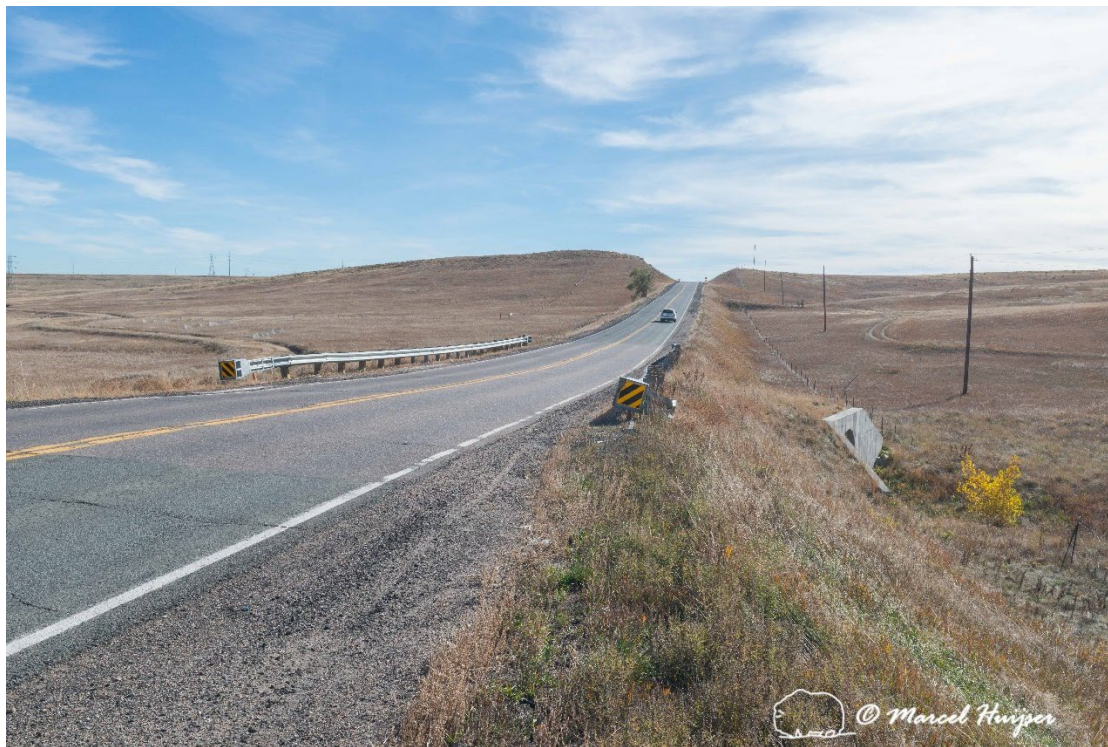
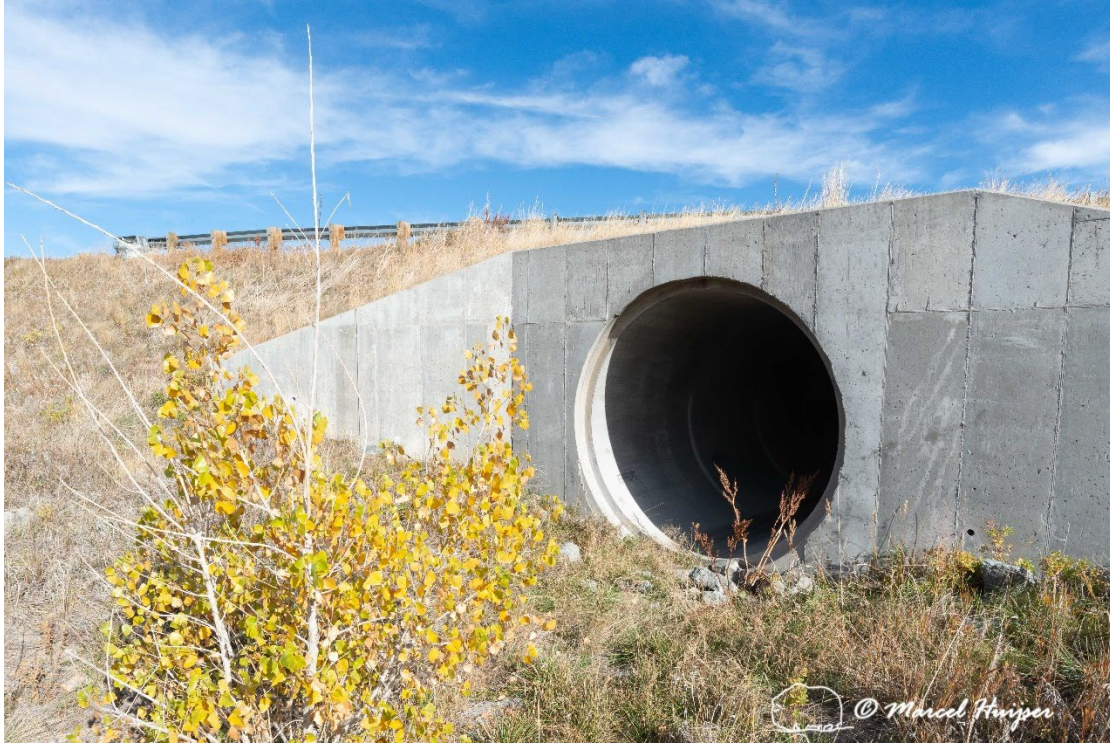
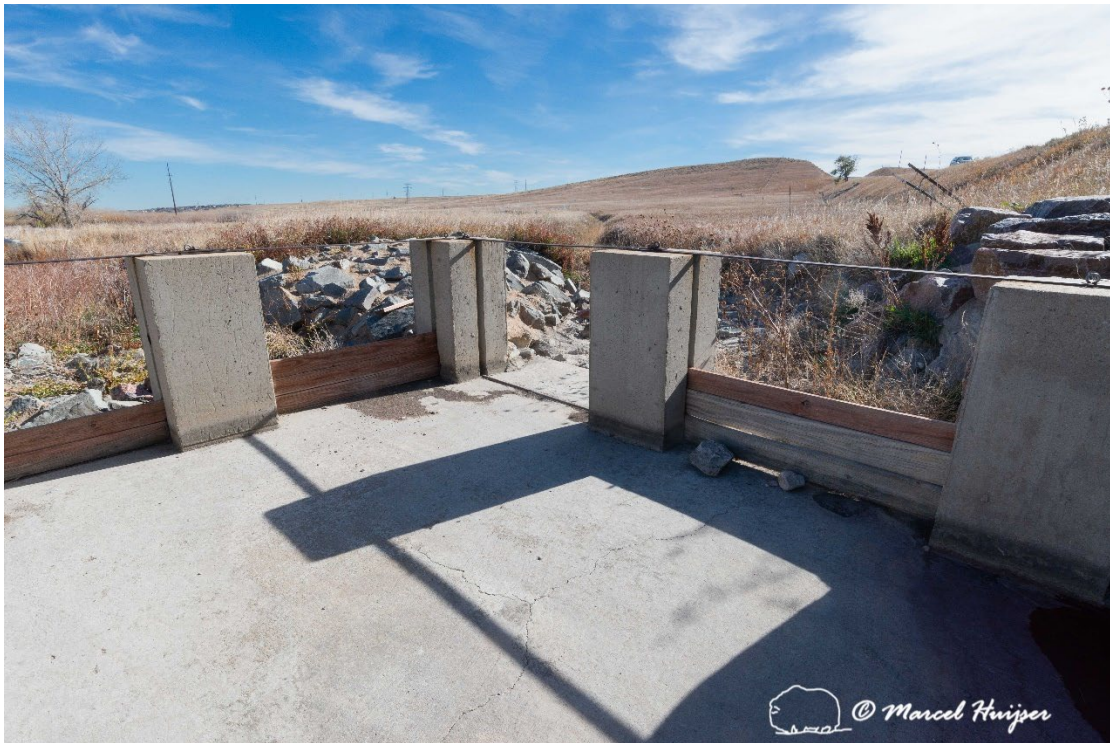
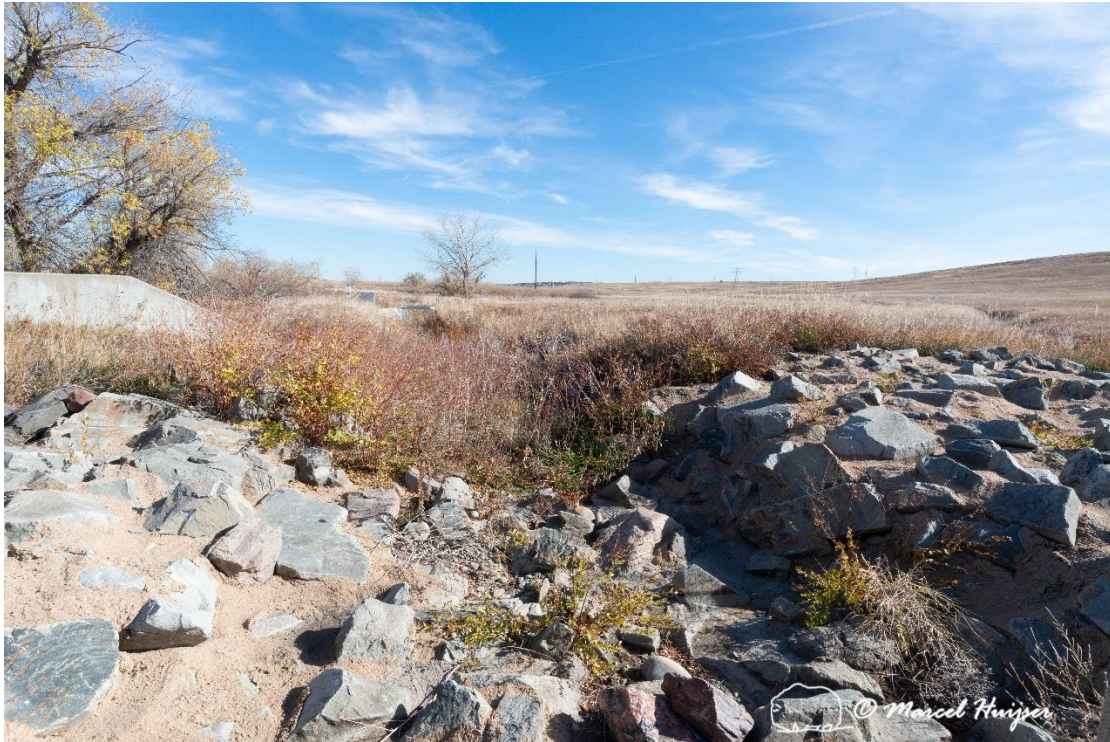
Figure 26: Surroundings, Walnut Creek (Indiana St., 0.62 mile south of junction with Hwy 128), west side, looking south.

Figure 27: Surroundings, Walnut Creek (Indiana St., 0.62 mile south of junction with Hwy 128), west side, inflow.

Figure 28: Outflow structures, Walnut Creek (Indiana St., 0.62 mile south of junction with Hwy 128), east side, outflow.

Figure 29: Riprap at outflow, Walnut Creek (Indiana St., 0.62 mile south of junction with Hwy 128), east side, outflow.

The crossing for Walnut Creek along Indiana St. (0.62 mile south of junction with Hwy 128) consists of a round culvert (Figure 26, 27, 28, 29).

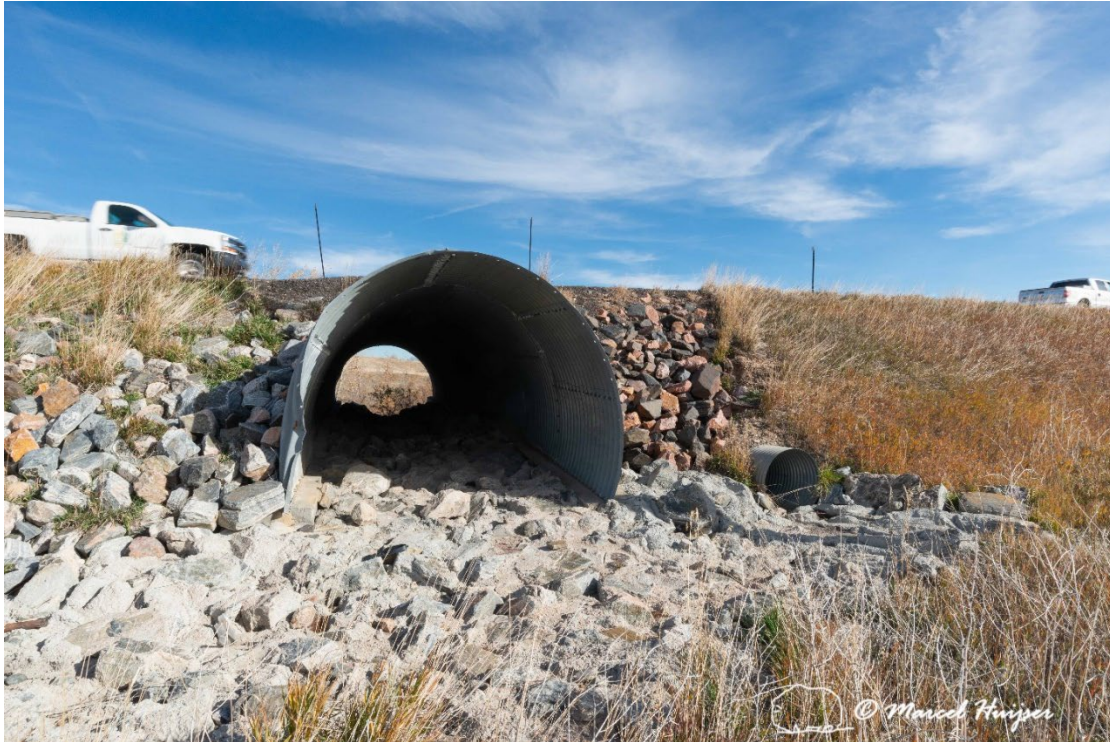
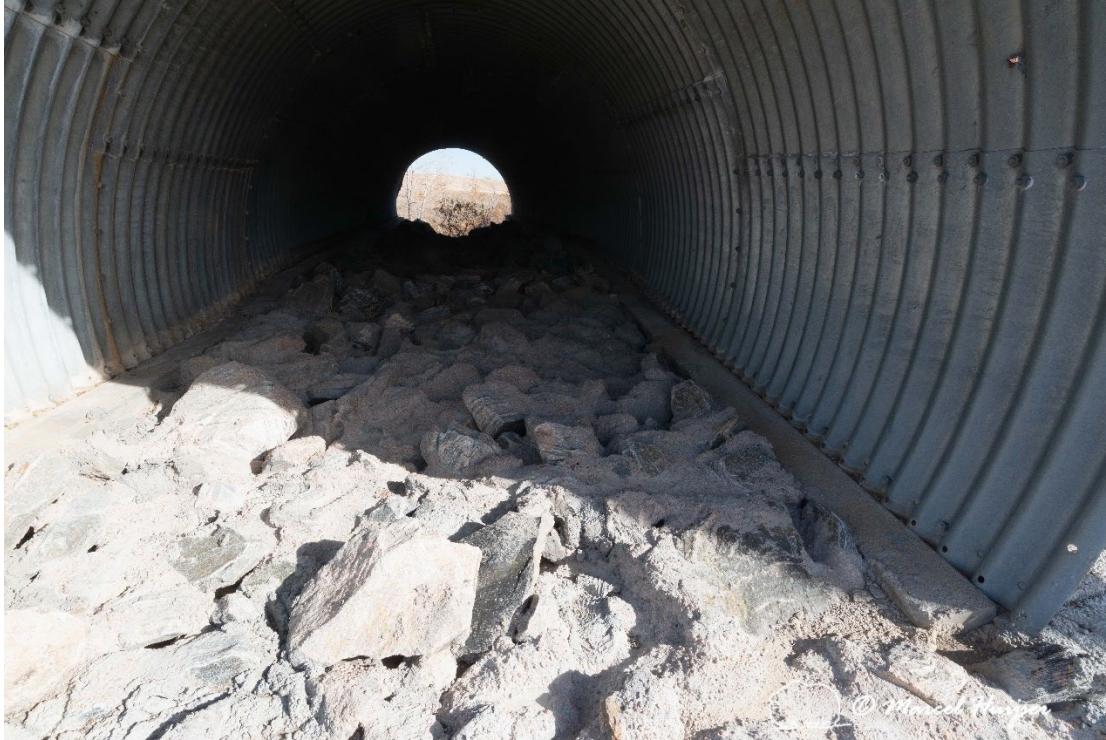
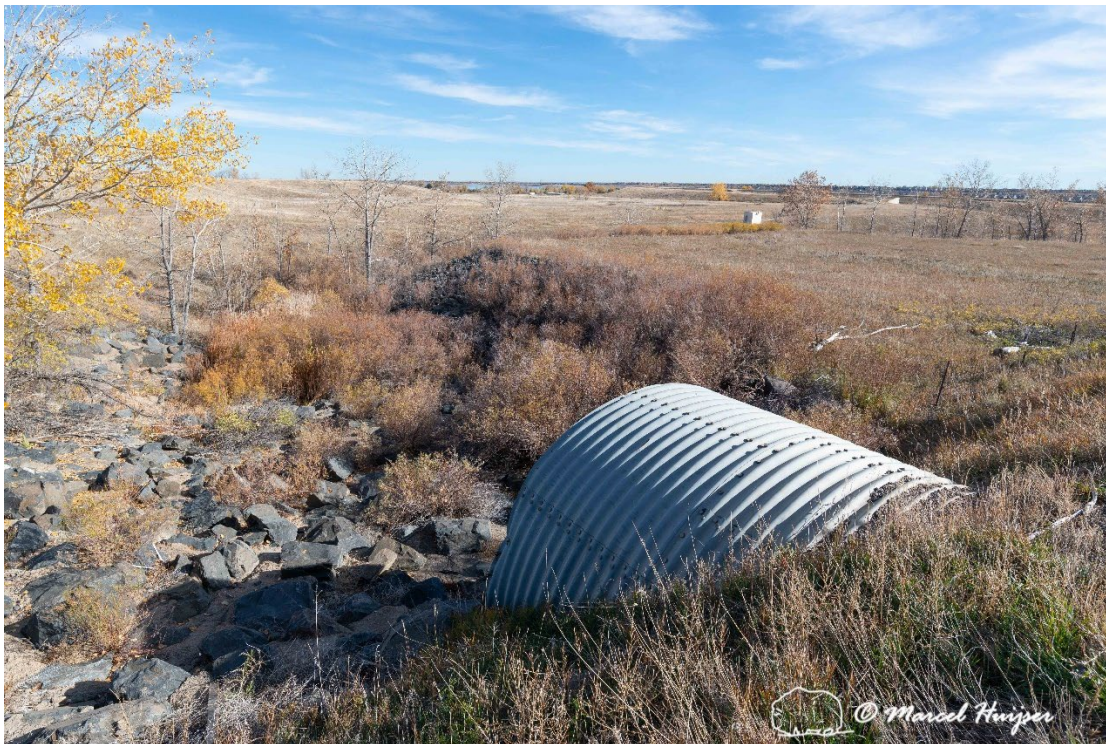
Figure 30: Riprap at inflow, South Woman Creek (Indiana St., 2.25 mile south of junction with Hwy 128), west side, inflow.

Figure 31: Riprap inside culvert, South Woman Creek (Indiana St., 2.25 mile south of junction with Hwy 128), west side, inflow.

Figure 32: Riprap at outflow, South Woman Creek (Indiana St., 2.25 mile south of junction with Hwy 128), east side, outflow.

The crossing for South Woman Creek along Indiana St. (2.25 miles south of junction with Hwy 128) consists of a round culvert (Figure 30, 31, 32).

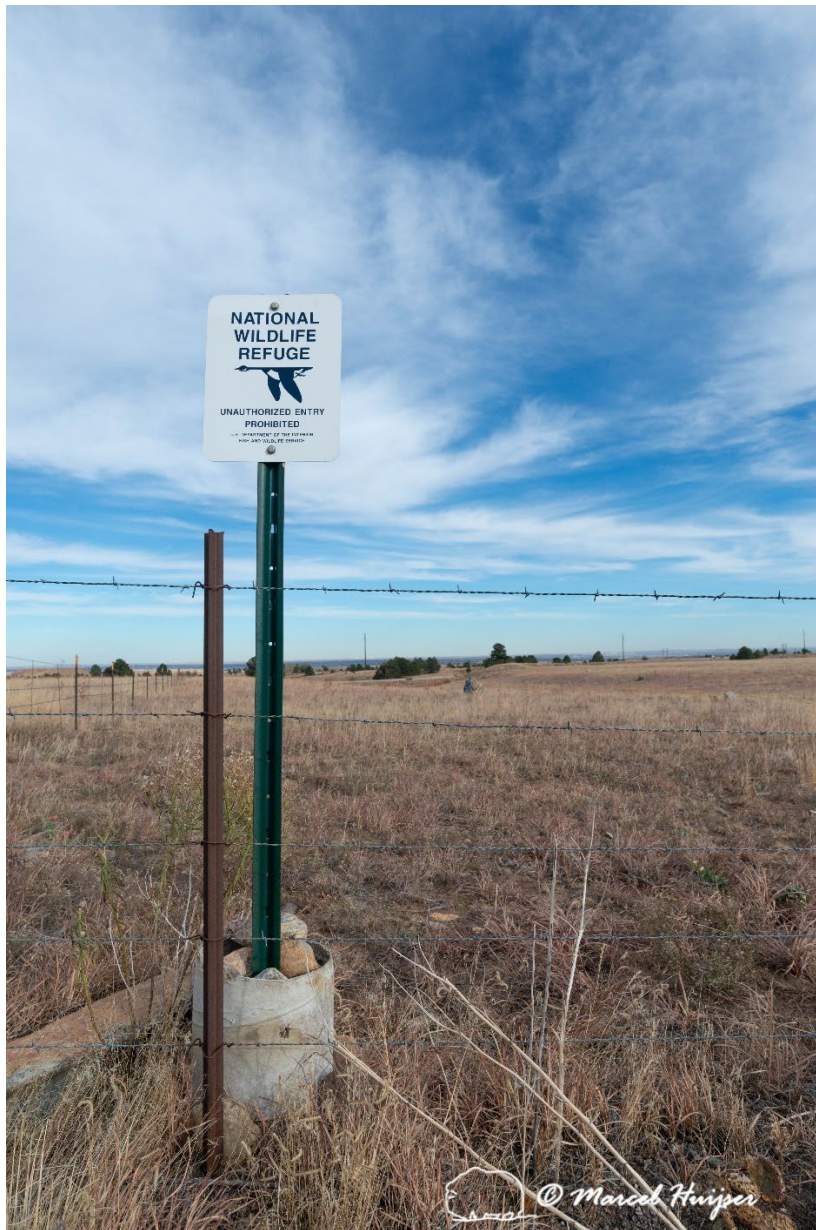
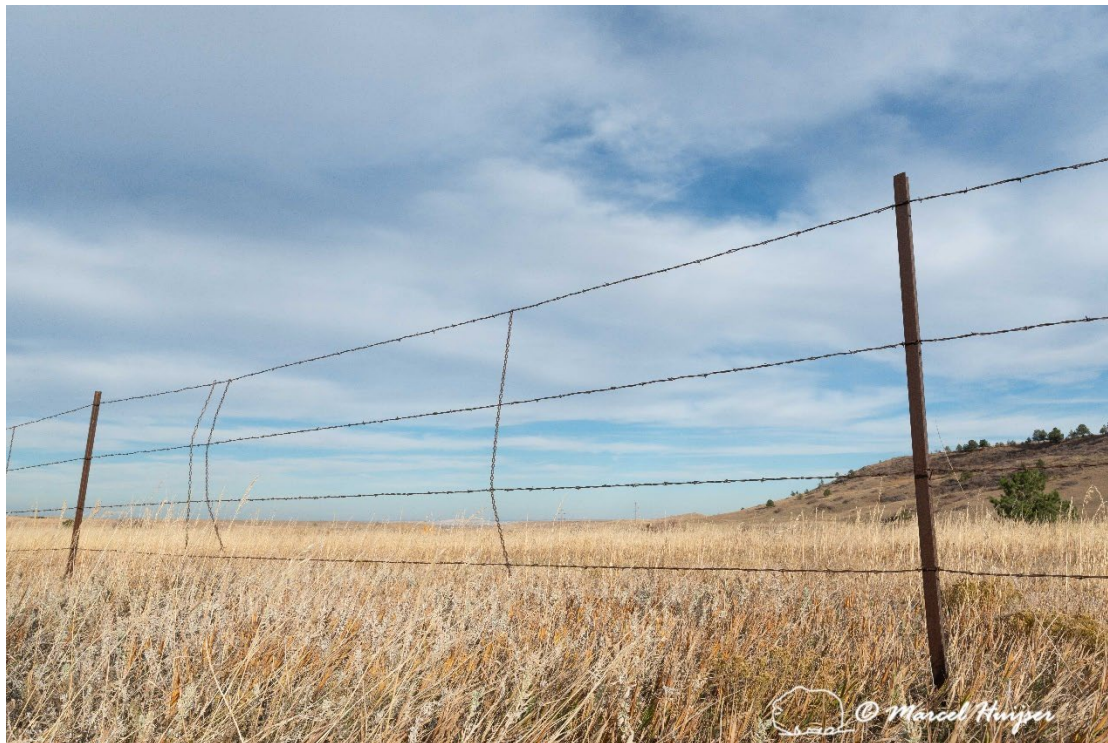
Figure 33: Right-of-way fence, Hwy 93, east side, near mile reference post 8.4.

Figure 34: Right-of-way fence, Hwy 93, east side, near mile reference post 11.3.

There are right-of-way fences or livestock fences along the highways, both on the side of the Refuge, and the other side of the highways (Figure 33, 34). These fences are not designed to keep large wild ungulates off the highway, but they can cause injuries, and even entanglement or death of large wild ungulates. Should the fences be required to keep livestock off the road, then they are likely more detrimental to wildlife than needed as wildlife friendly livestock fence designs are available (see e.g., Paige 2015).

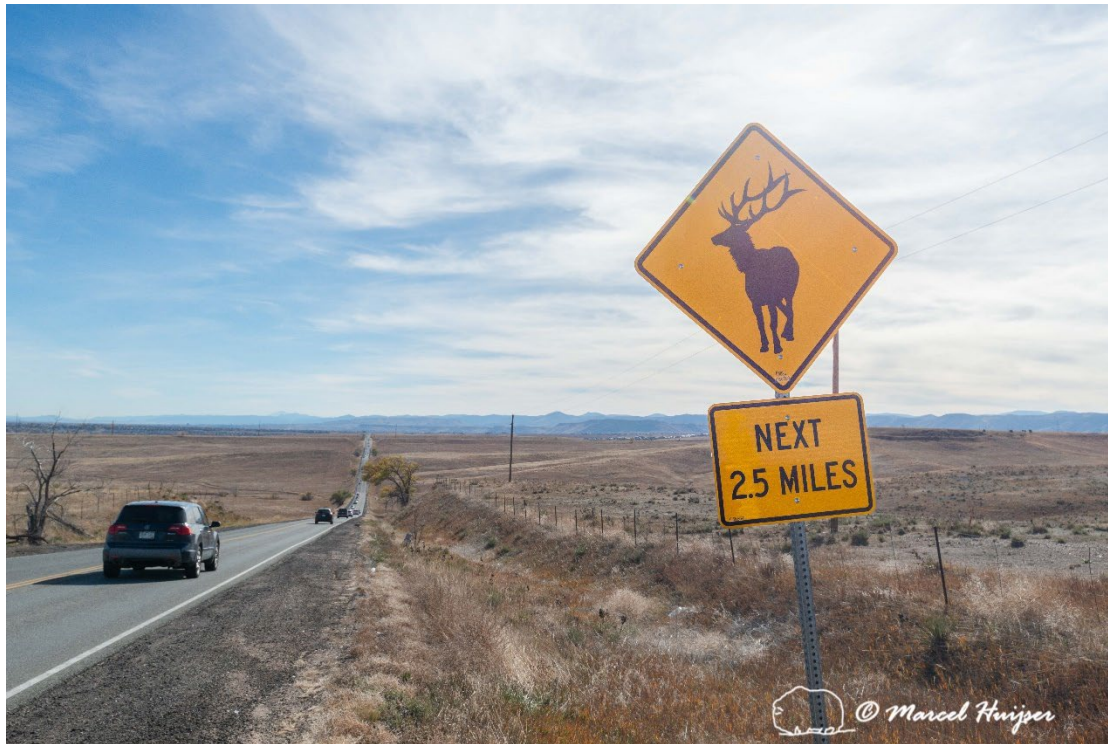
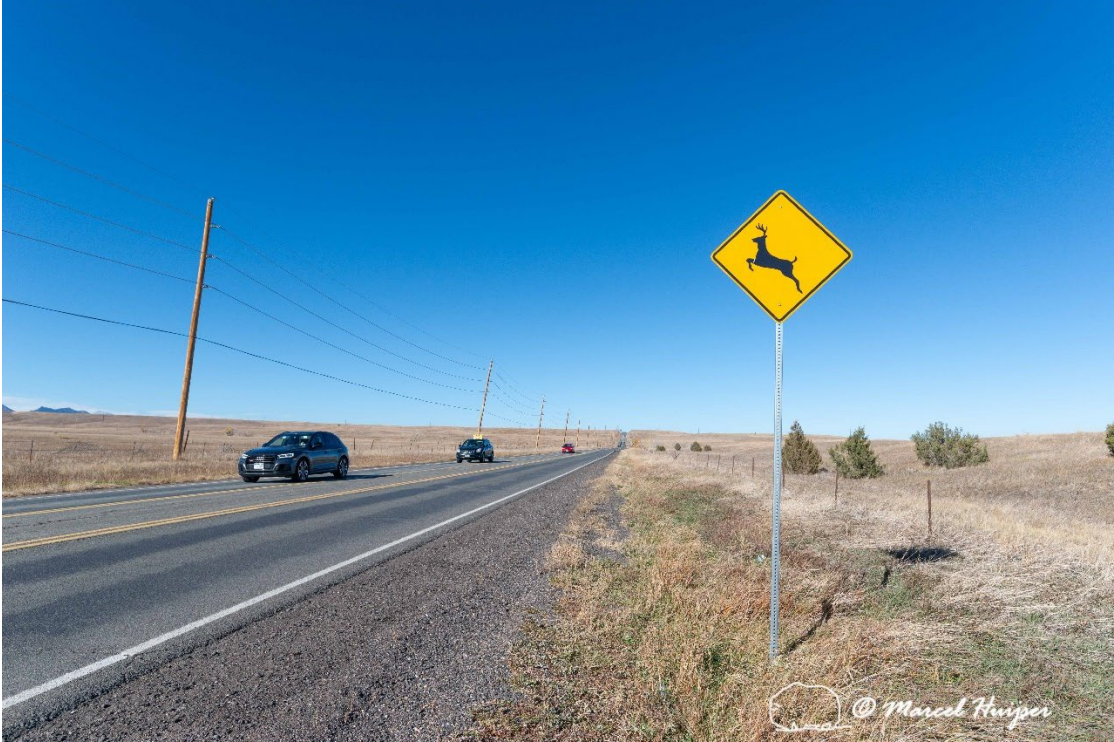
Figure 35: Elk warning sign, southbound on Indiana St., about 0.1 mile from the junction with Hwy 128.

Figure 36: Deer warning sign, northbound on Indiana St., about 2.6 mile from the junction with Hwy 128.

There are several standard wildlife warning signs along the roads surrounding the Refuge (Figure 35, 36).

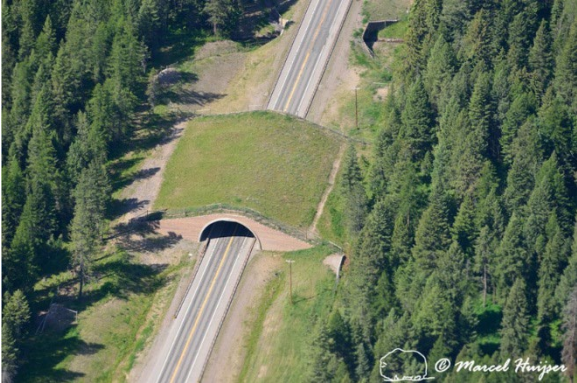
Safe Crossing Opportunity type	Indicative dimensions (as seen by the animals)	Image
Wildlife overpass	50-70 m wide

<p>An aerial photograph showing a wildlife overpass structure crossing a road. The structure is a wide, flat, grassy area that spans across the road. The road has two lanes in each direction. The surrounding area is densely forested with green trees. In the bottom right corner of the image, there is a small logo and the text "© Marcel Huijser".</p>

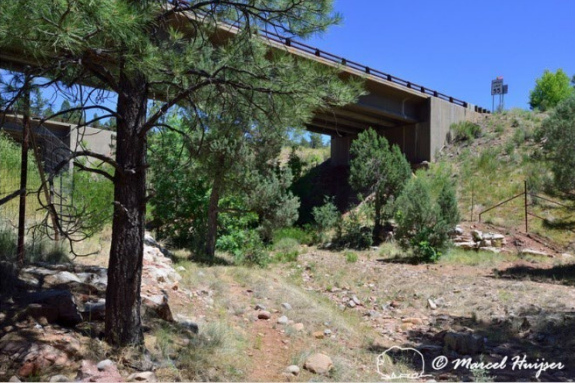
Safe Crossing Opportunity type	Indicative dimensions (as seen by the animals)	Image
Open span bridge	12-30 m wide, ≥5 m high

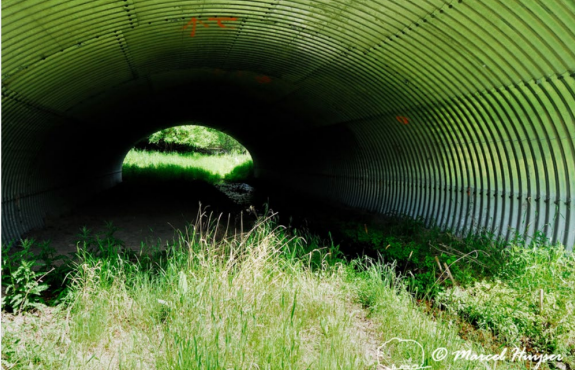
Large mammal underpass	7-8 m wide, 4-5 m high

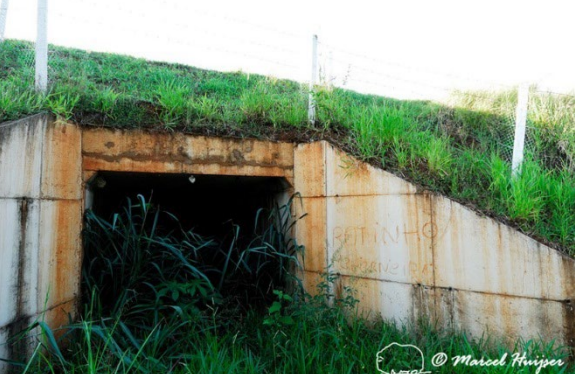
Medium mammal underpasses	0.8-3 m wide, 0.5-2.5 m high

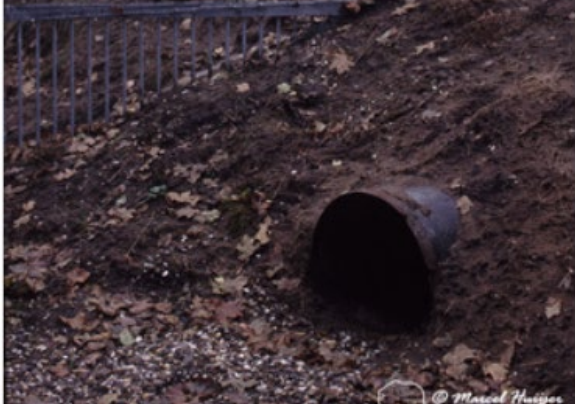
Small-medium mammal pipes	0.3-0.6 m in diameter
