Exploration of Opportunities to Address the Impacts of Roads and Traffic on Wildlife Around Rocky Flats National Wildlife Refuge

FINAL REPORT

Prepared by
Marcel P. Huijser, PhD
James S. Begley, MSc
Western Transportation Institute
Montana State University

November, 2023

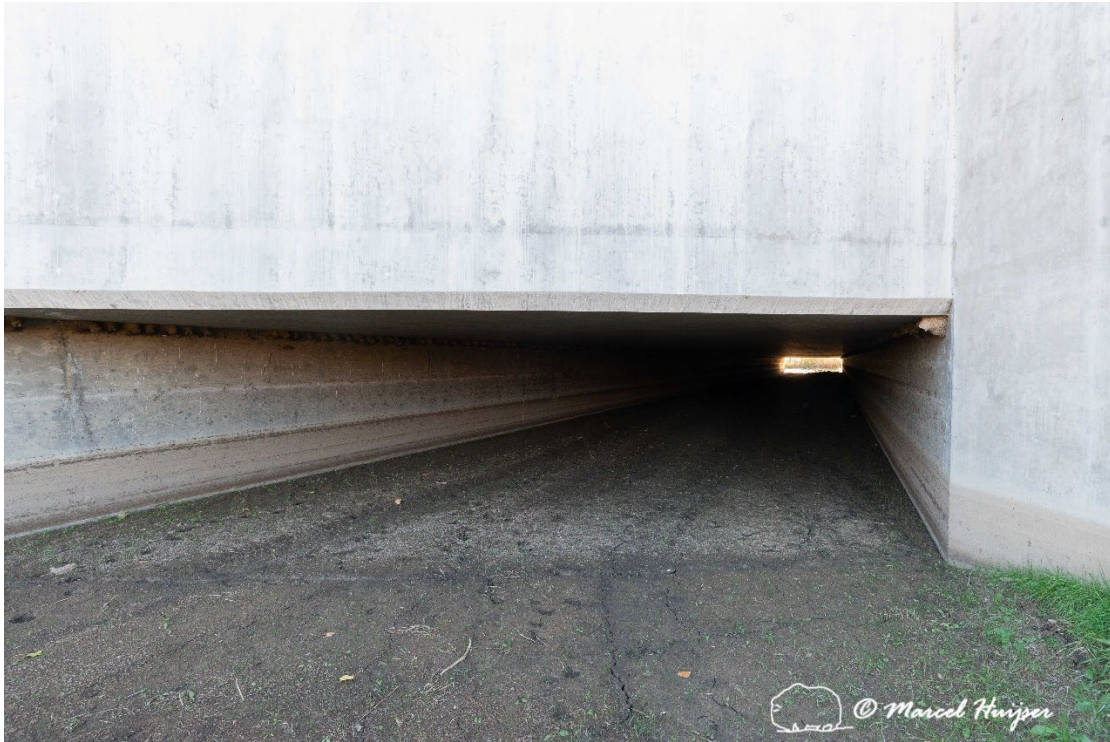
Figure 38: Culvert at Davidson Ditch (Hwy 36, mile reference post 40.8).

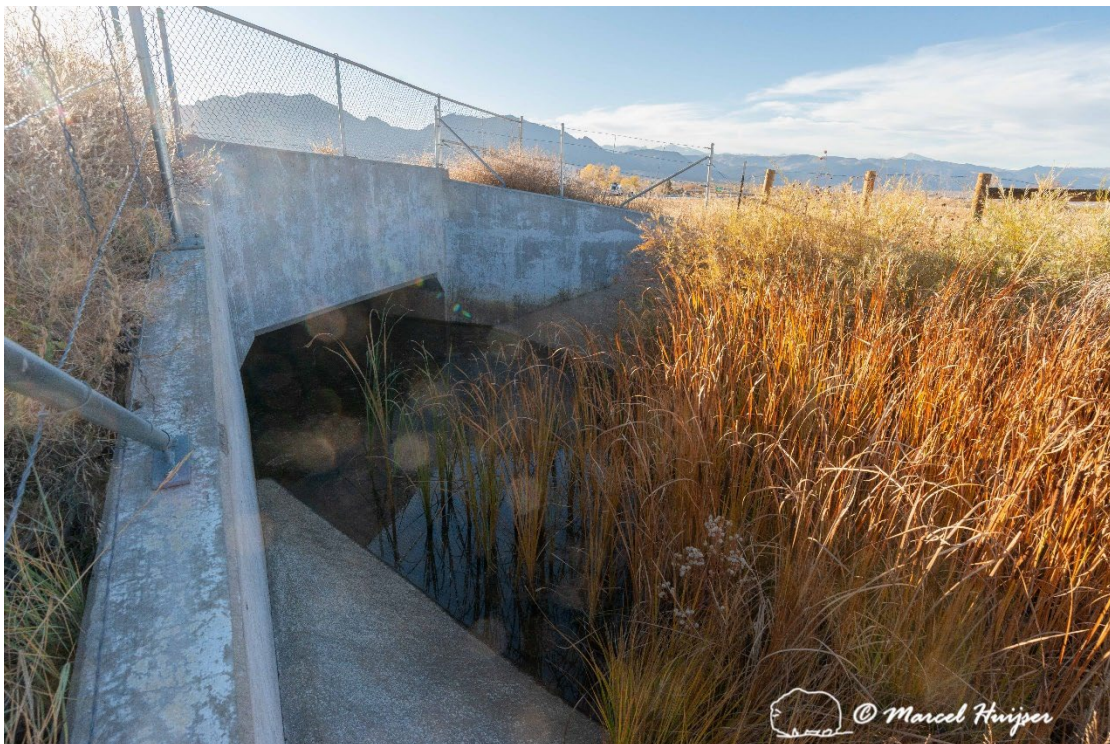
Figure 39: Culvert at Goodhue Ditch (Hwy 36, mile reference post 41.2).

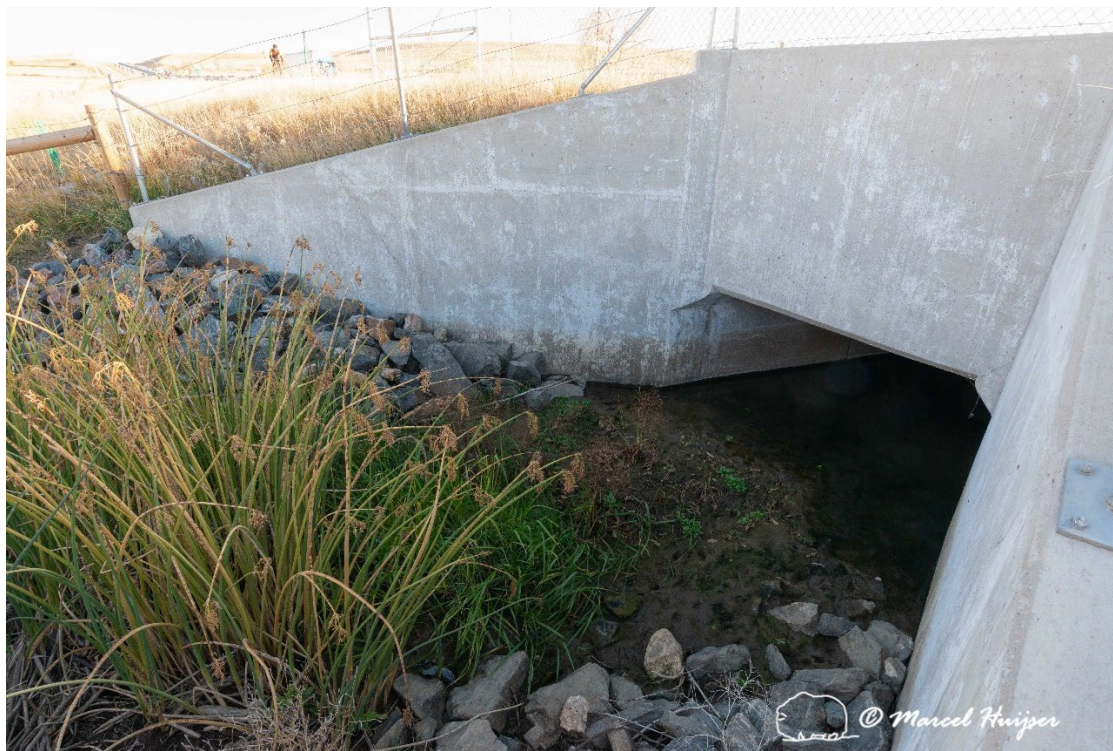
Figure 40: Culvert at Marshallville Ditch (Hwy 36, mile reference post 41.5).

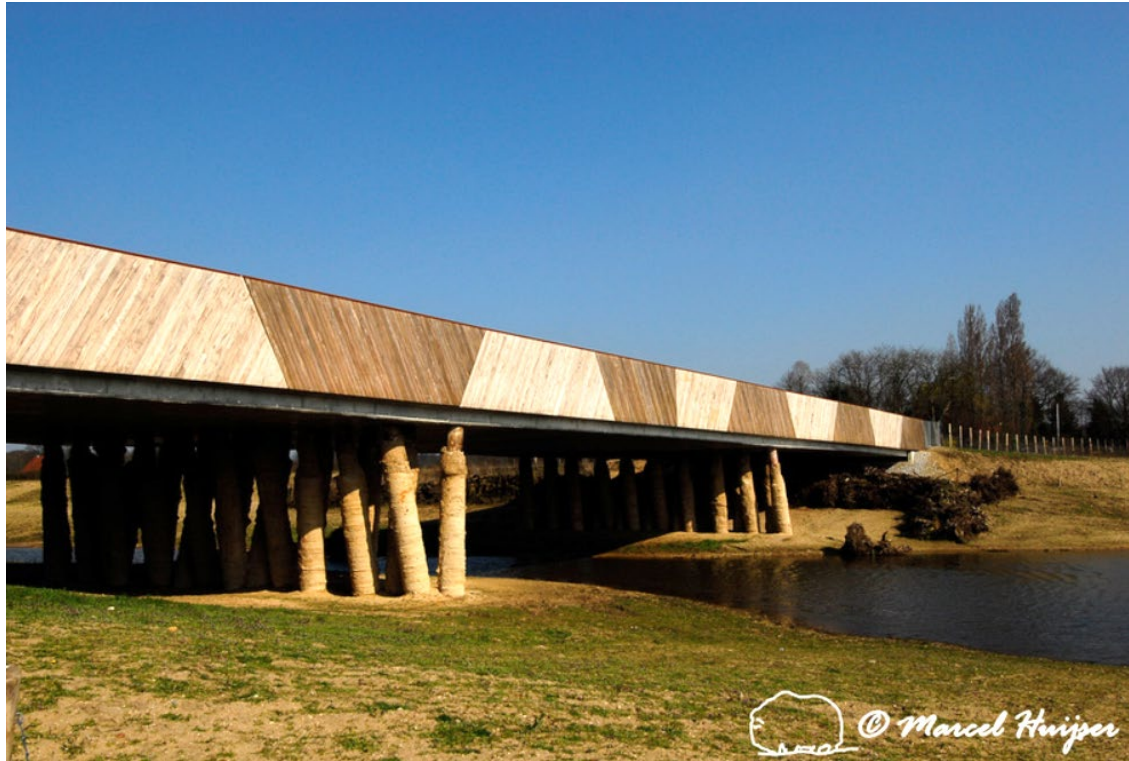
Figure 43. Multifunctional underpass, The Netherlands. The underpass is for hydrology and wildlife.

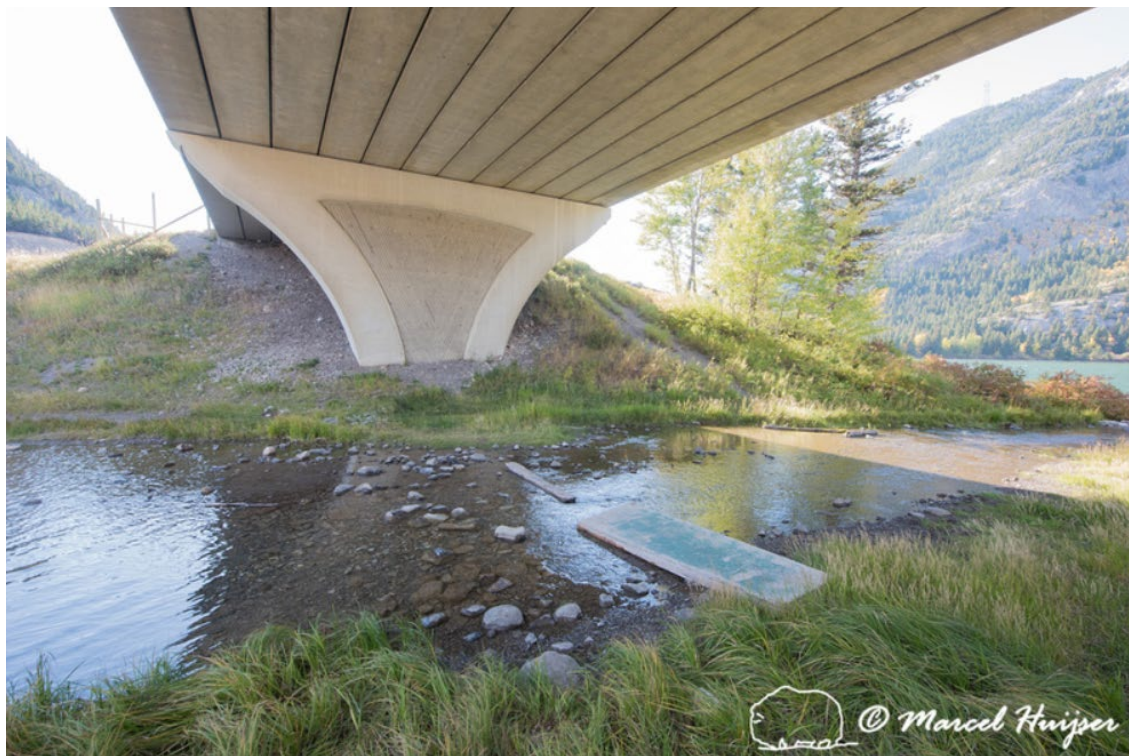
Figure 44. Multifunctional underpass, Hwy 3, Crowsnest Pass, Alberta, Canada. The underpass is for hydrology and wildlife. Note how the substrate and stream dynamics are unaffected by the structure and how light and moisture reaches the entire area under the bridge allowing for natural vegetation in the riparian and terrestrial zones.

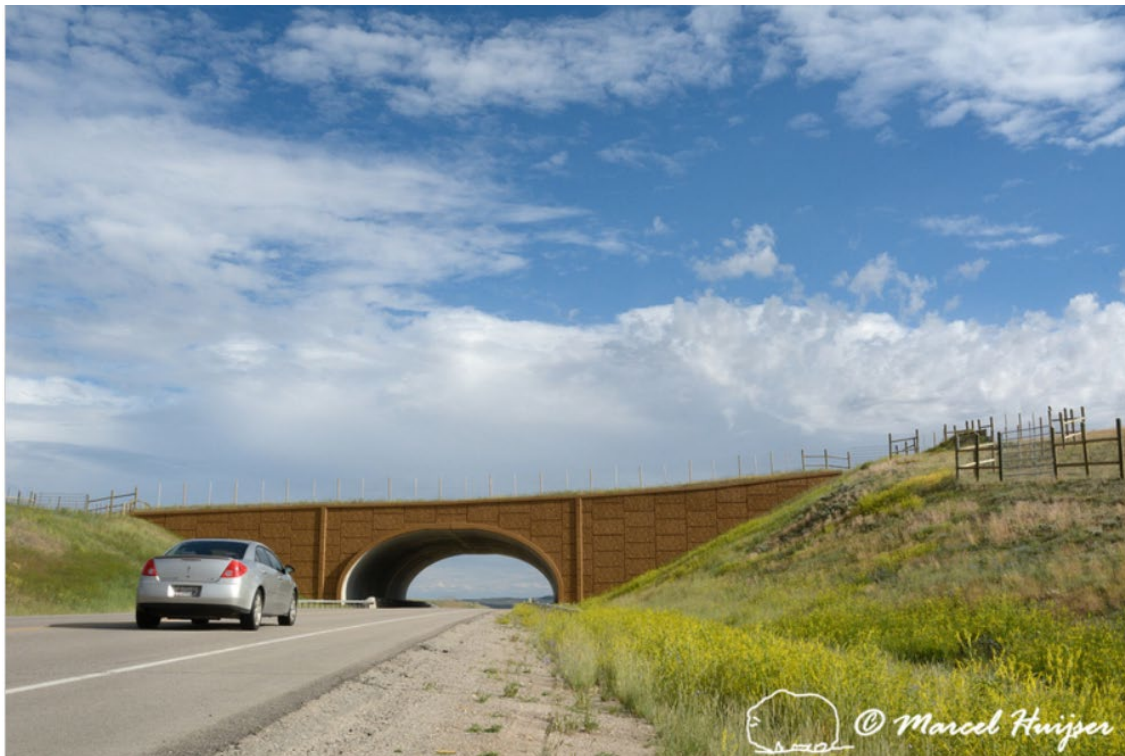
Figure 45. Wildlife overpass, primarily for pronghorn (*Antilocapra americana*) (46 m (150 ft) wide), on the Path of the Pronghorn, Trapper's Point, US Hwy 191, near Pinedale, Wyoming, USA.

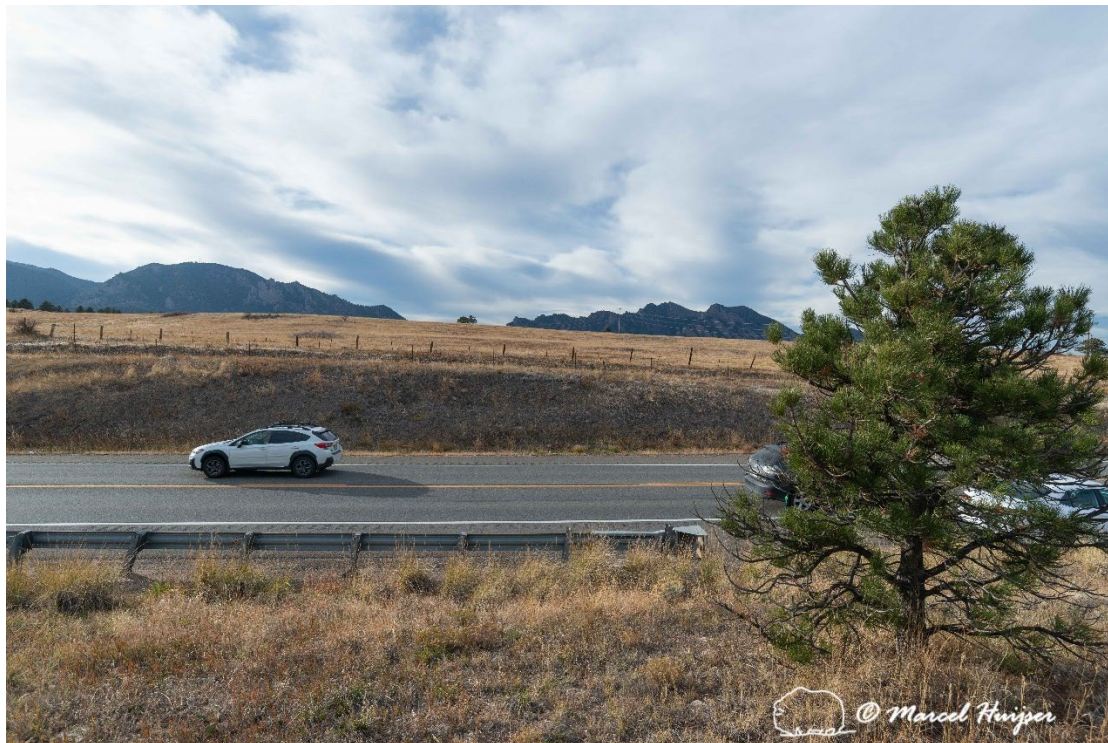
Figure 46. The roadcut along Hwy 93, around mile reference post 11.3.

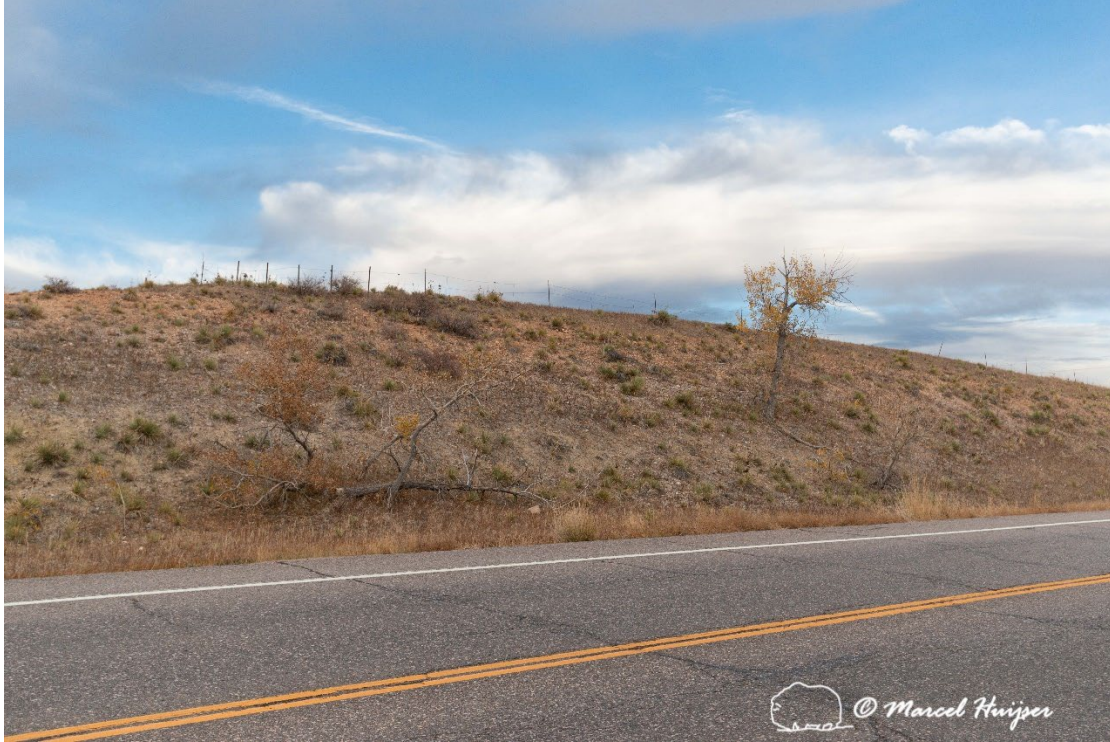
Figure 47. The roadcut along Hwy 128, around mile reference post 3.0.

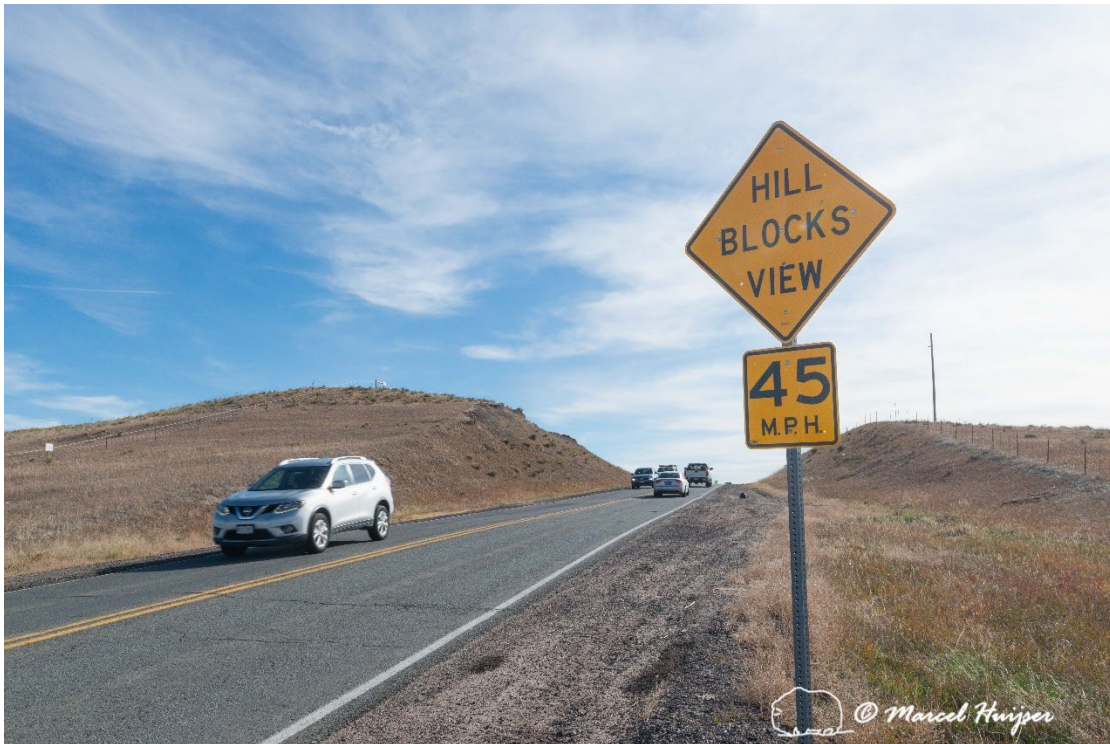
Figure 48. The roadcut along Indiana St., about 0.8 miles south of the junction with Hwy 128.

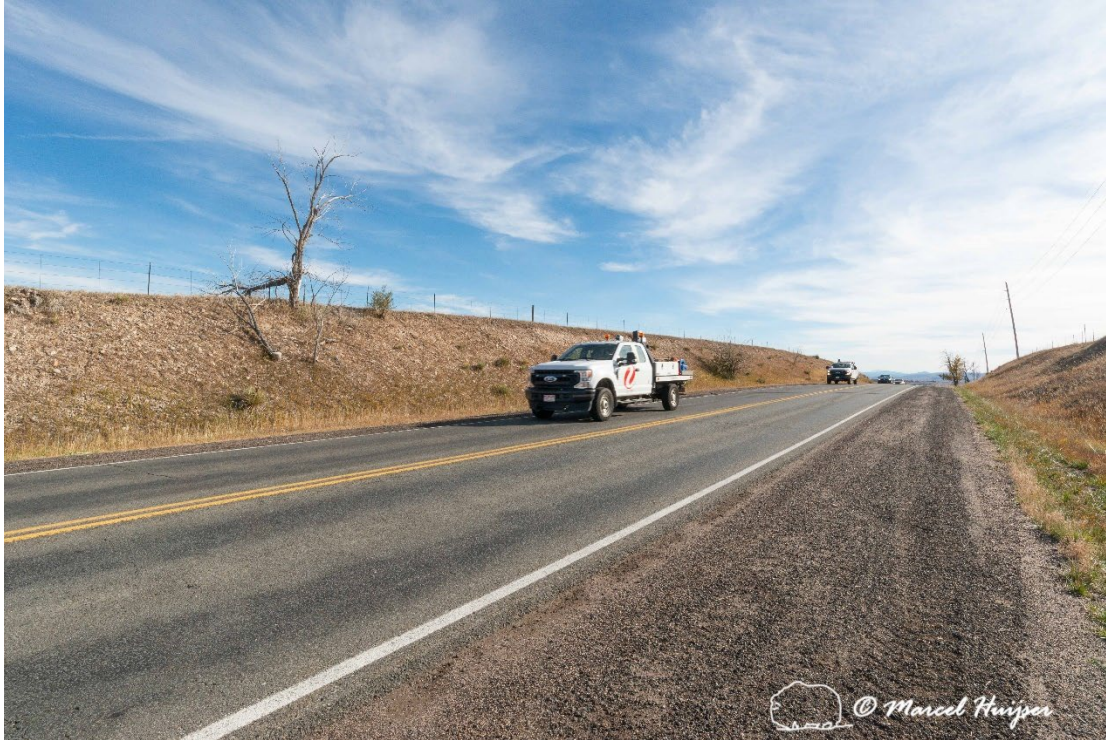
Figure 49. The roadcut along Indiana St., about 1.3 miles south of the junction with Hwy 128.

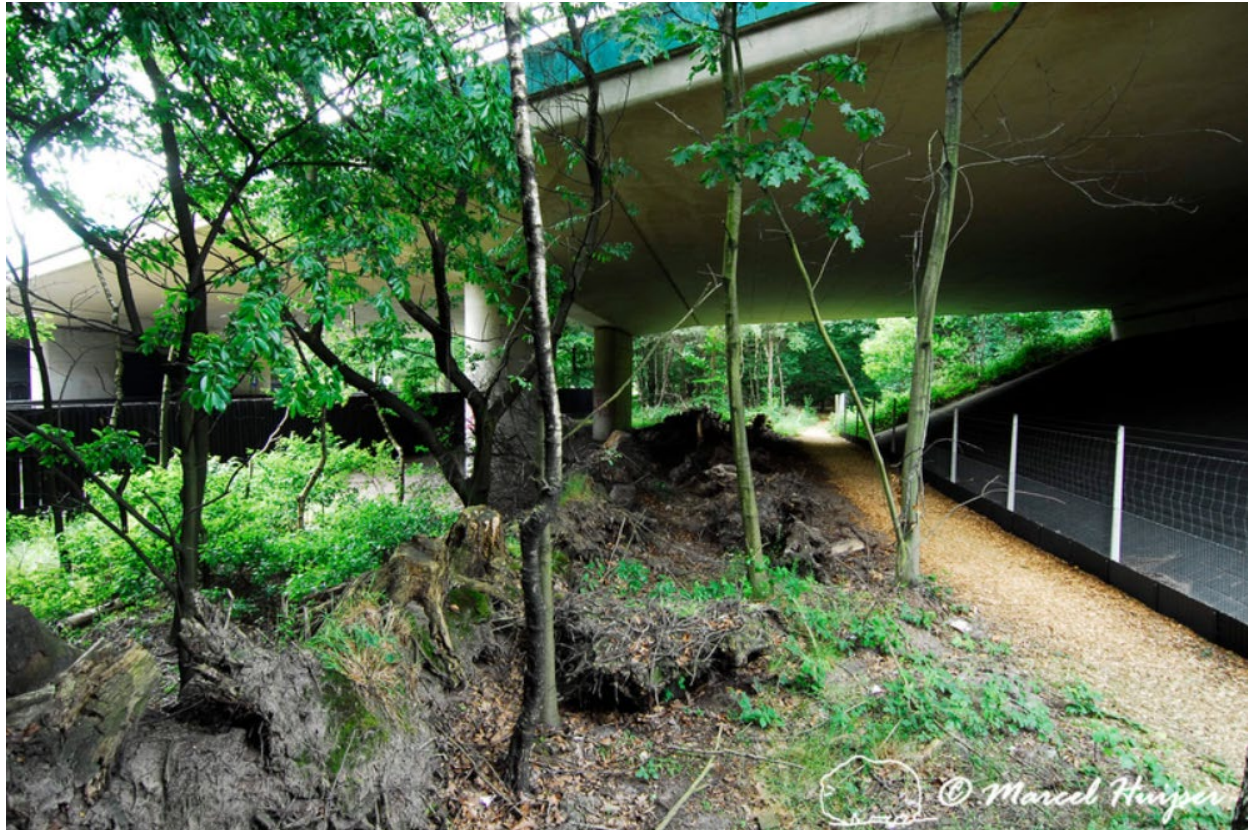
Figure 50. Multifunctional underpass under A28 motorway near Hilversum, The Netherlands. The trail for non-motorized human use is on the far-right side. A berm with root wads, small trees and shrubs in the center separates the trail from the wildlife zone further to the left. Beyond the black screen on the far left there is a 2-lane road.

1. A wider structure than a structure that is only for wildlife. The extra width should be at least the space taken by the recreational trail and the noise and visual barrier in between the trail and the wildlife zone (see one of the next points). If negative impacts spill further into the wildlife zone, additional width is recommended. If the target species include species that are sensitive to human presence and disturbance, increase the width even further.

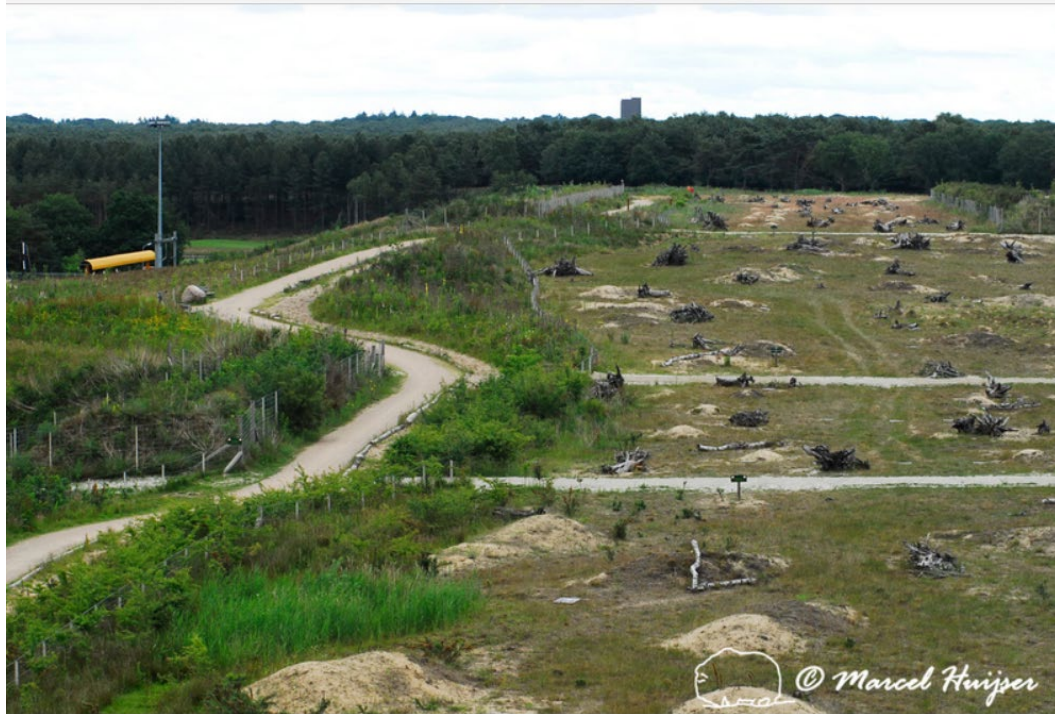
Figure 51. Multifunctional overpass across a 2-lane road and railroad tracks with a trail for non-motorized recreation on the left side, Natuurbrug Zanderij Crailoo, The Netherlands. The trail has a berm with trees and shrubs to reduce human presence and disturbance in the wildlife zone that is further to the right. The habitat on top of the overpass is dry and sandy grassland and heathland.

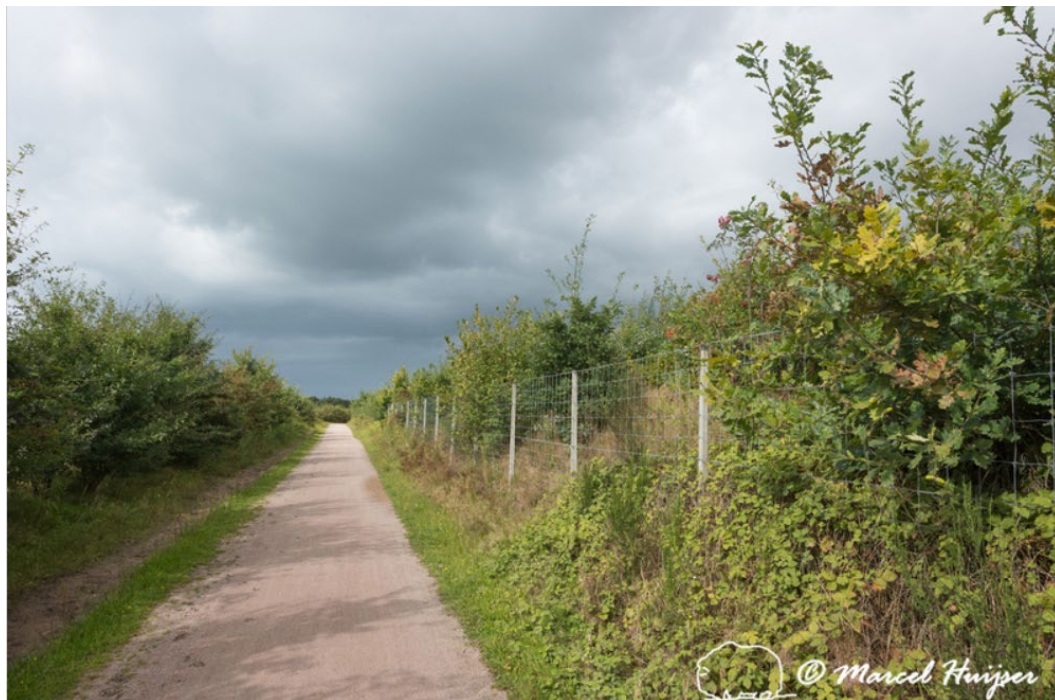
Figure 52. Multifunctional overpass across a 2-lane road and railroad tracks with a trail for non-motorized recreation, Natuurbrug Zanderij Crailoo, The Netherlands. The trail has a berm with trees and shrubs on the left-hand side to reduce human presence and disturbance in the wildlife zone that is further to the left. There is also a berm with trees and shrubs to the right of the trail, reducing visual and noise disturbance from vehicles towards the trail.

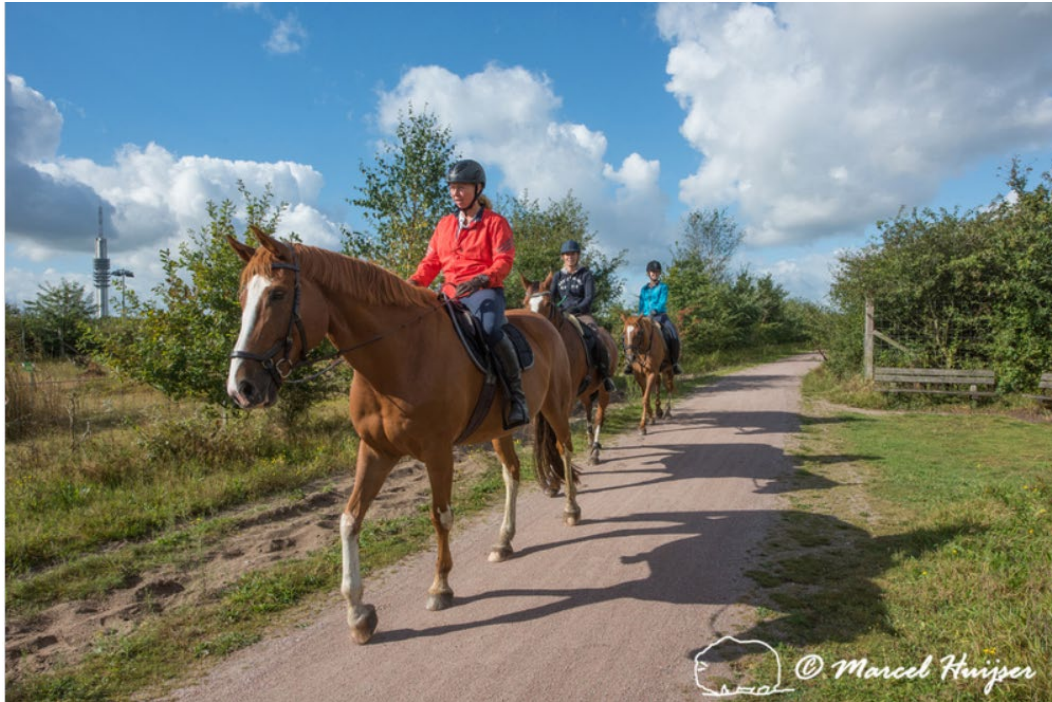
Figure 53. Horseback riders on a trail on a multifunctional overpass across a 2-lane road and railroad tracks. The trail is for non-motorized recreation. Natuurbrug Zanderij Crailoo, The Netherlands. The trail has a berm with trees and shrubs on the right-hand side to reduce human presence and disturbance in the wildlife zone that is further to the right. There is also a berm with trees and shrubs to the left of the trail, reducing visual and noise disturbance from vehicles towards the trail.

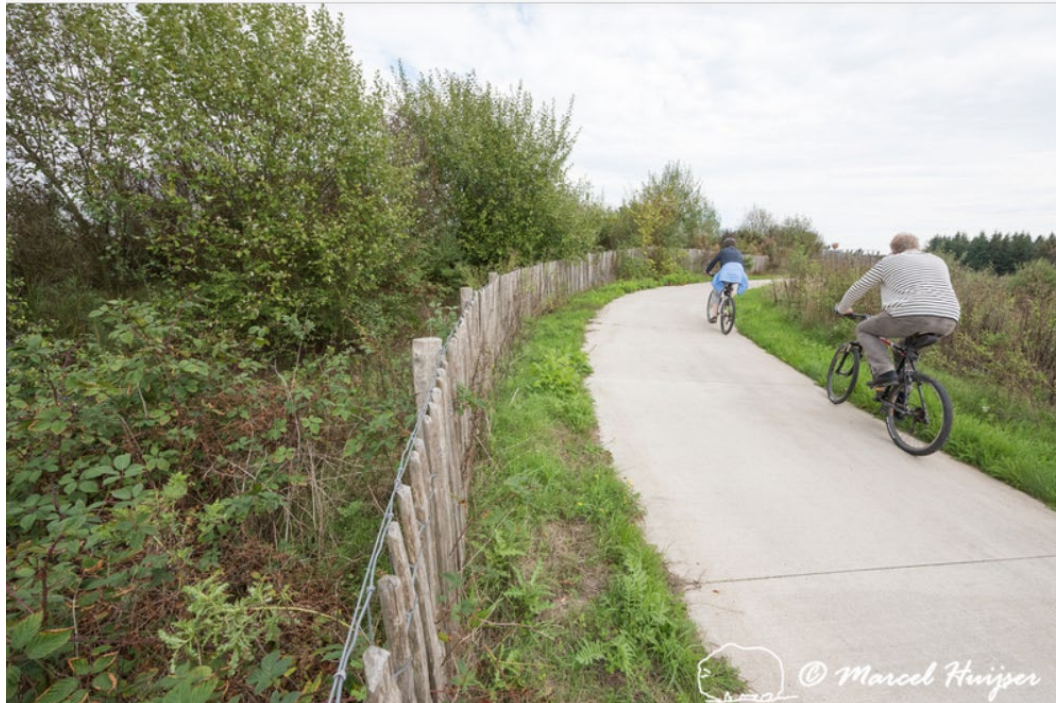
Figure 54. Bicyclists on a trail on a multifunctional overpass. The trail is for non-motorized recreation. Soest, The Netherlands. The trail has a fence and a berm with trees and shrubs on the left-hand side to reduce human presence and disturbance in the wildlife zone that is further to the left.
