EFFECTIVE WILDLIFE FENCES THROUGH BETTER FUNCTIONING BARRIERS AT ACCESS ROADS AND JUMP-OUTS

Effective Jump-Outs for White-tailed Deer and Mule
Deer - Interim Report

THE STATE OF MONTANA DEPARTMENT OF TRANSPORTATION

September 2023

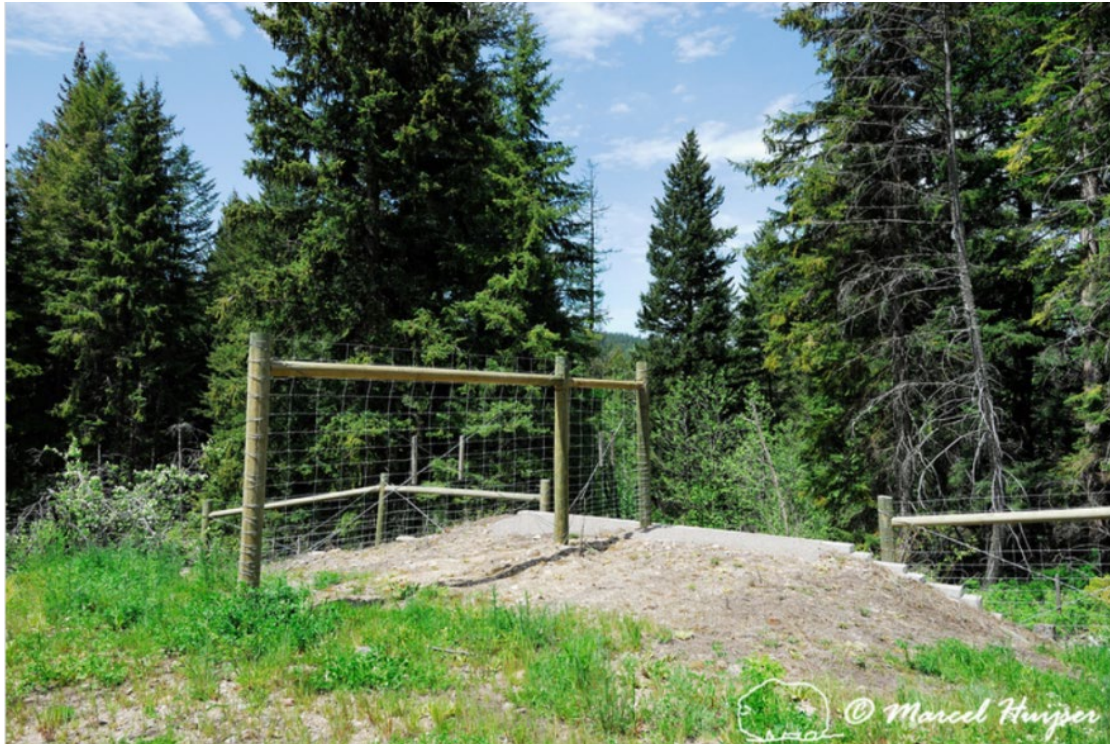
Figure 2: An unmodified jump-out in the Evaro area. The mound allows the animals to walk up to an opening in the fence, with a drop of around 1.83 m (6 ft) to the habitat side of the jump-out.

Between 2008-2015, 52 jump-outs or escape ramps were monitored using tracking beds on top and on the bottom of the jump-outs (Huijser et al. 2016) (Figure 2 and 3). Most of these jump-outs were about 1.83-2.13 m (6-7 ft) high and had a width (i.e., gap in the fence) of about 5 m (15 ft). Only 13.84% of the deer that were tracked on top (white-tailed deer and mule deer combined) were estimated to have jumped down. None of the deer that passed by on the habitat side of the jump-out were estimated to have jumped up into the fenced road corridor (Huijser et al. 2016). More detailed monitoring with wildlife cameras (2014-2016) of 10 of these 52 jump-outs (varying in height 1.75-2.04 m (5.7-6.7 ft)) showed that only 6.88% of the white-tailed deer and 32.35% of the mule deer detected on the top of the jump-outs jumped down to the safe side of the fence (Huijser et al. 2016). None of the deer that passed by on the habitat side of the jump-outs were observed jumping up into the fenced road corridor (Huijser et al. 2016).

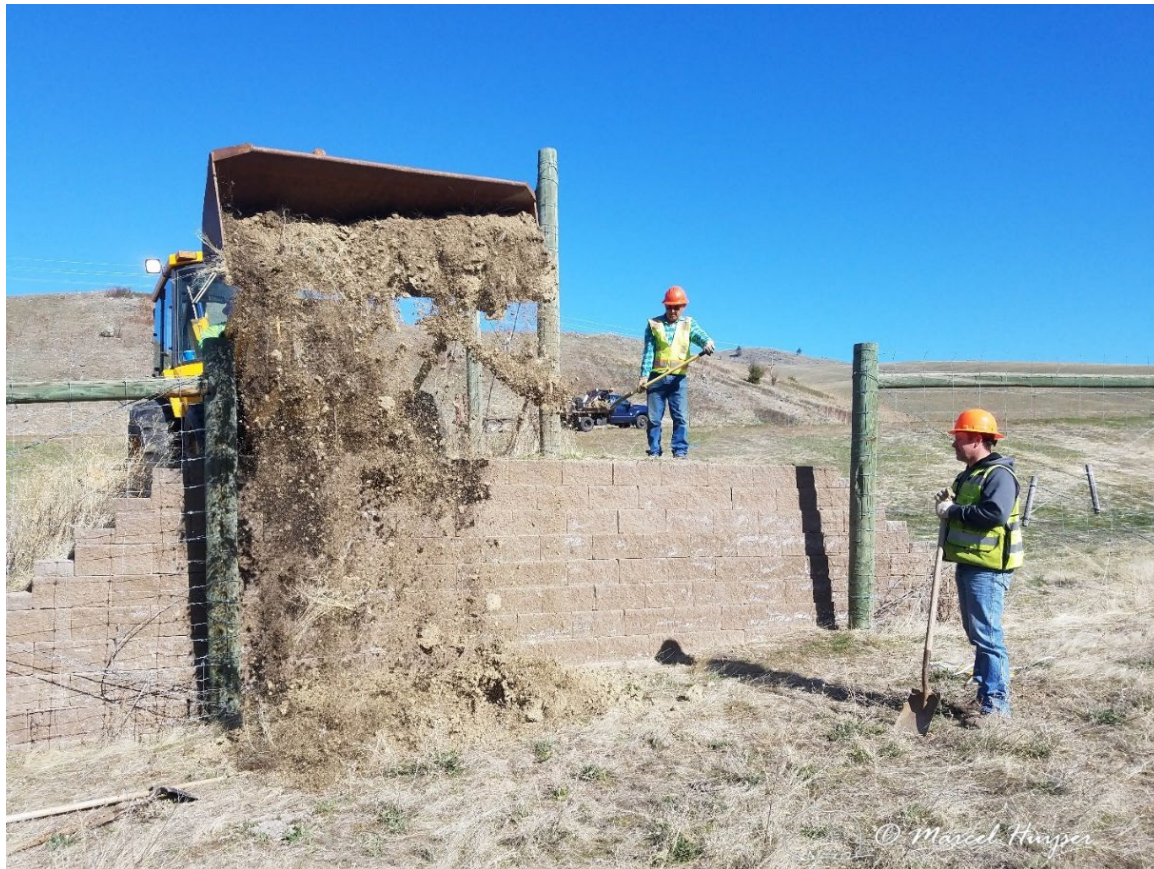
Figure 4: The Montana Department of Transportation assisted with the lowering of 10 jump-outs. After removing concrete blocks of the face, soil from the top was deposited at the bottom for the landing area.

- The face was lowered to exactly 1.52 m (5 ft). This was accomplished by removing soil from the top and removing one or multiple rows of the concrete blocks from the face (the wall) (Figure 4). The top blocks are 7.6 cm (3 inches) tall, and the standard blocks are 17.8 cm (7 inches) tall. The jump-outs in the Ravalli Hill area were lowered on 21 April 2021. The jump-outs in the Evaro area were lowered on 4 May 2021.
- The soil that was removed from the top was deposited at the bottom of the jump-outs to level the landing area up to about 2 m (6-7 ft) out from the vertical face of the jump-outs. This resulted in a consistent height of 1.52 m (5 ft) for the vertical face of the jump-outs.
- Tall vegetation was removed from the top and road-facing slopes of jump-outs, and the landing area.
- An adjustable bar was added on top of the jump-out above the ground level.

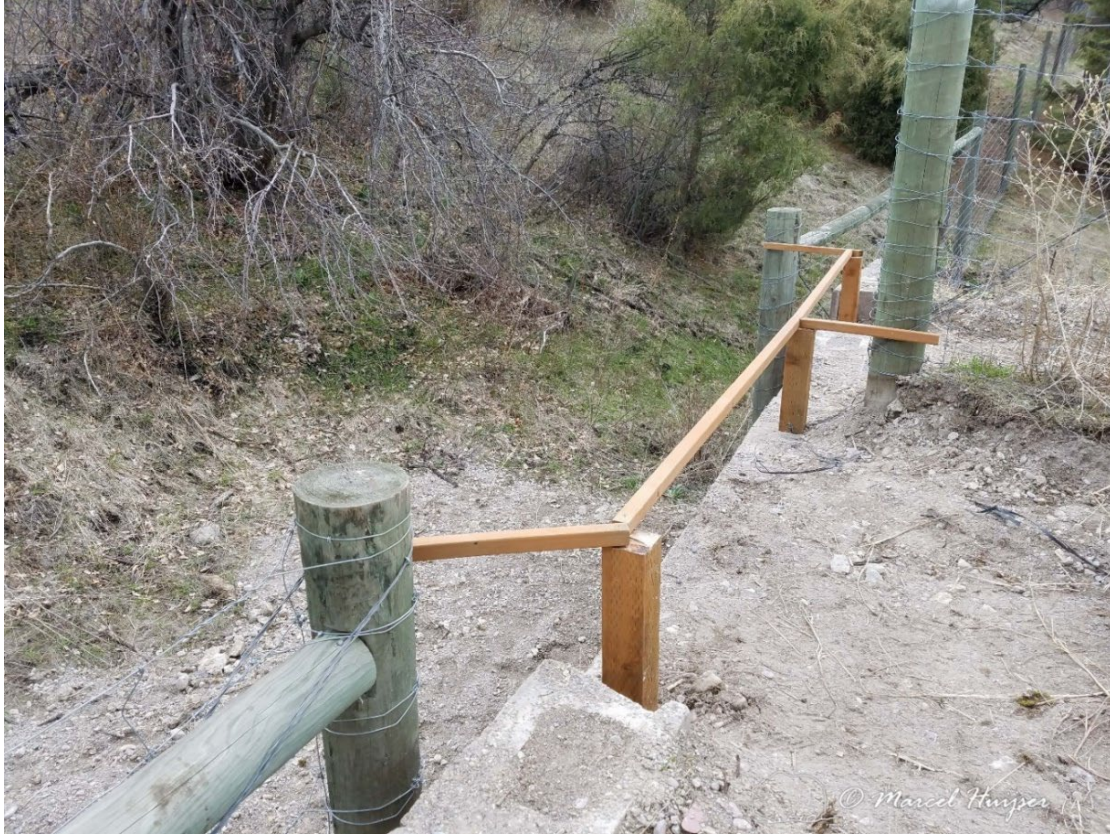
Figure 5: The prototype for the “bar” made from “5x5” cm (“2x2” inch) and “10x10” (“4x4” inch) treated lumber.

A prototype of the “bar” was made from treated lumber; “5x5” cm (“2x2” inch) and “10x10” cm (“4x4” inch) (Figure 5). The “10x10” cm (“4x4” inch) posts sat on the top of the concrete blocks allowing an initial setback of 4 inches from the face. More permanent “bars” were made from rebar (grade 60, 1.25 cm (1/2-inch) diameter) (Figure 6). The rebar was bent into giant “staples” that measured 152 cm (60 inches) horizontal with 107 cm (42 inch) legs. The 107 cm (42 inch) legs allowed the “staples” to go deep into the soil of the mound for stability, and also allowed for height adjustments (higher or lower above the ground on top of the mound). However, the setback for the rebar was 12 inches (30.5 cm) from the face at a minimum. This is because the legs could not go through the 12 inch (30.5 cm) wide concrete blocks that formed the face. L-shaped 91 cm (36 inch) swing arms (with 107 cm (42 inch) legs) were used to connect the bar to the fence posts at each side of the jump-out (Figures 7-9). The legs of the “staples” and L-shape corner elements were wrapped with metal wire twisted around both legs to increase rigidity.

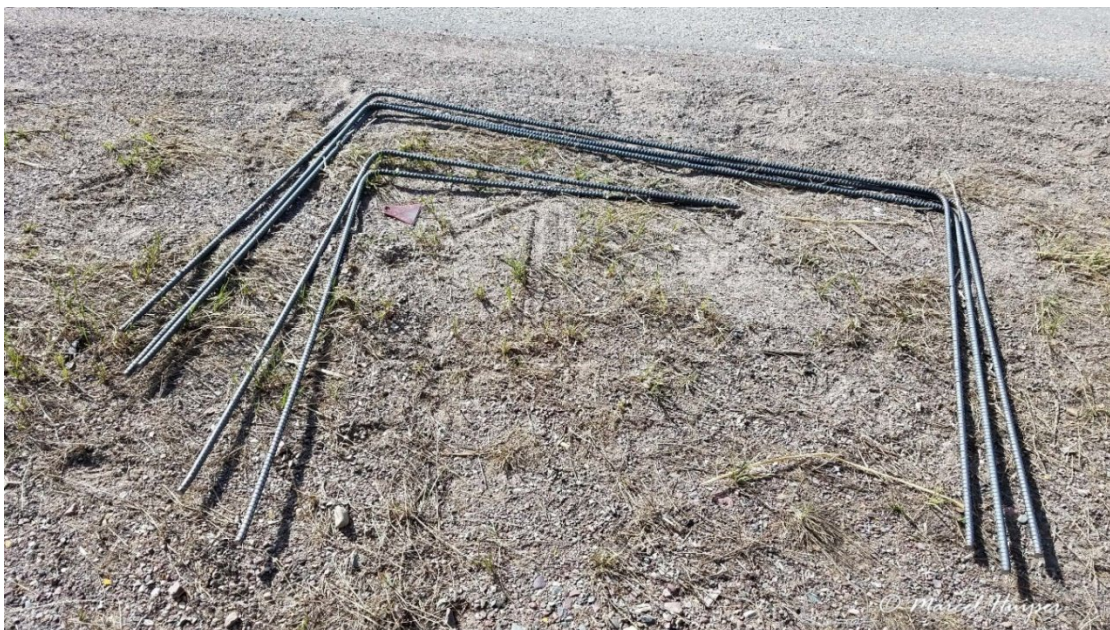
Figure 6: Several of the “staples” (60-inch horizontal, 107 cm (42 inch) legs) the L-shaped corner elements (91 cm (36 inch) swing arms, 107 cm (42 inch) legs).

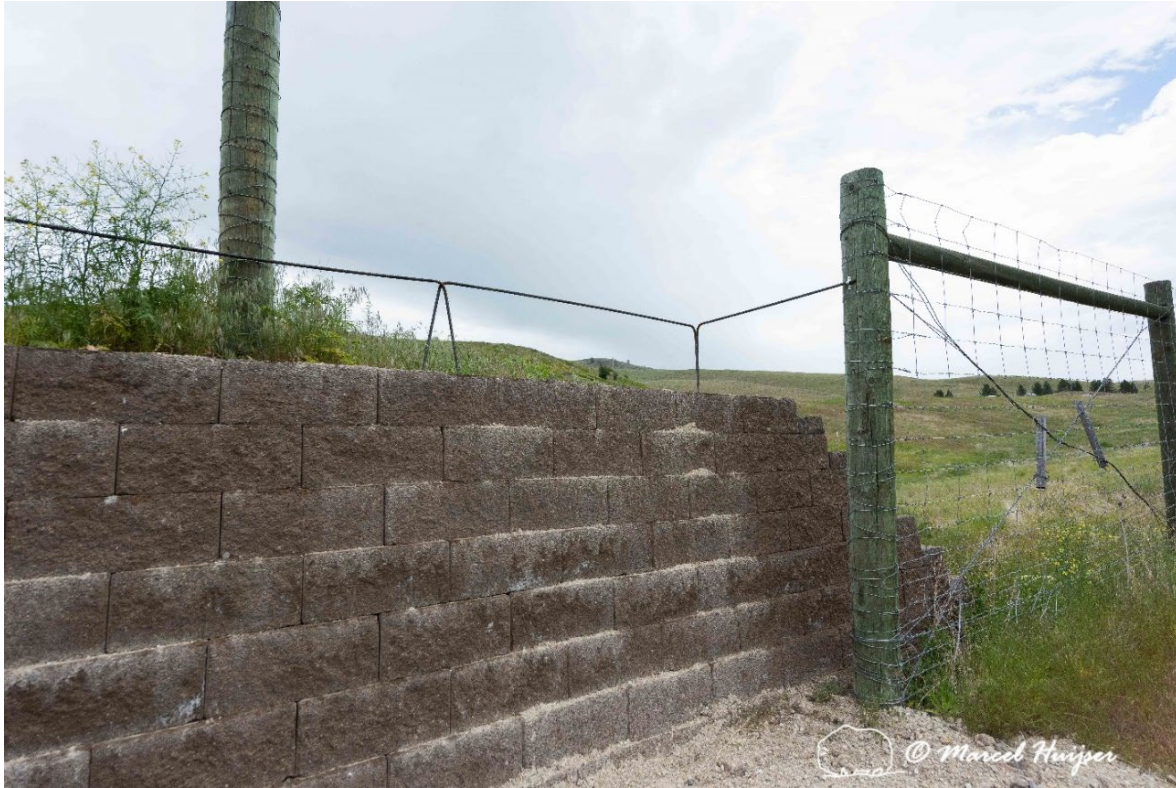
Figure 7: The rebar installed with the L-shaped corner elements connected to the fence post.

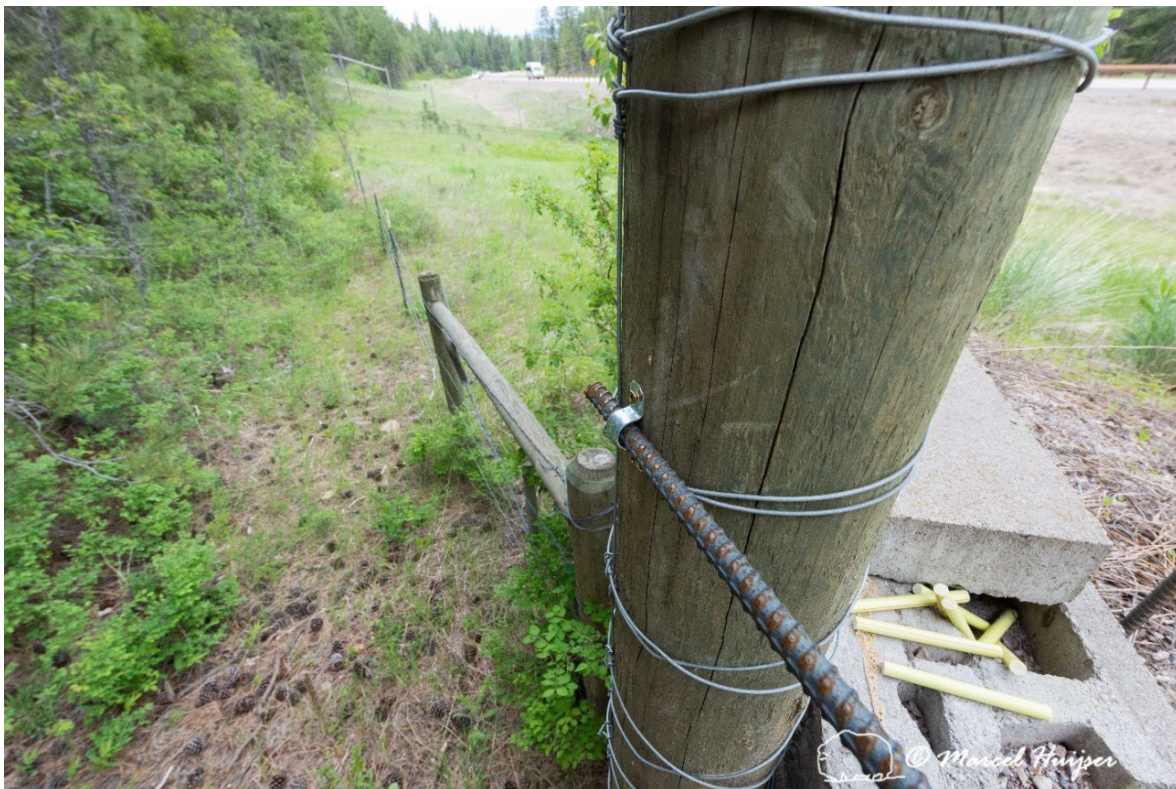
Figure 8: The L-shaped corner elements were connected to the fence posts with brackets and screws.

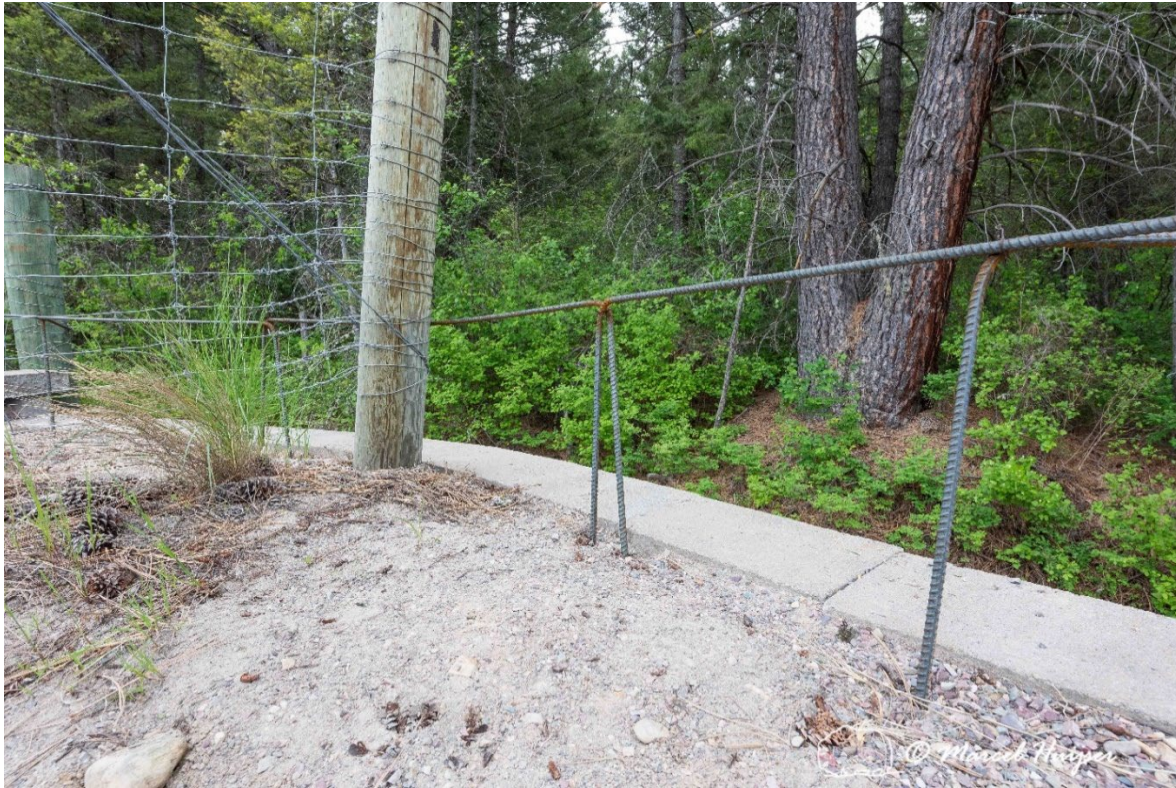
Figure 9: The legs of the “staples” and L-shaped corner elements were connected with metal wire.

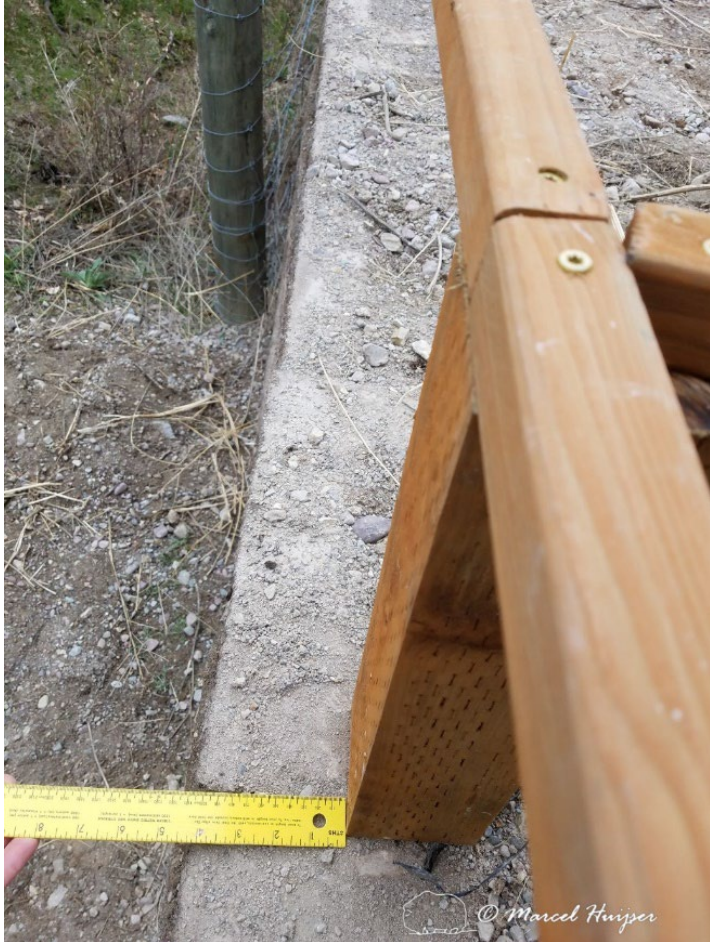
Figure 10: The wooden prototype had a setback of 10 cm (4 inches).

The top of the wooden prototype of the bar was 46 cm (18 inches) above the top or surface of the jump-out and had 10 cm (4 inches) setback from the wall (Figure 10). The bars made from rebar were initially also 46 cm (18 inches) above the top or surface of the jump-out. However, they had to be positioned behind the concrete blocks that formed the wall and therefore they had an initial setback of 30 cm (12 inches) (Figure 11). Based on the initial results with the prototype, 10 cm (4 inches) setback appeared to be insufficient to allow the deer to step over the bar with their front legs and take advantage of the low height of the jump-out (Figure 12). Because the deer jumped the bar going down, the effective height for the animals jumping down was 152 cm (5 ft) plus an additional 46 cm (18 inches): 1.98 cm (6½ ft) total height. Additional data from the rebar design (height 46 cm (18 inches), setback 30 cm (12 inches)) showed an increase in mule deer jumping down compared to the wooden prototype, but the performance was still marginal and similar to the use of the non-modified jump-outs; 10% or less of the white-tailed deer and only 30-40% of the mule deer that were recorded on top of the jump outs jumped down. Therefore, further modifications of the height and setback of the bars were initiated. The height was reduced, and the setback was increased in 7.5 cm (3 inch) increments (Figure 13, Table 2).

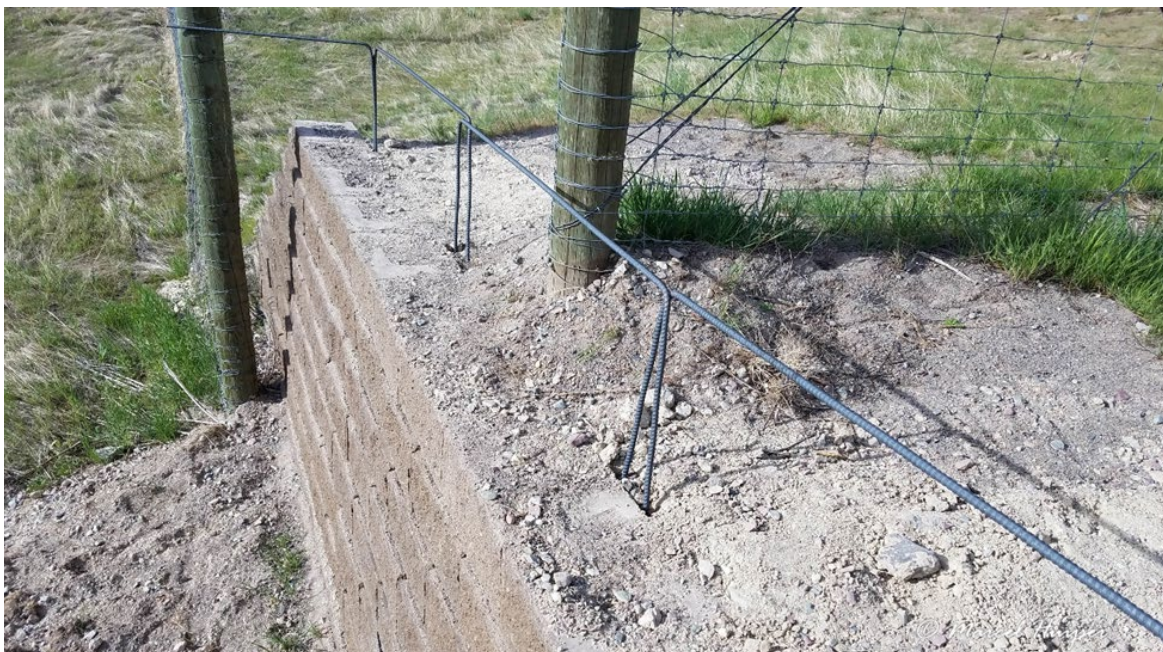
Figure 11: The rebar had a minimum setback of 30 cm (12 inches) as the legs had to be positioned behind the concrete blocks of the face of the jump-out.

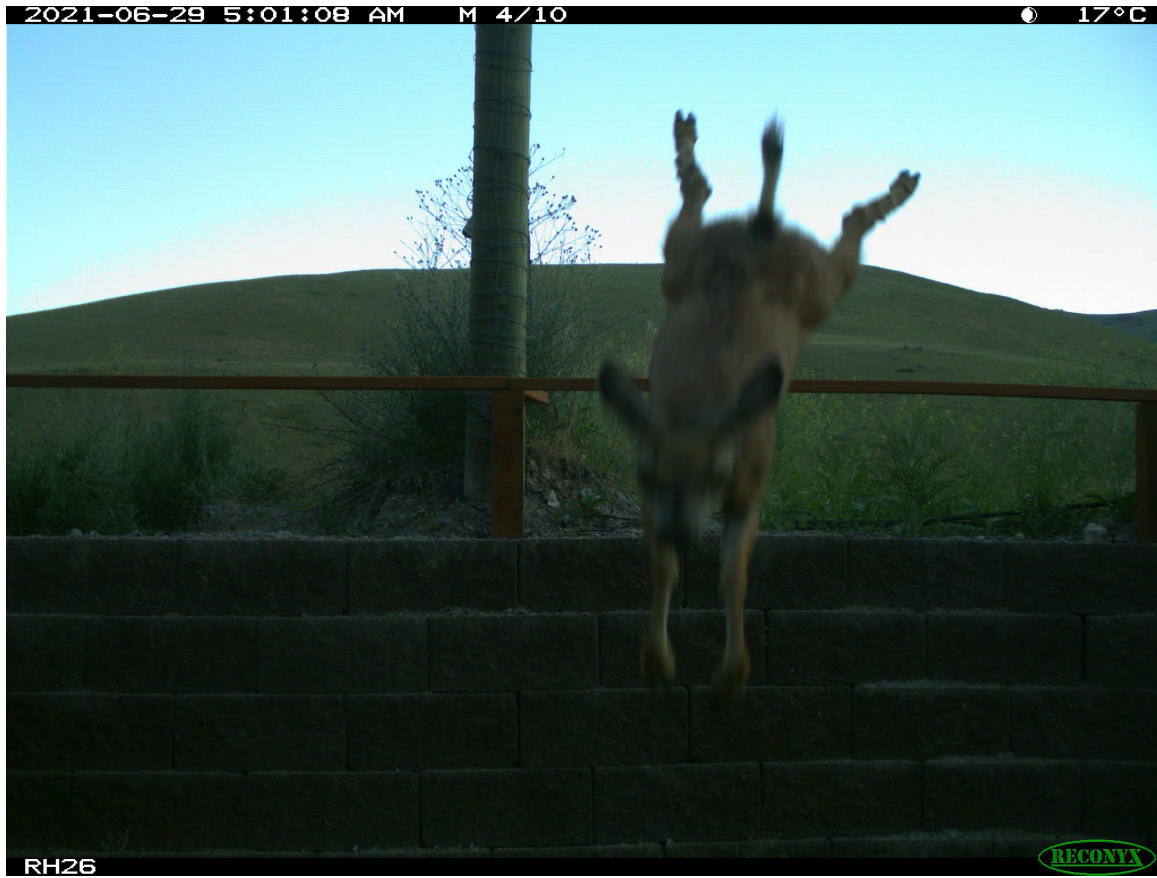
Figure 12: A mule deer jumps down the jump-out with the prototype (height 46 cm (18 inches), setback 10 cm (4 inches)). The animal starts the jump from behind the bar and does not step over the bar first before jumping down.

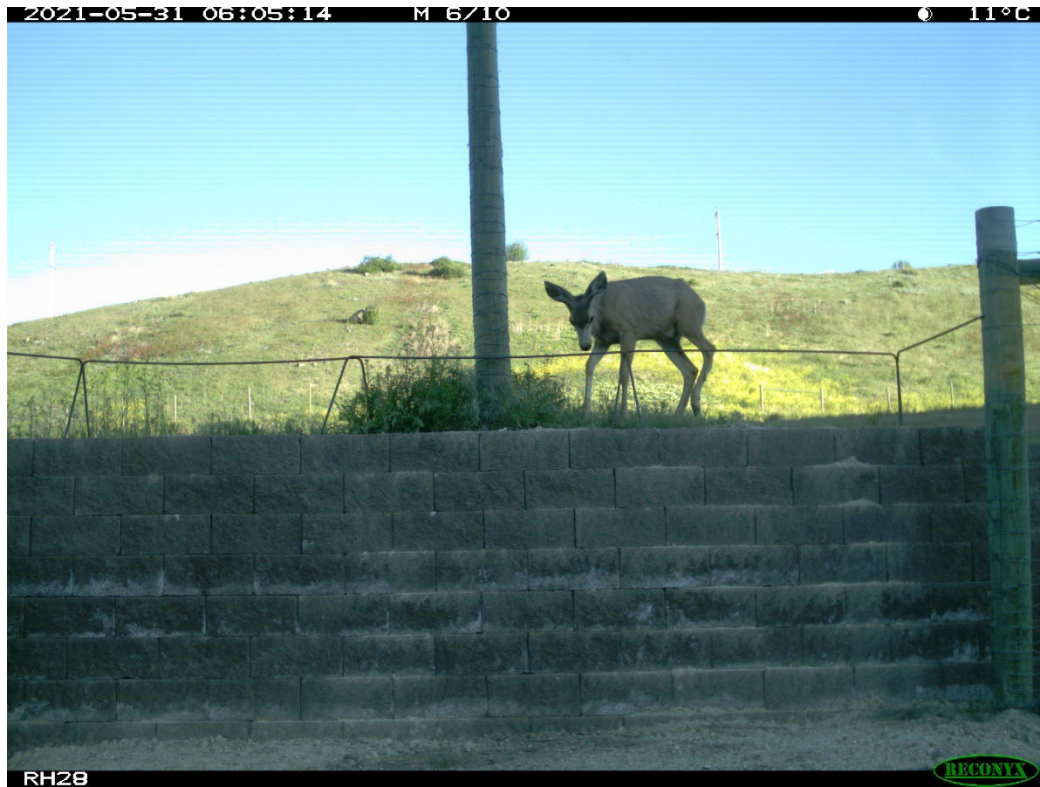
Figure 14: The typical view of the cameras allowing the researchers to see animals both on top and at the bottom of the jump-outs. Mule deer contemplates jumping down to the habitat side of the fence.

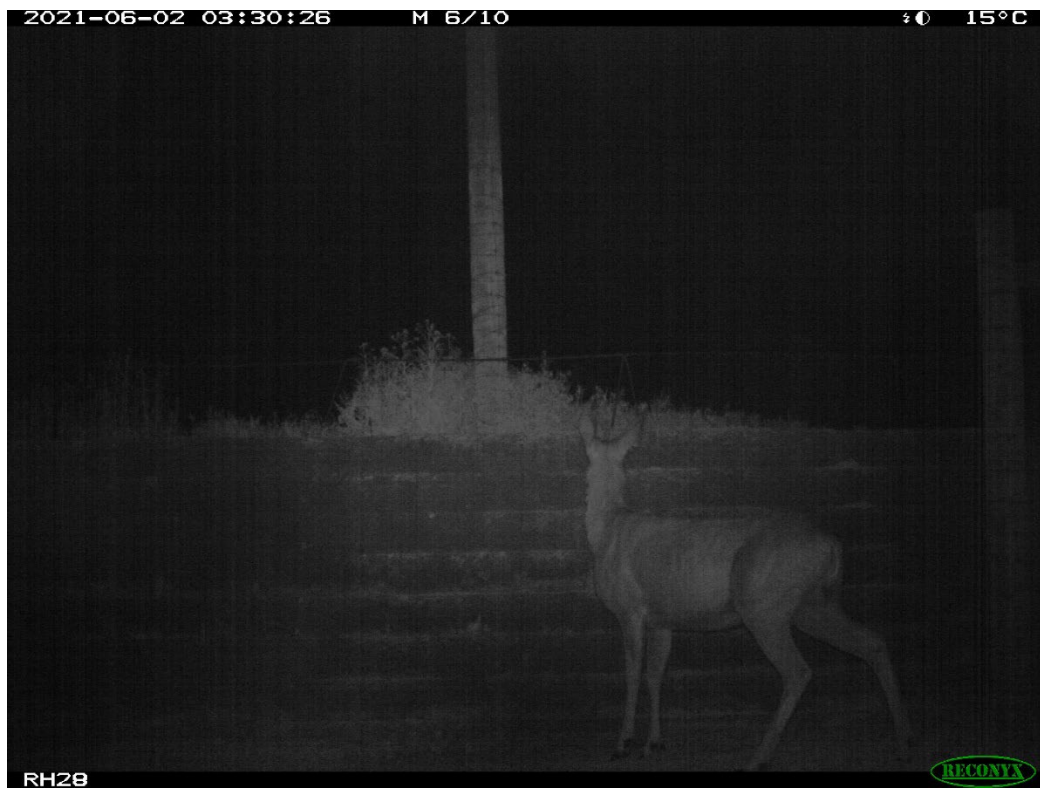
Figure 15: The typical view of the cameras allowing the researchers to see animals both on top and at the bottom of the jump-outs. Mule deer contemplates jumping up into the fenced road corridor.

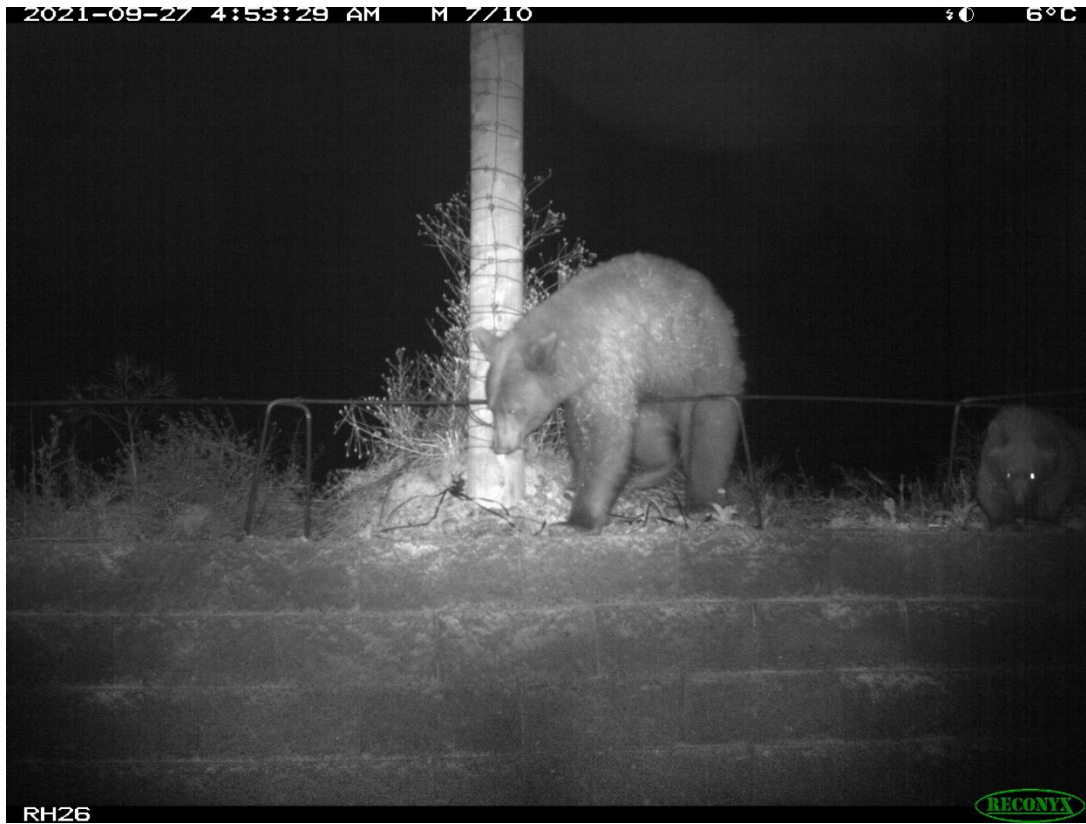
Figure 16: Some black bears first stepped over the bar; others crawled under.

Other mammal species greater or equal in size or weight to a raccoon were also evaluated for their behavior at the jump-outs (Table 3, Figures 16-20). However, due to small sample sizes no distinction was made between the different treatments for the bar. Black bear, bobcat, elk, mountain lion and wolf usually jump down to the safe side of the jump-out (>50%), whereas coyote and red fox occasionally jump down (\leq 50%). Bobcat and mountain lion always jumped up (100%), whereas black bear occasionally climbed up the face into the fenced right-of-way (12.5%), and coyote, elk, and moose were never observed jumping up.

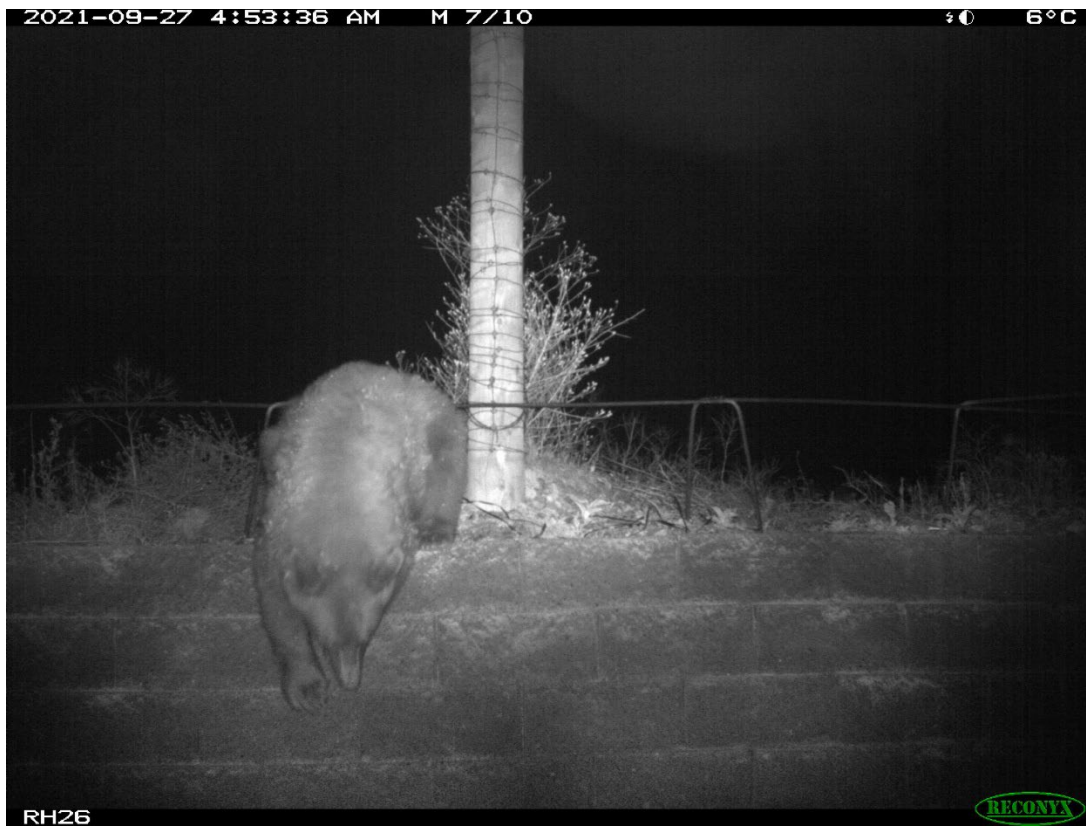
Figure 17: Black bears typically jumped down (desired behavior) headfirst.

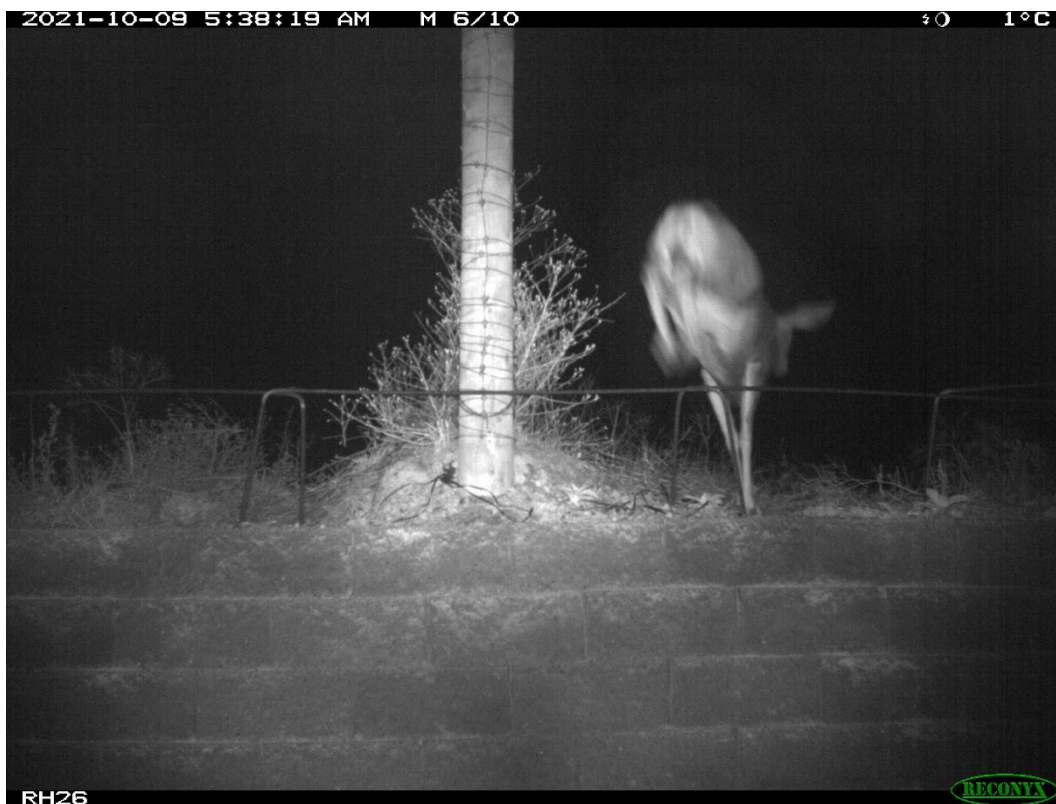
Figure 24: A mule deer jumps up into the fenced road corridor, clearing the bar (undesired behavior).

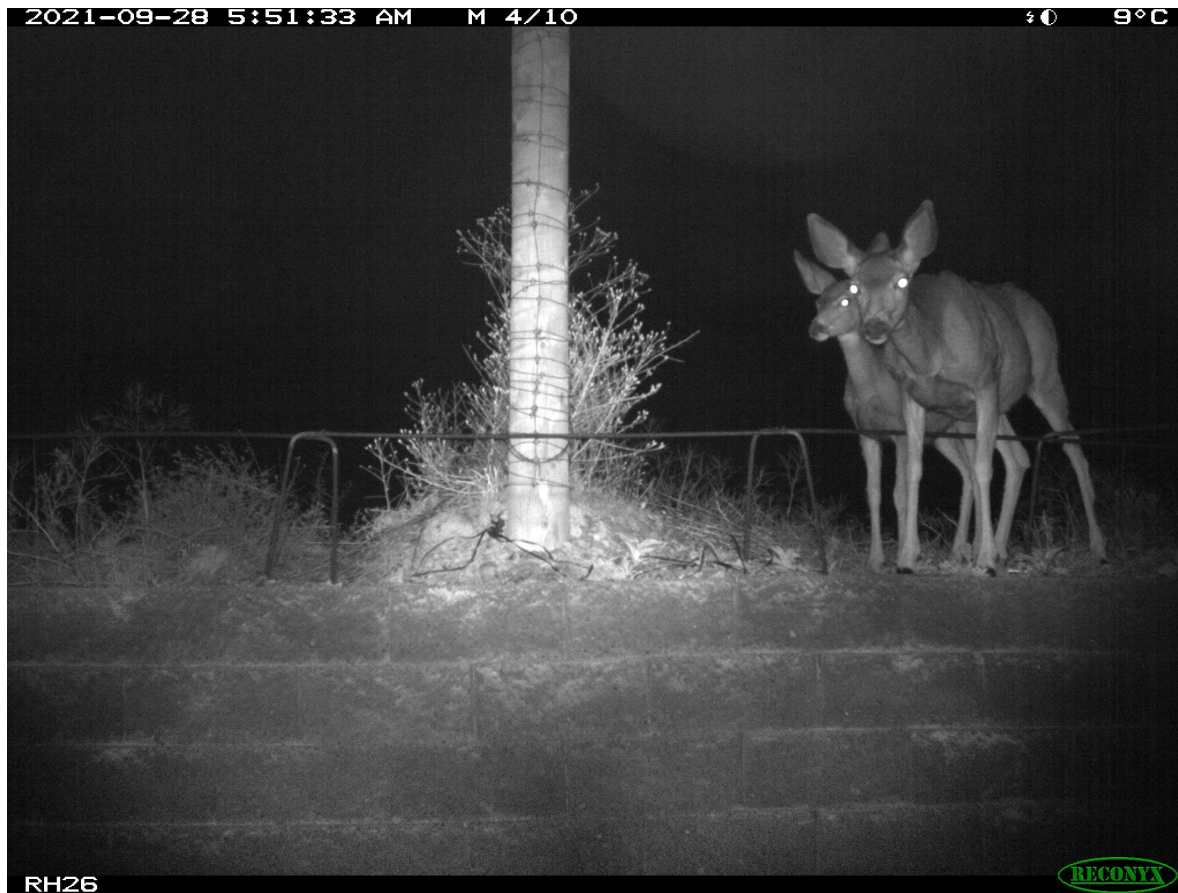
Figure 25: A mule deer steps over the bar with both its front legs before jumping down (desired behavior).
