Potential Future Mitigation Measures for Large Wild Mammals, along US Hwy 20, between Burns and Ontario, Oregon

FINAL REPORT

A report prepared for the
Oregon Department of Fish and Wildlife
3814 Clark Boulevard, Ontario, OR 97914

June, 2023

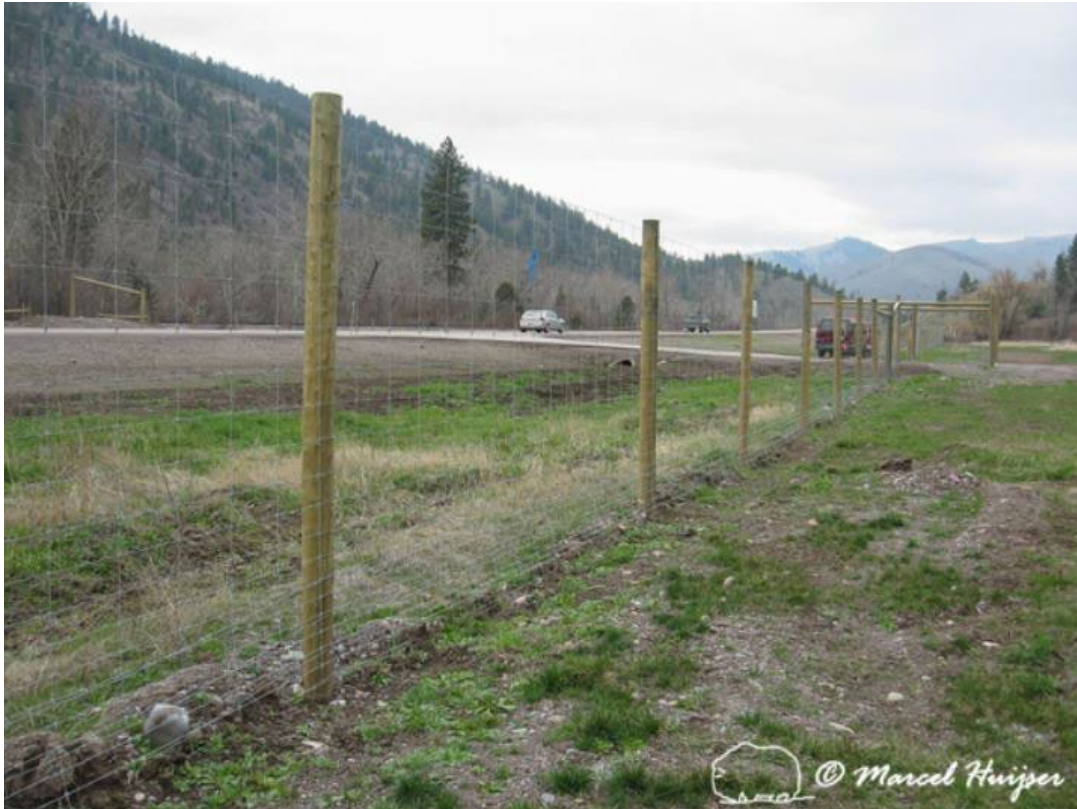
Figure 5. Typical large ungulate fence in North America, 8 ft tall, wooden posts and mesh-wire fence material, US Hwy 93 North, Montana, USA. Note that there is a dig barrier attached to the main fence material (e.g. for canids).

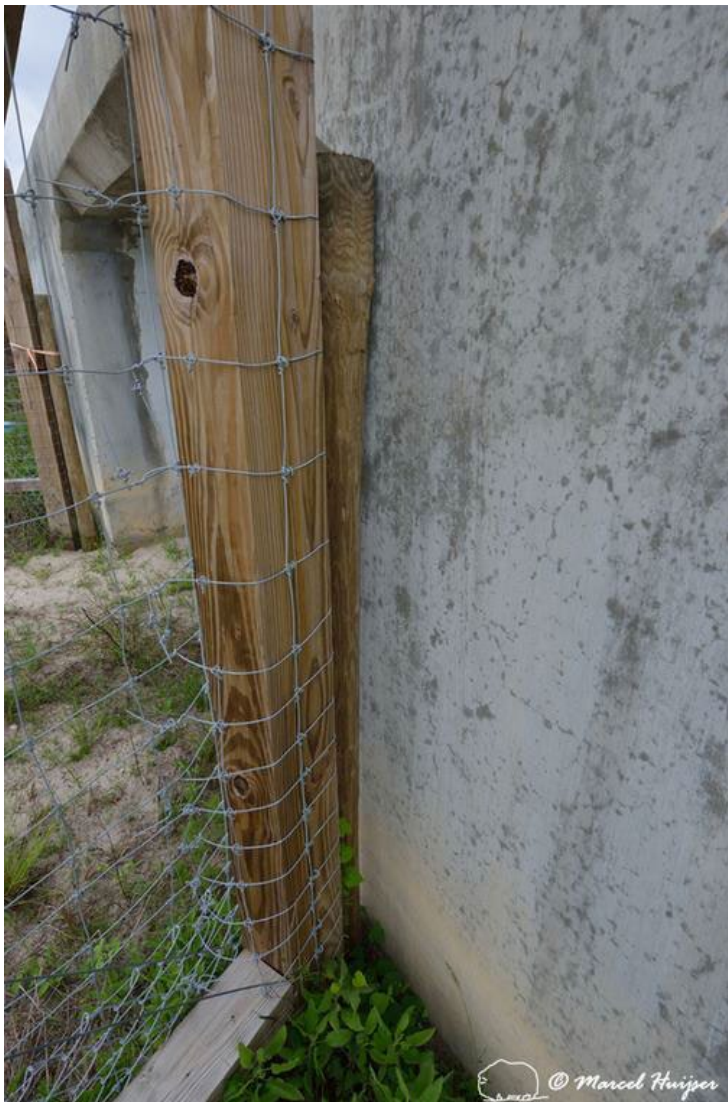
Figure 6. Tight connection (no gap) between last fence post and wall of the wildlife underpass, Hwy 331, Hwy 83 near Freeport, Florida, USA. The angle at which the fence comes in does not result in a dangerous wedge or funnel that could lead to animals getting trapped.

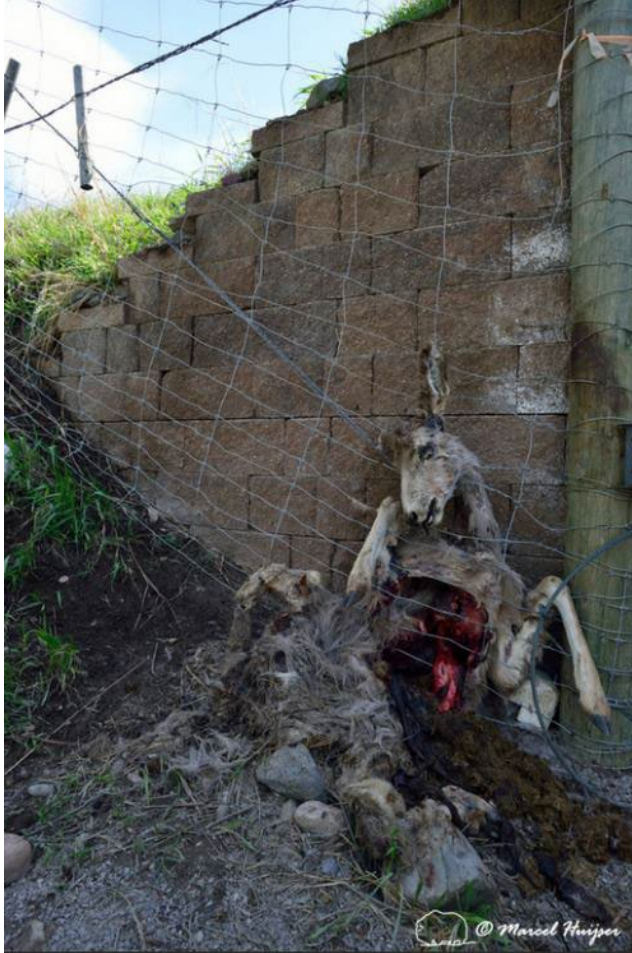
Figure 7. Mule deer got stuck between wildlife fence and the wing wall associated with a wildlife underpass and died, Montana, USA. The fence should be snug up to the wing wall. Here the last fence post was close enough to the wing wall but the second to last post allowed for a funnel or wedge like configuration making the deer believe it could potentially pass in between the wall and the fence. When it realized it could not go forward anymore it tried to turn itself around and then got stuck and died. It is important that both the post and the fence are positioned such that no space is left between the wing wall and the fence.

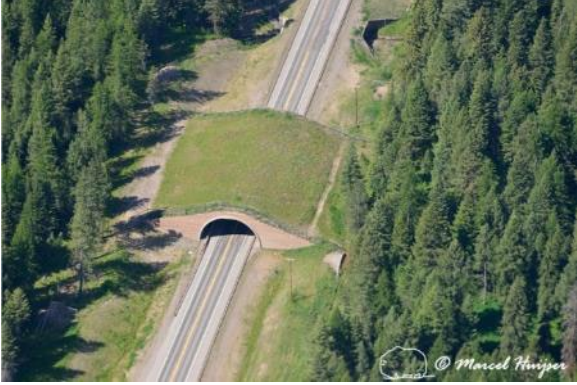
Open span bridge	12-30 m wide, ≥ 5 m high

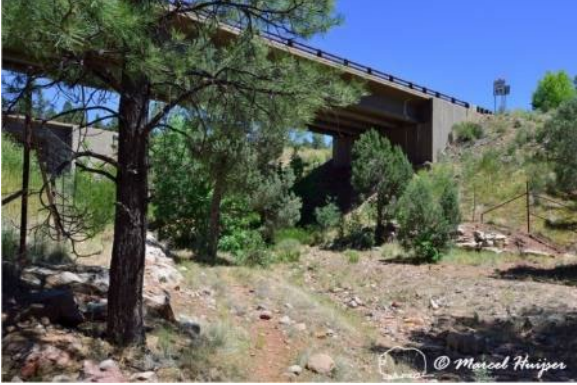
Large mammal underpass	7-8 m wide, 4-5 m high

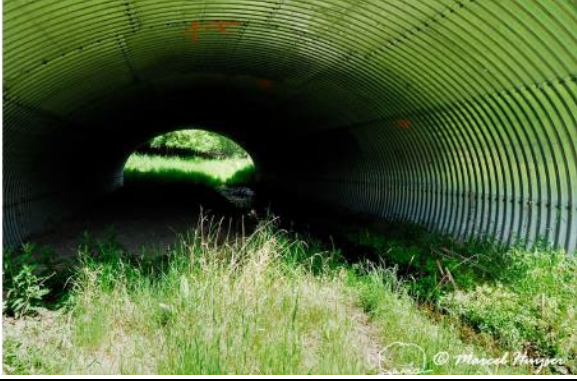
Medium mammal underpasses	0.8-3 m wide, 0.5-2.5 m high

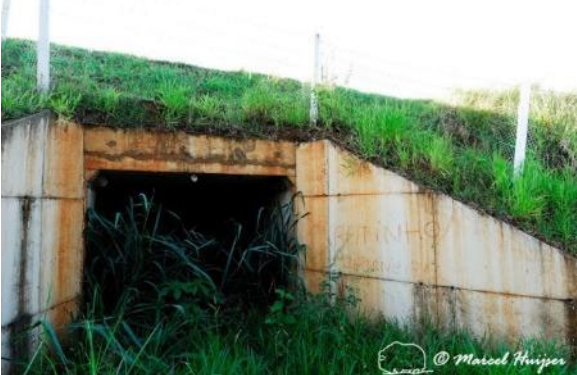
Safe Crossing Opportunity type	Indicative dimensions (as seen by the animals)	Image
Small-medium mammal pipes	0.3-0.6 m in diameter

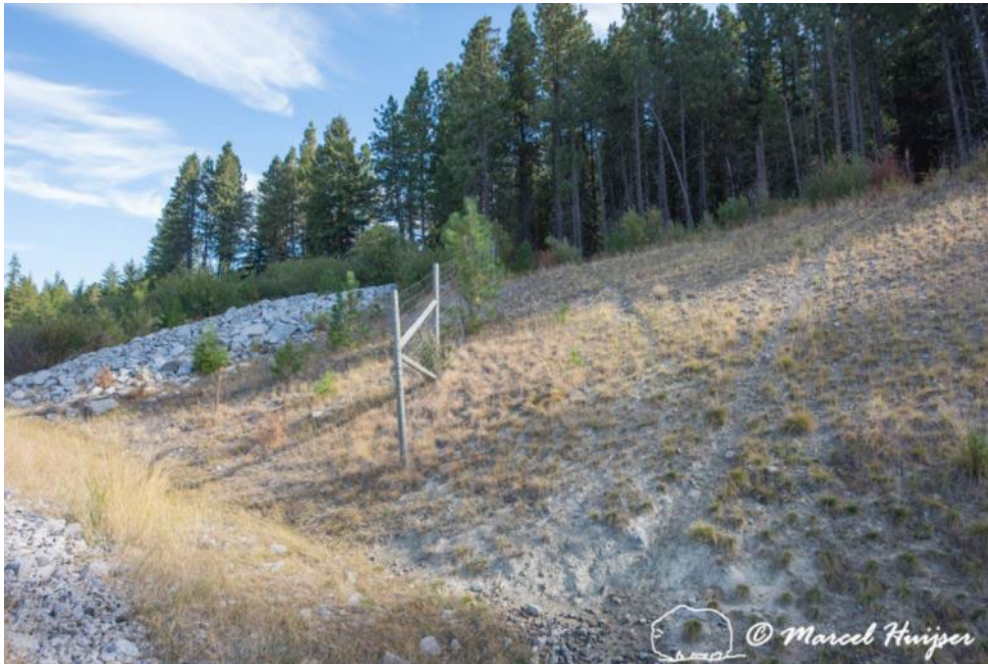
Figure 8. Wildlife trail at a fence-end, US Hwy 95, Bonners Ferry, Idaho, USA. This is an indication that there is a concentration of wildlife crossings at the fence-end (a "fence-end run"), potentially resulting in a concentration of collisions at or near the fence-end, just inside or just outside the fenced road section.

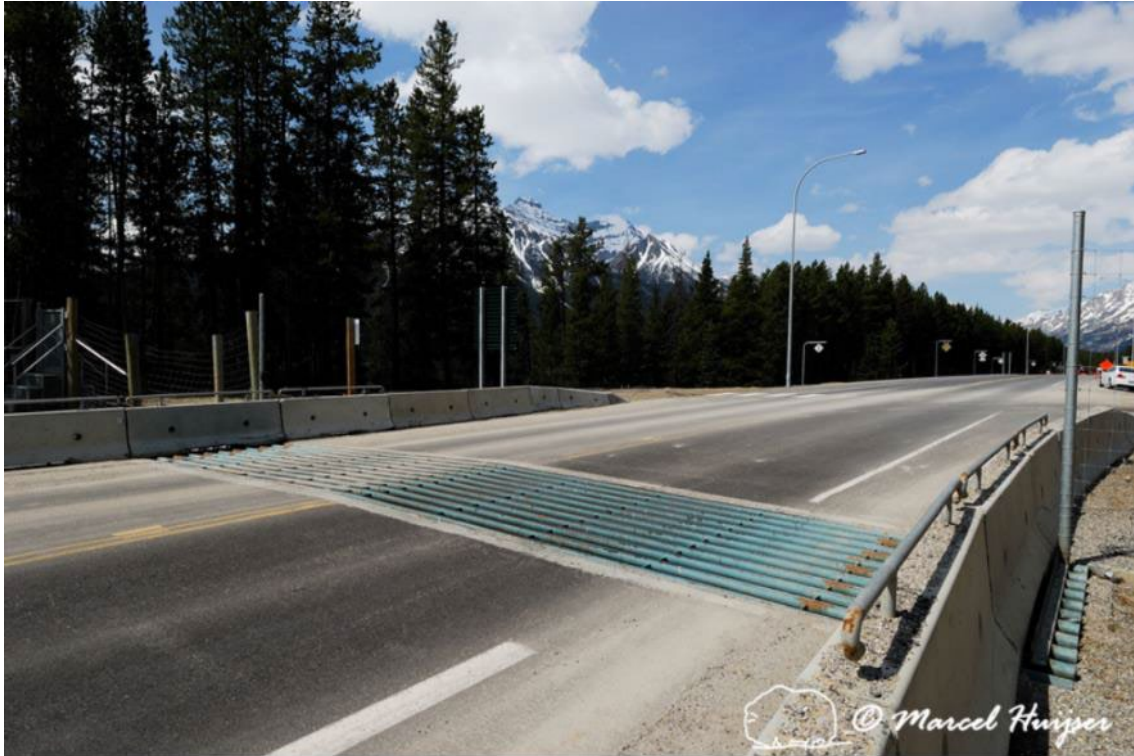
Figure 9. Fence-end brought close to the edge of the pavement, protected by Jersey barriers. Also note that there is a wildlife guard embedded in the travel lanes, Alberta, Canada.

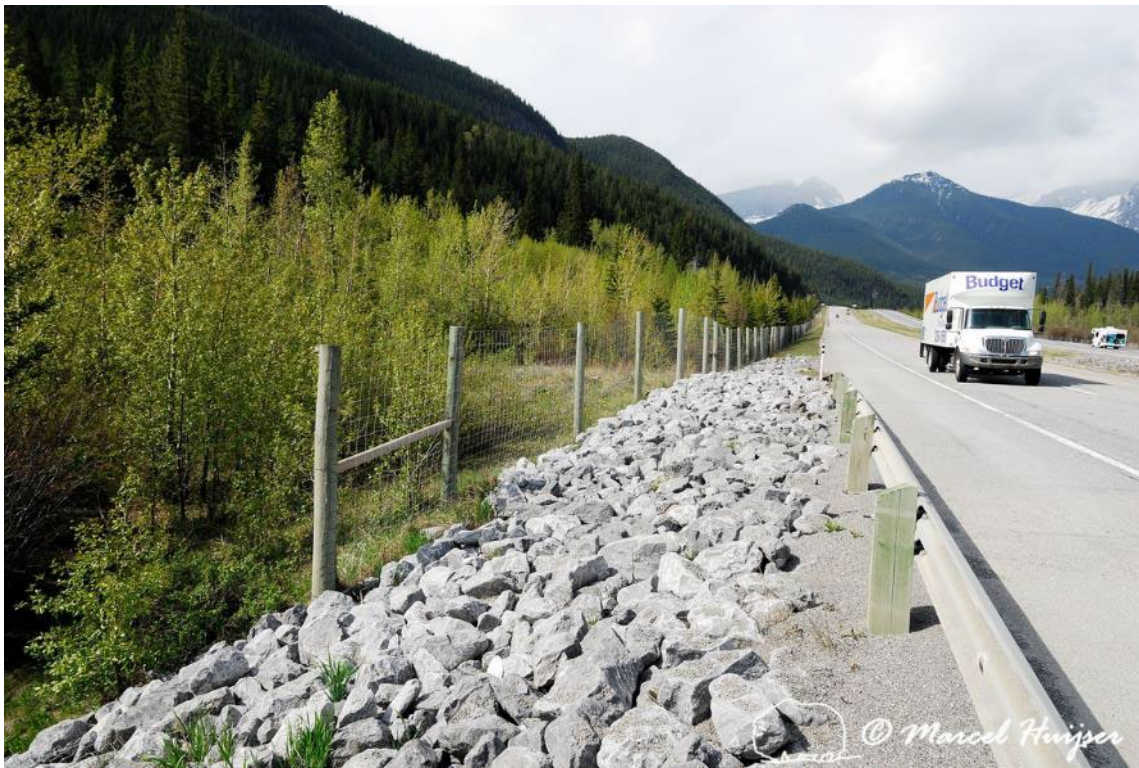
Figure 10. Boulder field at a fence-end, Alberta, Canada.

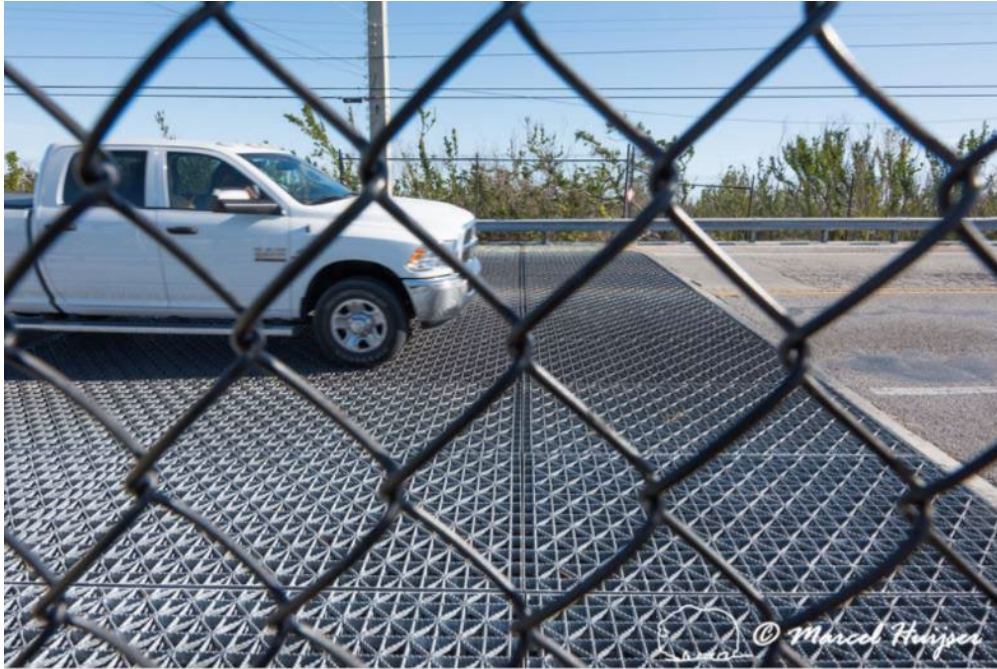
Figure 11. Wildlife guard at a fence-end on US Hwy 1, Big Pine Key, Florida, USA.

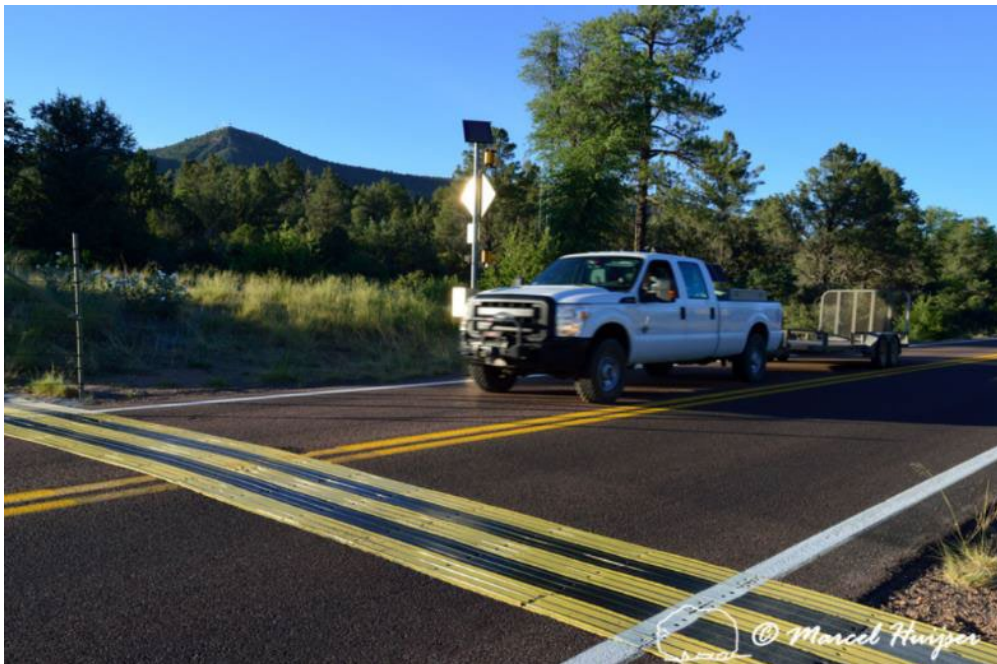
Figure 12. Electrified mat associated with an animal detection and driver warning system at a fence-end, S.R. 260 east of Payson, Arizona, USA.

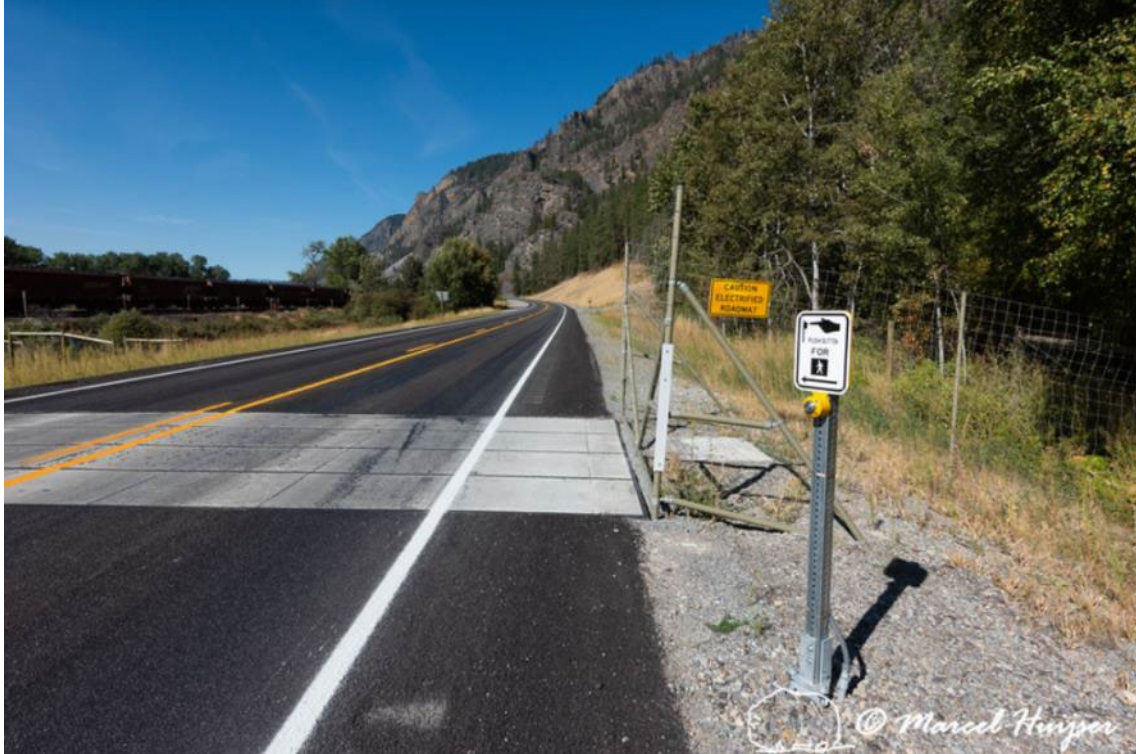
Figure 13. Electrified barrier embedded in travel lanes to keep large mammals, including bighorn sheep, out of fenced road corridor, MT Hwy 200, Thompson Falls, Montana, USA.

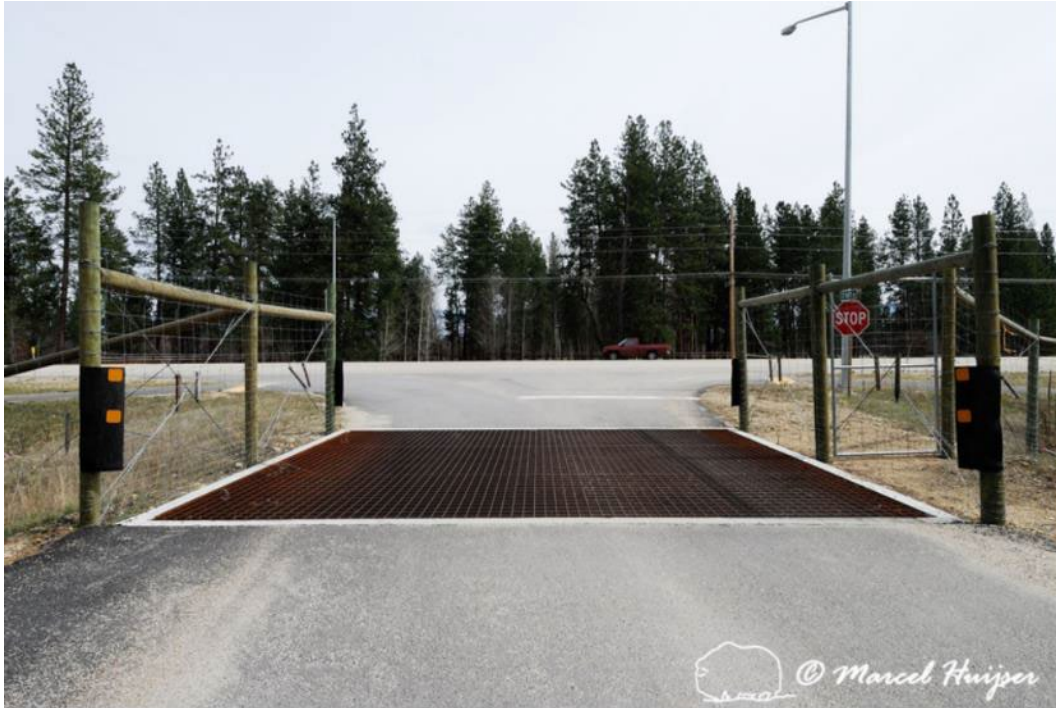
Figure 14. Wildlife guard installed at an access road to the main highway (US Hwy 93S), near Stevensville, Montana, USA. The metal barrier is easy to walk and bike over. Note that the concrete ledge can be used by wildlife to access the fenced road corridor. This concrete ledge should be made inaccessible.

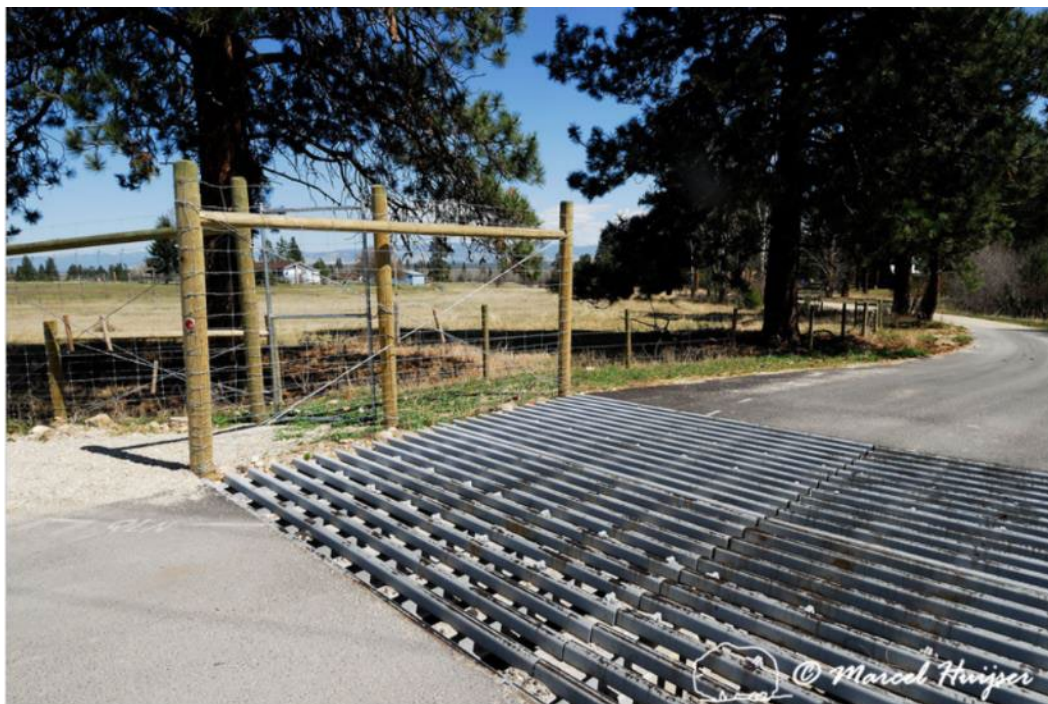
Figure 15. Wildlife guard at an access road to US Hwy 93S, near Victor, Montana, USA. This type of wildlife guard is less suited for pedestrians and cyclists.

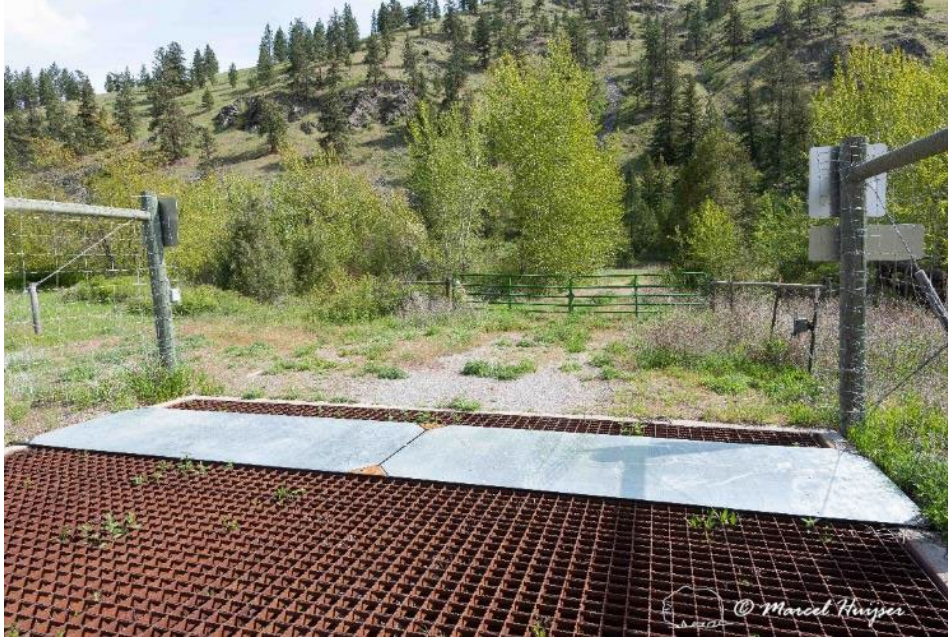
Figure 16. Electrified barrier, designed for low traffic volume and low traffic speed, on top of a wildlife guard at an access road to US Hwy 93S, near Ravalli, Montana, USA.

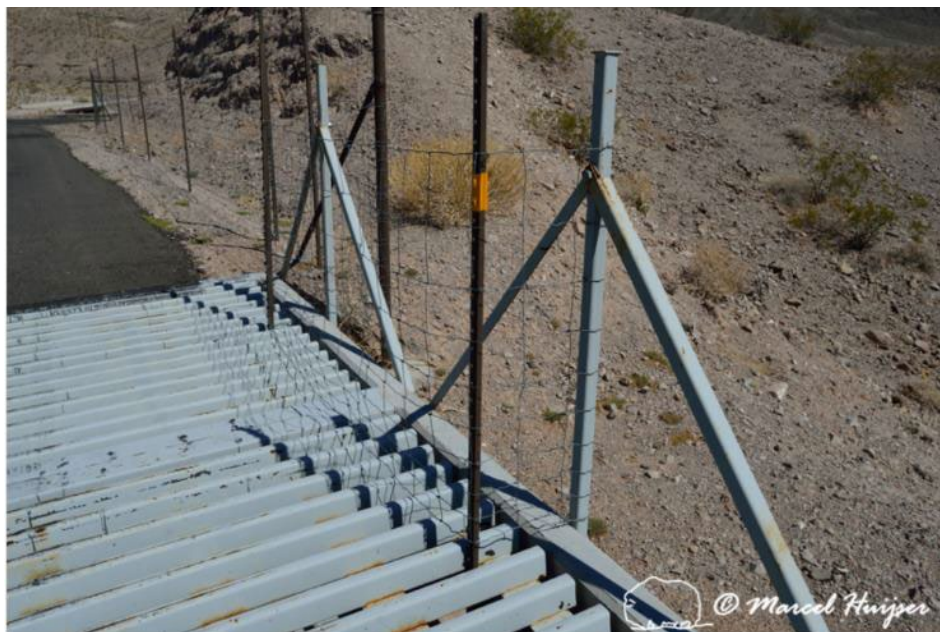
Figure 17. Blocked concrete edge at side of wildlife guard at access road US Hwy 93, Arizona, USA. Some wildlife species will walk on the narrow concrete edge of the wildlife guard to access the fenced road corridor. The concrete edge is part of a wall for the pit under the metal bars. Here the edge is made inaccessible to large mammals through an extra piece of wildlife fence.

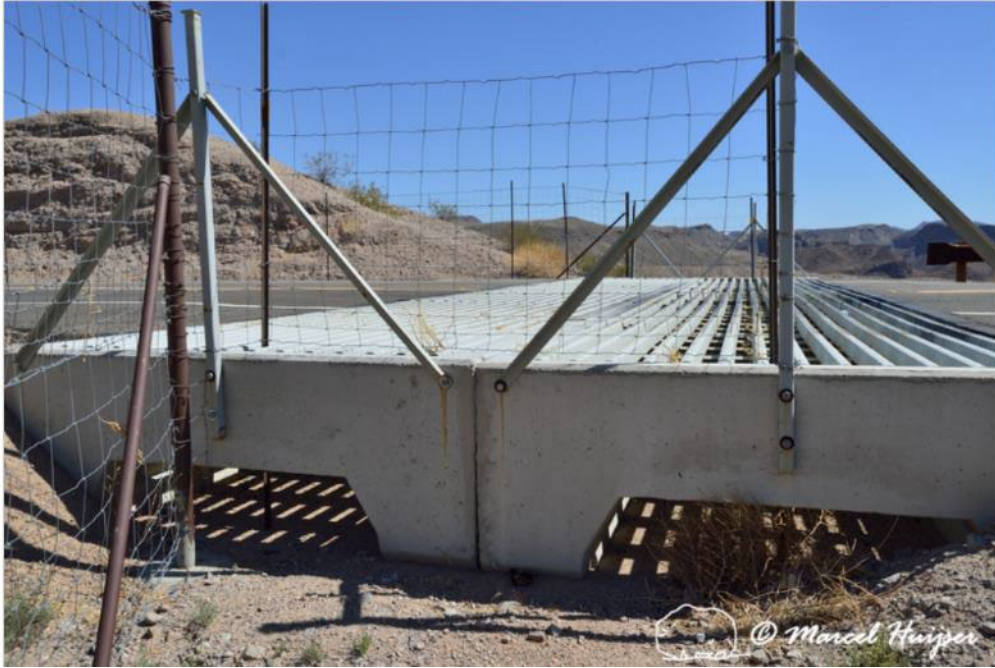
Figure 18. Combined drainage and escape for small animals under wildlife guard, Arizona, USA. The openings on the side allow for drainage under the culvert. The openings also allow invertebrates, amphibians, reptiles, small mammals and other species that may fall in between the metal bars to escape.

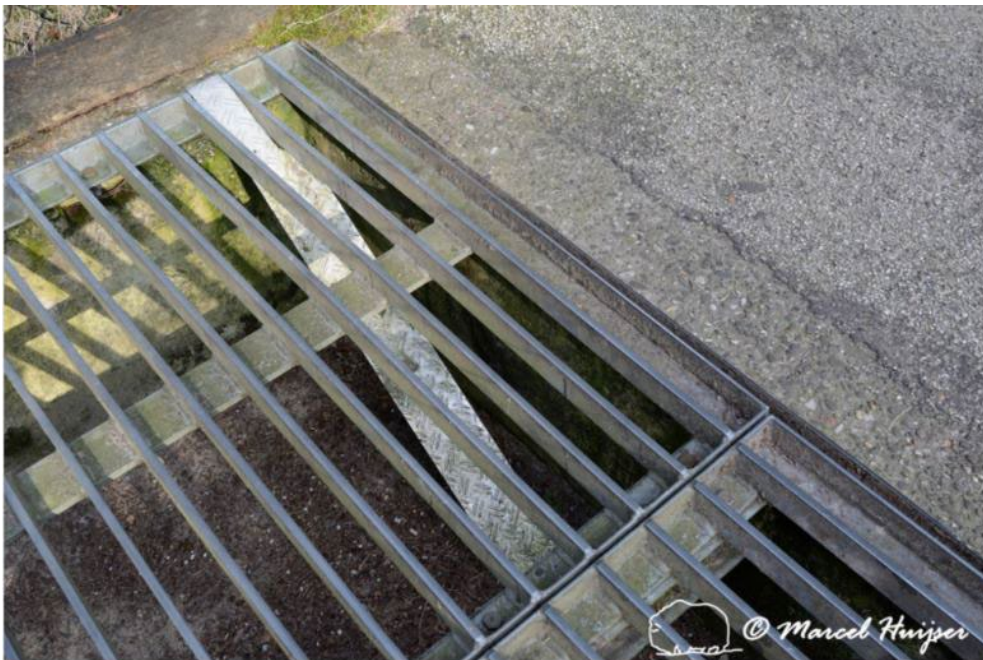
Figure 19. For wildlife guards that have a fully enclosed pit with contiguous walls sometimes wooden planks or metal strips are attached, potentially allowing small animal species to climb out of the pit.

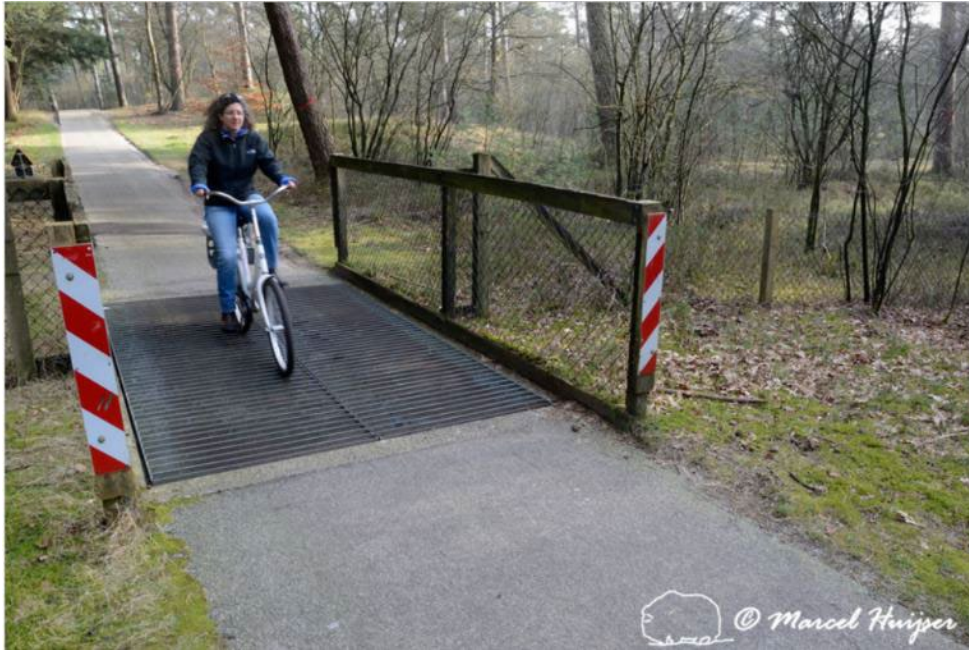
Figure 20. Bicyclist on wildlife guard for wild boar (*Sus scrofa*) and moeflon (*Ovis orientalis*) at a bicycle path, National Park Hoge Veluwe, The Netherlands. This wildlife guard has an escape ramp for small animals that fall into the pit under the metal grate.

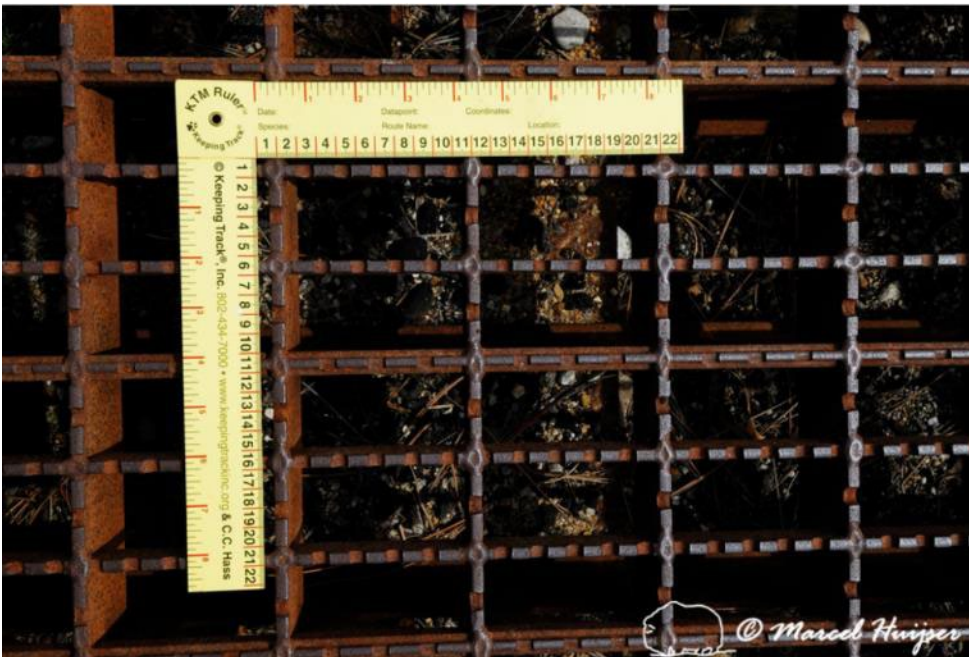
Figure 21. Detail of the modified bridge grate material used for wildlife guards installed at access roads along US Hwy 93, near Ravalli, Montana, USA. This material is more suitable for pedestrians and cyclists compared to the bars of a traditional wildlife guard or cattle guard.

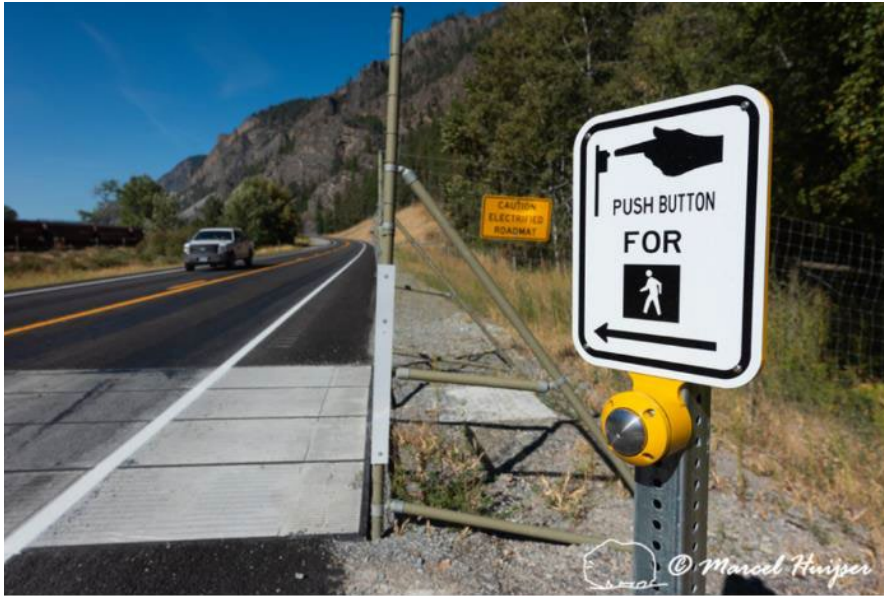
Figure 22. Push button on timer (turns electricity off for 1 minute) for pedestrians at an electrified barrier embedded in travel lanes to keep large mammals, including bighorn sheep, out of fenced road corridor, MT Hwy 200, Thompson Falls, Montana, USA.

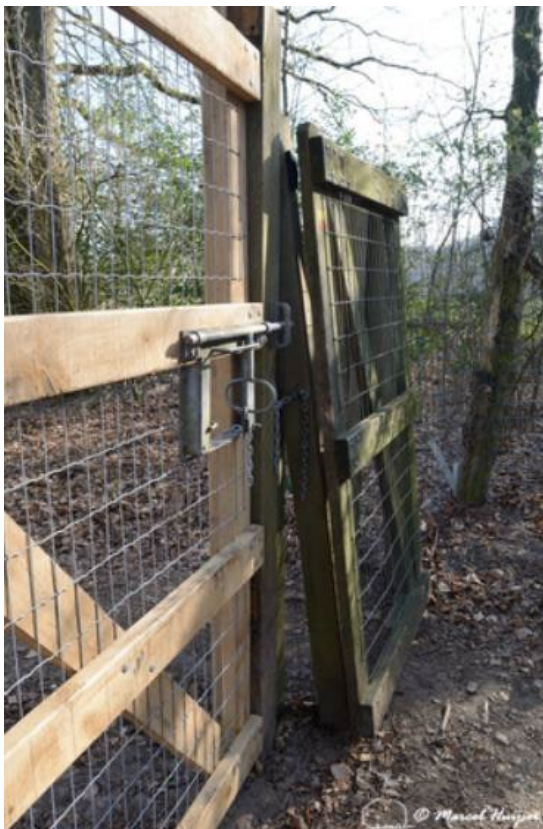
Figure 23. Swing gate at a wildlife fence, set at an angle so it closes through gravity, The Netherlands.

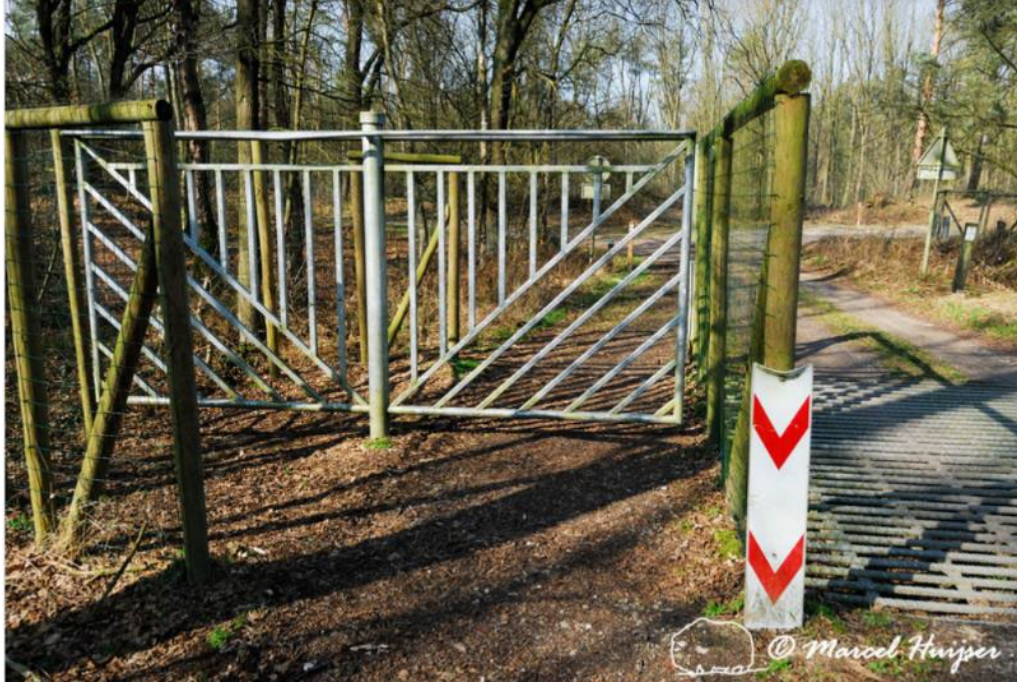
Figure 24. Wildlife guard (right) and horse gate (left), Heugterdijk, Weerterbos, near Maarheeze, The Netherlands. The riders do not have to dismount and can push the rotating gate while in the saddle. The gate is set at an angle so that gravity will bring the rotating fence in line with the main fence.

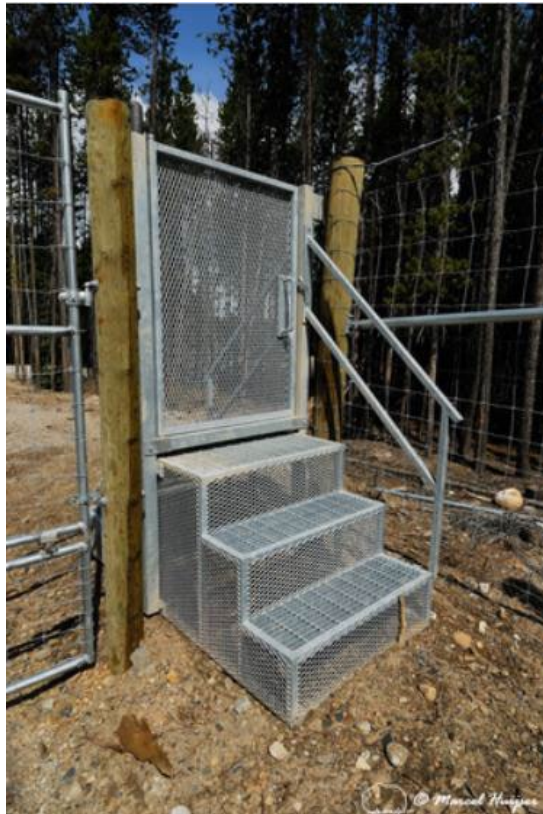
Figure 25. Pedestrian gate with steps (for high snow accumulation) at a wildlife fence, Alberta, Canada.

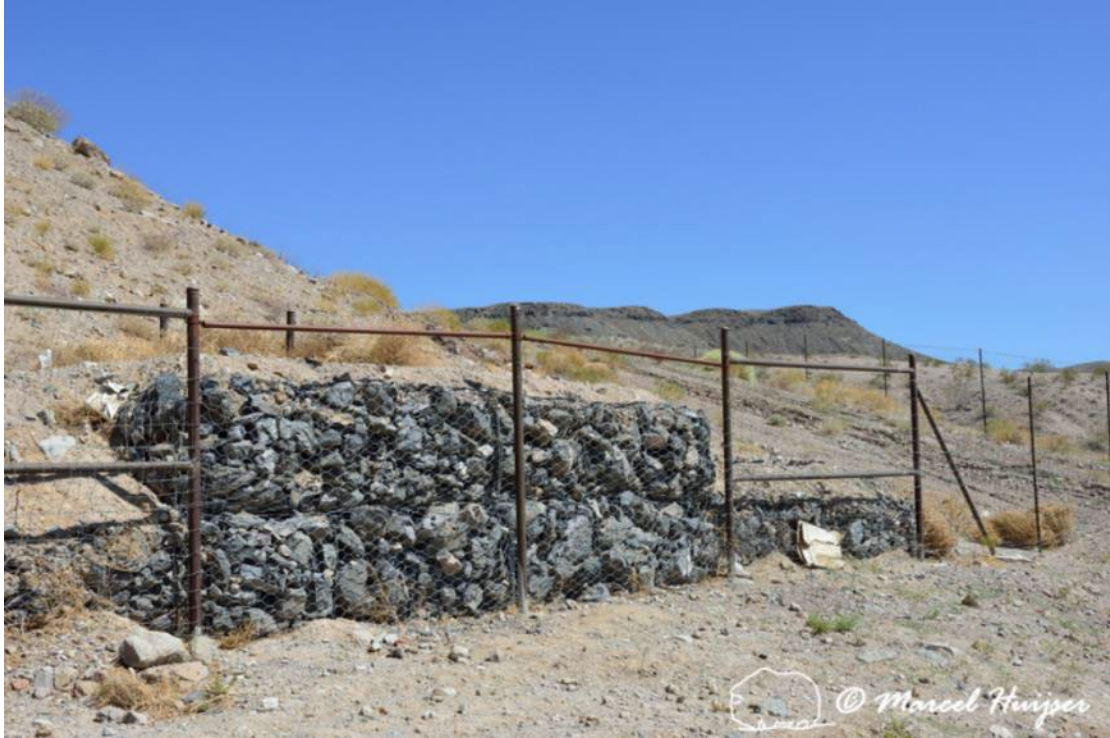
Figure 26. Wildlife jump-out or escape ramp with a rock wall and bar designed for desert bighorn sheep (*Ovis canadensis nelsoni*), US Hwy 93, Arizona, USA. The bar reduces the probability that bighorn sheep will jump up into the fenced road corridor while it does not decrease the probability that the bighorn sheep will jump down to the safe side of the fence. The sheep can crawl under the bar before jumping down.

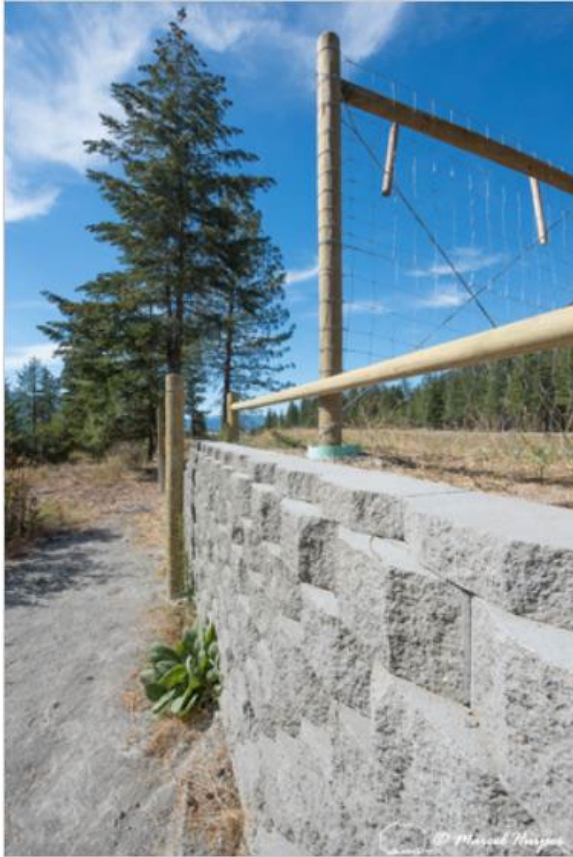
Figure 27. Wildlife jump-out with concrete blocks and a bar for bighorn sheep (*Ovis canadensis*), near Thompson Falls, Montana, USA. Note that it is probably better to not have the concrete blocks protrude as it makes it easier for species to climb the face.

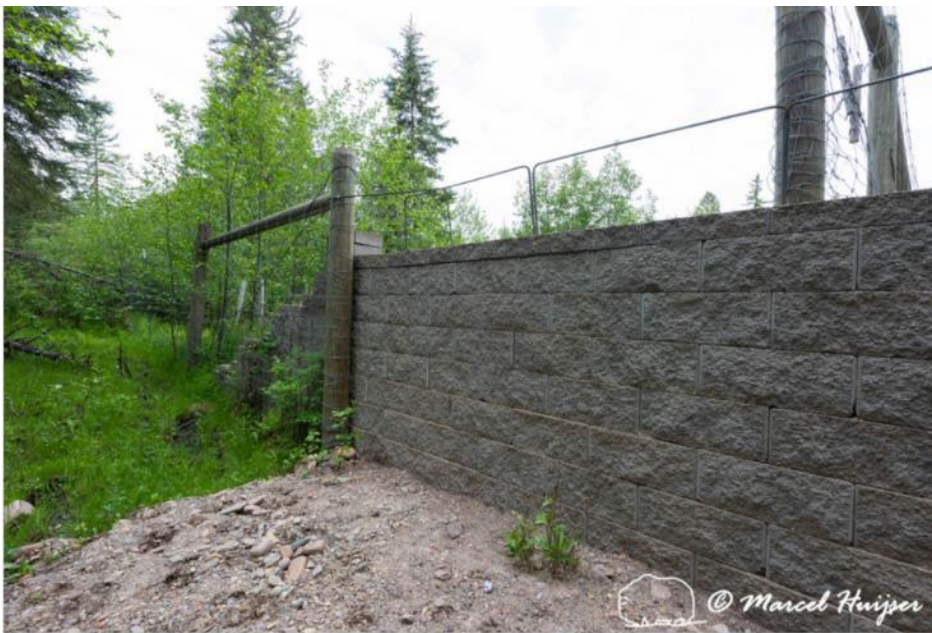
Figure 28. Wildlife jump-out along US Hwy 93, Flathead Indian Reservation, Montana, USA. Jump out is 5 ft tall with rebar on top.

While widely implemented, little is known how well or how poor wildlife jump-outs or escape ramps function. The appropriate height depends on the jumping and climbing capabilities of the target species. Since there is often more than 1 target species, there is no one recommended height. However, jump-outs for deer may need to be around 5 ft high and for elk around 6 ft. A bar on top of the wildlife jump out can help reduce the likelihood that animals will jump into the road corridor. Animals that want to jump down can first step over the bar and take advantage of the low height of the wall of the jump-out. For mule deer, a 5 ft high face of the jump-out, combined with a bar that is 18 inches high above the top of the jump-out, and that has a setback of 15 inches is recommended (Huijser & Getty 2022b). This design resulted in 80.4% of all mule deer that were observed on the top of the jump-out within the fenced right-of-way jumping down to the habitat side of the jump-outs (Figure 28).

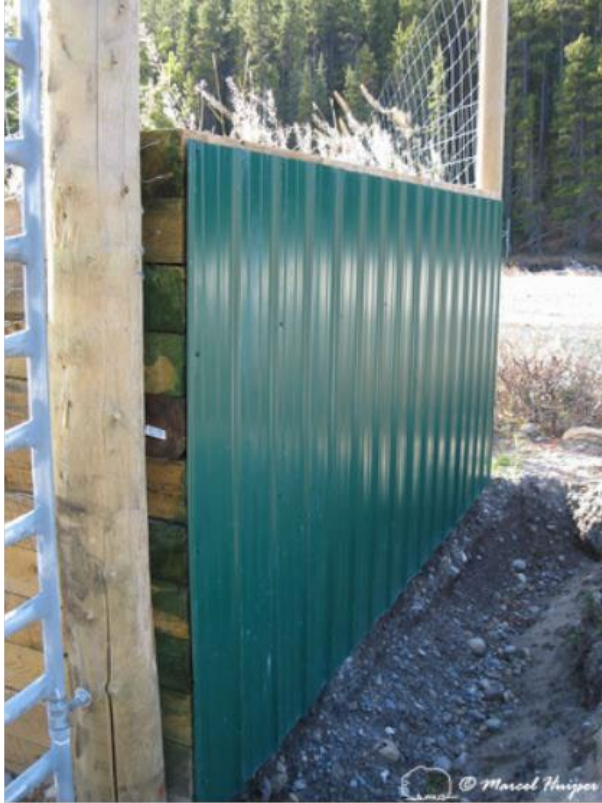
Figure 29. Wildlife jump-out with a smooth metal face to reduce the likelihood that bear will climb the jump-out and end up in fenced right-of-way, Banff National Park, Alberta, Canada.

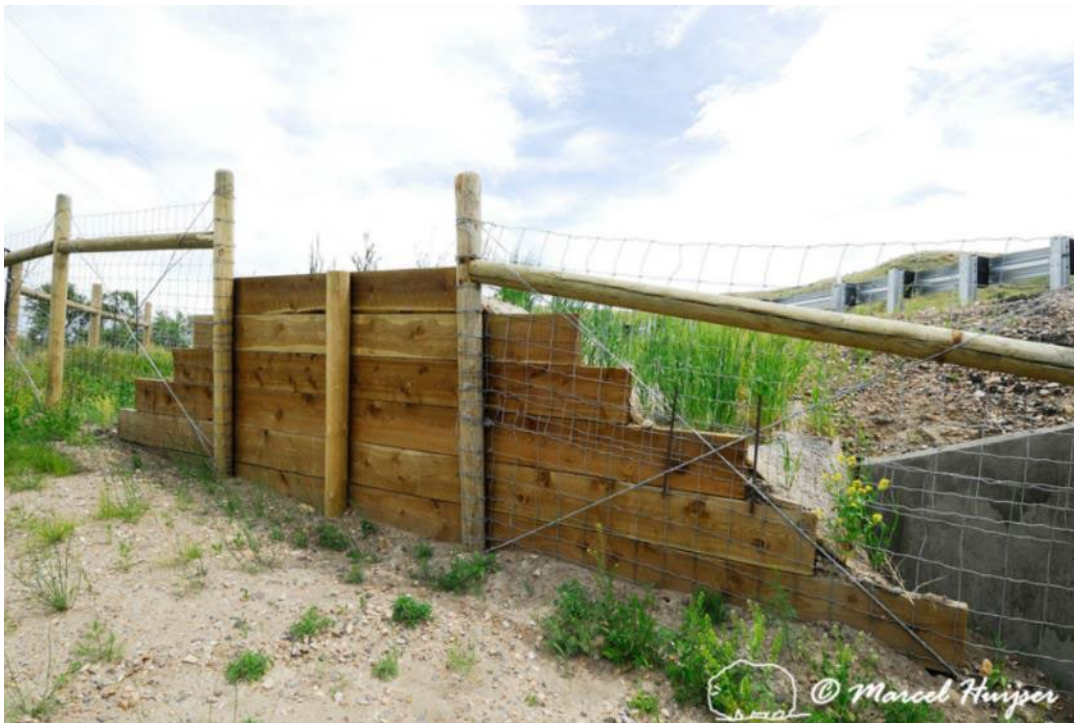
Figure 30. Wildlife fence and jump-out with a face consisting of wooden planks, near Havre, Montana, USA.

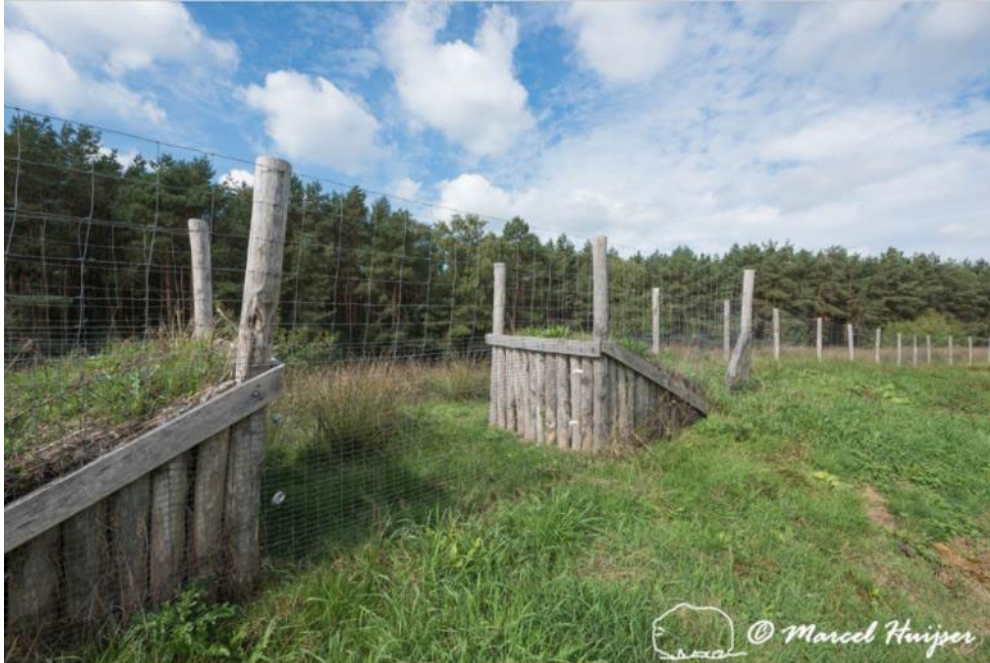
Figure 31. Wildlife fence and jump-out along A28 motorway, near Spier, Drenthe, The Netherlands. The fence is a barrier for medium and large mammal species. The electric fence is an additional barrier for livestock (sheep, cattle) that are used as a tool for nature management in the area.

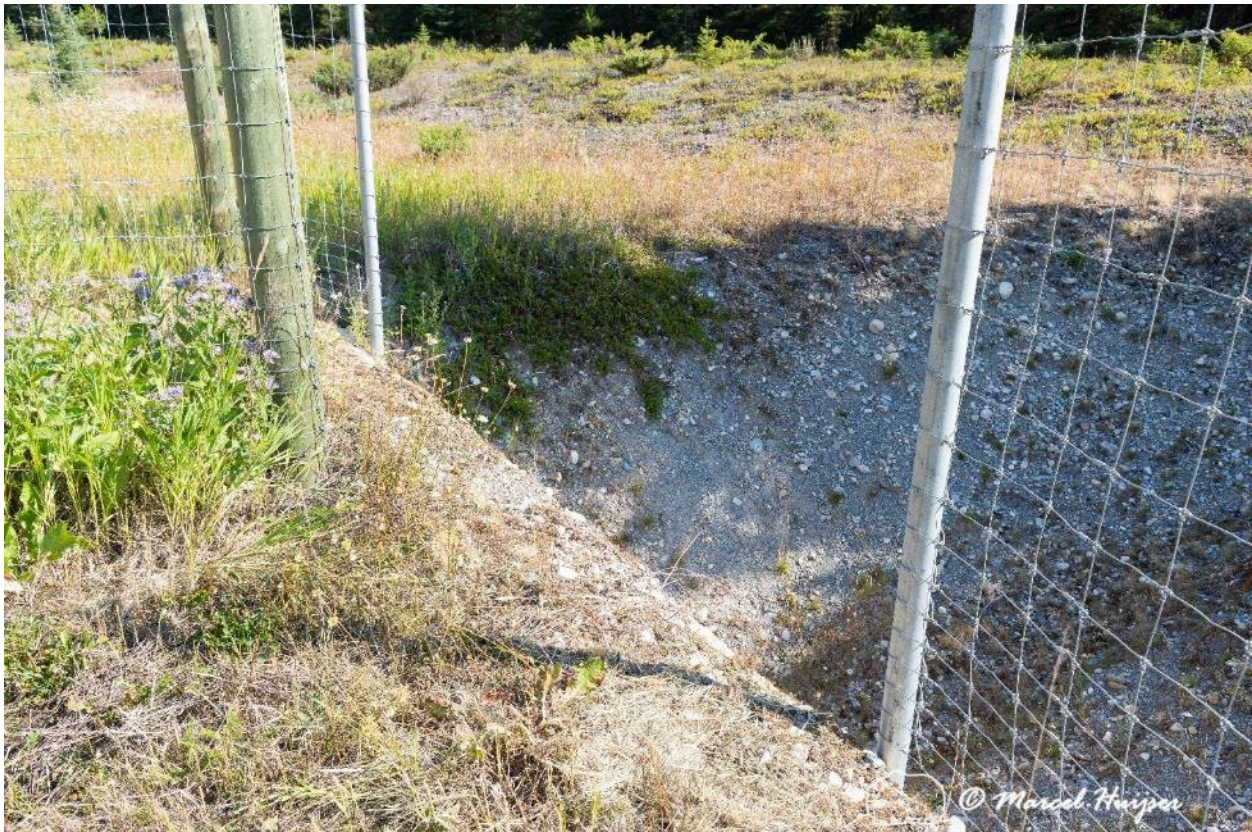
Figure 32. Wildlife fence with jump-out, Kootenai National Park, British Columbia, Canada. The pit is dug on the habitat side of the fence.

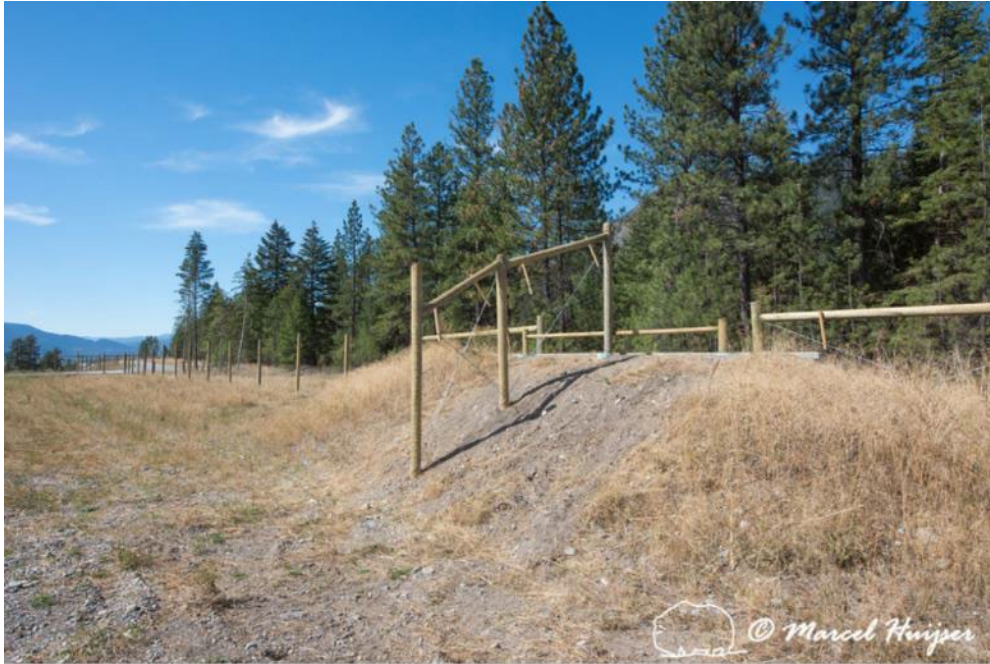
Figure 33. Jump-out for bighorn sheep (*Ovis canadensis*) with a short perpendicular fence, near Thompson Falls, Montana, USA. The potential benefits of the perpendicular fence in guiding wildlife to the jump-out are not known.
