Potential Future Mitigation Measures for Large Wild Mammals, along US Hwy 20, between Burns and Ontario, Oregon

FINAL REPORT

A report prepared for the
Oregon Department of Fish and Wildlife
3814 Clark Boulevard, Ontario, OR 97914

June, 2023

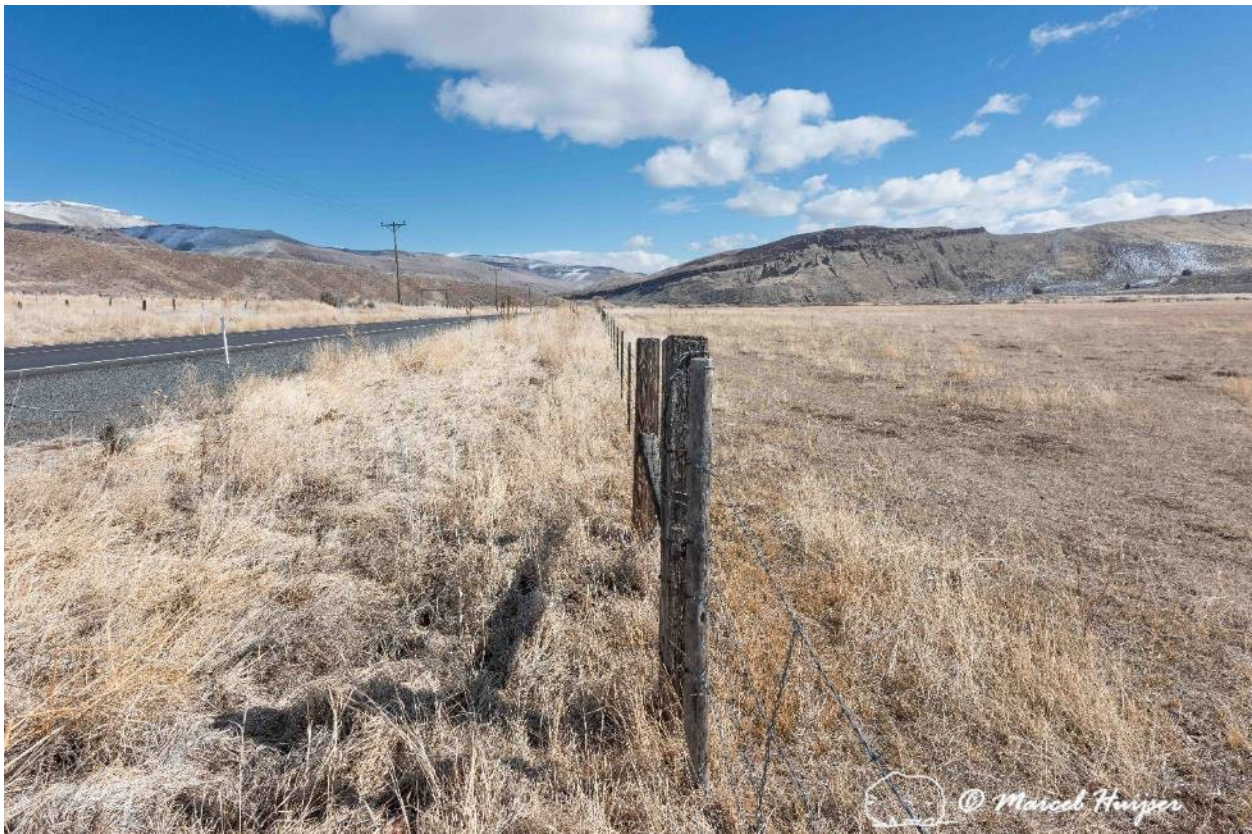
Figure 39. Right-of-way or livestock fence along US Hwy 20 between Juntura and Harper, Oregon.

Some sections of US Hwy 20 have right-of-way or livestock fence (Figure 39). From a technical perspective, these fences could be replaced with wildlife fences. Other road sections have no right-of-way or livestock fence, and there is sometimes little room between the road and the river (Figure 40). Erosion may occur during floods, and if the flood levels reach the fence, debris may be caught in the fence, further jeopardizing the stability of the potential future barrier.

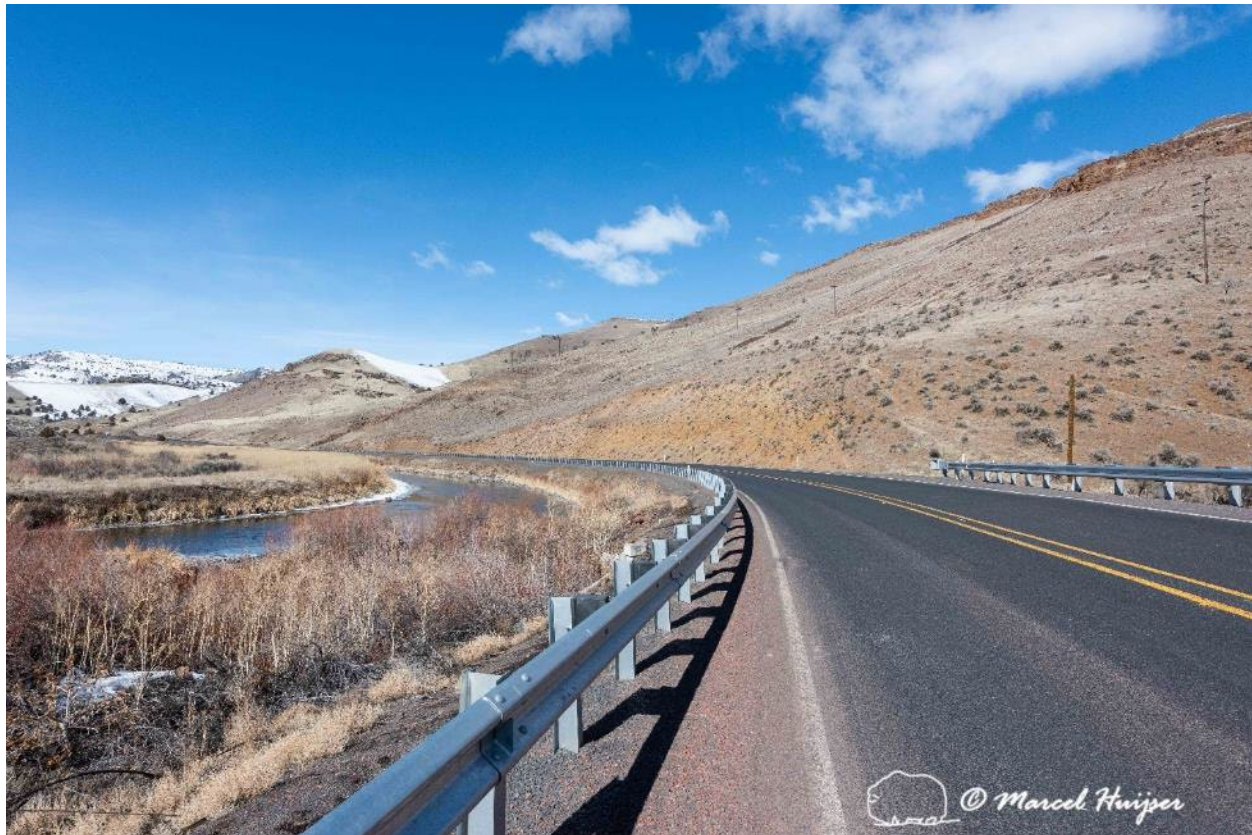
Figure 40. There is little space for a wildlife fence between the Malheur River and US Hwy 20, and floods may jeopardize the stability of the fence.

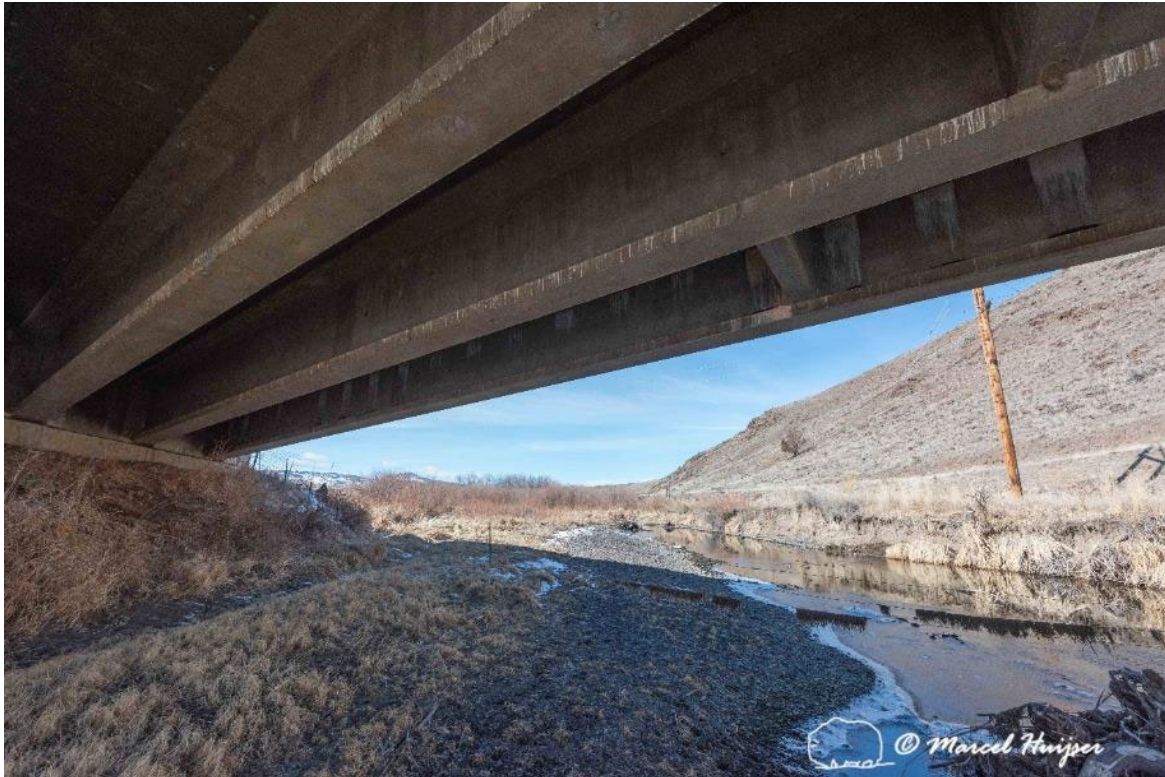
Figure 41. This bridge is sufficiently wide and high for mule deer, it has a good line-of-sight through the structure, and there is enough dry and flat terrain for them to travel under the bridge, at least in winter.

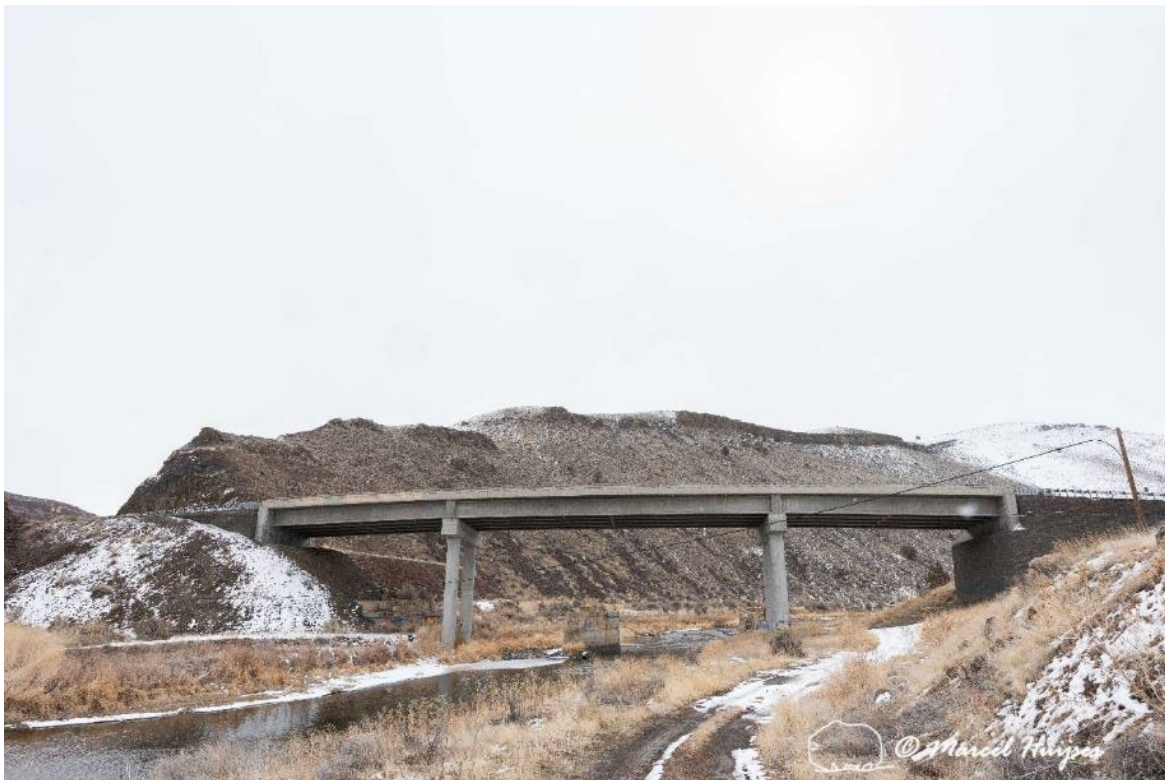
Figure 42. This bridge is sufficiently wide and high for mule deer, it has a good line-of-sight through the structure, and there is enough dry and flat terrain for them to travel under the bridge, at least in winter.

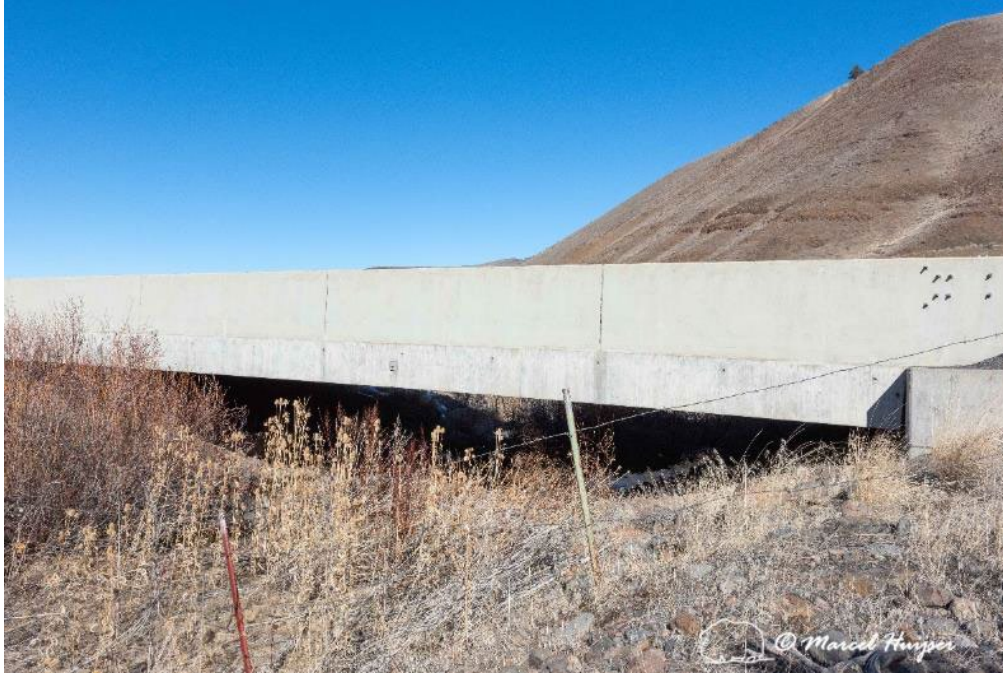
Figure 43. A right-of-way or livestock fence hinders access to the structure for large wild mammals. If this fence is still needed, consider replacing it with a wildlife friendly livestock fence.

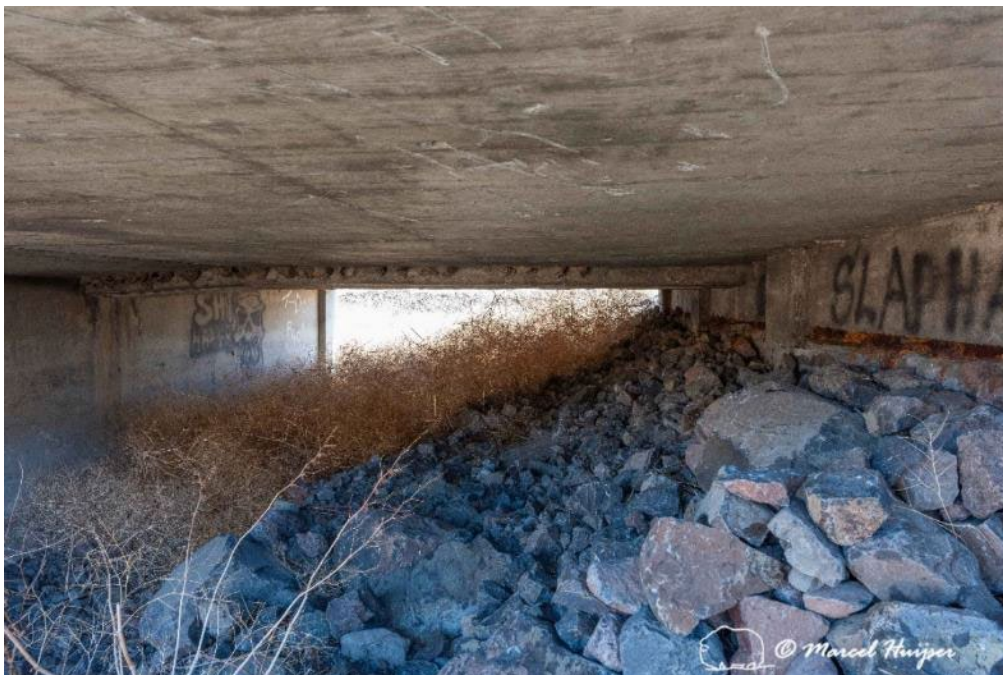
Figure 44. Riprap (large rocks and boulders) and tumble weed that has accumulated inside a structure or on its approaches can be a physical barrier to mule deer and other large ungulates.

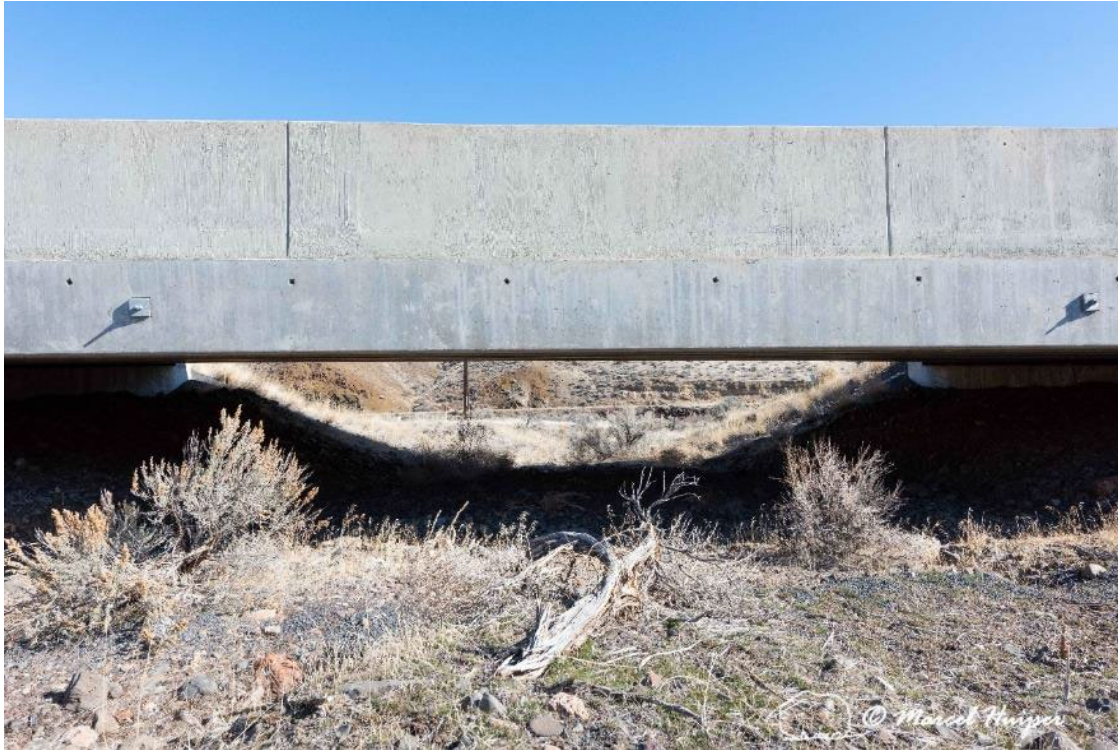
Figure 45. Low clearance (height) of a structure likely impacts use by large wild mammals, including deer.

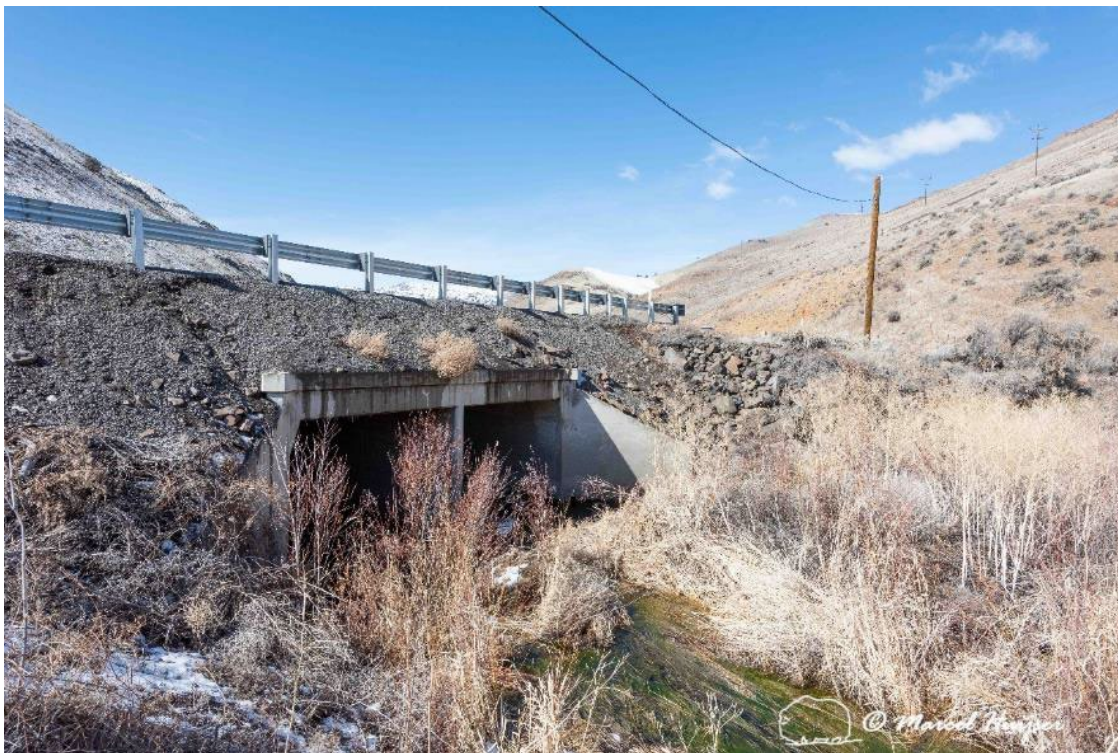
Figure 46. A double box culvert like this one is likely too small for mule deer (width and height).

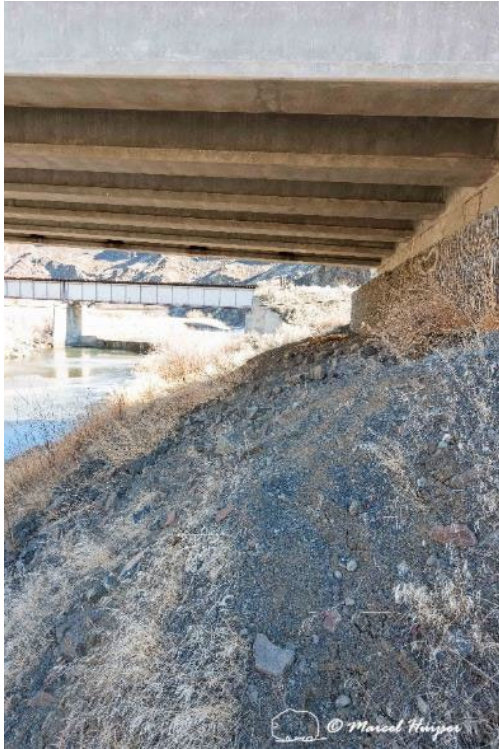
Figure 47. A steep slope can reduce use by large wild mammals.

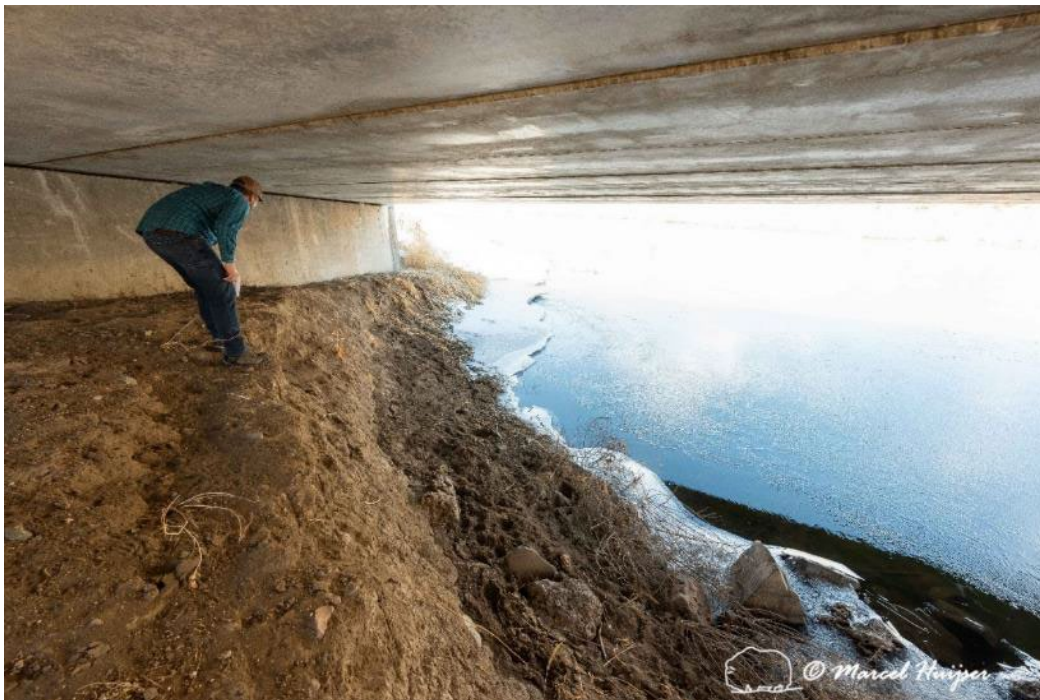
Figure 48. An eroded slope can reduce use of an underpass by large wild mammals.

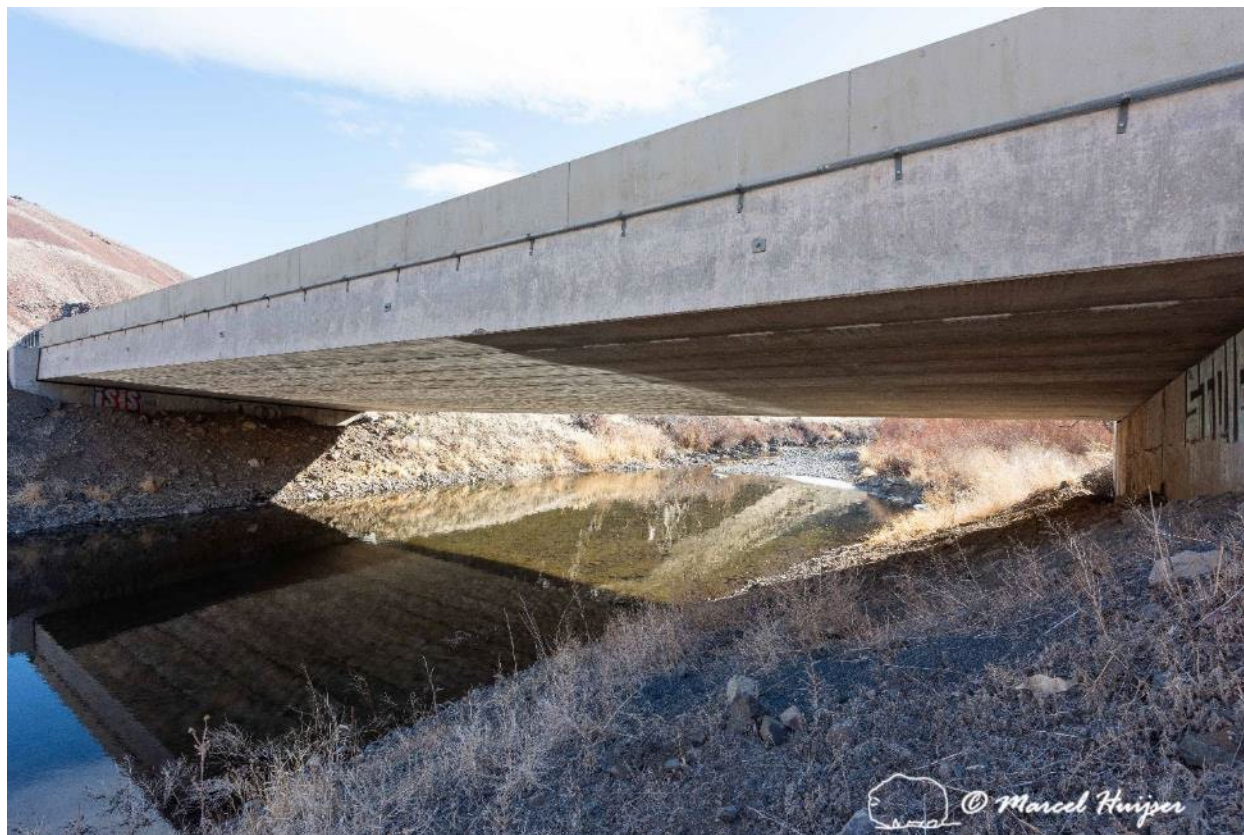
Figure 49. An open structure with a clear line-of-sight towards the other side of the road is recommended. Note that this structure would still benefit from a dry flat path with sand or gravel.

An open structure, e.g. an over-span bridge, with a clear line-of-sight to the other side of the road is recommended (Figure 49). If there are supports for the structure, consider pillars (Figure 50) rather than walls (Figure 51) as pillars allow for better visibility inside the structure and also towards the other side of the road.

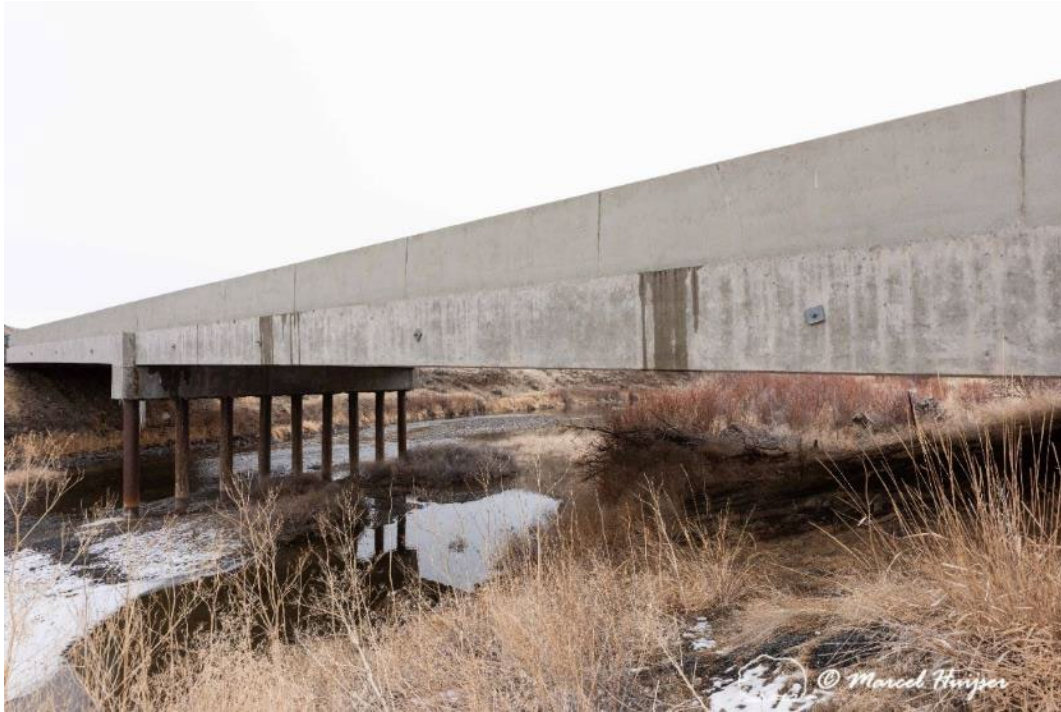
Figure 50. A structure with pillars can still allow for visibility under the bridge and a good line-of-sight towards the other side of the road. Note that this structure would still benefit from a dry flat path with sand or gravel with sufficient clearance (height).

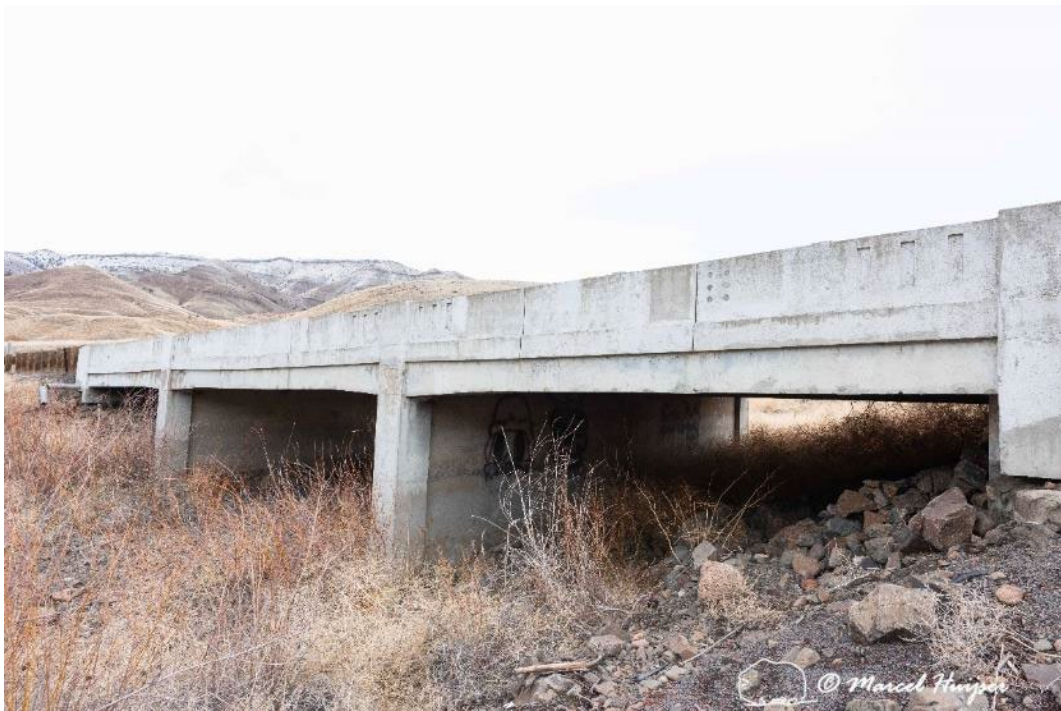
Figure 51. A structure with walls typically hinders visibility under the bridge and hinders a good line-of-sight towards the other side of the road.

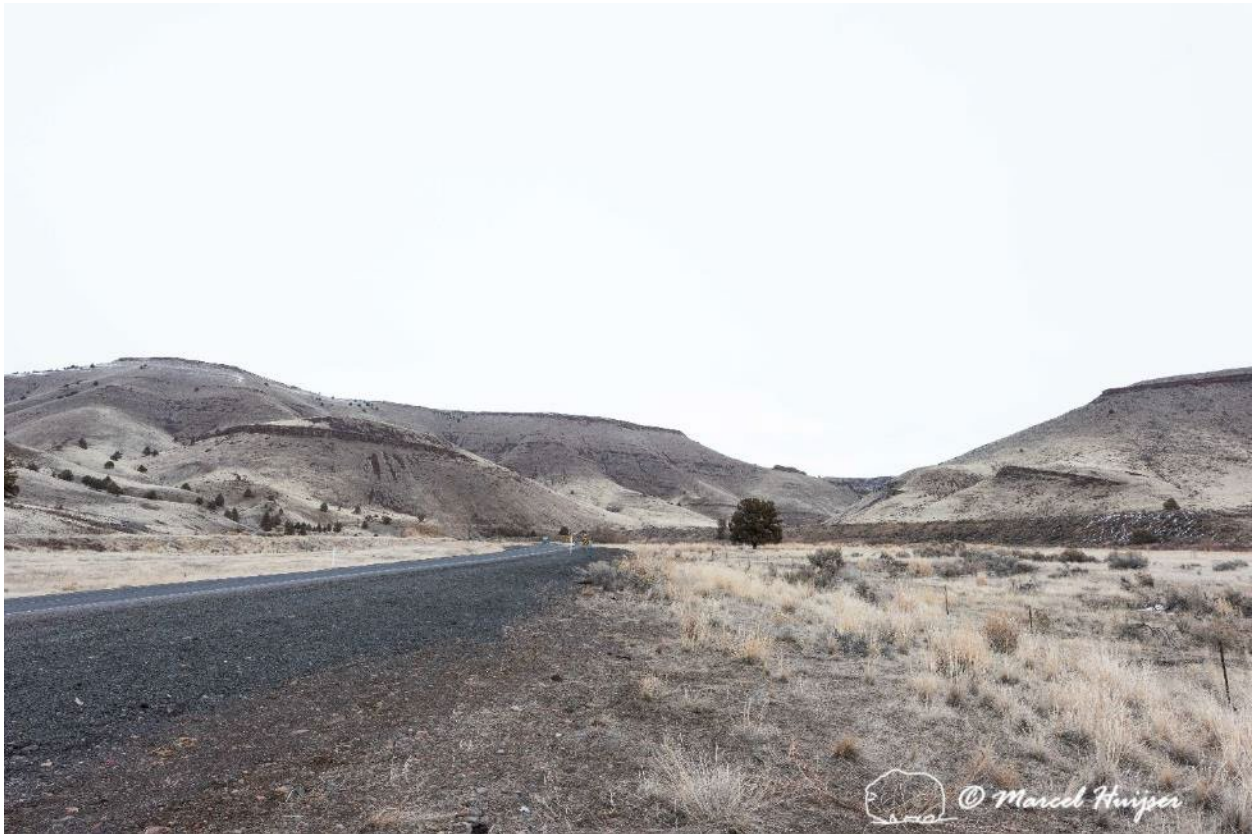
Figure 52. It is likely difficult to construct an underpass in flat terrain, especially near a river where the ground water table may be high. Raising the roadbed for hundreds of meters on each side of the underpass is a potential solution.

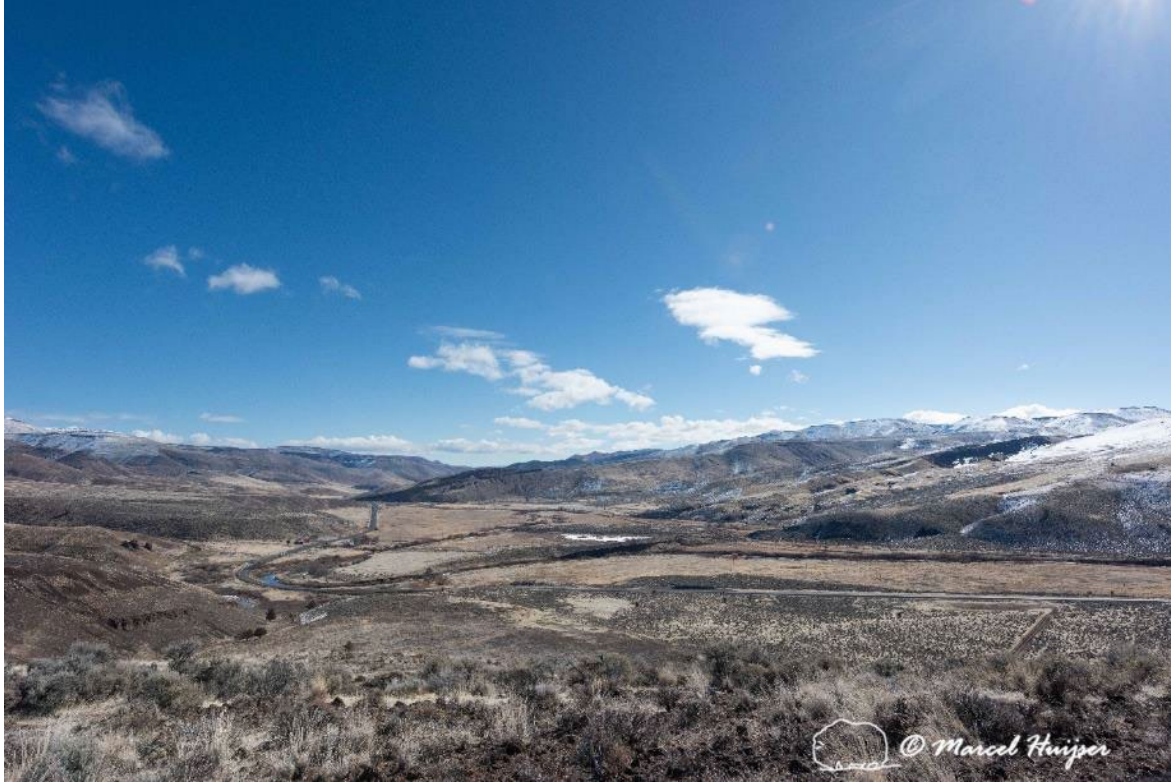
Figure 53. The flat areas along the Malheur River at the Denny Jones Ranch, Malheur River Mitigation Site, managed by the Burns Paiute Tribe, is a site that may attract both elk and pronghorn, and one may consider an overpass in this location.

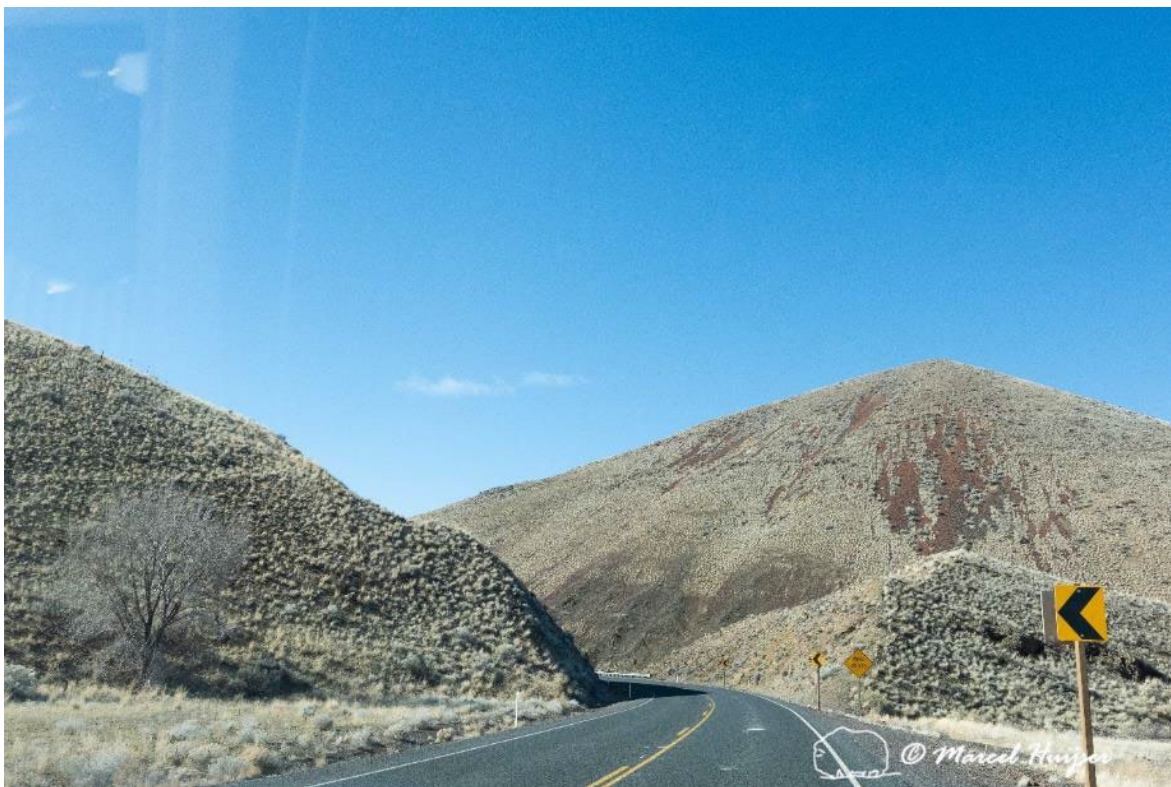
Figure 54. A roadcut may be a convenient location for a wildlife overpass.
