**HIGHWAYS AND DIRT ROADS AROUND
ITIRAPINA AND BROTAS, SÃO PAULO, BRAZIL**

**FINDINGS AND RECOMMENDATIONS BASED
ON A ROAD ECOLOGY EXCURSION OF THE
ESCOLA SUPERIOR DE AGRICULTURA LUIZ DE
QUIROZ (ESALQ), UNIVERSITY OF SÃO PAULO,
PIRACICABA, BRAZIL**

Dr. Marcel P. Huijser,
Western Transportation Institute – Montana State University
PO Box 174250, Bozeman, MT 59717-4250, USA

August 2015

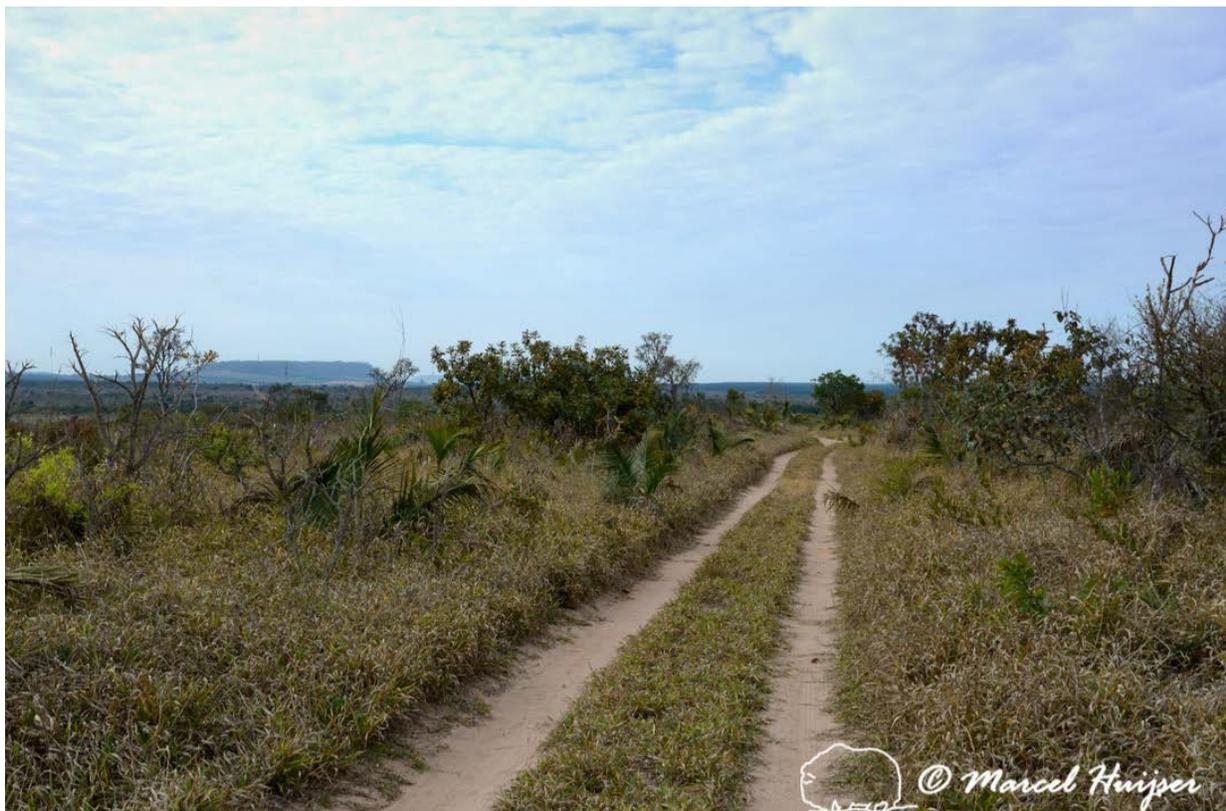
Figure 1: A typical dirt road in the Itirapina Ecological Research Station.

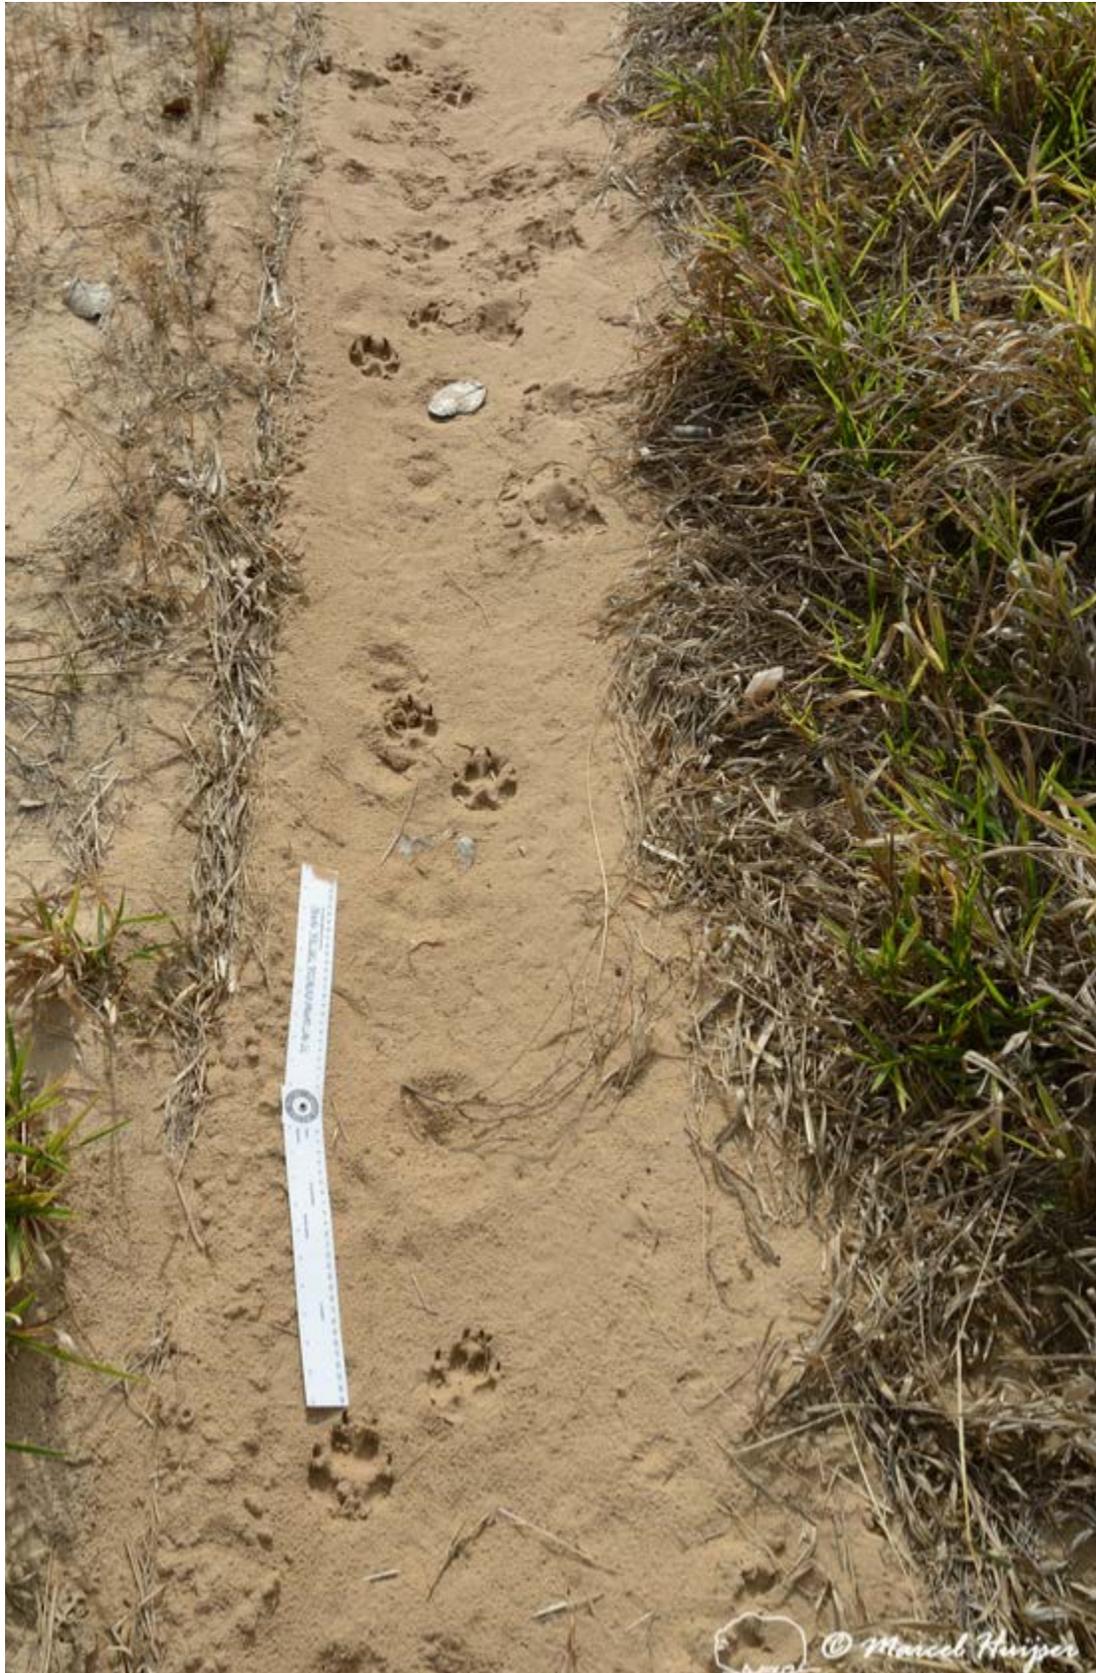
Figure 2: Tracks of a maned wolf on a dirt road in the Itirapina Ecological Research Station.

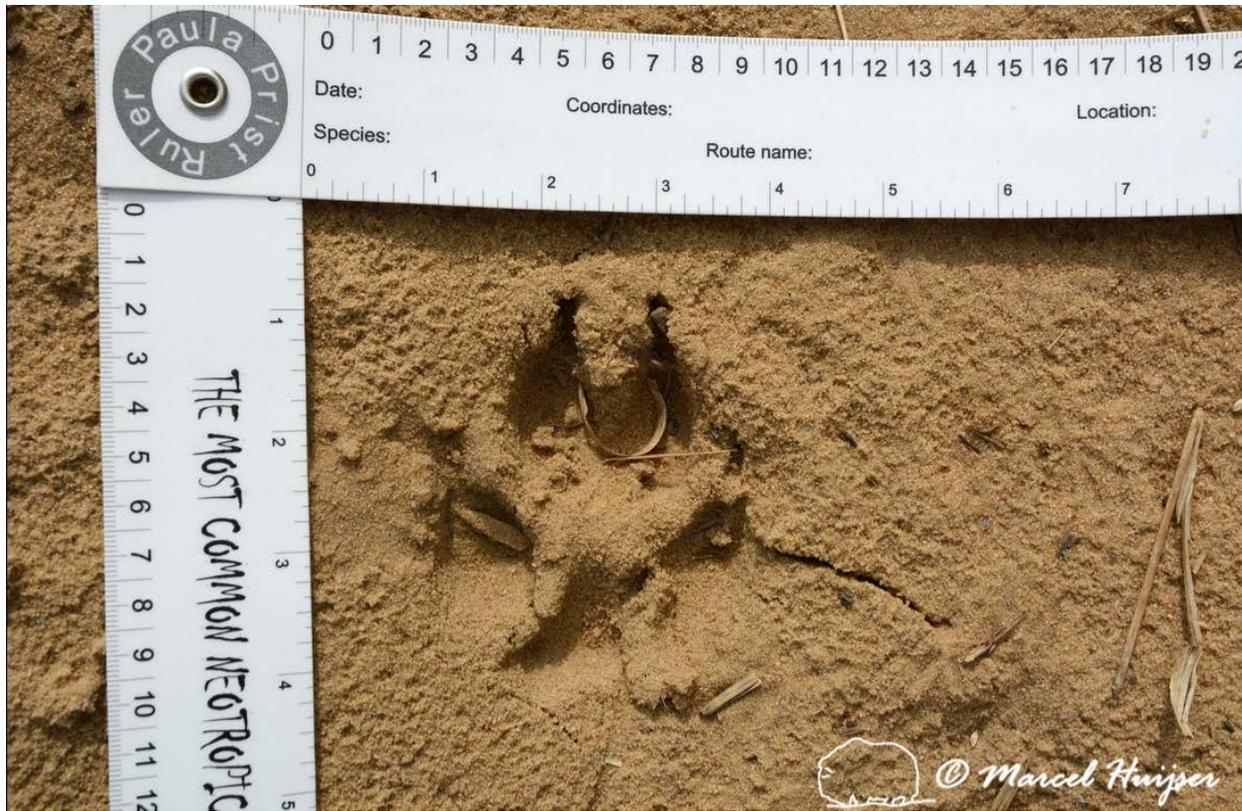
Figure 3: Close-up of a footprint of a maned wolf on a dirt road in the Itirapina Ecological Research Station.

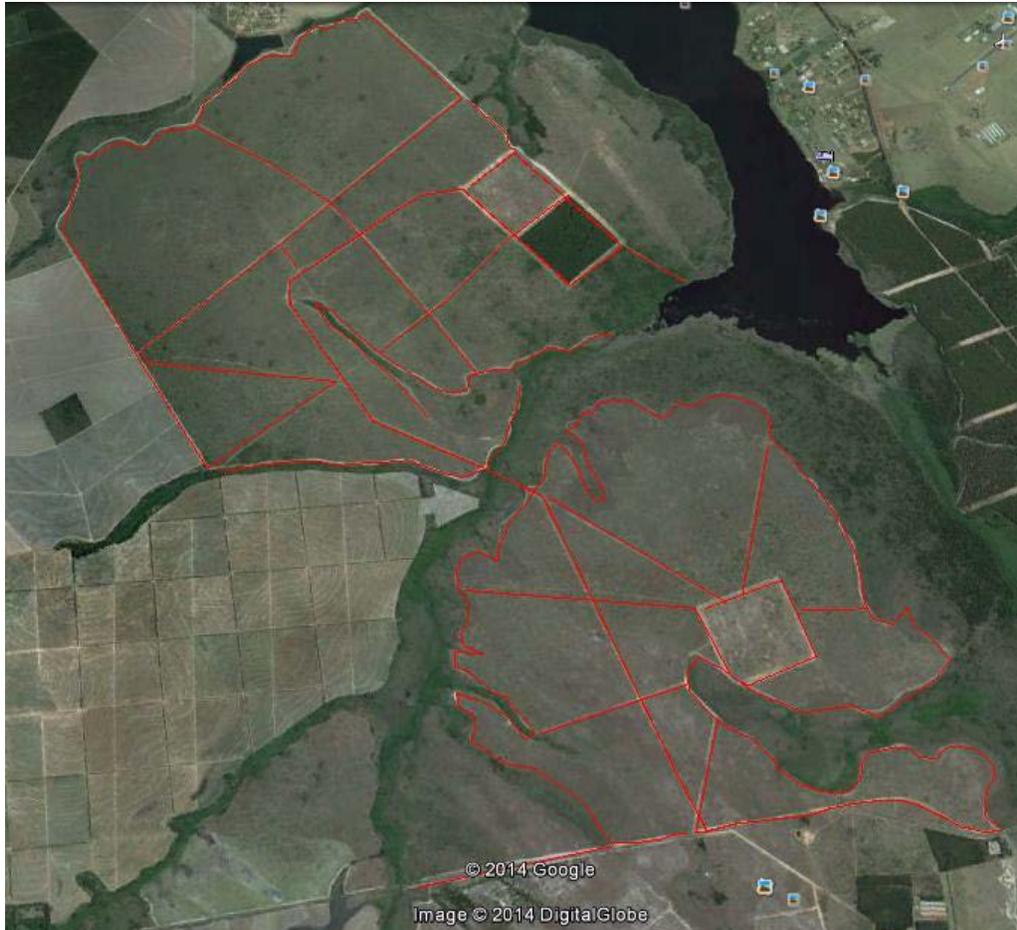
The Itirapina reserve has many dirt roads and fire breaks throughout the area (Figure 5). The average width of the dirt roads was about 3.3 m (Unpublished data, Bruna G. Oliveira, road ecology student, ESALQ).

Figure 5: Dirt roads and fire breaks (in red) in the Itirapina reserve (Source: Bruna G. Oliveira, road ecology student, ESALQ).

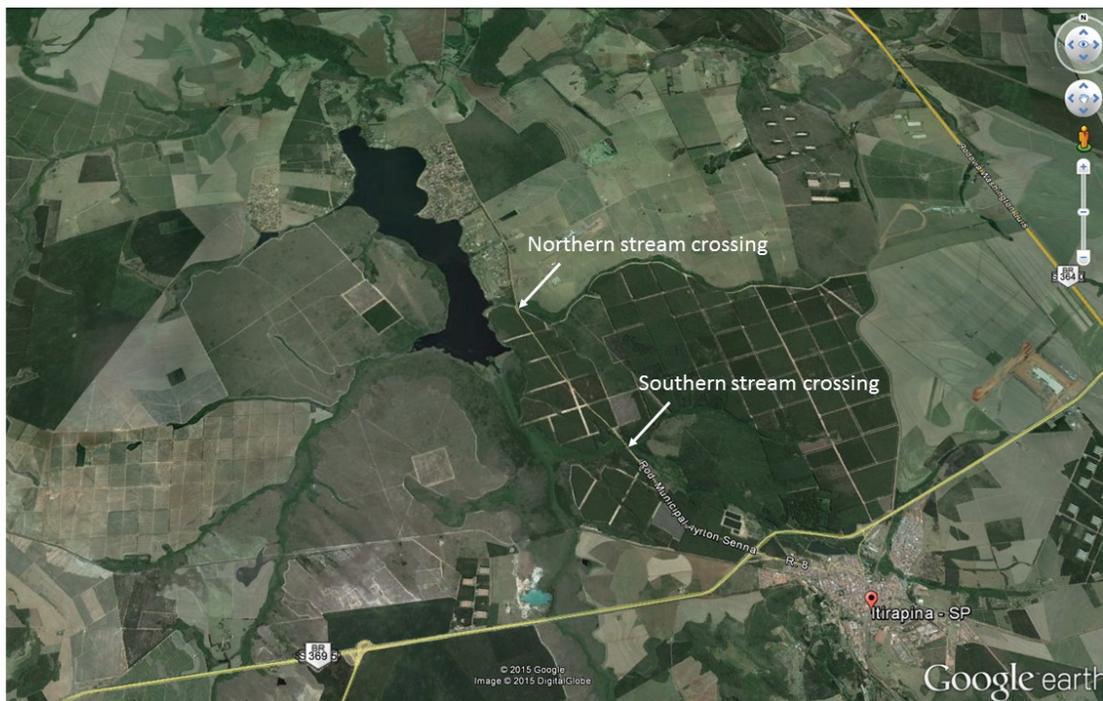
Figure 6: The two lane road (Rod. Municipal Ayrton Senna) bisects the Itirapina reserve and forest plantations.

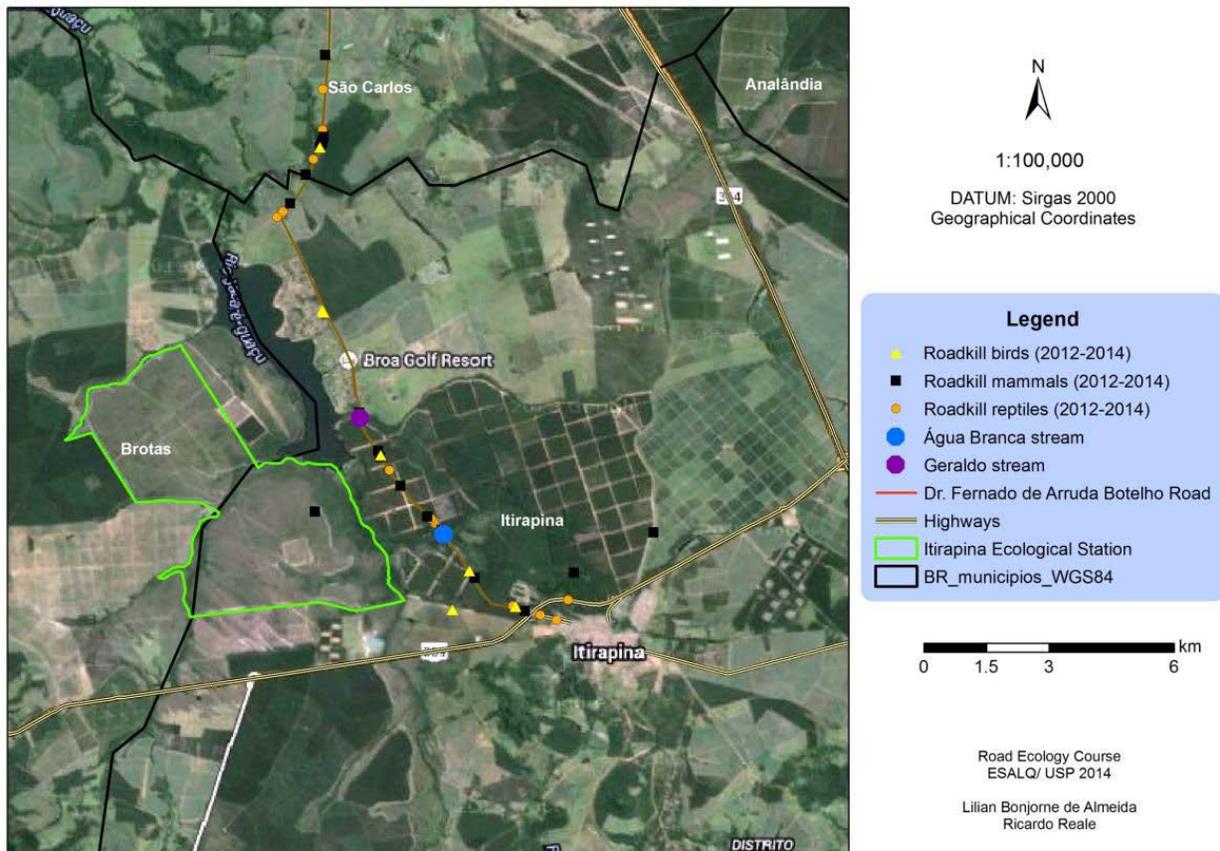
Road-killed animals were mostly located along the section through the forest plantations (Figure 7). The road-killed animals (grouped in reptiles, birds, and mammals) were not particularly concentrated around the two stream crossings (blue and the purple dots). However, capybara (*Hydrochoerus hydrochaeris*) and coypu (*Myocastor coypus*) have been hit by vehicles at or immediately near the creek crossings. One collision with capybara resulted in a human fatality at the northern stream crossing (Figure 8). The data suggest that wildlife-vehicle collisions in general, including with maned wolf (*Chrysocyon brachyurus*), occur throughout the area with forest plantations, but that collisions with semi-aquatic mammals such as capybara occur especially at or near stream crossings. Traffic volume is estimated to be a few thousand vehicles per day, and while the posted speed limit is 80 km/h vehicles often drive around 100 km/h (Pers. Comm. Paulo Ruffino, Itirapina Ecological Research Station (Estação Ecológica de Itirapina)).

Figure 7: The distribution of road-killed reptiles, birds, and mammals along the two lane road (Rod. Municipal Ayrton Senna) that bisects the Itirapina reserve and forest plantations (Unpublished data. Lilian Bonjorne de Almeida and Ricardo Reale, road ecology students ESALQ).

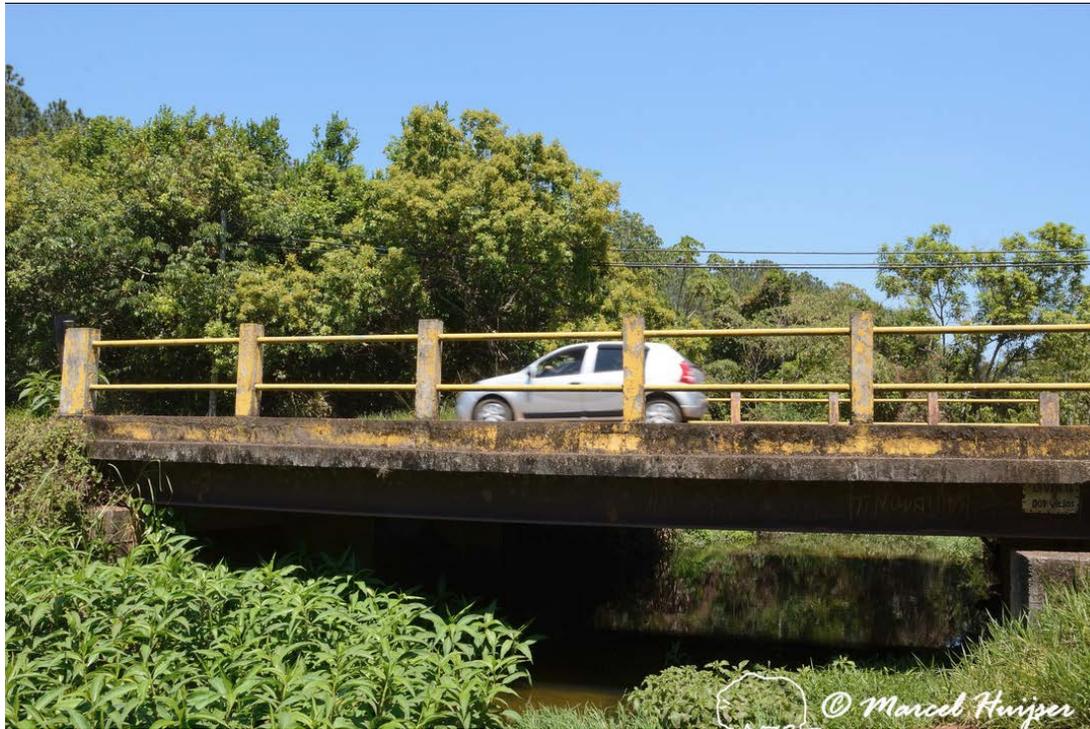
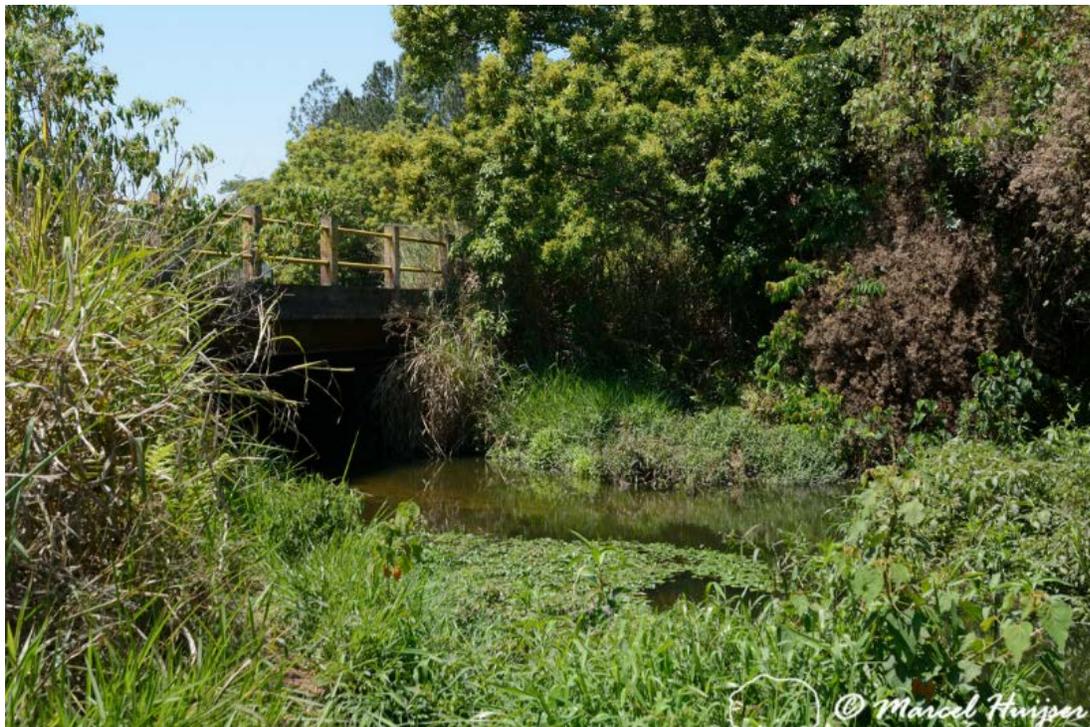
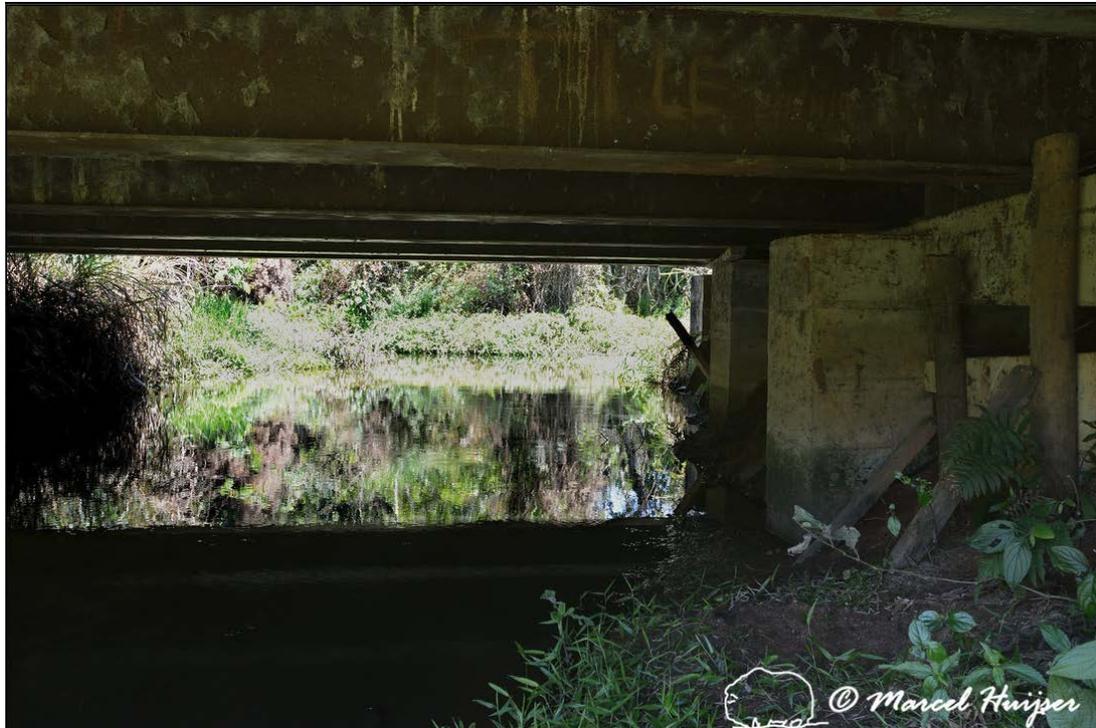
There is one existing bridge (southern stream crossing) and one existing culvert (northern stream crossing) (Figure 6, 9-12). The bridge (southern stream crossing) allows for more or less similar stream characteristics under the bridge as upstream and downstream. However, there is not really suitable habitat for semi-aquatic species, and certainly not for terrestrial species. In addition, the height of the bridge is likely too low for large mammals (Figures 9-11). Furthermore, there is no wildlife fencing that would keep the animals from entering the road and that would guide them towards the structure.

Figure 9: Bridge across the southern stream crossing (Córrego água Branca), Itirapina Ecological Reserve, São Paulo, Brazil.

Figure 10: Bridge across the southern stream crossing (Córrego água Branca), Itirapina Ecological Reserve, São Paulo, Brazil.

Figure 11: Bridge across the southern stream crossing (Córrego água Branca), Itirapina Ecological Reserve, São Paulo, Brazil.

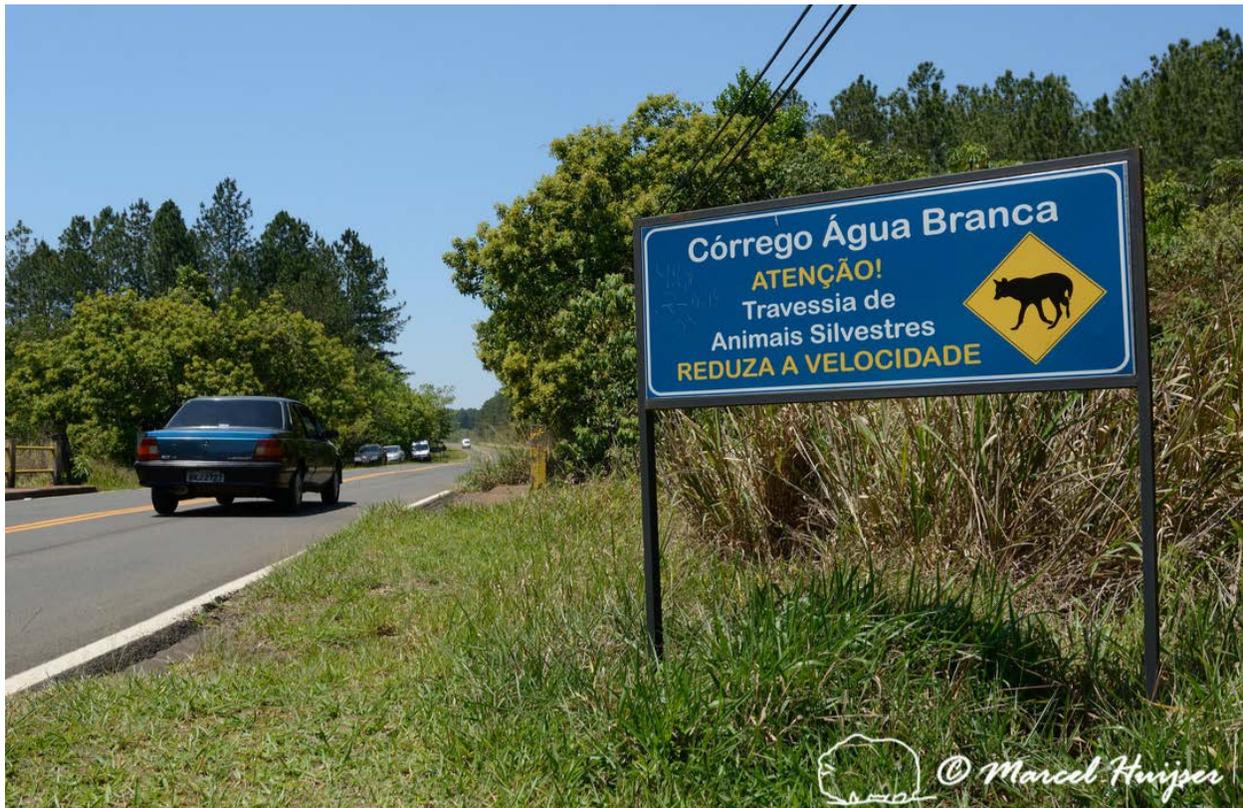
Standard and enhanced wildlife warning signs – similar to the signs that have already been installed at the southern stream crossing (Figure 14) – are often used in an attempt to reduce vehicle speed and/or increase the attention of drivers so that fewer wildlife-vehicle collisions occur. In many cases there is also an attempt to lower vehicle speed in sensitive areas through lowering the posted speed limit and traffic calming measures at selected locations (e.g. speed bumps, radar). However, standard and enhanced wildlife warning signs do not reduce wildlife-vehicle collisions, and traffic calming measures such as speed bumps and radar only result in lower vehicle speeds at those exact locations and not at other location. In addition, traffic calming measures may not be an appropriate measure for through roads to begin with (see e.g. Huijser & Ferraz, 2015).

Figure 14: Wildlife warning sign picturing for maned wolf at the southern stream crossing under two lane road, Itirapina Ecological Station, São Paulo, Brazil.

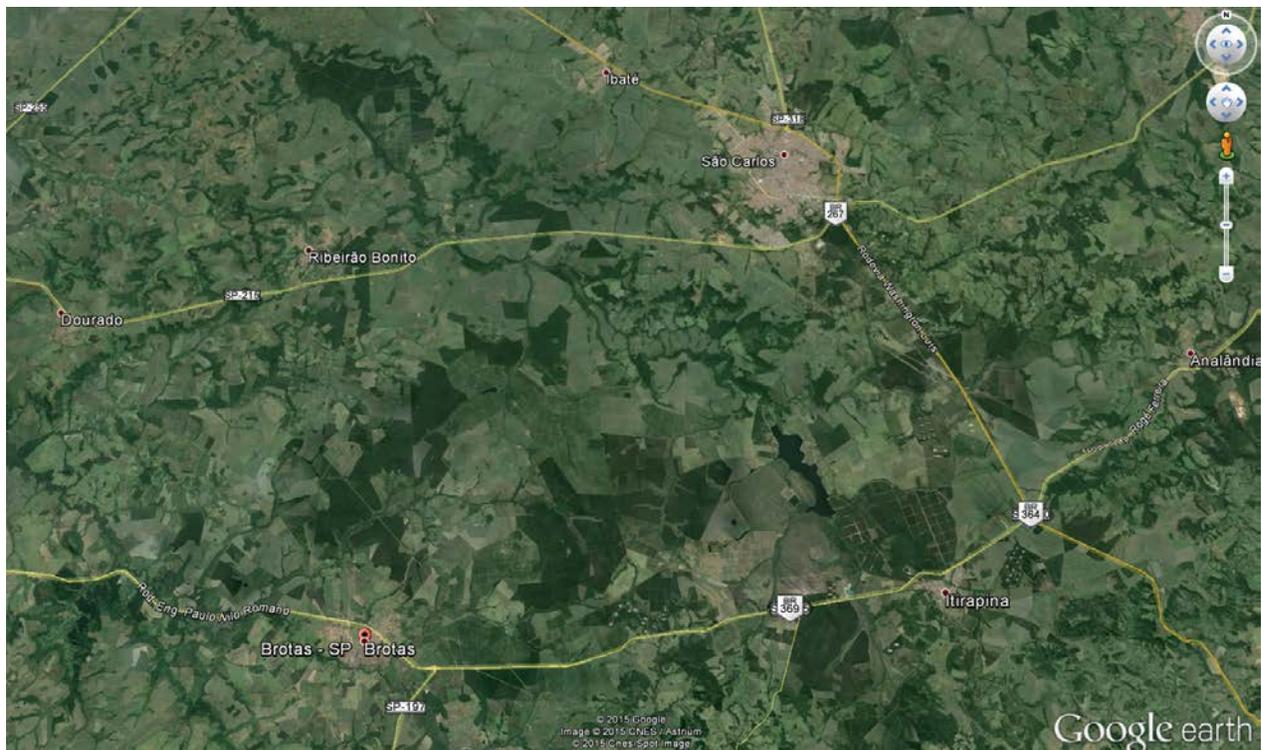
The SP 225 highway between Brotas and Itirapina (Figure 15) was upgraded from a two-lane road to a four-lane road in 2006-2007. There are a number of concrete box culverts and culverts for wildlife, livestock, and also a tall bridge across the Rio Jacaré-Pepira, just west of Brotas (Abra, 2012). Some sections have wildlife fencing installed to reduce wildlife-vehicle collisions, especially with large mammals, and to guide wildlife to the safe crossing opportunities.

Figure 15: The four-lane motorway between Brotas and Itirapina, São Paulo, Brazil.

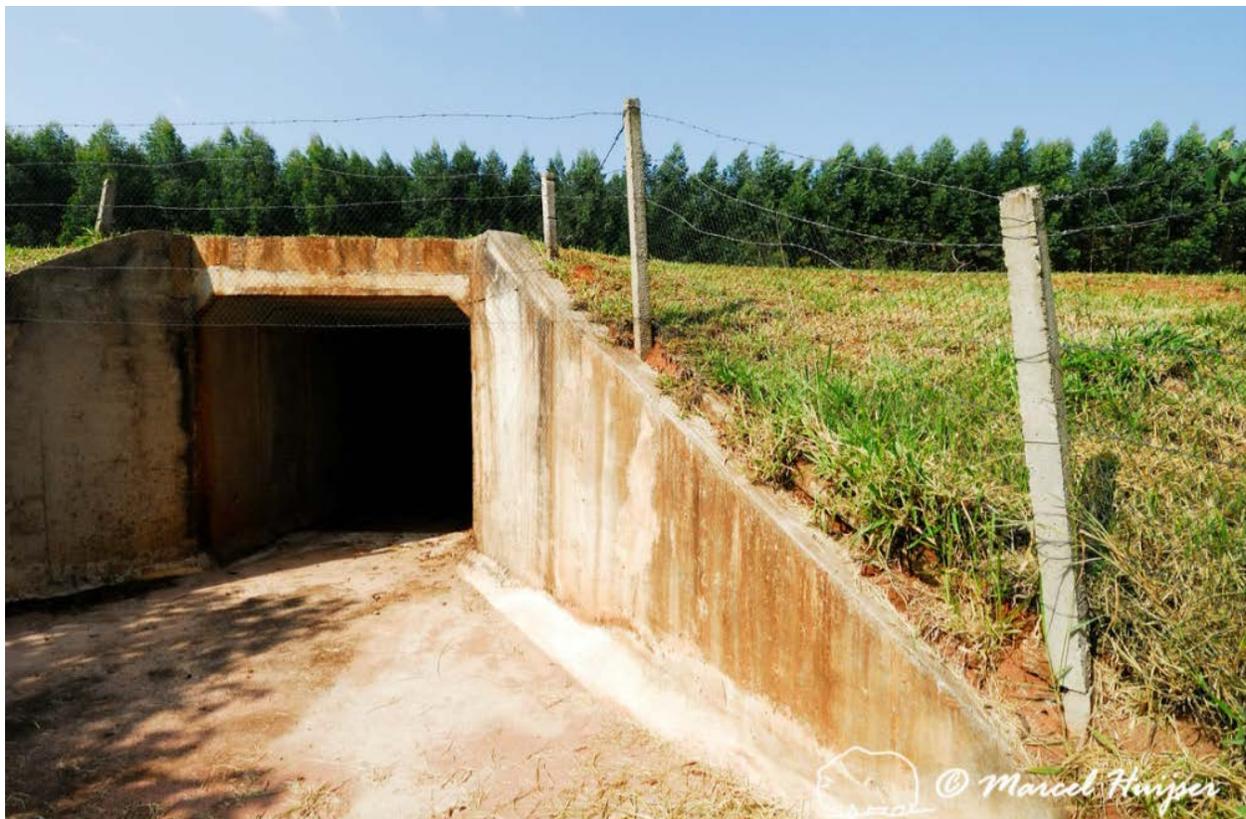
Most of the safe crossing opportunities for wildlife along the SP-225 are concrete box culverts (Figure 24) that sometimes also have a function for hydrology or livestock. The concrete box culverts are typically a few meters wide and a few meters high.

Figure 24: Wildlife underpass (concrete box culvert), along SP-225, near Brotas, São Paulo, Brazil.

It is best to construct wildlife crossing structures in such a way that it allows wildlife that approaches the road to see the sky and vegetation on the other side of the road through or across the structure. This means that the approach for wildlife should preferably be level (avoid steep slopes at the approaches (e.g. Figure 25-26)), and that two separate structures for the two travel directions should be designed as one wildlife crossing structure with a good line of sight for wildlife.

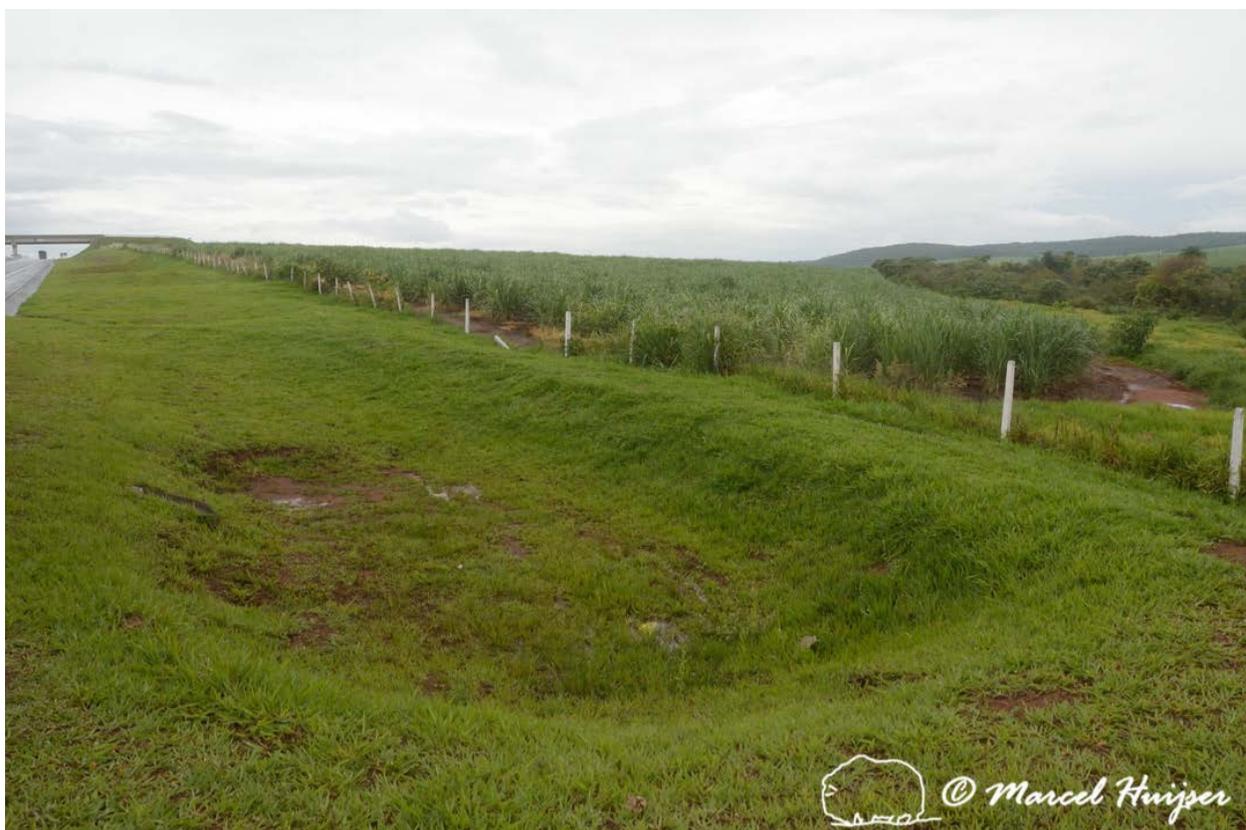
Run-off from the road (and associated pollutants and sediments) should – in general - not directly flow into streams or rivers. It is best to allow the water to filtrate into the soil, reducing peak flows and the probability of flooding downstream. In addition, the soil can help filter out potential pollutants and sediments before the water enters a stream or river. Basins in the right-of-way (see Figure 33) are a measure that allows for such practices.

Figure 33: Basin to reduce the velocity and quantity of water and allow infiltration and associated removal of sediments and potential pollutants in the soil rather than a stream, along SP-225 motorway, São Paulo, Brazil
