OVERVIEW OF ANIMAL DETECTION AND ANIMAL WARNING SYSTEMS IN NORTH AMERICA AND EUROPE

Marcel P. Huijser & Patrick T. McGowen

Western Transportation Institute, Montana State University, 416 Cobleigh Hall,
Bozeman, MT 59717-3910, e-mail: mhuijser@coe.montana.edu

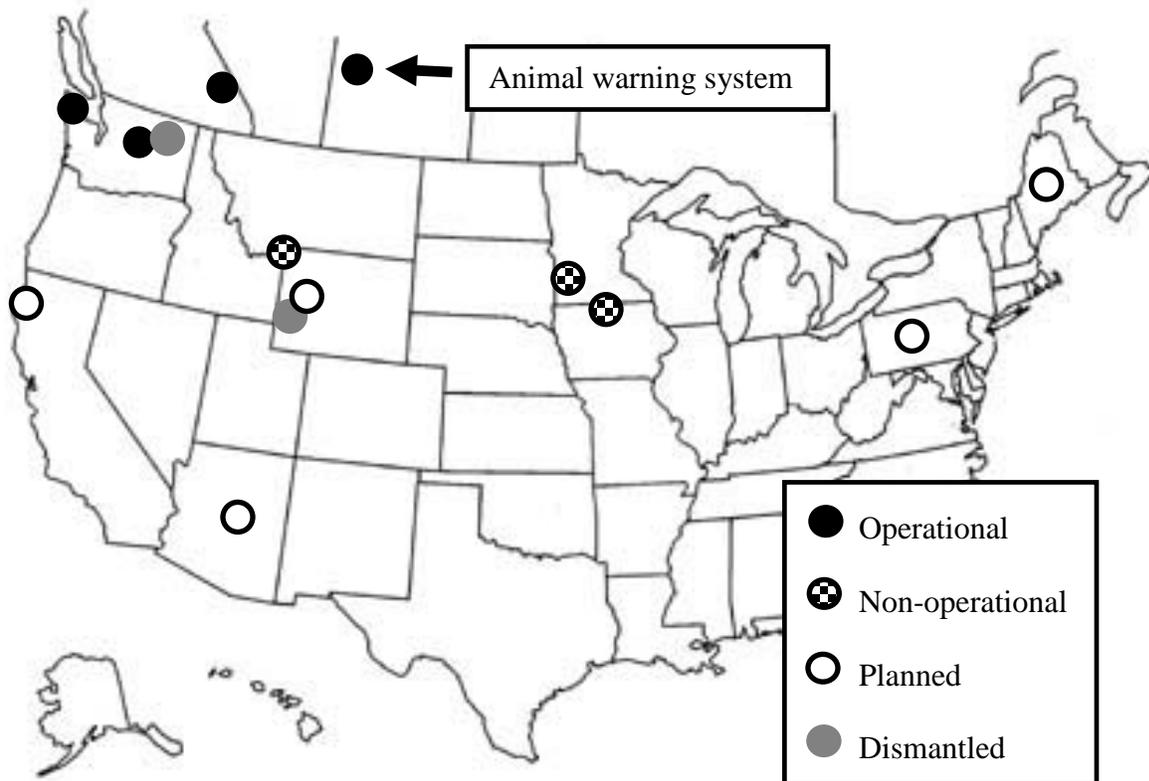
Fig. 1. The location of animal detection and animal warning systems in North America.

We identified 27 locations with an animal detection or animal warning system. Nine of these sites are located in North America; eight sites with an animal detection system, and one site with an animal warning system (fig. 1). As far as we know only four of these sites have a system that is currently in operation (situation September 2003). On three sites a system has been installed, but the systems are not operational yet. On the remaining two sites the systems have been dismantled. In Europe we identified 18 locations with animal detection systems (fig. 2). As far as we know 17 of them have a system that is currently in operation. The system on the remaining site has been dismantled. In addition to the 27 sites mentioned above, we have identified 5 sites in North America and 15 sites in Europe for which an animal detection system has been planned.

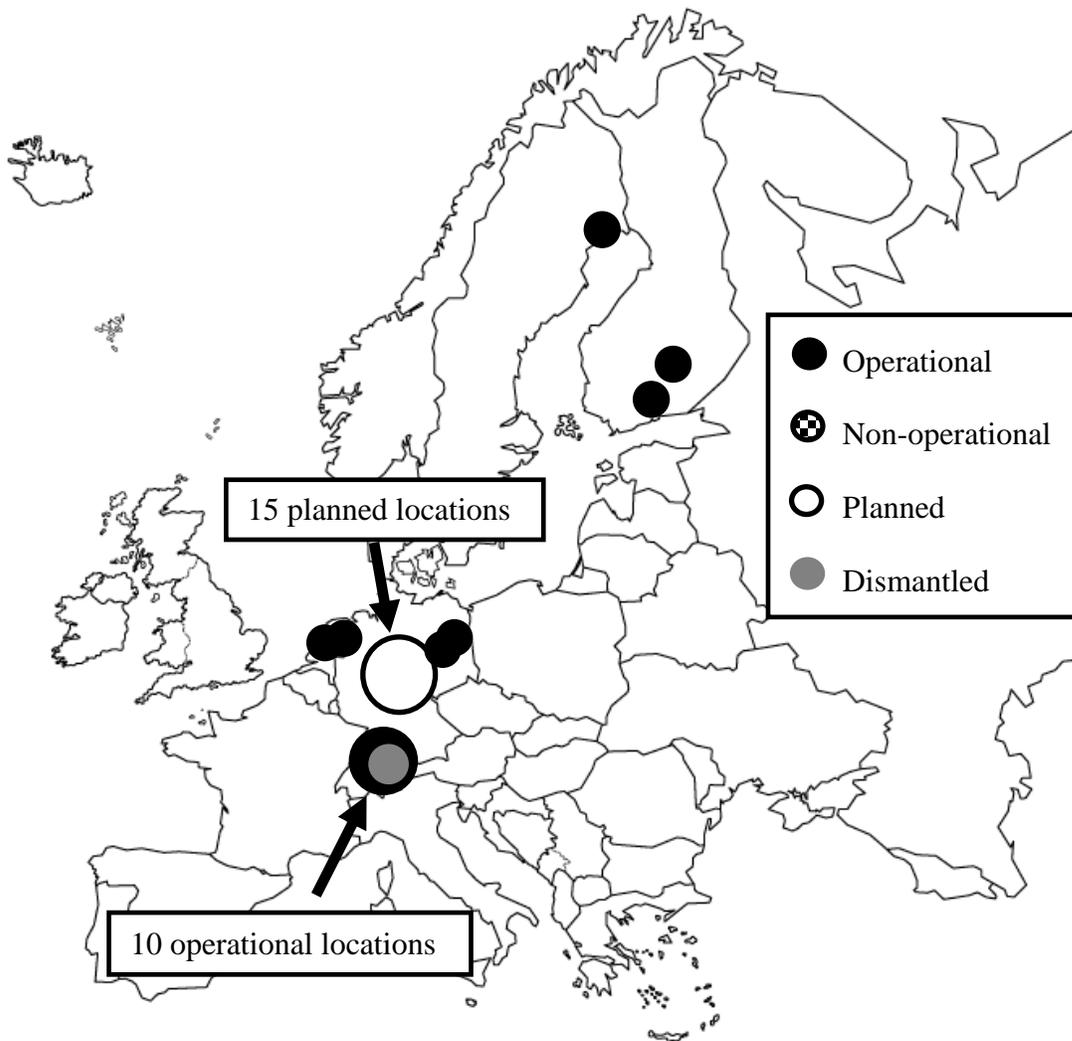
Fig. 2. The location of animal detection systems in Europe.
