# **Impacts of Roads and Traffic on the Red Wolf: Potential Avoidance, Mitigation and Compensation Strategies**

FINAL REPORT

Western Transportation Institute - Montana State University,  
PO Box 174250, Bozeman, MT 59717-4250, USA

September, 2023

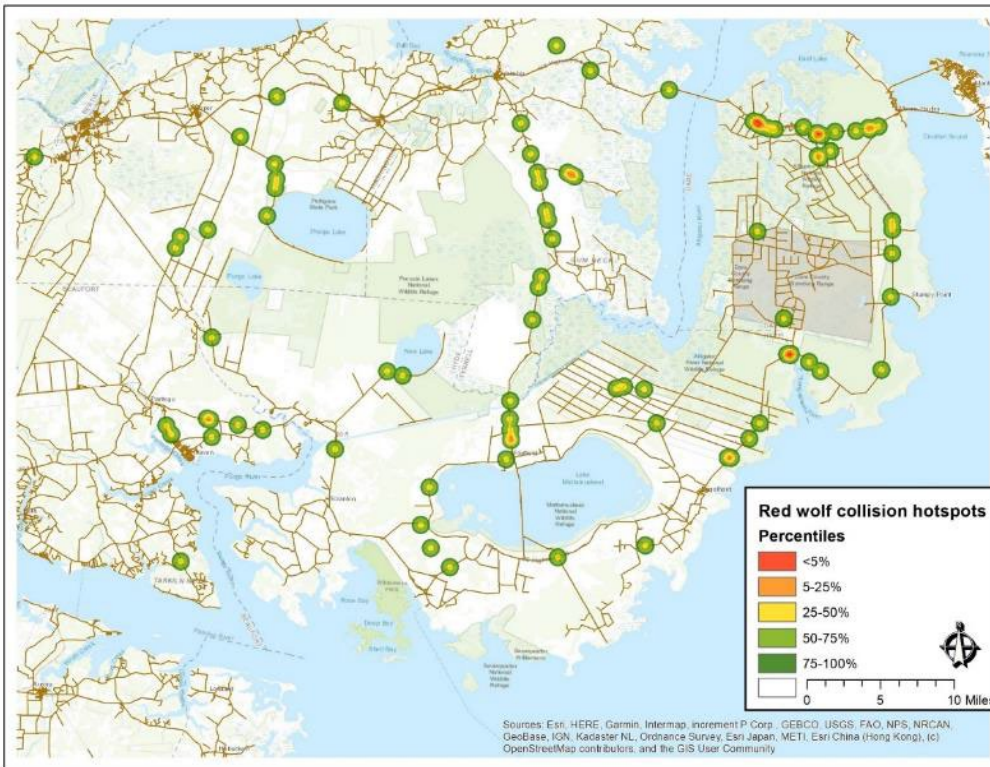
Figure 3: Kernel density hotspot percentiles red wolf-vehicle collisions (1987–2022).

While collisions with red wolves are widespread along the major highways as well as smaller roads throughout the ENC RWP area, there are 6 road sections that have a concentration of collisions in the two highest density categories (orange and red) (Figure 3, 4):

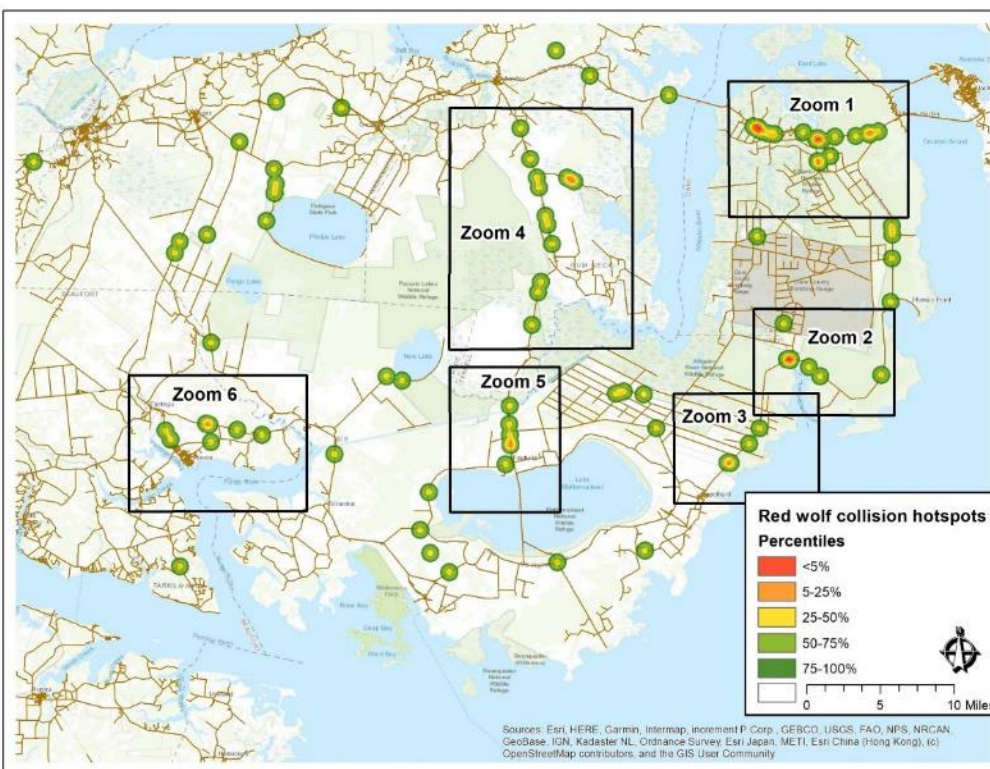
Figure 4: Kernel density hotspot percentiles red wolf-vehicle collisions (1987–2022), overview Zoom 1-6.

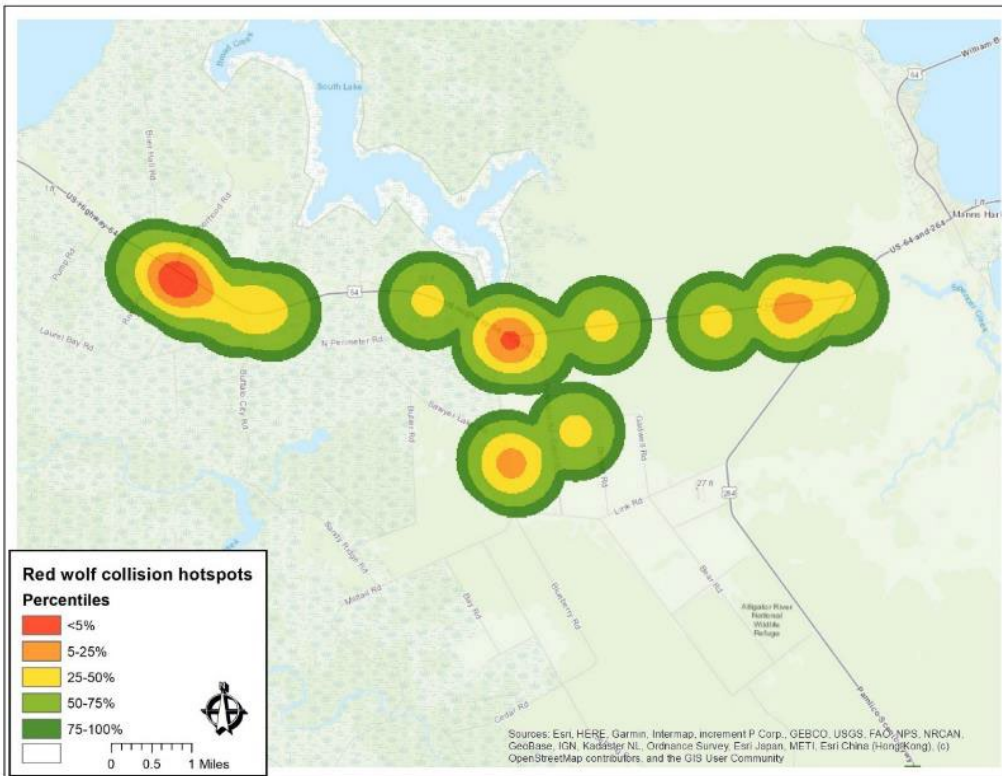
Figure 5: Zoom 1, US Hwy 64. Kernel density hotspot percentiles red wolf-vehicle collisions (1987–2022).

- Zoom 1 (Figure 5). US Hwy 64, through and adjacent to Alligator River National Wildlife Refuge.
  - Around Lake Neighborhood Rd./River Rd. – Buffalo City Rd.
  - Around Milltail Rd.
  - Just west of the junction with US Hwy 264.
- Zoom 2 (Figure 6). US Hwy 264, around Long Shoal River/Stomper Rd.
- Zoom 3 (Figure 7). US Hwy 264, north of Engelhard.
- Zoom 4 (Figure 8). Hwy 94, Columbia – Northwest Fork Alligator River.
- Zoom 5 (Figure 9). Hwy 94, north of Fairfield.
- Zoom 6 (Figure 10). Beech Ridge Rd., north of Belhaven.

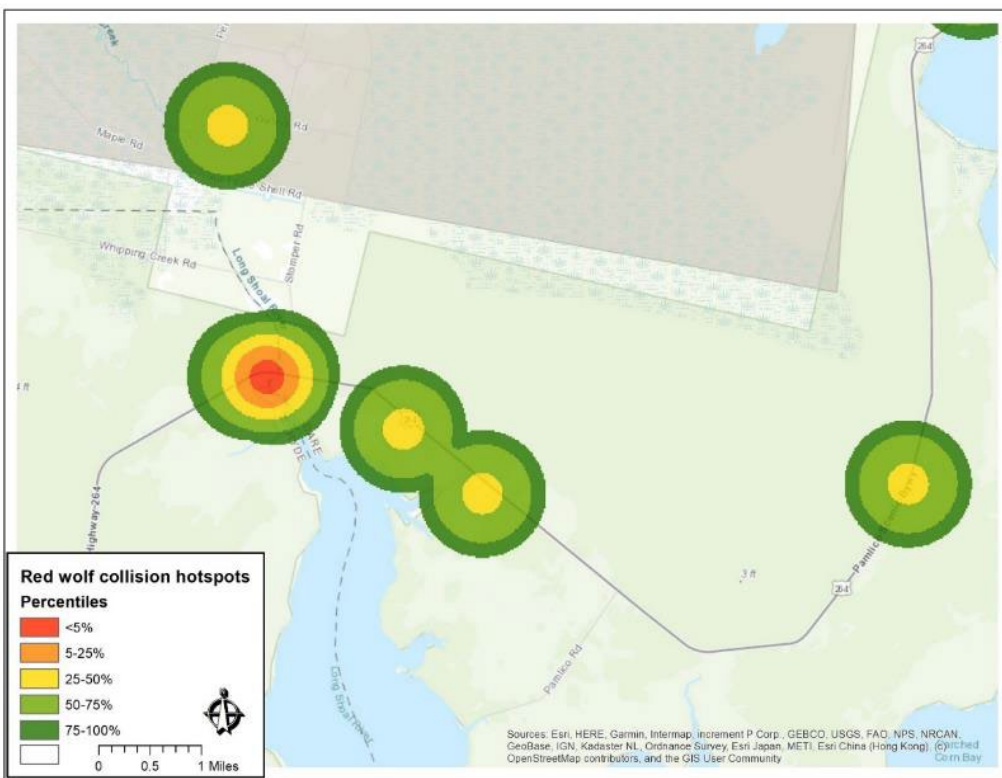
Figure 6: Zoom 2, US Hwy 264. Kernel density hotspot percentiles red wolf-vehicle collisions (1987–2022).

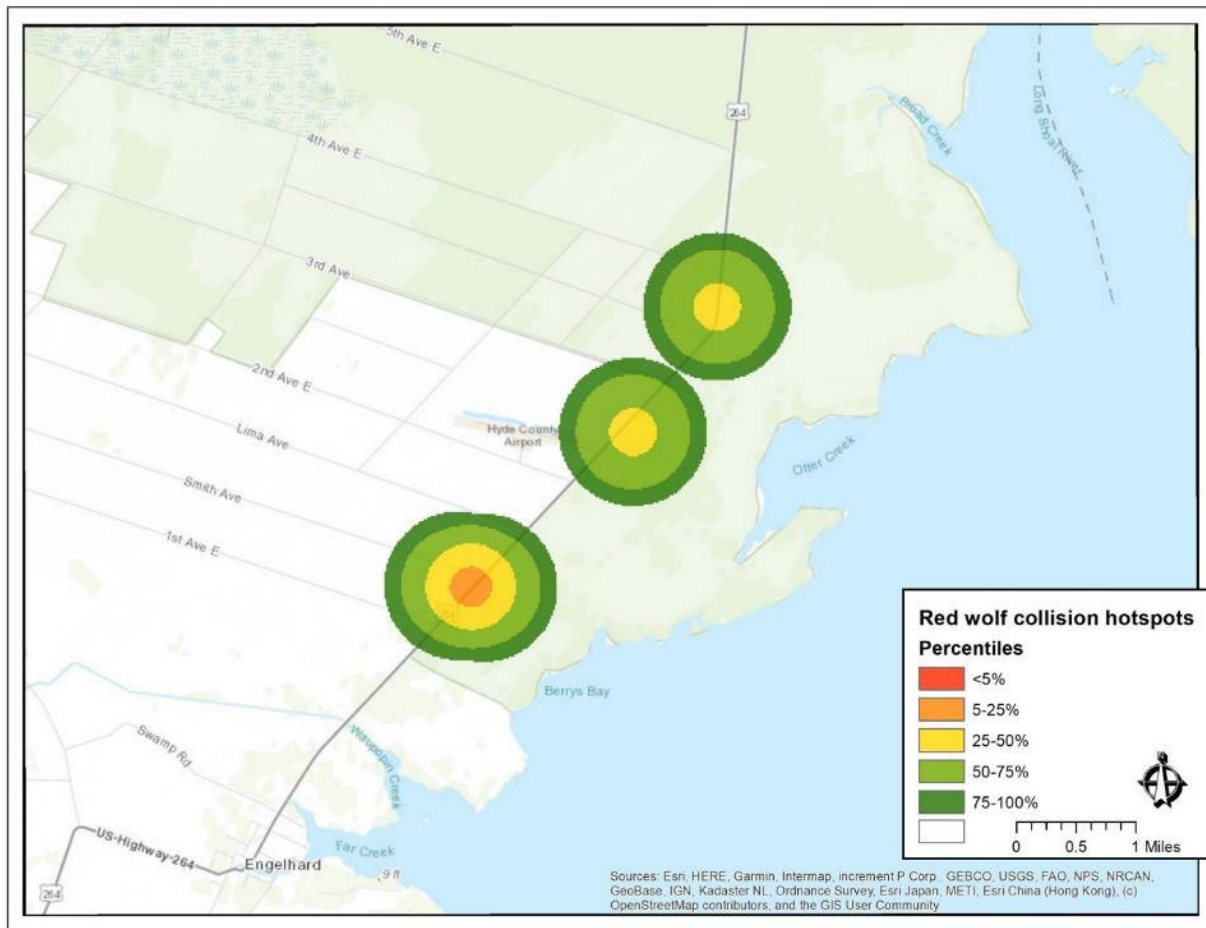
Figure 7: Zoom 3, US Hwy 264. Kernel density hotspot percentiles red wolf-vehicle collisions (1987–2022).

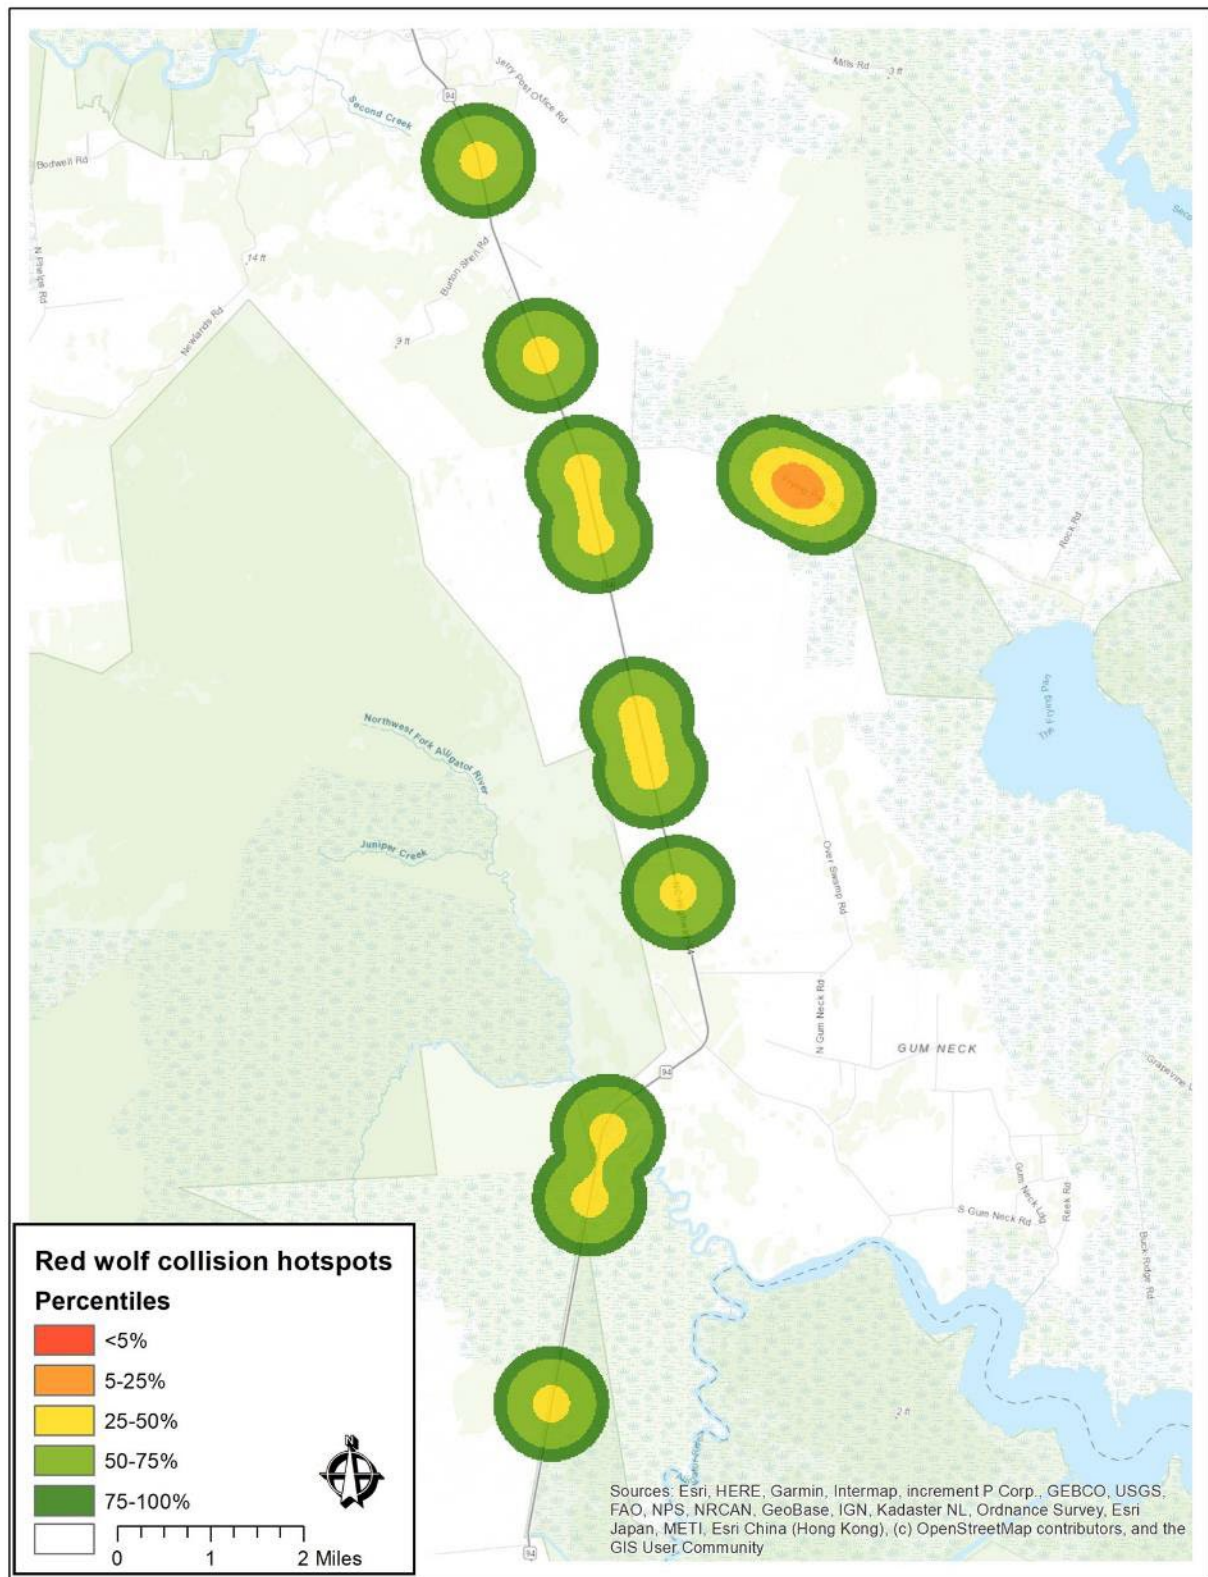
Figure 8: Zoom 4, Hwy 94. Kernel density hotspot percentiles red wolf-vehicle collisions (1987–2022).

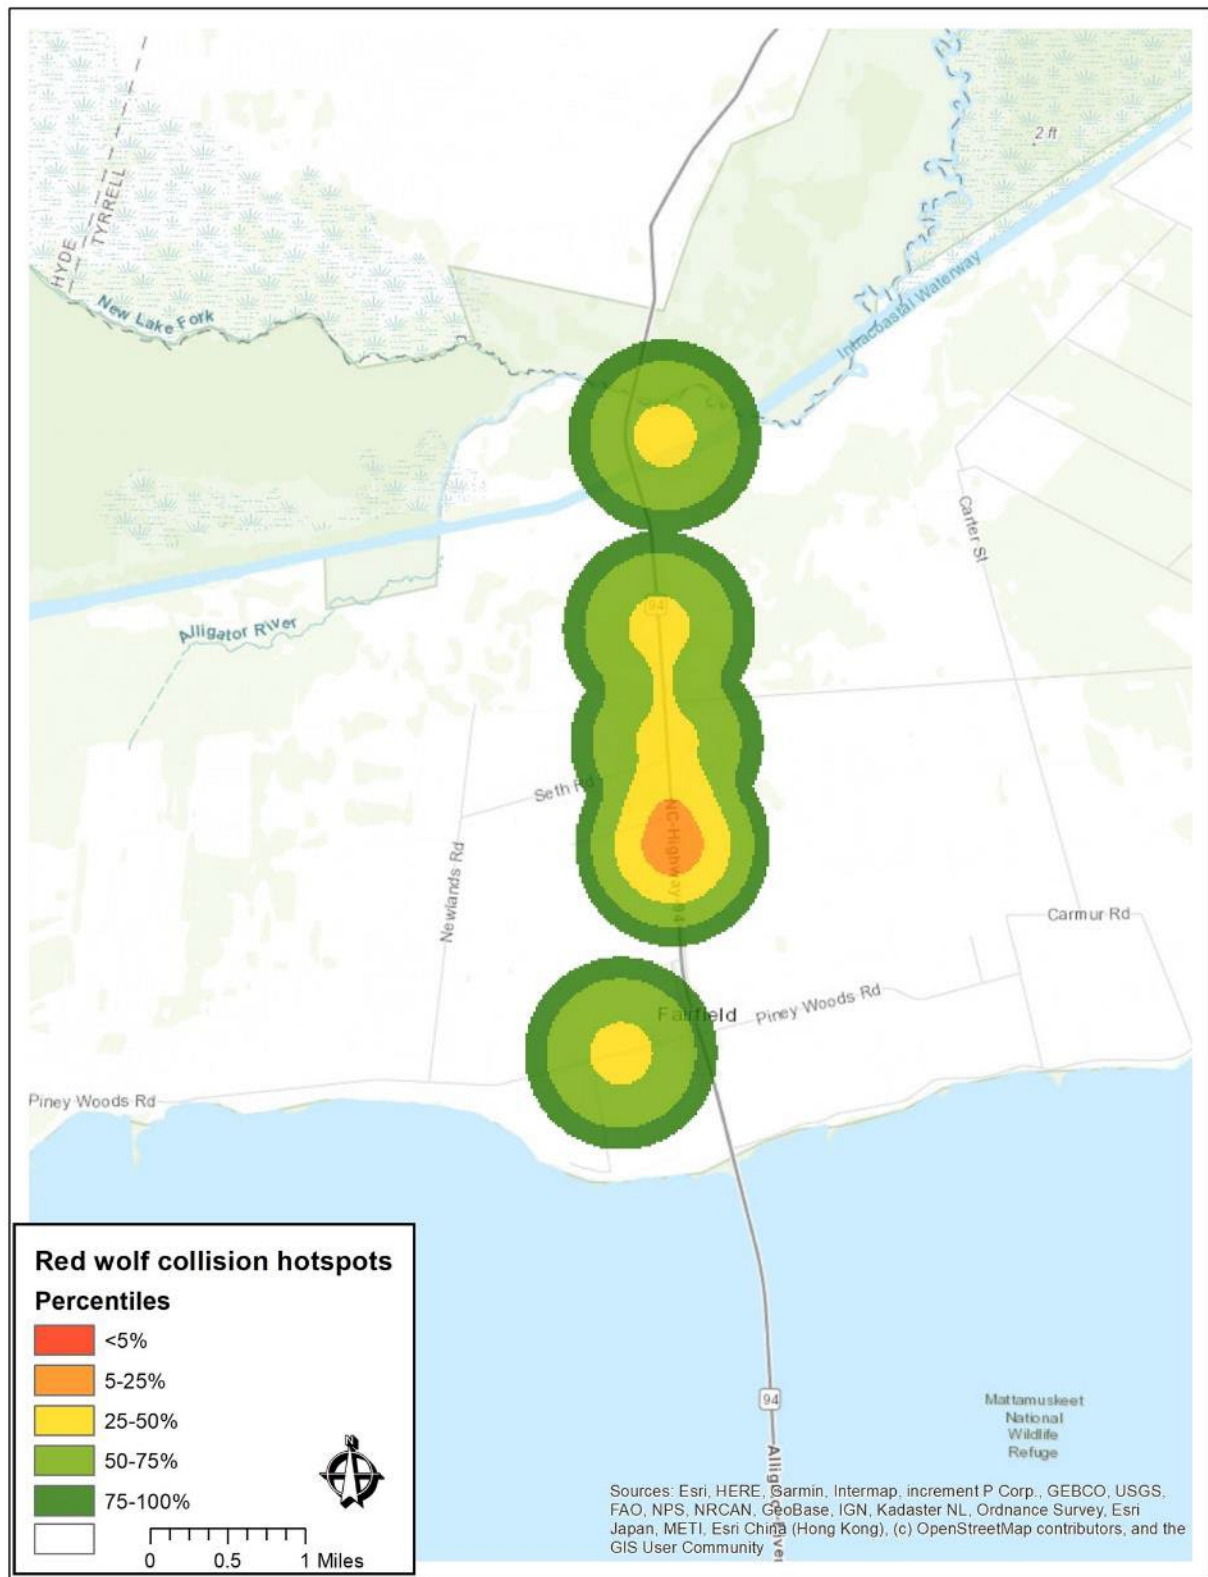
Figure 9: Zoom 5, Hwy 94. Kernel density hotspot percentiles red wolf-vehicle collisions (1987–2022).

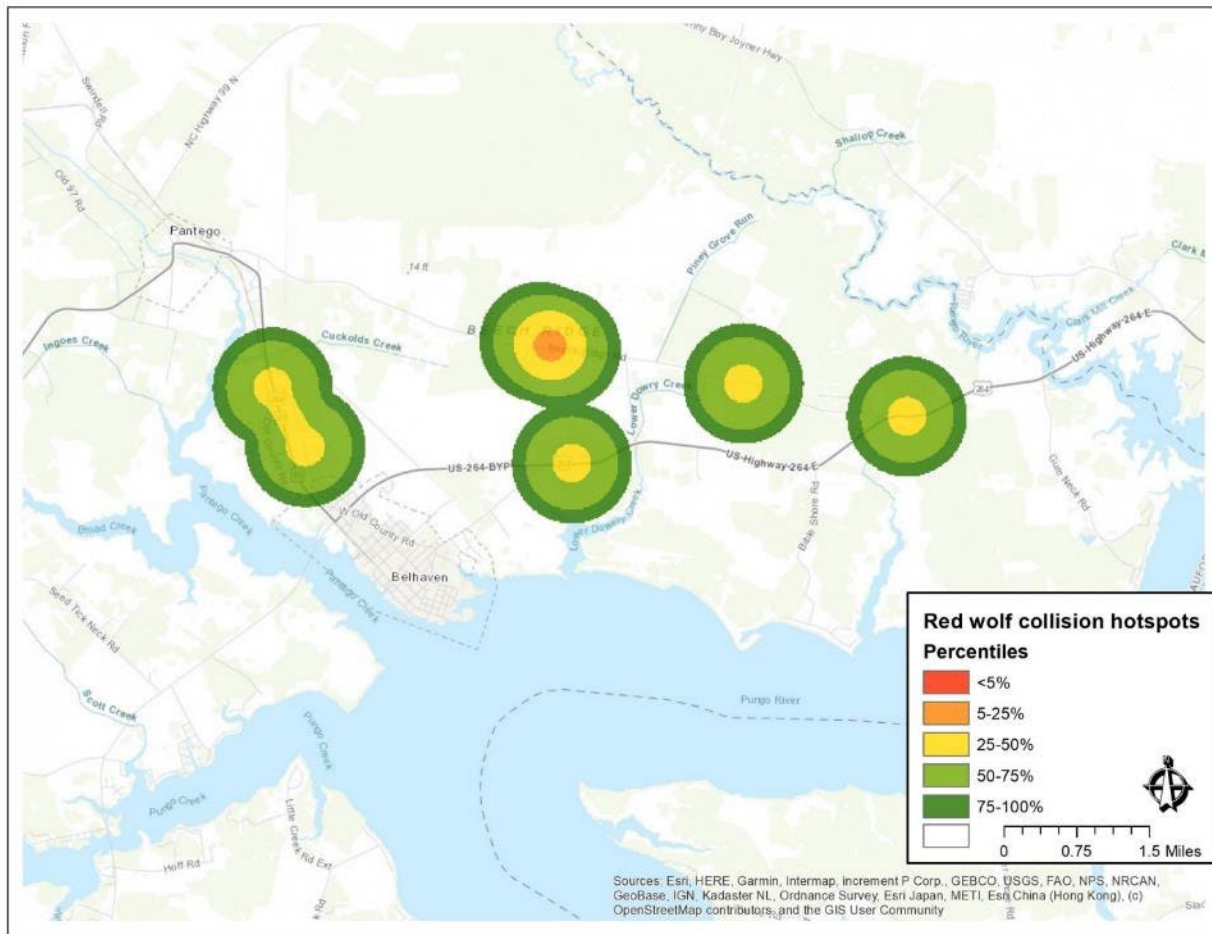
**Figure 10: Zoom 6, Beech Ridge Rd. Kernel density hotspot percentiles red wolf-vehicle collisions (1987–2022).**

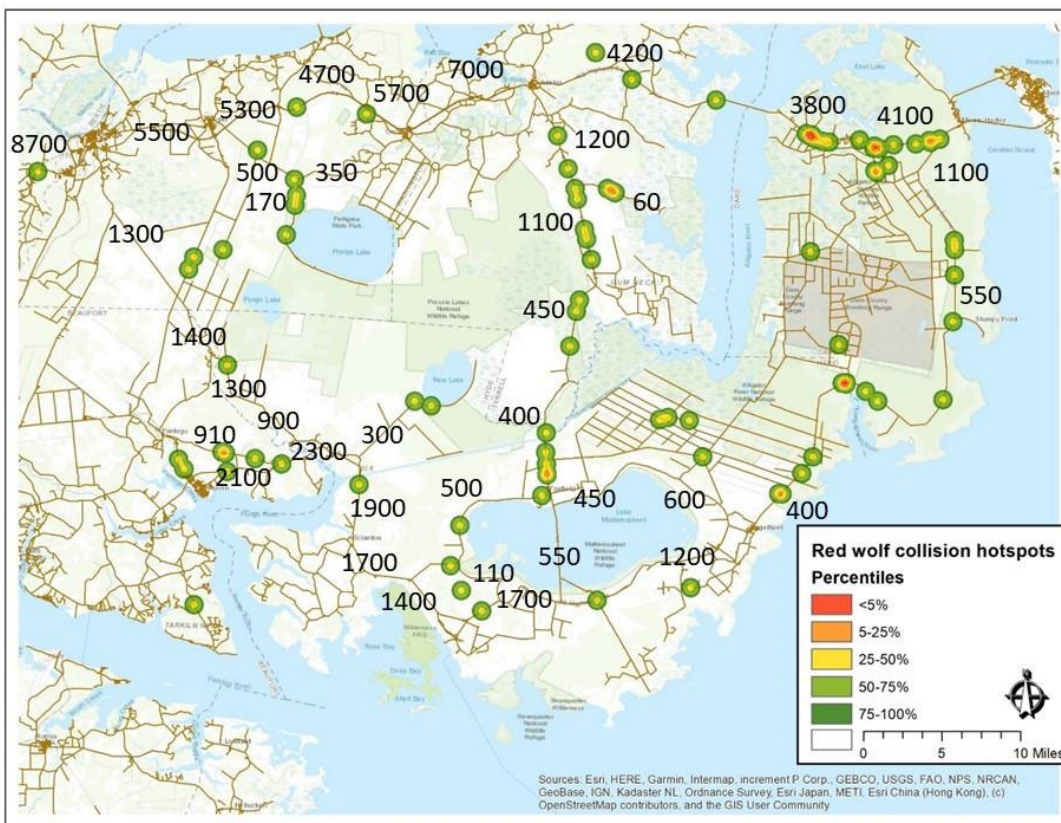
**Figure 11: Annual Average Daily Traffic (AADT) projected on the red wolf vehicle collision hotspots. Note that not all roads or road sections have their traffic volume displayed.**

Traffic volume data were obtained for the main roads in the ENC RWP area (Figure 11) (NCDOT 2023). Most of the traffic volume data related to the most recent year the data were available for (2021), but for some minor roads the most recent data were from earlier years. US Hwy 64 has the highest traffic volume of roads in the area, ranging from 8,700 vehicles per day towards the west end of the area to around 4,000 vehicles per day near the coast (Figure 11). Other highways and highway sections in the area had much lower traffic volume, ranging from a few hundred vehicles per day up to about 1,000 or 2,000 vehicles per day. Interestingly, red wolf collision hotspots occurred along both the busiest highway (US Hwy 64, through Alligator River National Wildlife Refuge) as well as with roads with about 1,000 or even just a few hundred vehicles per day (Figure 11).

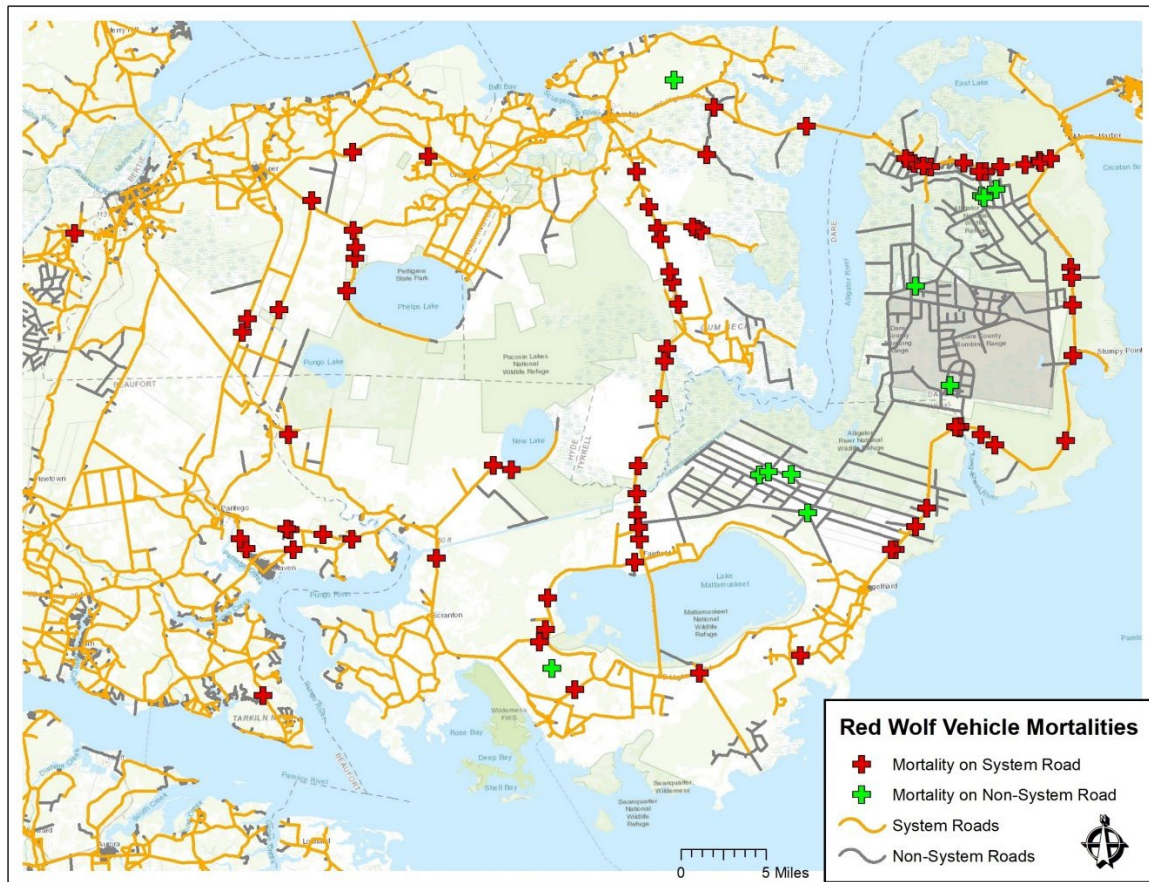
**Figure 12: System roads and red wolf road mortalities on systems roads (red) and red wolf mortalities on non-system roads (green).**

There were 91 recorded road mortalities for red wolves in total (see Appendix). However, two road mortality records did not have coordinates, and 11 road mortalities were on non-system roads, such as gravel or dirt roads) (Figure 12). This left 78 recorded red wolf road mortalities that had coordinates and that were associated with system roads. Of the selected system roads, each road section was divided in 0.1 mile road segments and each road segment was coupled with the AADT from the most recent year (usually 2021, but for some low volume roads the most recent counts were older, up to 2012) (NCDOT 2023). The number of red wolf road mortalities on the system roads was tallied for each of the traffic volume categories shown in Figure 13. The traffic volume category 101-500 vehicles per day had more red wolf road mortalities (N=26, 33.33% of all reported road mortality on system roads) than the other traffic volume categories (Figure 13). Overall, the vast majority of all direct red wolf road mortalities (N= 72, 92.31%, of all reported road mortality on system roads) occurred on roads between 101 and 5,000 vehicles per day (Figure 13). This means that if the total direct road mortality of red wolves is to be substantially reduced in the ENC RWP area, the historic data suggest that the efforts should be focused on roads with a traffic volume between 101 and 5,000 vehicles per day. Efforts aimed at reducing direct road mortality of red wolves along busier roads (>5,000 AADT) in the ENC RWP area would not be an effective strategy. This is likely because of two reasons: 1) higher traffic volume roads may be more of a barrier for red wolves and they may not try to cross these busy roads as often, and 2) higher traffic volume roads mostly occur in the extreme west and north of the area where red wolves may have been present less often, and therefore they would not have been trying to cross these roads as frequently.

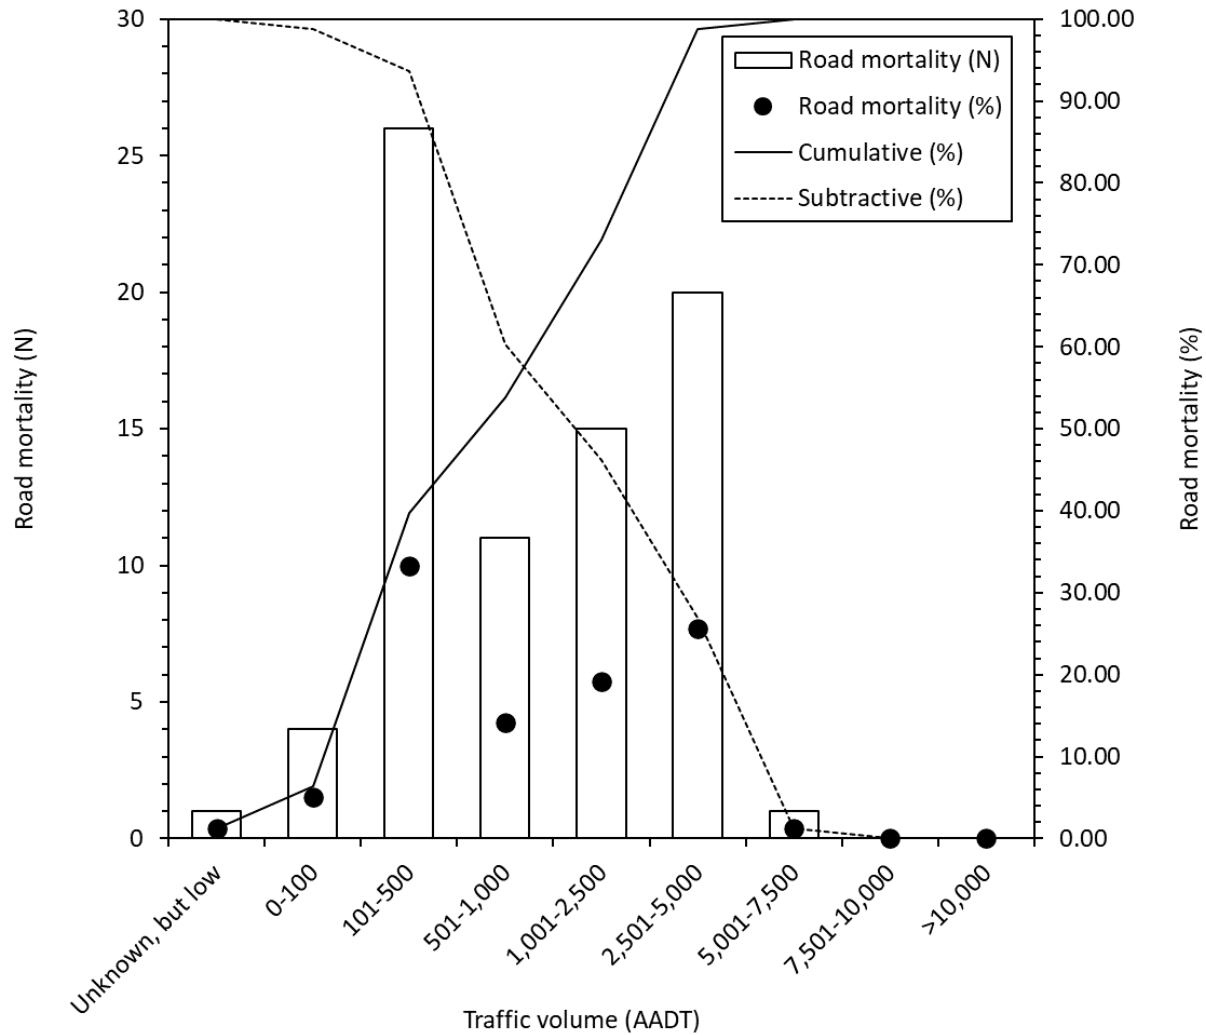
**Figure 13: Road mortality counts of red wolves (bars, left Y-axis) for the different traffic volume (AADT) categories and the percentage of the total road mortalities on system roads that these counts represent (dots, right-Y-axis). The two lines illustrate what percentage of mortalities would be addressed if mitigation measures would start with either the highest or lowest volume roads.**

implementing mitigation measures along roads with a traffic volume of 2,500-5,000 vehicles per day would be most “efficient” with the highest number of red wolf road mortalities addressed for the shortest mitigated road length. Traffic volume categories with a traffic volume between 0 and 2,500 vehicles per day had red wolf road mortalities that were roughly proportional to their road length (Figure 14). The lowest (“unknown, but low”) and highest traffic volume categories (over 5,000 vehicles per day) had proportionally very few road mortalities of red wolves, and this is where mitigation measures would be most “inefficient” with the fewest red wolf road mortalities addressed for the road length mitigated.

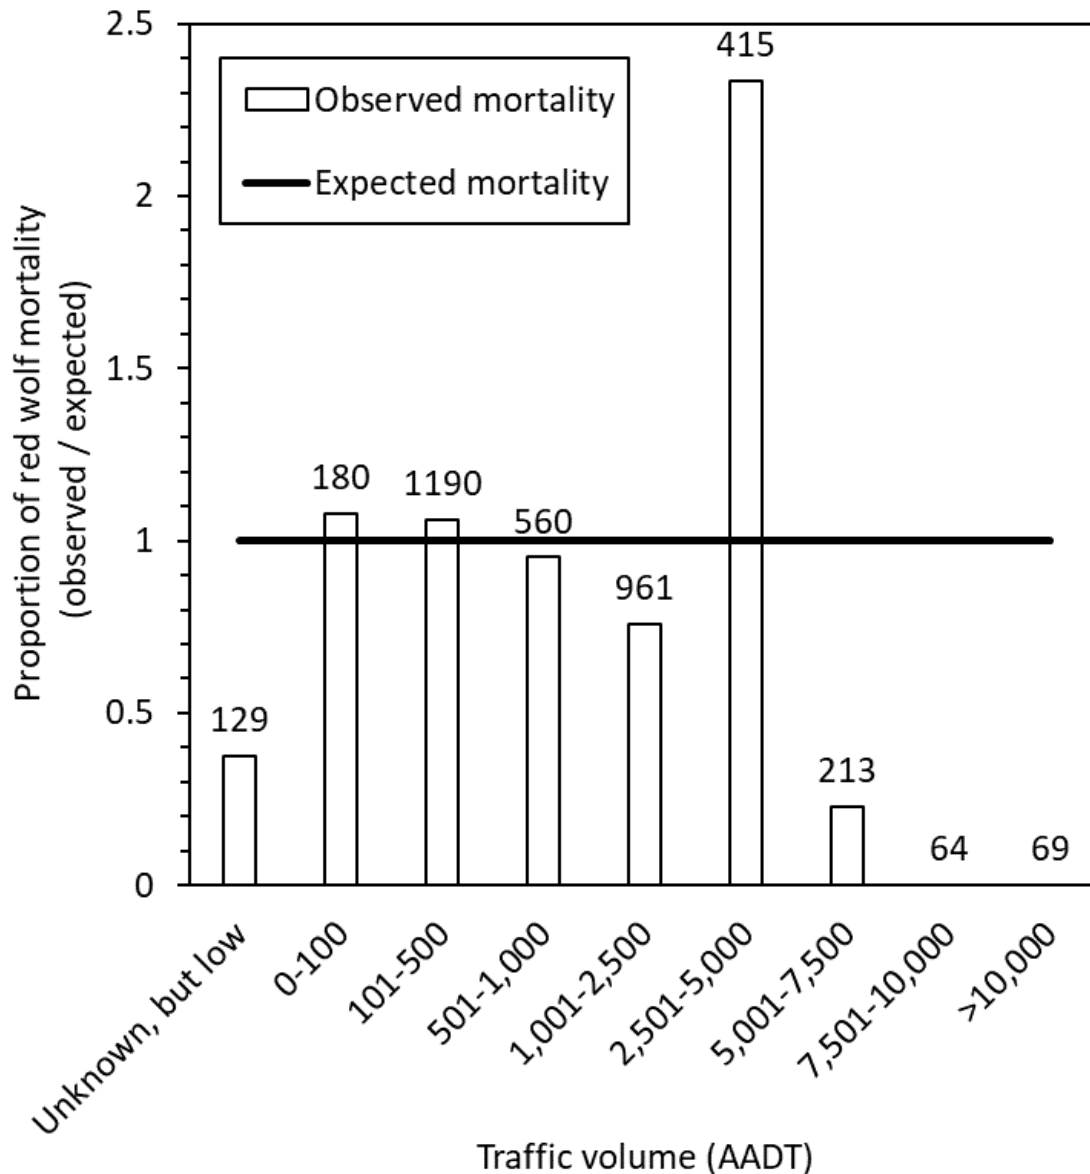
**Figure 14:** The proportion of observed of direct road mortality of red wolves for each traffic volume category compared to what would be expected if red wolves would be hit proportionally among the different traffic volume categories. The total number of 0.1 mile road segments for each traffic volume category, regardless of whether red wolf road mortality was observed in the 0.1 mile segments, is shown above the bars. This number is equivalent to the sample size for each traffic volume category.

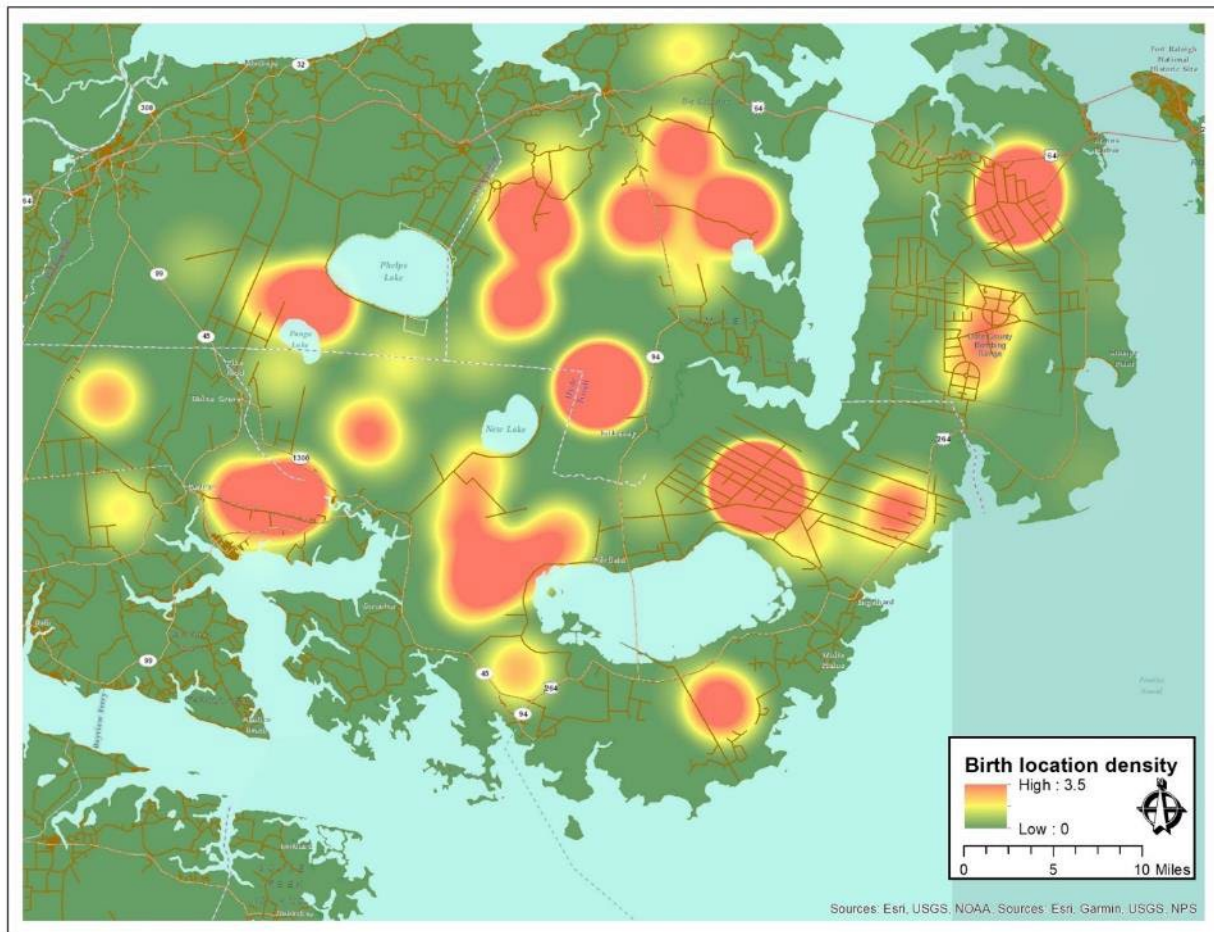
**Figure 15: Kernel density hotspot birth locations for red wolves (1987–2022).**

Highway sections that bisect or that are near the home ranges of breeding pairs are of high importance for mitigation. If one of the breeding adults dies, e.g., because of a vehicle strike, the whole litter may be in jeopardy. In order for the red wolf population to recover, the survival of breeding individuals and their offspring is essential. For this analysis, we investigated where the highest concentrations of birth locations were for red wolves between 28 April 1988 and 8 April 2016 (707 reported birth locations of red wolves in total) (Figure 15).

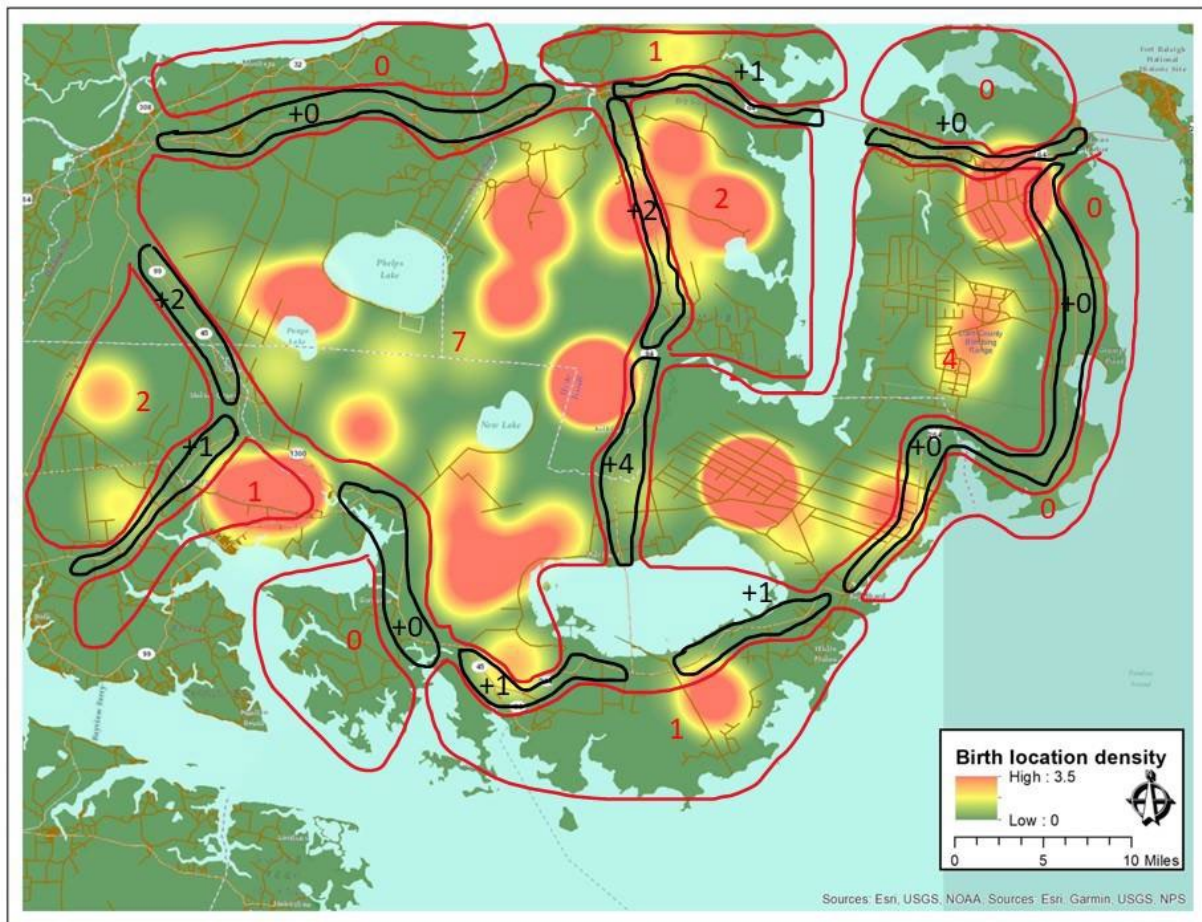
**Figure 16: Areas with red wolf birth locations separated by highways and water (red lines) and the number of birth location hotspots (red numbers). The road sections separating these areas are indicated by the black lines and have the lowest number of hotspots on one of the two sides of the road was indicated in black (the numbers with a “+” in front of it).**

Since the birth location hotspot map is based on all birth locations between 28 April 1988 and 8 April 2016, and since there was a substantial decline in the red wolf population between 2014 and 2022, we can expect most of these birth location hotspots to be historic rather than current. This also means that there is evidence of good habitat quality that allowed for breeding and where dispersing red wolves may be able to find mates, establish territories, and breed successfully. In that context these two areas can form the “source” for colonizing or recolonizing other areas that may be smaller and more isolated.

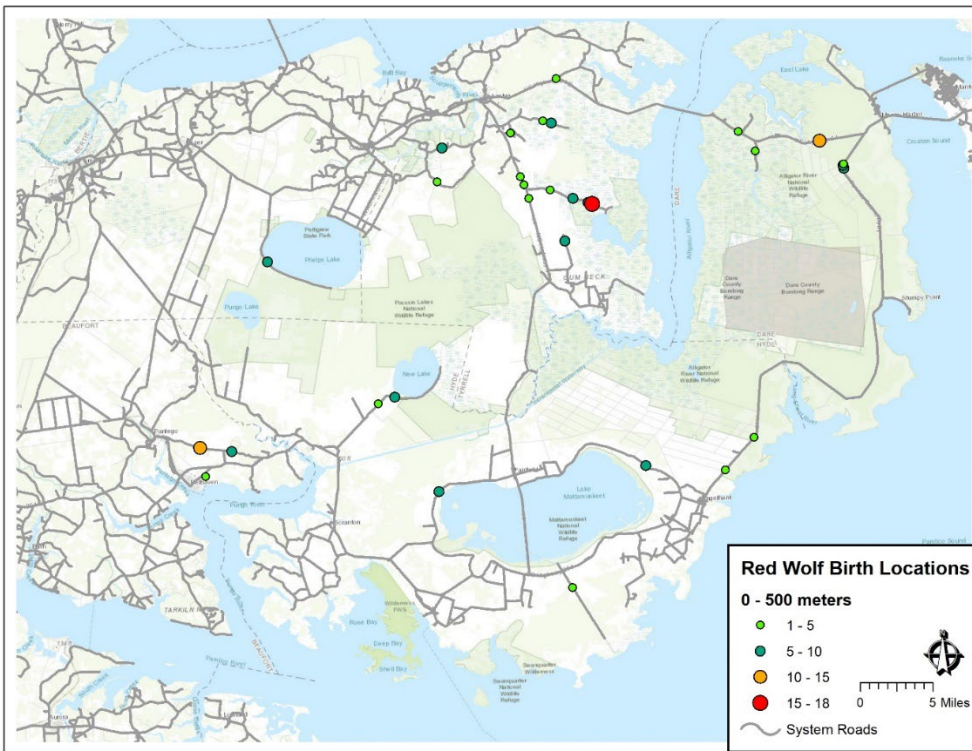
**Figure 17:** The number of red wolf birth locations projected to the nearest 0.1 mile system road segment, up to 500 m from the road, regardless of which side of the road.

To examine which system road sections were closest to birth locations, the selected road segments were divided in 0.1 mile road segments. Each birth location was projected on the closest 0.1 mile road segment of a system road. Three search distances were used for birth locations, regardless of the side of the road the birth location was on: 1) up to 500 m, 2) up to 1,000 m, and 3) up to 1,500 m. The number of birth locations projected on each 0.1 mile road segment was tallied, and higher numbers of birth locations were represented by larger circles (Figure 17, 18, 19). The 0.1 mile road sections with the highest numbers of birth locations close to the road (Table 1) can be considered the most dangerous 0.1 mile road segments to breeding red wolves and their offspring, regardless of whether direct red wolf mortality has occurred there in the past. The maps can also be interpreted beyond the 0.1 mile road segments. If there are different 0.1 mile road segments close together with a total high number of projected birth locations, then these road sections may represent a similar danger to breeding red wolves and their offspring. An example is Hwy 94 just north and south of the junction with Frying Pan Rd.

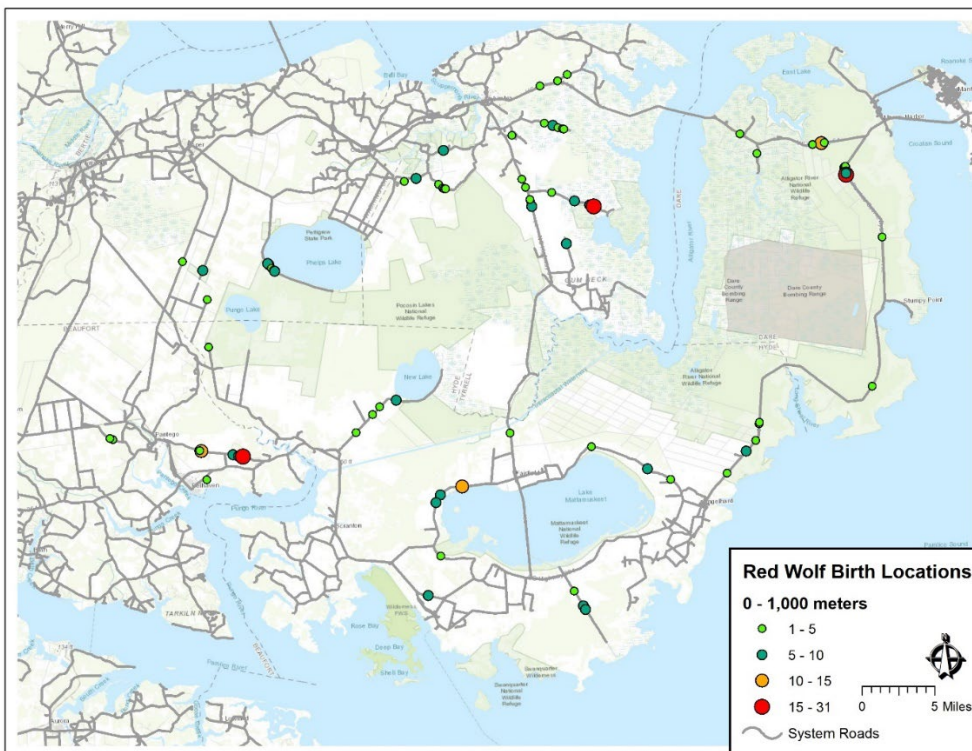
**Figure 18:** The number of red wolf birth locations projected to the nearest 0.1 mile system road segment, up to 1,000 m from the road, regardless of which side of the road.

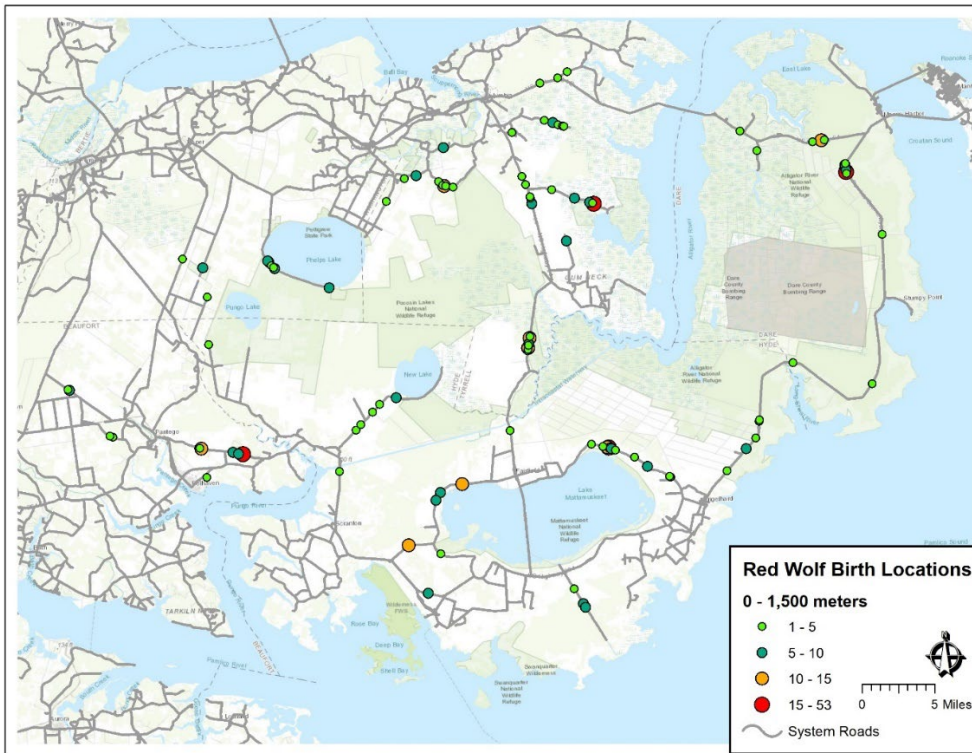
**Figure 19: The number of red wolf birth locations projected to the nearest 0.1 mile system road segment, up to 1,500 m from the road, regardless of which side of the road.**

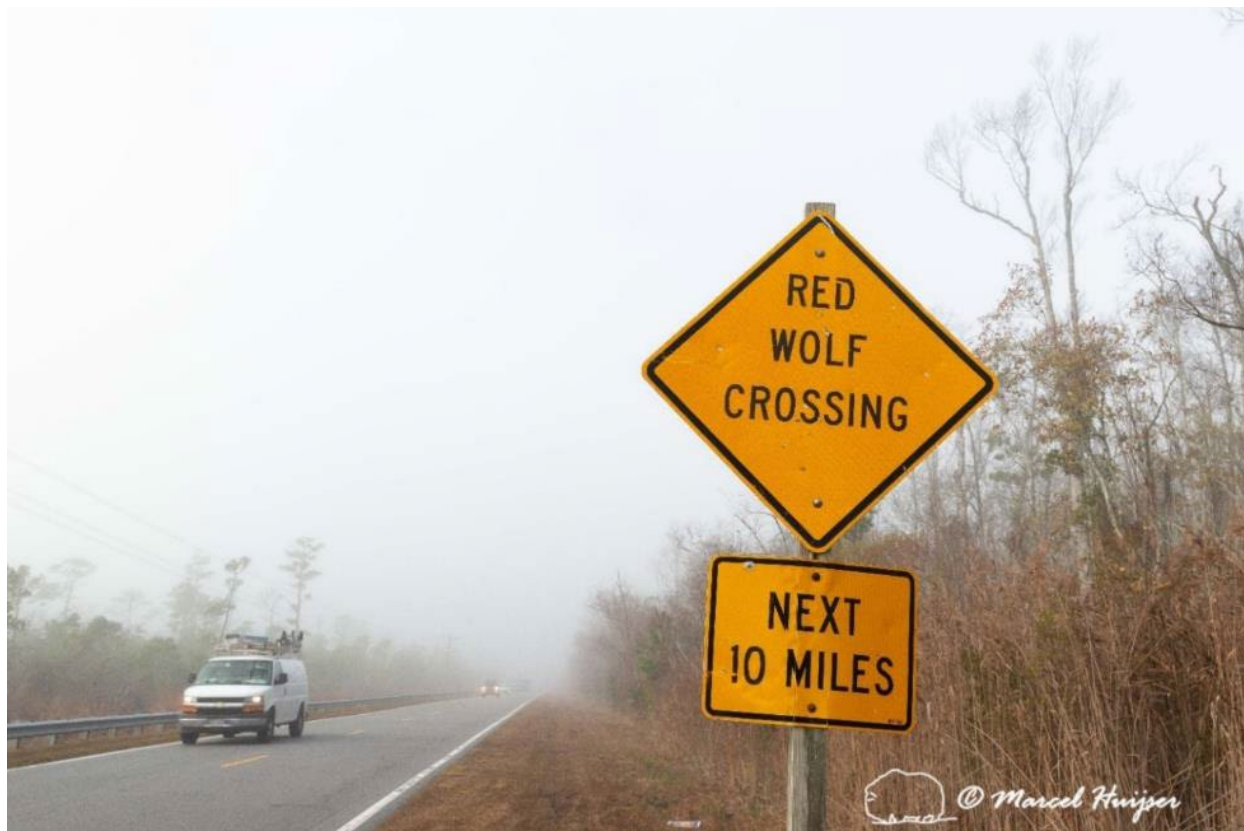
Figure 20: Static wildlife warning sign for red wolf, US Hwy 64, North Carolina.

Both static (standard) wildlife warning signs and Variable Message Signs (VMS) have been installed along the highways in area designated for the ENC RWP (Figure 20, 21). The assumed purpose of these signs is to reduce the probability of vehicles hitting and killing red wolves. However, in general, these types of wildlife warning signs have been found to not, or not substantially, reduce the likelihood of collisions with wildlife, especially not if they have been in place for a while (see review in Huijser et al. 2015a, 2021). It is only when warning signs are more specific in time and location (e.g., along seasonal migration routes and animal detection systems) that there is evidence of wildlife warning signs reducing collisions. While animal detection systems can be substantially effective in reducing collisions with large wild mammals (range 33-97%), all other wildlife warning sign types do not, or do not substantially, reduce collisions (a reduction of few dozen percentages at best) (see reviews in Huijser et al. 2015, 2021). Furthermore, none of the warning sign types reduce the barrier effect of the roads and traffic for animals, as they still have to navigate the open unnatural surface of a road and the vehicles that drive on it. However, wildlife warning signs can contribute to a different objective. For example, the VMS signs for red wolves have generally been well received by the community and are considered an effective communication tool for informing local landowners and visitors driving through the area about existence and presence of endangered red wolves (Pers. com. Joe Madison, NC Project Manager, Red Wolf Recovery Program). These VMS signs are placed on roads in closest proximity to release sites where naïve red wolves are at greatest risk of being hit by vehicles, and these signs are moved as needed to other areas within the ENC RWP when monitoring shows that red wolves are using habitat near roads (Pers. com. Joe Madison, NC Project Manager, Red Wolf Recovery Program). In this context, warning signs can increase awareness of the problems, but it would be better for signs to be directly targeting increased awareness and building support for measures that address the road mortality problem more substantially.
