# **Impacts of Roads and Traffic on the Red Wolf: Potential Avoidance, Mitigation and Compensation Strategies**

FINAL REPORT

Western Transportation Institute - Montana State University,  
PO Box 174250, Bozeman, MT 59717-4250, USA

September, 2023

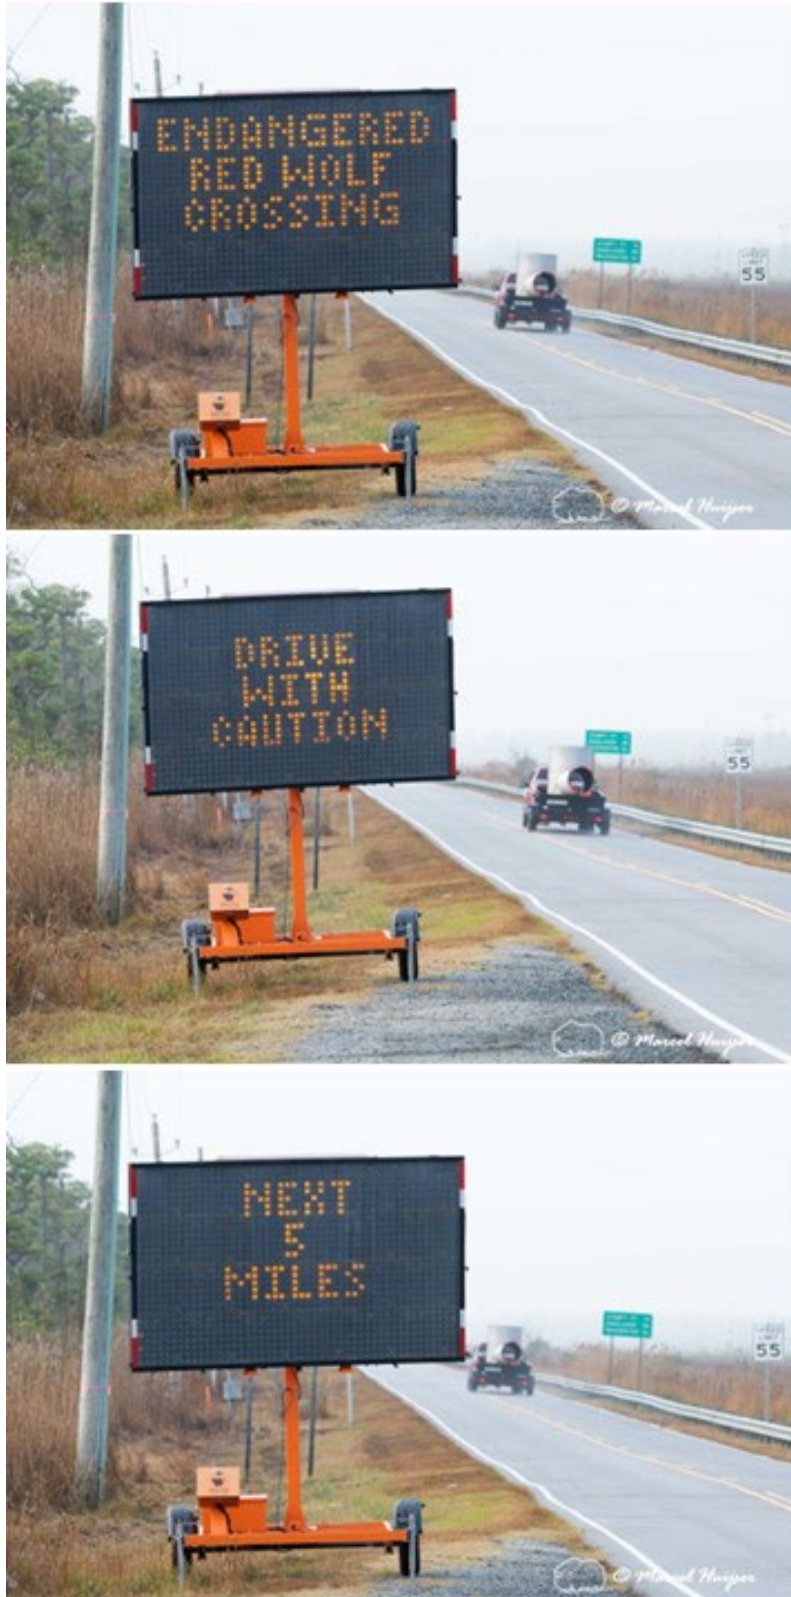
Figure 21: Variable Message Sign (VMS) for red wolves, US Hwy 264, Alligator River National Wildlife Refuge, North Carolina.

Both static (standard) wildlife warning signs and Variable Message Signs (VMS) have been installed along the highways in area designated for the ENC RWP (Figure 20, 21). The assumed purpose of these signs is to reduce the probability of vehicles hitting and killing red wolves. However, in general, these types of wildlife warning signs have been found to not, or not substantially, reduce the likelihood of collisions with wildlife, especially not if they have been in place for a while (see review in Huijser et al. 2015a, 2021). It is only when warning signs are more specific in time and location (e.g., along seasonal migration routes and animal detection systems) that there is evidence of wildlife warning signs reducing collisions. While animal detection systems can be substantially effective in reducing collisions with large wild mammals (range 33-97%), all other wildlife warning sign types do not, or do not substantially, reduce collisions (a reduction of few dozen percentages at best) (see reviews in Huijser et al. 2015, 2021). Furthermore, none of the warning sign types reduce the barrier effect of the roads and traffic for animals, as they still have to navigate the open unnatural surface of a road and the vehicles that drive on it. However, wildlife warning signs can contribute to a different objective. For example, the VMS signs for red wolves have generally been well received by the community and are considered an effective communication tool for informing local landowners and visitors driving through the area about existence and presence of endangered red wolves (Pers. com. Joe Madison, NC Project Manager, Red Wolf Recovery Program). These VMS signs are placed on roads in closest proximity to release sites where naïve red wolves are at greatest risk of being hit by vehicles, and these signs are moved as needed to other areas within the ENC RWP when monitoring shows that red wolves are using habitat near roads (Pers. com. Joe Madison, NC Project Manager, Red Wolf Recovery Program). In this context, warning signs can increase awareness of the problems, but it would be better for signs to be directly targeting increased awareness and building support for measures that address the road mortality problem more substantially.

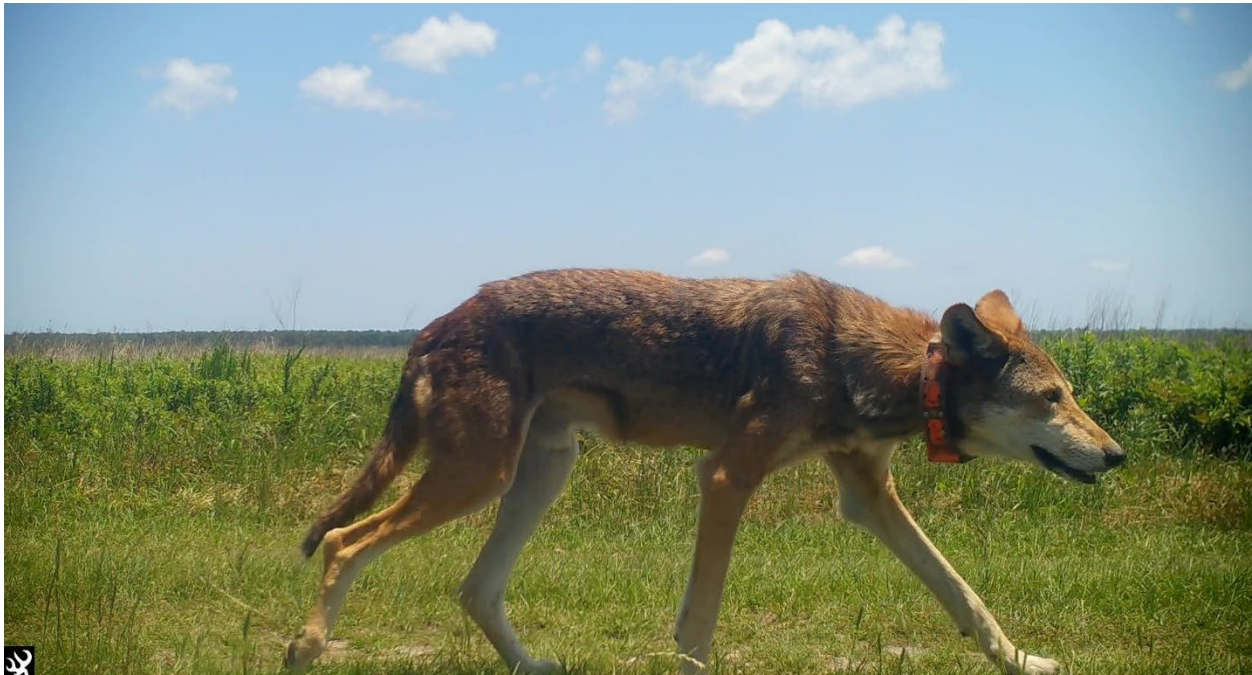
**Figure 22: Red wolf with a collar equipped with reflective orange material (Image provided by Joe Madison, NC Project Manager, Red Wolf Recovery Program).**

When red wolves have reached a certain age, they are equipped with orange radio collars with orange reflective material on the side of the collar (Figure 22, 23). Methods to potentially increase the visibility of the radio collar, and therefore the red wolves, are being discussed with the engineering department at North Carolina State University (NCSU). Besides allowing hunters to better distinguish between red wolves and coyotes, the reflective material on the collar may also help increase visibility of red wolves to drivers and thereby potentially help reduce the likelihood of a collision. Since beginning the use of the orange reflective material on the radio collars, drivers, including Red Wolf Recovery Program and law enforcement personnel, have relayed that they were able to see the orange reflective material on the collar at night time and felt that it substantially increased the visibility of the red wolf. This may be especially helpful on high speed roads where the reflective material makes the animals visible from a greater distance and allows drivers more time and a greater distance to attempt avoiding hitting the animal. This would be mostly through reducing vehicle speed as road departures at high speed (e.g., because of swerving) is associated with a high risk of human injuries and fatalities (Riexinger & Gabler 2020, Roque et al. 2021). While no data are available on the effectiveness of reflective materials in reducing collisions with animals, high visibility reflective vests worn by bicyclists resulted in a 38-47% reduction in crashes (review in Huijser et al. 2021).

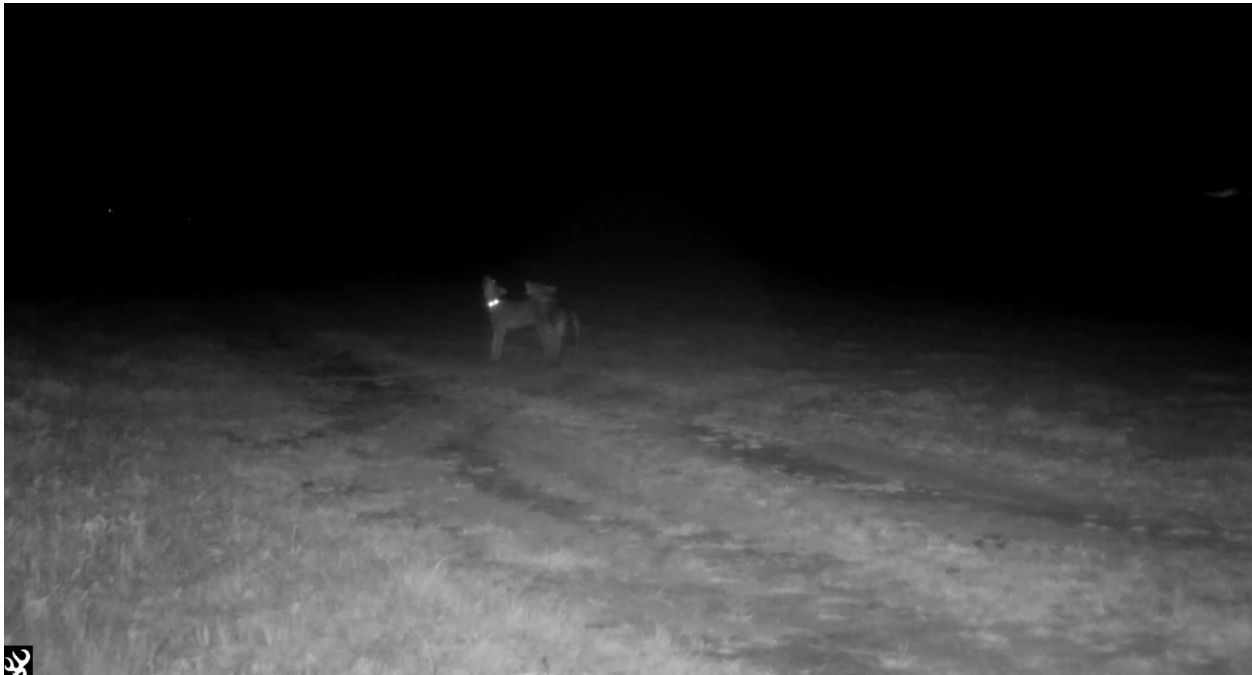
**Figure 23: Two red wolves filmed with a remote sensing camera at night using infrared lighting on Alligator River National Wildlife Refuge illustrates the reflective material. The red wolf on the left has the reflective material on its collar and the red wolf on the right does not (Image provided by Joe Madison, NC Project Manager, Red Wolf Recovery Program).**

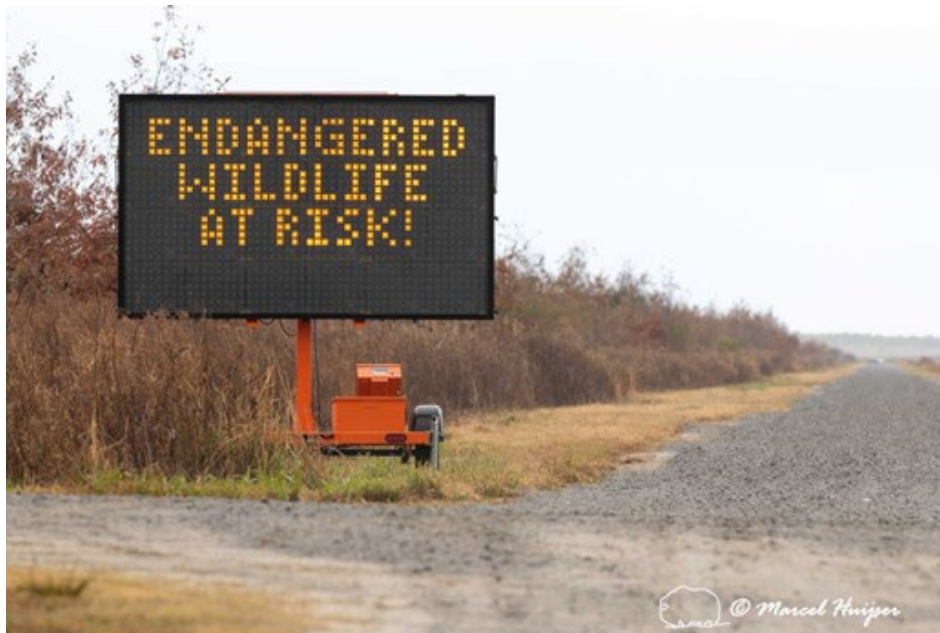
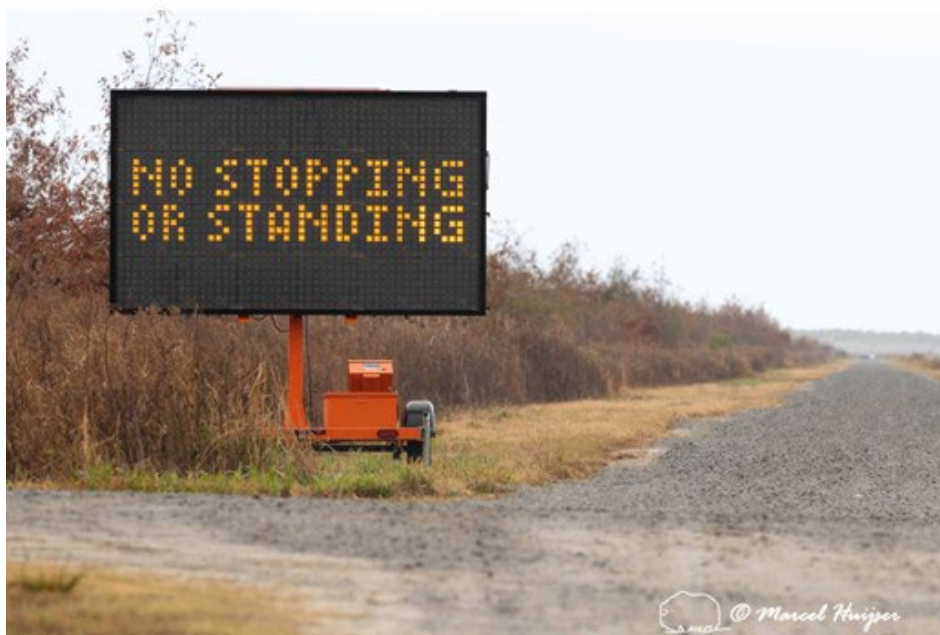
**Figure 28: Wildlife warning sign for the red wolf, “endangered wildlife at risk”, “No stopping or standing”, Red Wolf, Alligator River National Wildlife Refuge, North Carolina.**

In the fall of 2022, variable message signs were deployed along selected road sections in an area frequented by red wolves (Figure 28). The signs informed visitors that they cannot stop their vehicles and that they cannot not stand around. This measure was intended to reduce potential habituation of red wolves to vehicles and humans which may cause the red wolves to lose their fear of vehicles and people. Not knowing to stay away from vehicles and people is likely to negatively affect the survival of red wolves.

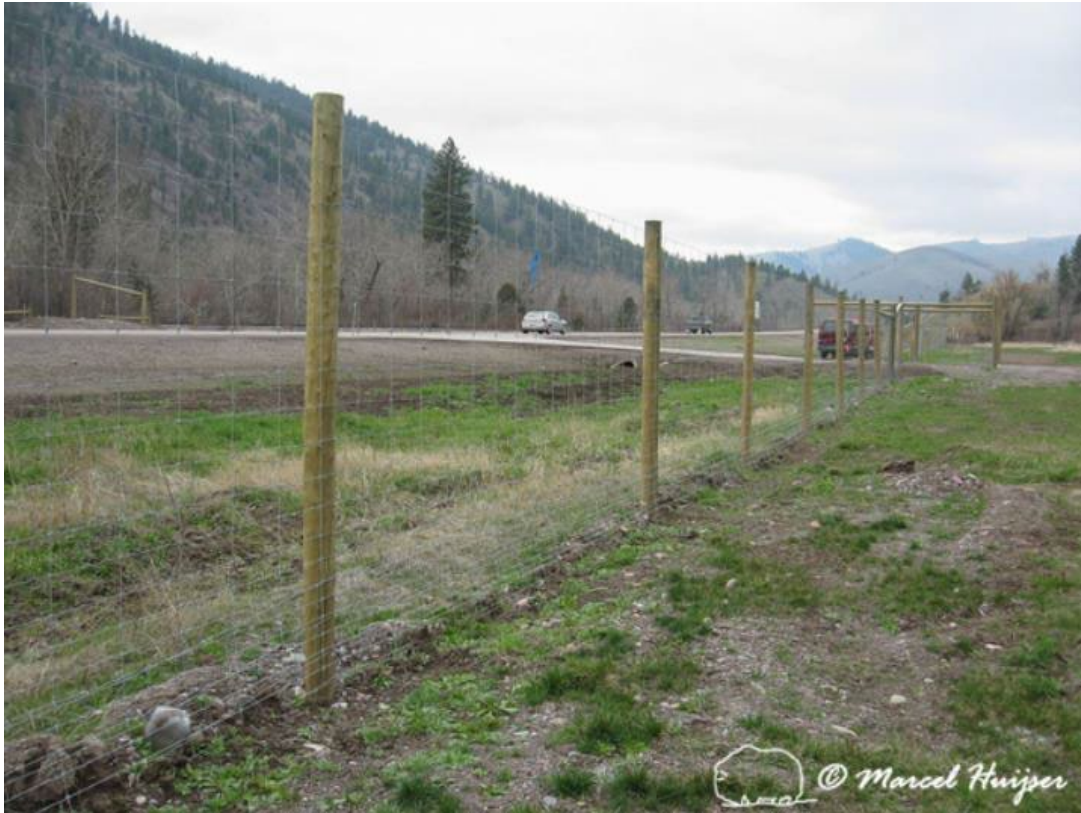
**Figure 35.** Typical large ungulate fence in North America, 8 ft tall, wooden posts and mesh-wire fence material, US Hwy 93 North, Montana, USA. Note that there is a dig barrier attached to the main fence material (e.g., for canids).

The recommended height is based on the jumping and climbing capabilities of a species, as well as tolerance or intolerance when some individuals breach the barrier. The material for the fence post depends on whether the species can climb wooden posts (metal recommended) or not (wood recommended), but the substrate (rocks) can also dictate the post material (Figure 35, 36). The fence material is based on the size of a species and whether they would be able to pass through the meshes. A dig barrier is usually a 4-5 ft wide galvanized chain-link fence that is attached to the bottom of the actual fence (Figure 37). The buried fence should extend approximately 3.5 ft (1.1 m) under the ground (Clevenger & Huijser 2011). An overhang is attached to the top of the main fence and angles towards the safe side of the fence (Figure 38). Species or individuals that climb a fence would also have to navigate the overhang to make it to the other side of the fence. Electric fences or electrified wires attached to mesh-wire or chain-link fences can also be considered in the design of a wildlife fence (Figure 39). Finally, a high-tensile top wire is recommended when trees are in the vicinity of the wildlife fence (Figure 40). High-tensile top wires can reduce the damage of a fallen tree and prevent a temporary gap in the fence.

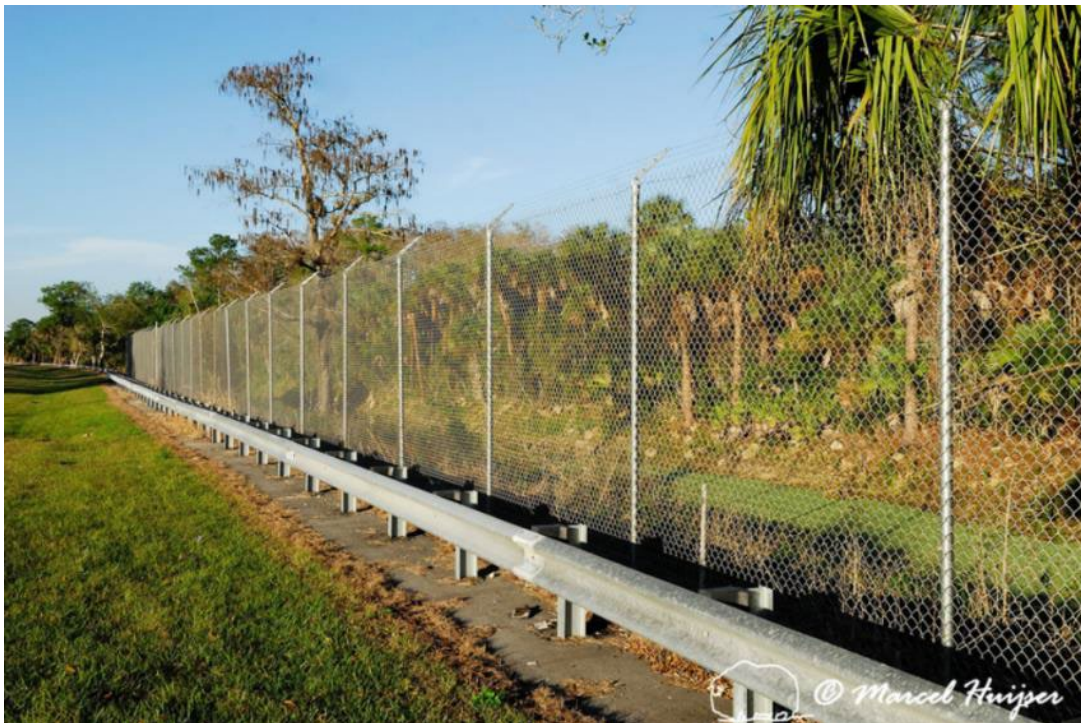
**Figure 36.** Fence for Florida panther (*Puma concolor coryi*), 10 ft tall, metal posts, chain-link fence material, and overhang or outrigger, SR 29, Florida, USA).

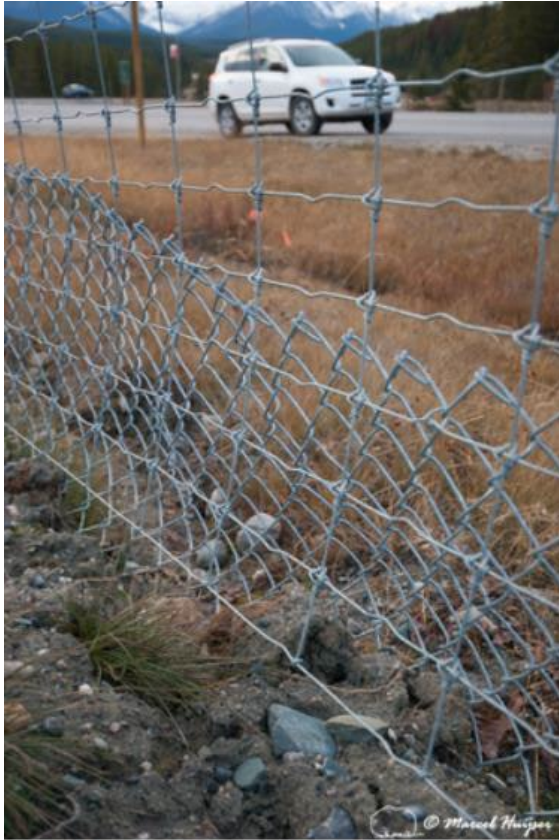
**Figure 37. Wildlife fence and dig barrier (“buried fence” or “apron”), Trans-Canada Highway, Banff National Park, Alberta, Canada. The dig barrier in the soil angles (45°) towards the safe side or habitat side; it angles away from the fence and the road on the other side (Clevenger and Huijser 2011). The dig barrier keeps animals from digging under the fence. The dig barrier may consist of a 4-5 ft (1.0-1.2 m) wide galvanized chain-link fence that is attached to the bottom of the actual fence. The buried fence should extend approximately 3.5 ft (1.1 m) under the ground (Clevenger and Huijser 2011).**

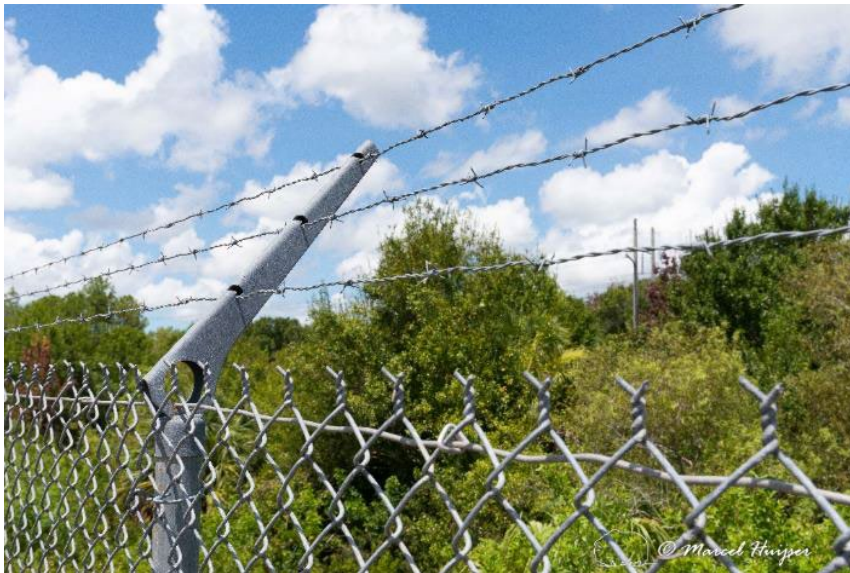
**Figure 38. Outrigger or overhang on a fence for Florida panther (*Puma concolor coryi*), SR 29, Florida, USA. Note that the outrigger faces the safe side, the habitat side of the fence. A longer overhang from chain-link fence material is suggested for red wolf.**

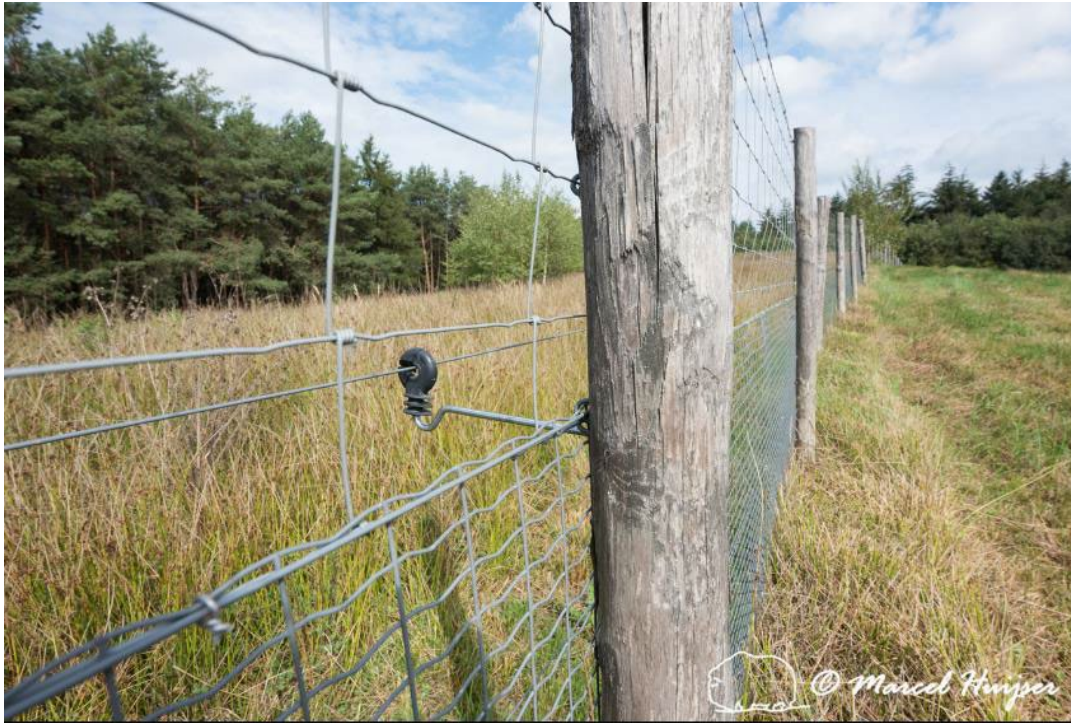
**Figure 39:** Wildlife fence along A28 motorway, near Spier, Drenthe, The Netherlands. The fence is a barrier for medium and large mammal species. The electrified wire is an additional barrier to keep animals out of the fenced road corridor.

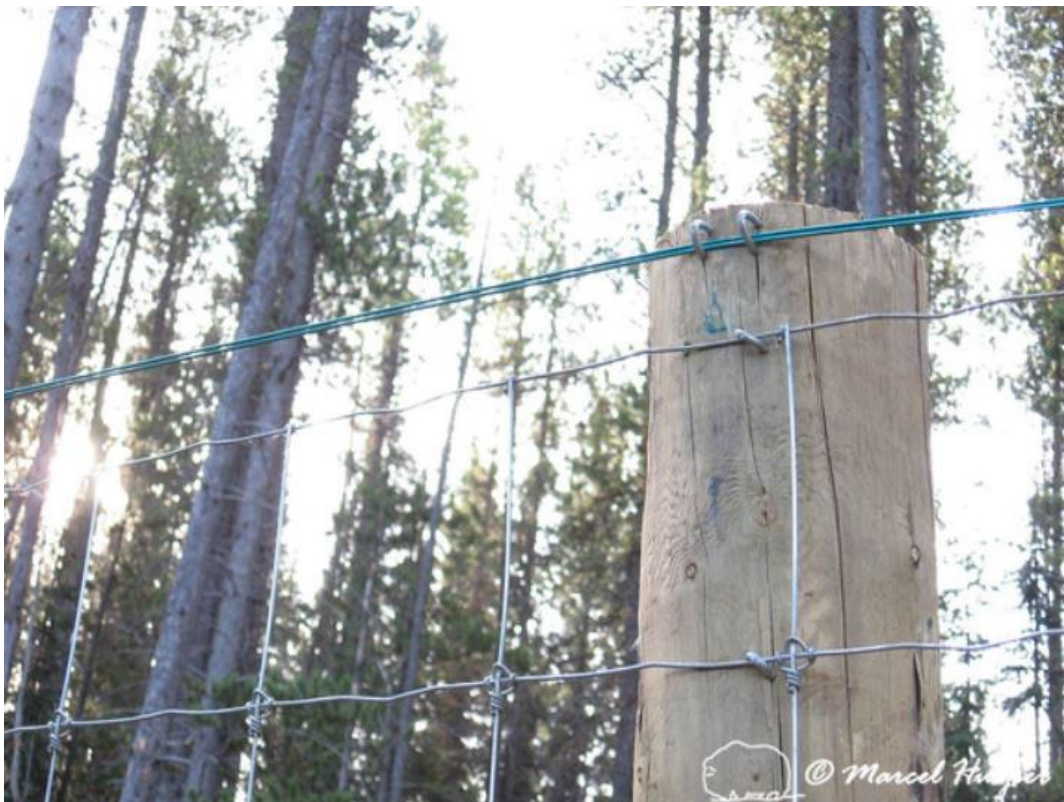
**Figure 40:** Wildlife fence with high-tensile top wire to reduce damage from falling trees, Trans-Canada Highway, Banff National Park, Alberta, Canada.

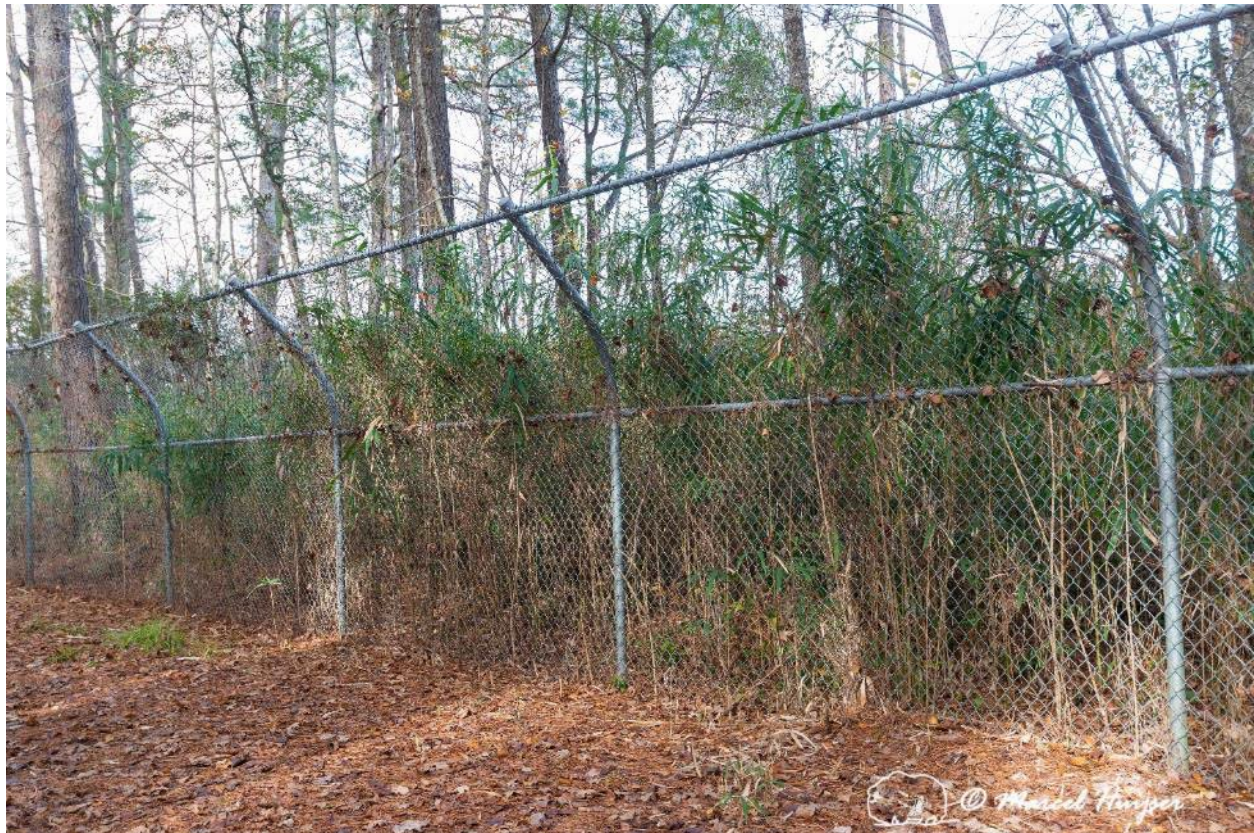
**Figure 41: Wildlife fence for red wolf, Red Wolf Center, Pocosin Lakes National Wildlife Refuge, North Carolina.**

An example of a fence that is specifically designed for keeping red wolves in captivity is from the Red Wolf Center in Columbia (Figure 41). This fence is about 10 ft high, has metal posts, chain-link fence material, is dug into the soil, and has a very large overhang, angled towards the holding pen of the red wolves. Fences for red wolves around pens are required to have an angled overhang of 3 feet (Pers. com. Joe Madison, NC Project Manager, Red Wolf Recovery Program). Coyotes and red wolves can and do go over the fence when the overhang is absent or damaged (Pers. com. Joe Madison, NC Project Manager, Red Wolf Recovery Program). This fence design is likely to be a substantial barrier for all large mammal species listed in Table 2.

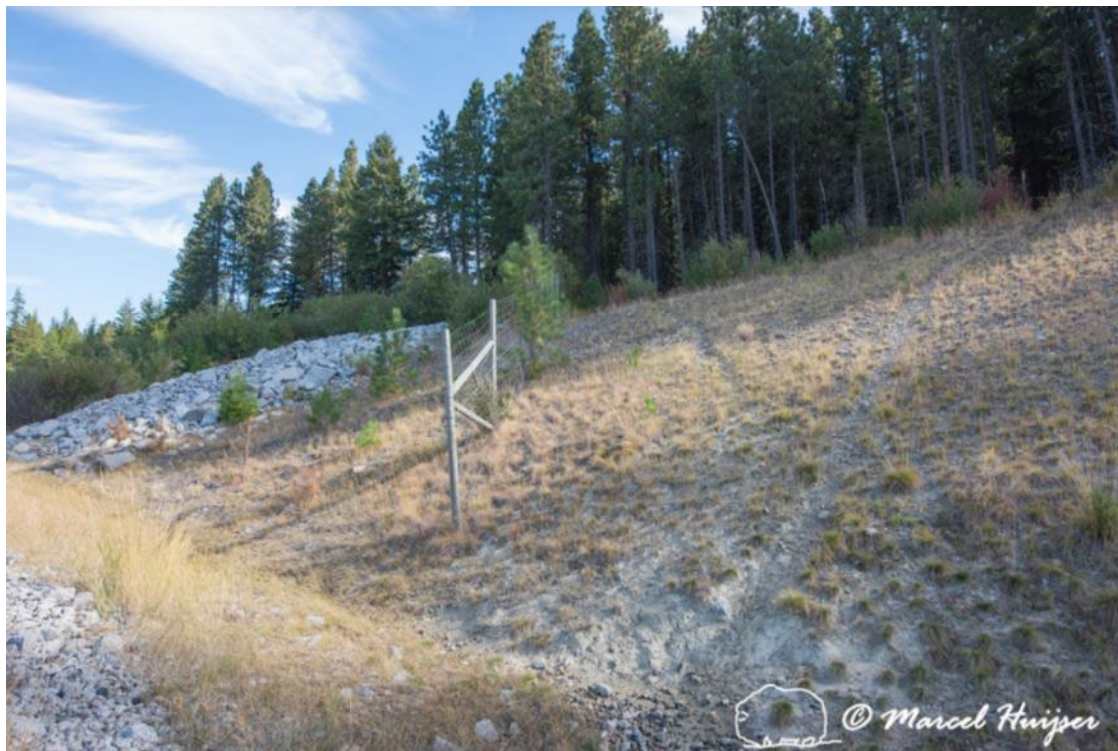
**Figure 42. Wildlife trail at a fence-end, US Hwy 95, Bonners Ferry, Idaho, USA. This is an indication that there is a concentration of wildlife crossings at the fence-end (a “fence-end run”), potentially resulting in a concentration of collisions at or near the fence-end, just inside or just outside the fenced road section.**

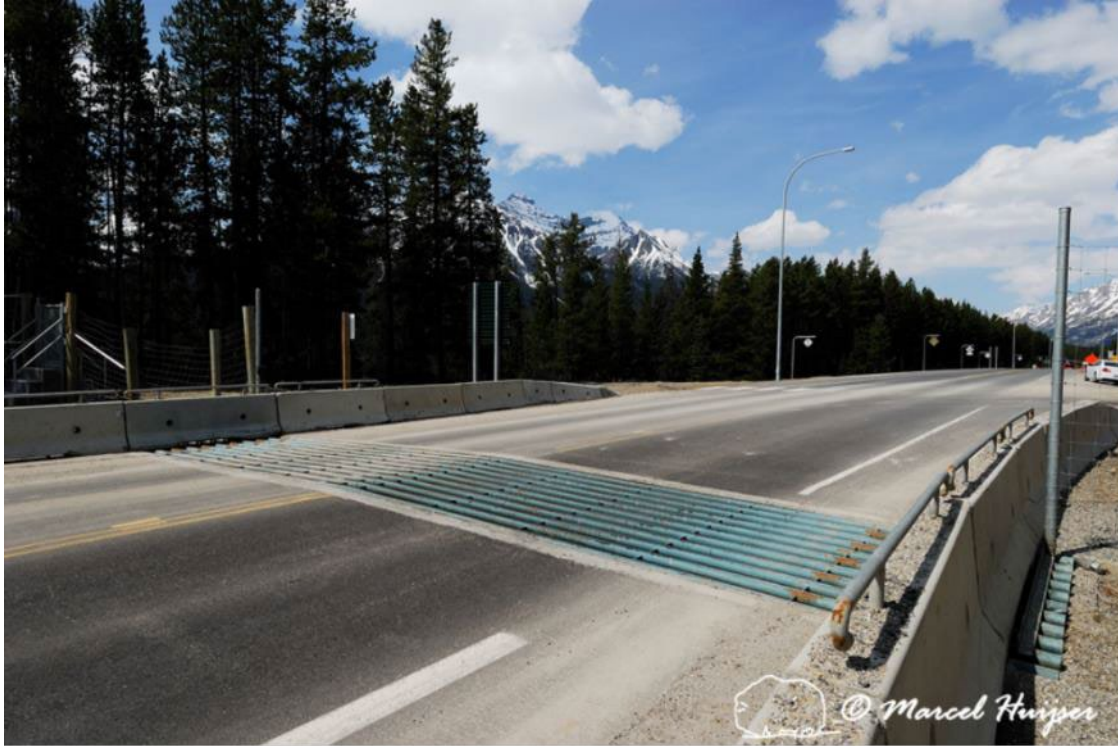
**Figure 43. Fence-end brought close to the edge of the pavement, protected by Jersey barriers. Also note that there is a wildlife guard embedded in the travel lanes, Alberta, Canada.**

- Fence-end treatments are especially important if the fenced road length is relatively short (e.g., shorter than 3 miles) (Huijser et al. 2016b). To reduce the likelihood of animals accessing the fenced road corridor at a fence-end, consider bringing the fence-ends close to the edge of the pavement, potentially in combination with a wildlife guard or electrified barrier embedded in the pavement (Figure 43, 44) (Allen et al. 2013, Huijser et al. 2022a). To further reduce the likelihood of animals getting on the road at or near a fence-end, consider angling the fence away from the road at the fence-end. This may encourage animals to turn back into the surrounding area, walk back along the fence and potentially find and use a suitable wildlife crossing structure, or it may result in them crossing the road further away from the fence-end. A split fence-end is possible where the other fence-end angles towards the road.

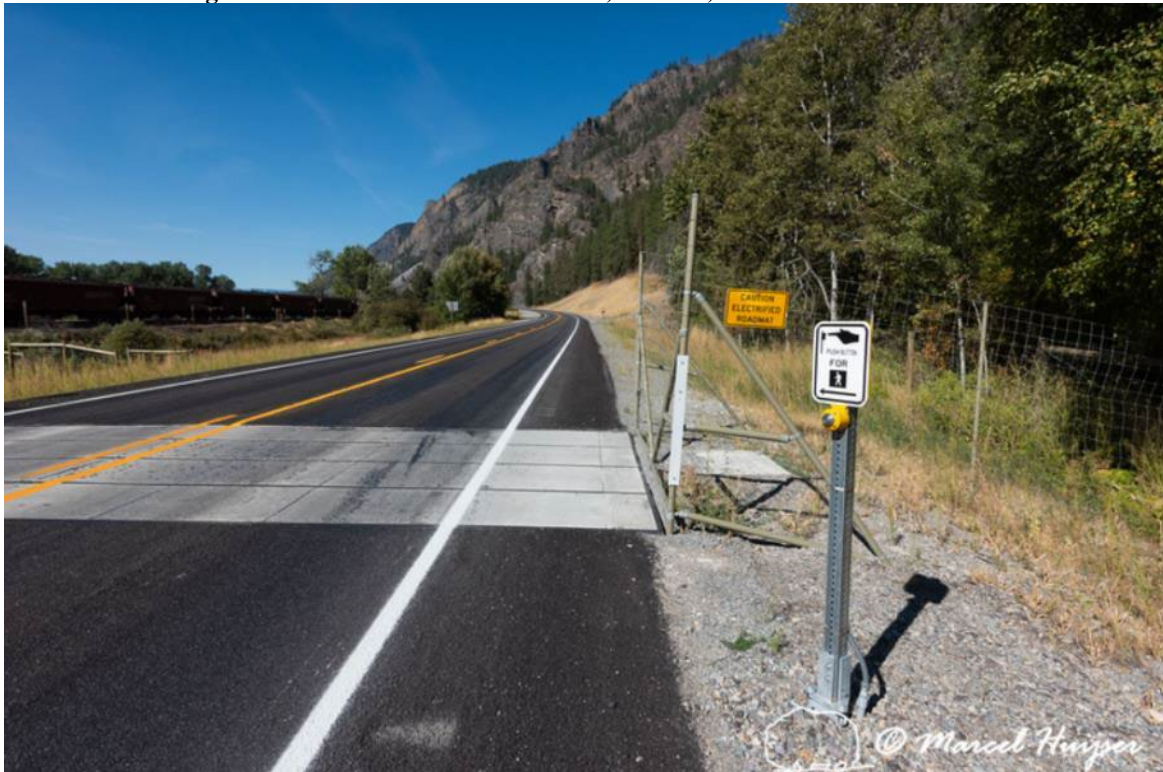
**Figure 44. Electrified barrier embedded in travel lanes to keep large mammals, including bighorn sheep, out of fenced road corridor, MT Hwy 200, Thompson Falls, Montana, USA.**

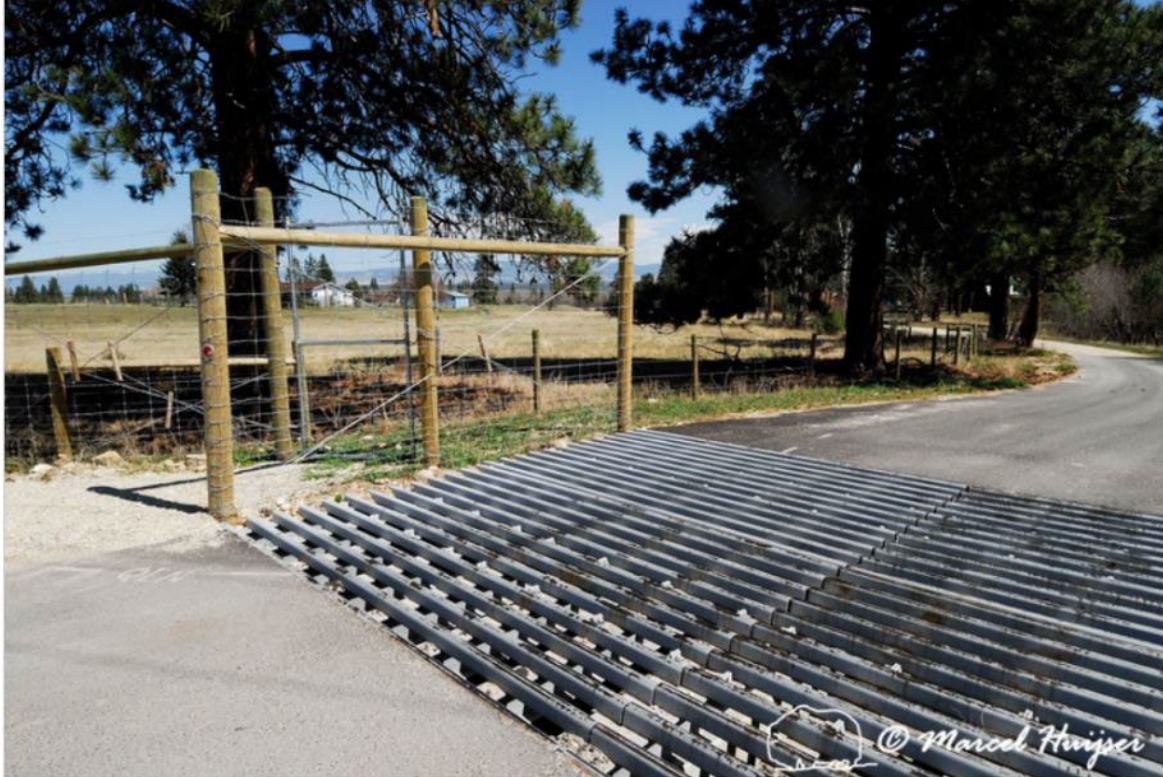
**Figure 45.** Wildlife guard at an access road to US Hwy 93S, near Victor, Montana, USA. This type of wildlife guard is less suited for pedestrians and cyclists.

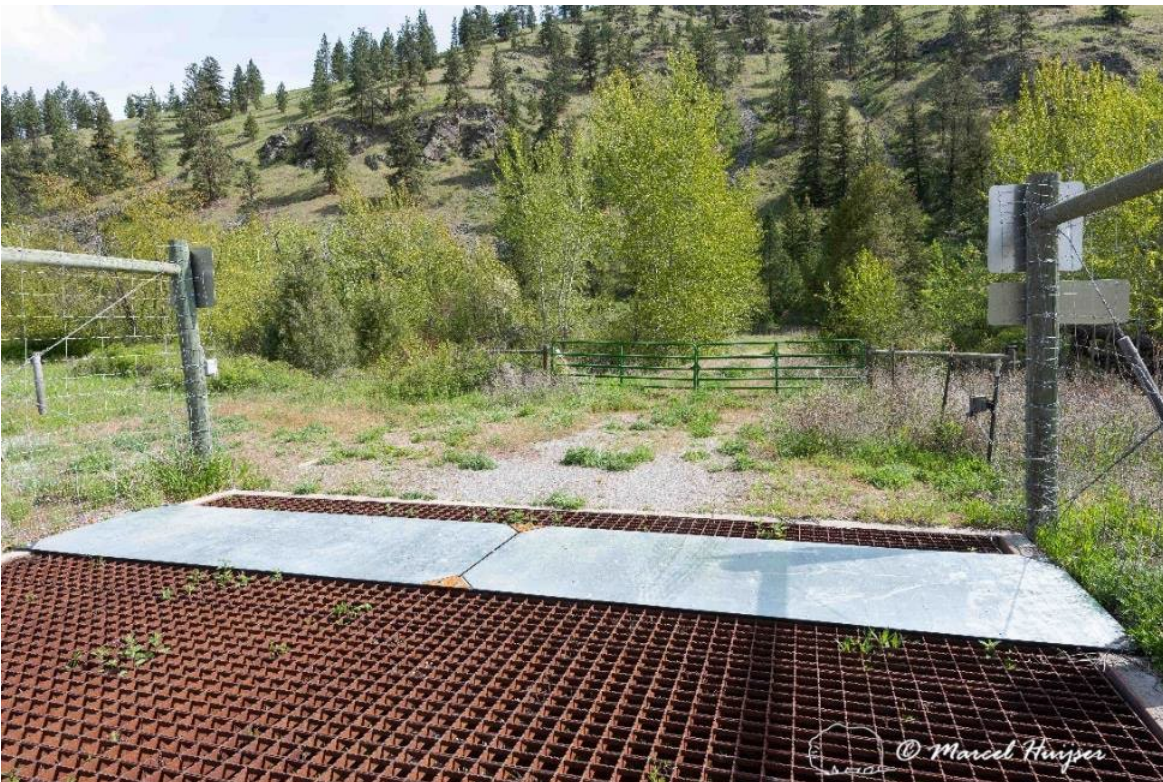
**Figure 46.** Electrified barrier, designed for low traffic volume and low traffic speed, on top of a wildlife guard at an access road to US Hwy 93S, near Ravalli, Montana, USA.

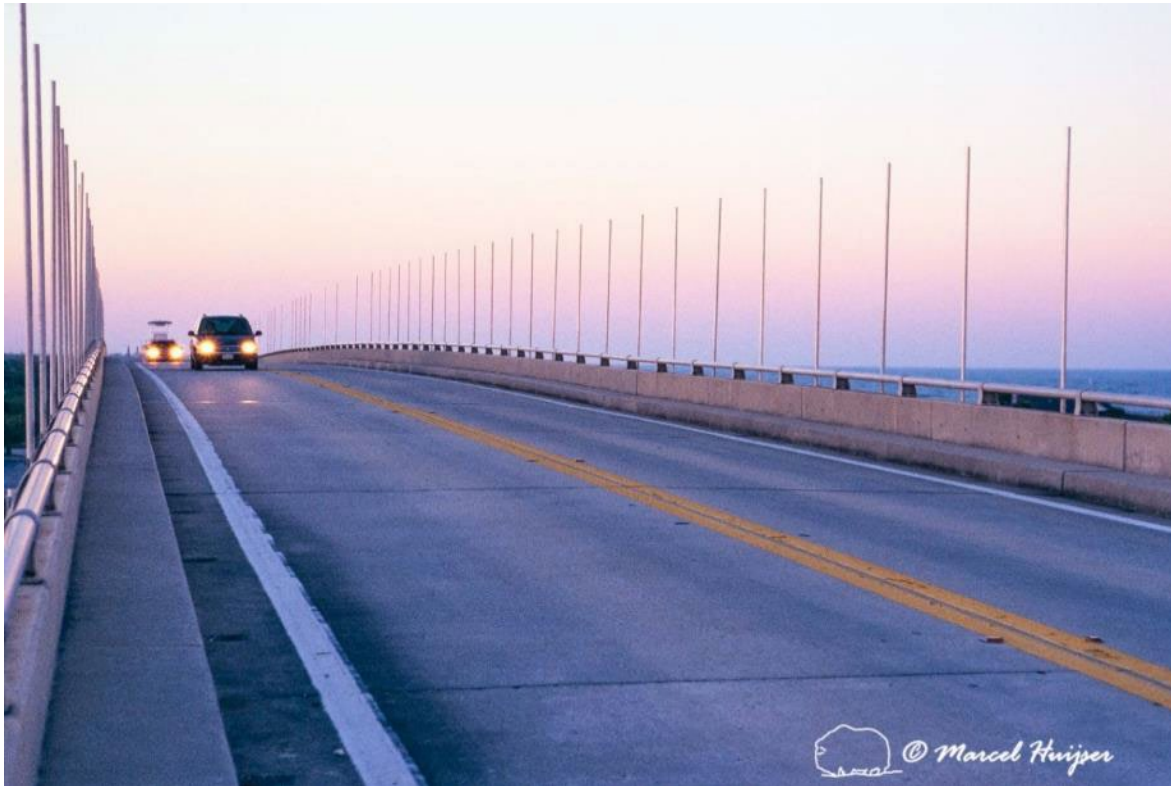
**Figure 50: Metal poles attached to bridge to reduce bird-vehicle collisions by making the birds fly higher, State Road A1A, Sebastian Inlet State Park, Florida.**

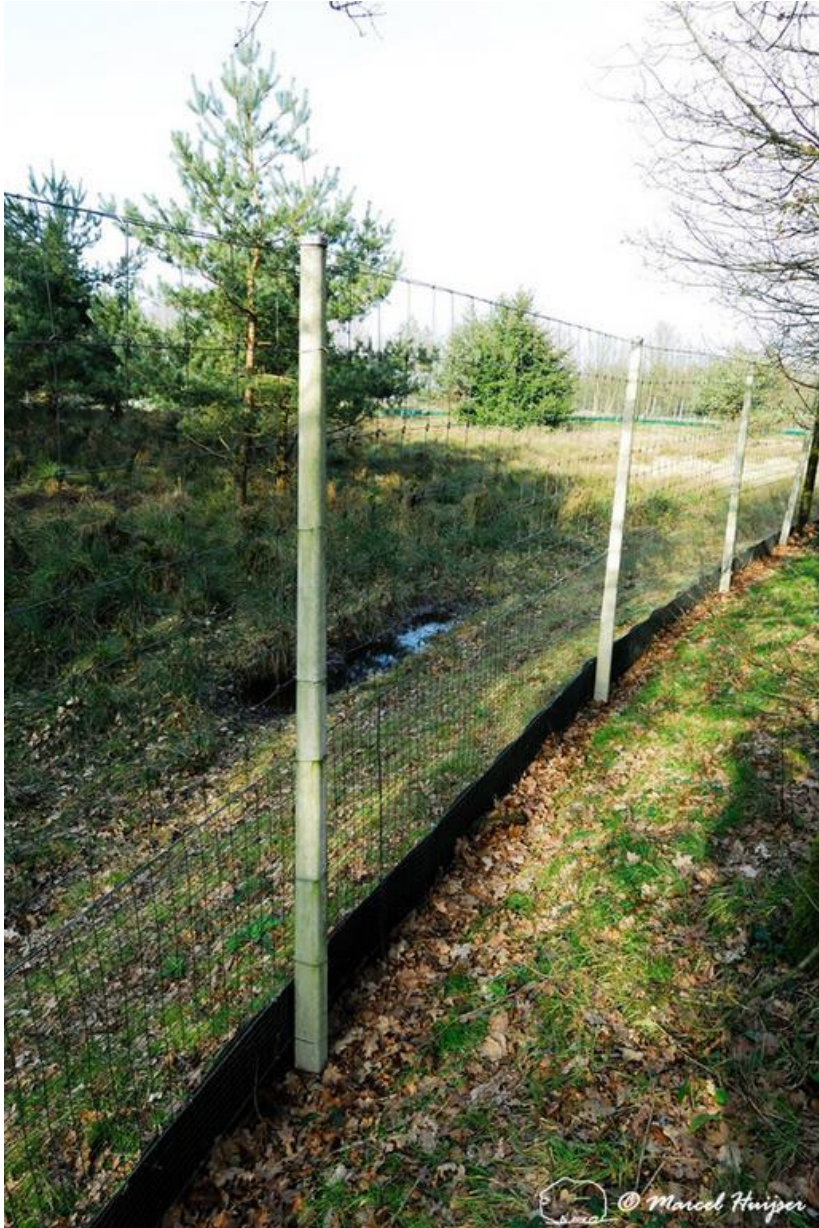
Figure 51. Wildlife fence for amphibians (e.g., common toad (*Bufo bufo*)), medium sized mammals (e.g., Eurasian badger (*meles meles*)) and large ungulates (e.g., roe deer (*Capreolus capreolus*), red deer (*Cervus elaphus*)) at ecoduct Woeste Hoeve A50 near Apeldoorn, The Netherlands.

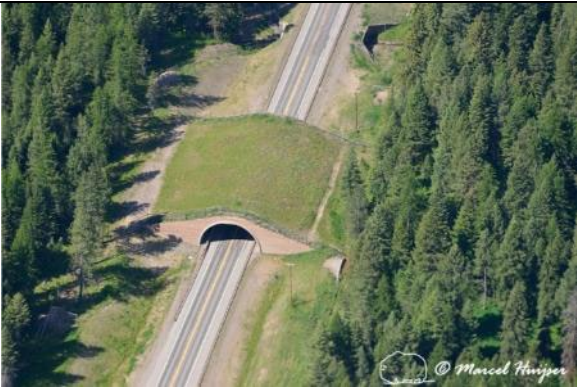
| Safe Crossing Opportunity type | Indicative dimensions (as seen by the animals) | Image |
|---|---|---|
| Wildlife overpass | 50-70 m wide | |

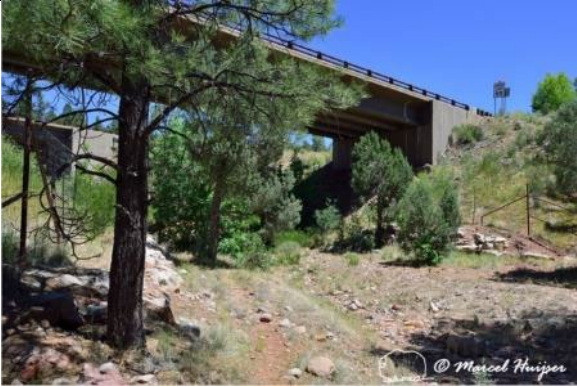
| Safe Crossing Opportunity type | Indicative dimensions (as seen by the animals) | Image |
|---|---|---|
| Open span bridge | 12-30 m wide, $\geq 5$ m high | |

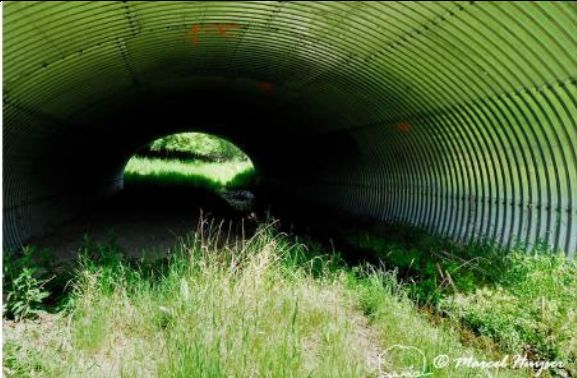
| Safe Crossing Opportunity type | Indicative dimensions (as seen by the animals) | Image |
|---|---|---|
| Large mammal underpass | 7-8 m wide, 4-5 m high | |

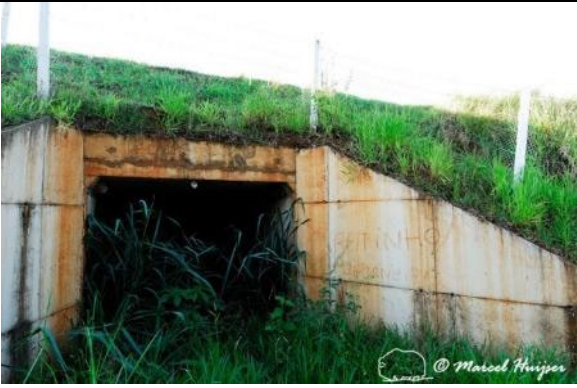
| Safe Crossing Opportunity type | Indicative dimensions (as seen by the animals) | Image |
|---|---|---|
| Medium mammal underpasses | 0.8-3 m wide, 0.5-2.5 m high | |

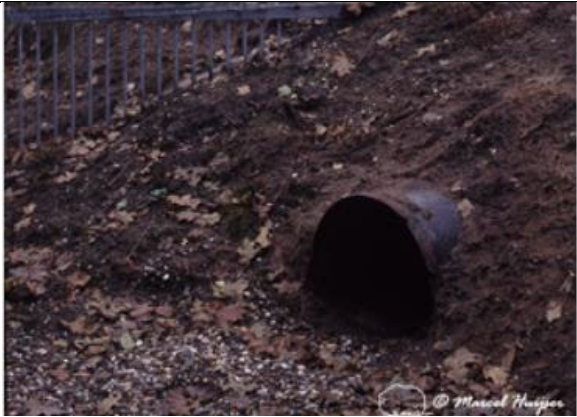
| Safe Crossing Opportunity type | Indicative dimensions (as seen by the animals) | Image |
|---|---|---|
| Small-medium mammal pipes | 0.3-0.6 m in diameter | |

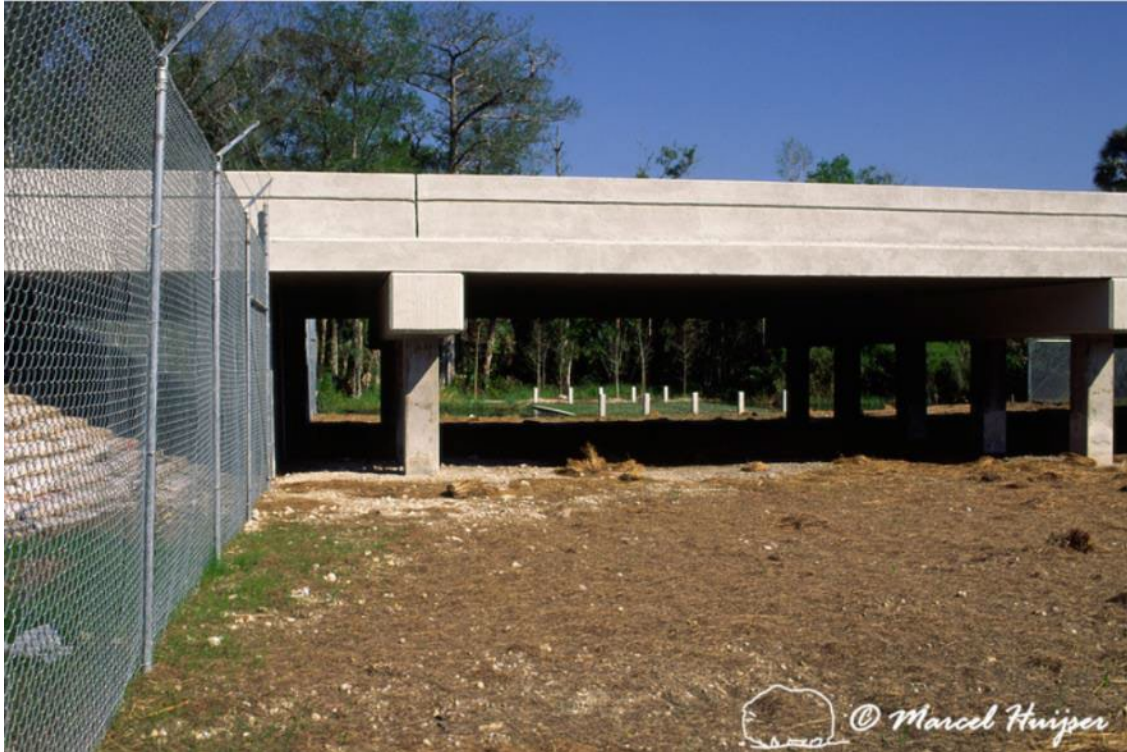
Figure 52: Wildlife underpass for Florida panthers (*Puma concolor coryi*), about 119 ft (36 m) wide (but only 21-26 m wide at grade level) and about 10-13 ft (3-4 m) high, just after construction in 1998, SR 29, Florida, USA.

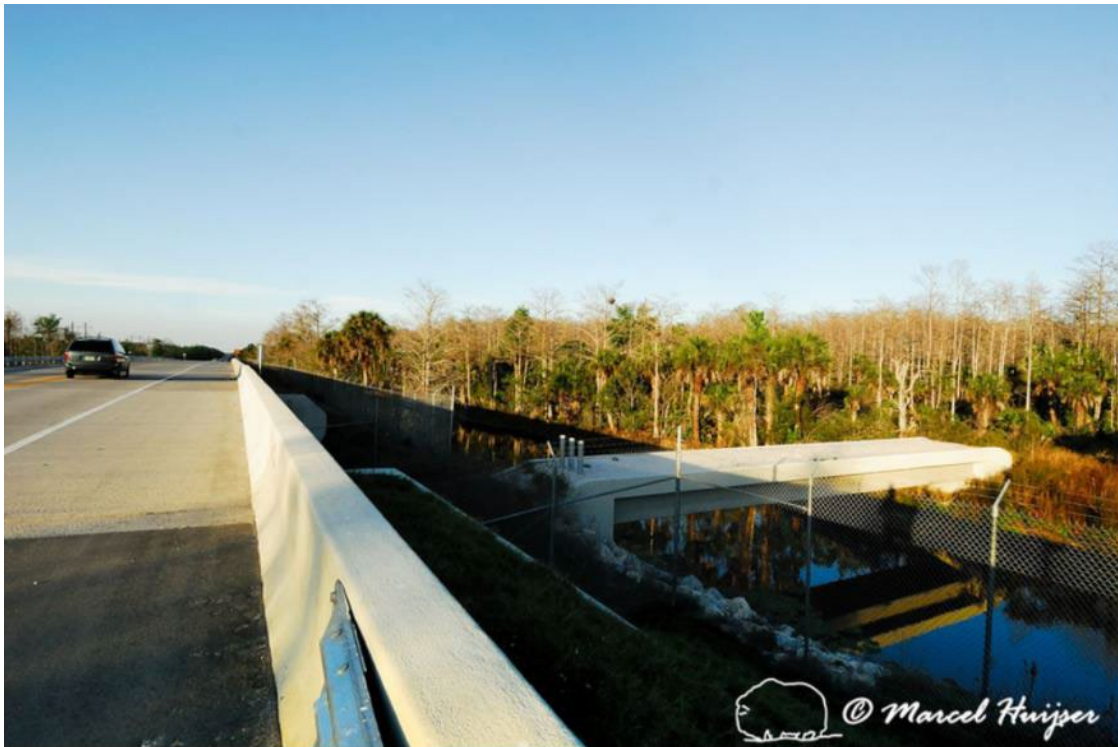
Figure 53: Wildlife underpass for Florida panthers (*Puma concolor coryi*) (on the left, under the road), and a wildlife bridge across canal leading up to the underpass (on the right), SR 29, Florida, USA.

Both wildlife overpasses and underpasses may be considered for the roads in the ENC RWP area. If underpasses are considered, the design of underpasses built for in Florida, primarily for the Florida panther, may be also applicable for the roads in the ENC RWP area (Figure 52, 53, 54). The roadbed is elevated on the approaches, followed by a bridge of about 119 ft (36 m) wide and 1-13 ft (3-4 m) high (Foster & Humphrey 1995). Many road sections in the ENC RWP area have a canal adjacent to the road, similar to some of the structures for the Florida panther in South Florida. Consider making the bridge across canals the same width as the wildlife crossing structure under the road rather than having much narrower bridges across canals.
