# **Impacts of Roads and Traffic on the Red Wolf: Potential Avoidance, Mitigation and Compensation Strategies**

FINAL REPORT

Western Transportation Institute - Montana State University,  
PO Box 174250, Bozeman, MT 59717-4250, USA

September, 2023

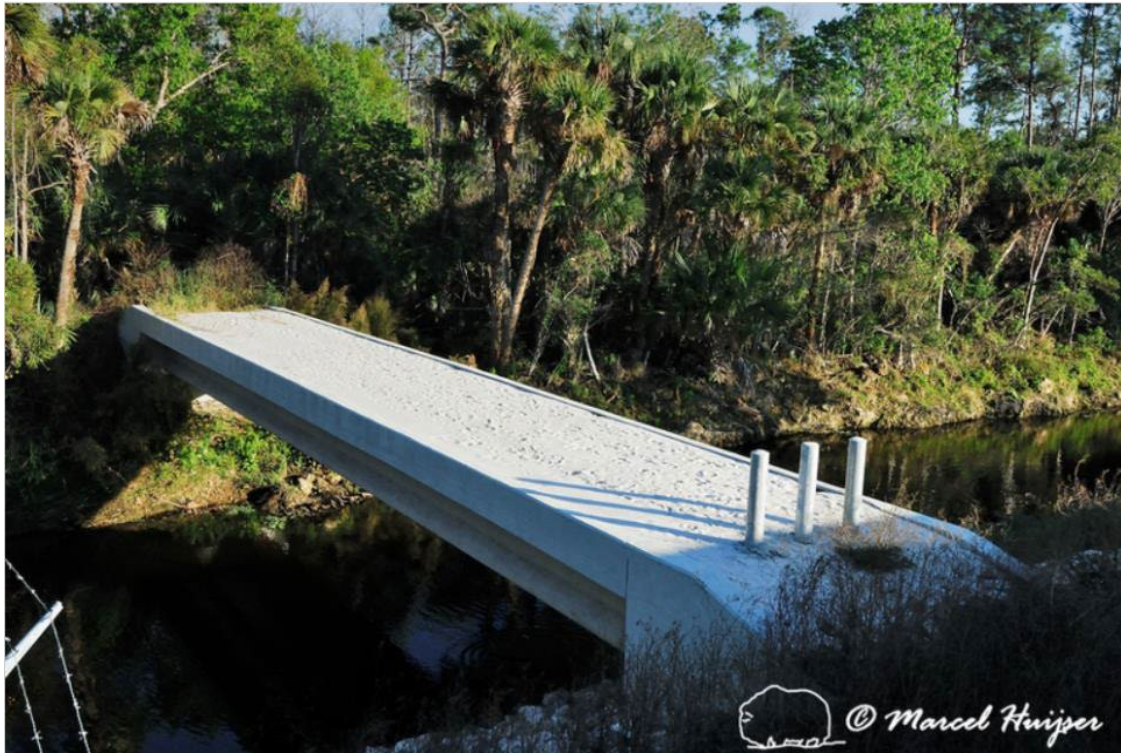
**Figure 54: Wildlife underpass for Florida panthers (*Puma concolor coryi*) (to the right, outside of image) and a wildlife bridge across canal, SR 29, Florida, USA. Note that the posts on the bridge block illegal use of motorized vehicles such as ATVs.**

Both wildlife overpasses and underpasses may be considered for the roads in the ENC RWP area. If underpasses are considered, the design of underpasses built for in Florida, primarily for the Florida panther, may be also applicable for the roads in the ENC RWP area (Figure 52, 53, 54). The roadbed is elevated on the approaches, followed by a bridge of about 119 ft (36 m) wide and 1-13 ft (3-4 m) high (Foster & Humphrey 1995). Many road sections in the ENC RWP area have a canal adjacent to the road, similar to some of the structures for the Florida panther in South Florida. Consider making the bridge across canals the same width as the wildlife crossing structure under the road rather than having much narrower bridges across canals.

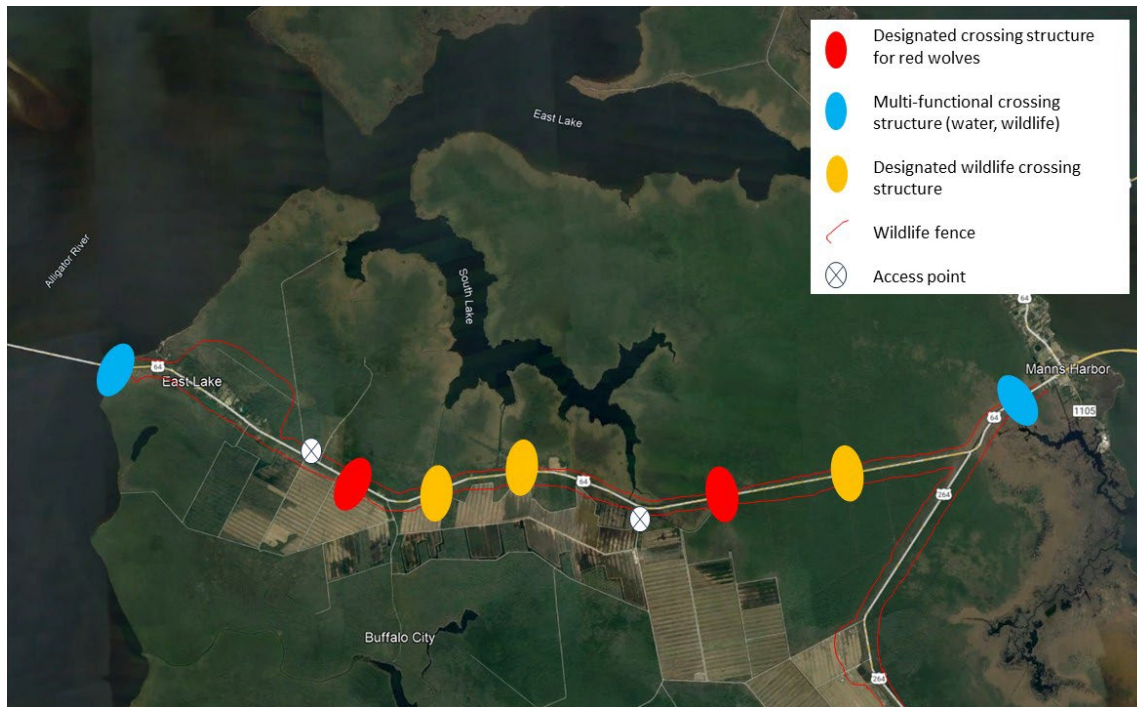
**Figure 55: US Hwy 64, suggested crossing structures, wildlife fence, and access points, Alligator River NWR, North Carolina.**

- In general, it is considered bad practice to only implement wildlife fences. In general, wildlife fences should be combined with wildlife crossing structures that are in the correct locations (Figure 55) and are of the right type and dimensions for the target species that may be affected by the road, traffic, and the wildlife fence.

structure near River Rd and Buffalo City Rd. (Figure 55, 56, 57) and one east of Milltail Rd. (Figure 55, 58, 59). Both locations have a history of red wolf crossings (and direct road mortality) and both locations have a history of a concentration of birth locations. The road length of US Hwy 64 through Alligator River National Wildlife Refuge is about 12-13 miles. Given a home range diameter of about 5-7 miles, this would suggest that potentially 2 packs would be present, each would have 1 suitable crossing structure in their territory. This would make the area north of the highway accessible to red wolves. However, facilitating dispersal of red wolves north of US Hwy 64 is not the main objective for this road section; there is no historic evidence for the presence of birth locations in Alligator River National Wildlife Refuge north of US Hwy 64 as the area may be too small and not may not have sufficient prey (wetlands, forest).

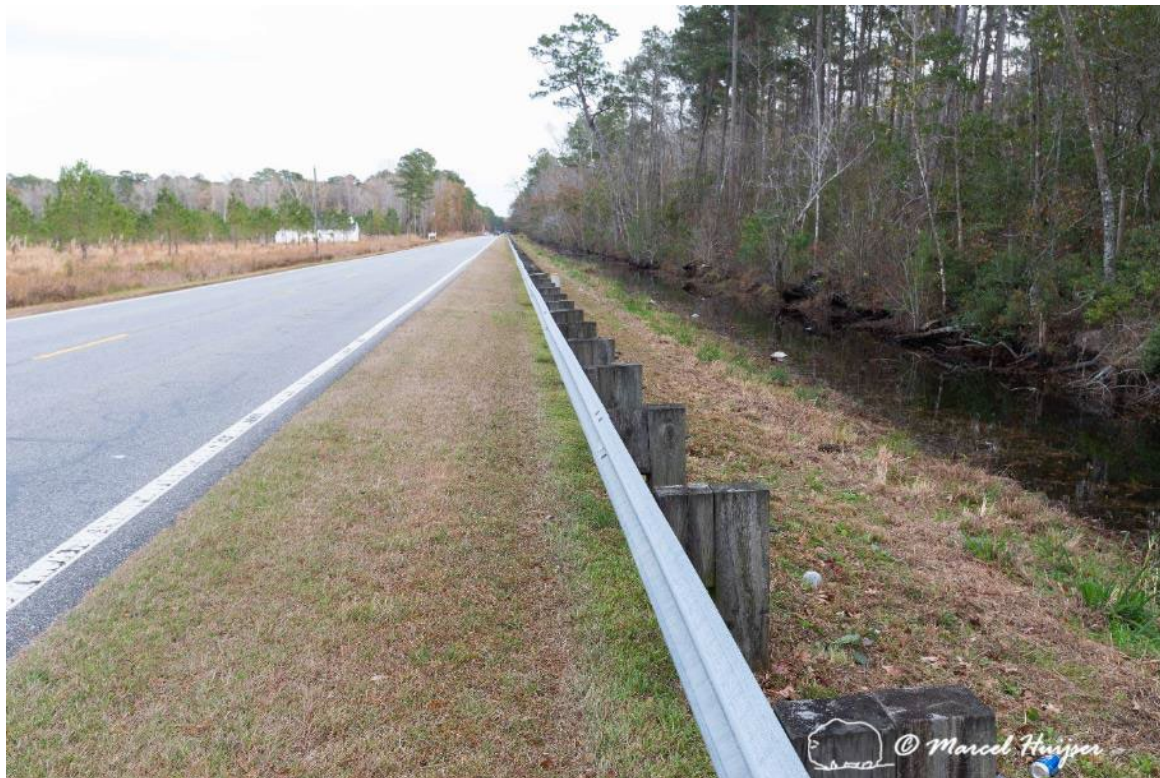
**Figure 56: US Hwy 64, near Lake Neighborhood Rd, North Carolina.**

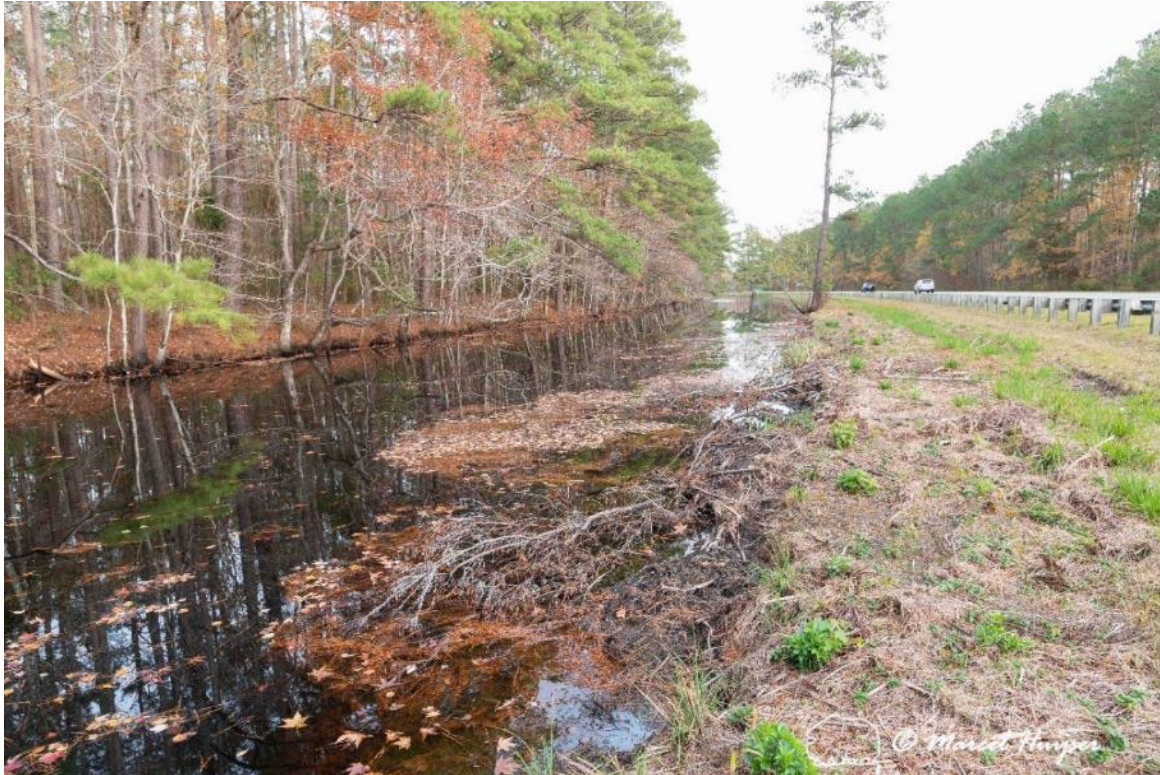
**Figure 57: US Hwy 64 and adjacent canal at Buffalo City Rd., Alligator River National Wildlife Refuge, North Carolina.**

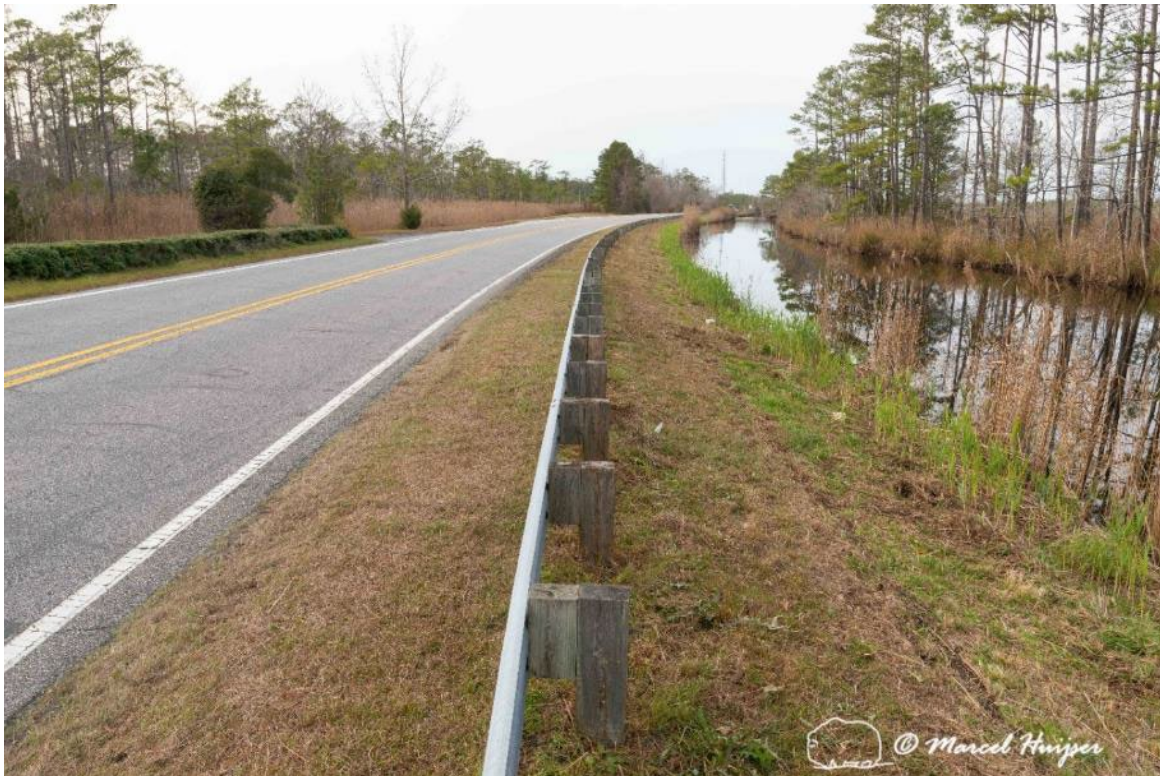
**Figure 58: US Hwy 64 and adjacent canal at Milltail Rd, Alligator River National Wildlife Refuge, North Carolina.**

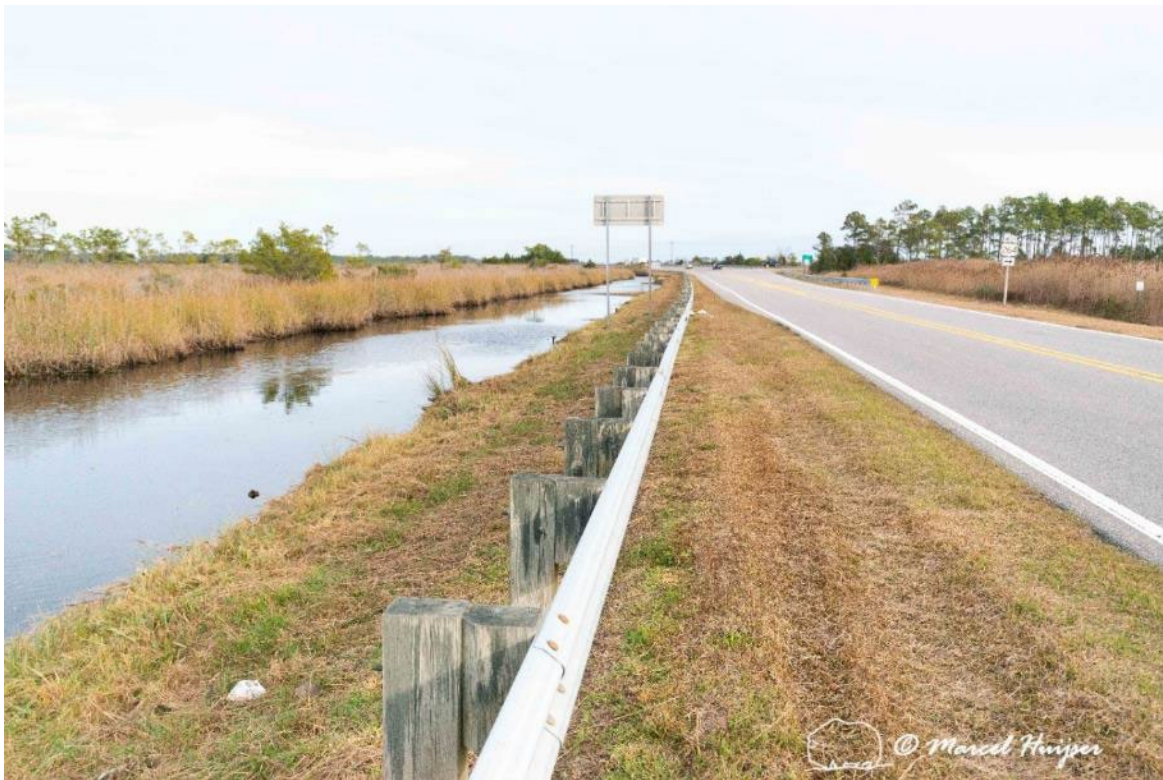
**Figure 59: US Hwy 64 and adjacent canal, just west of the junction with US Hwy 264, Alligator River National Wildlife Refuge, North Carolina.**

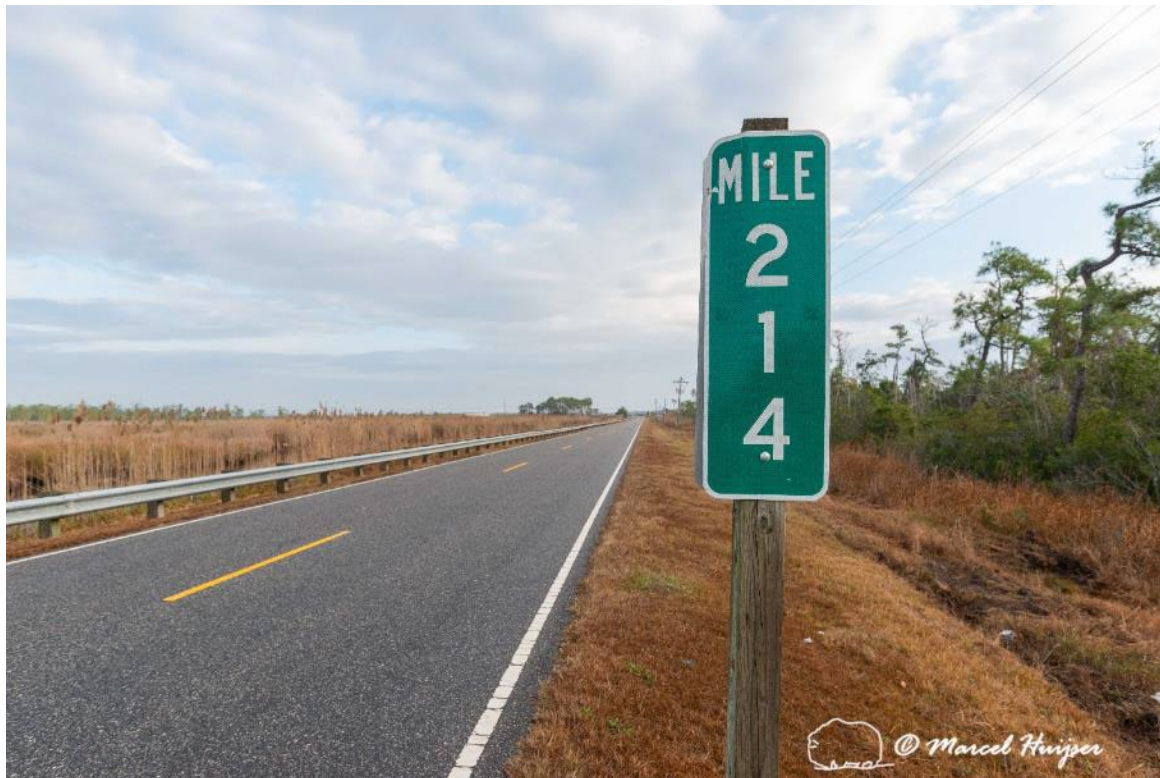
Figure 61: US Hwy 264, near the junction with US Hwy 64, Alligator River NWR, North Carolina.

- This road section is close to the Milltail area which is an important birth location for red wolves. To reduce the likelihood of direct red wolf mortality, a 10 ft (3 m) tall chain-link wildlife fence with metal poles can be implemented (Figure 61, 62). For the red wolves in the Milltail area, the fence should be extended to south of Borrow Pit Rd. For red wolf conservation in general, the entire length of US Hwy 264 should be fenced.

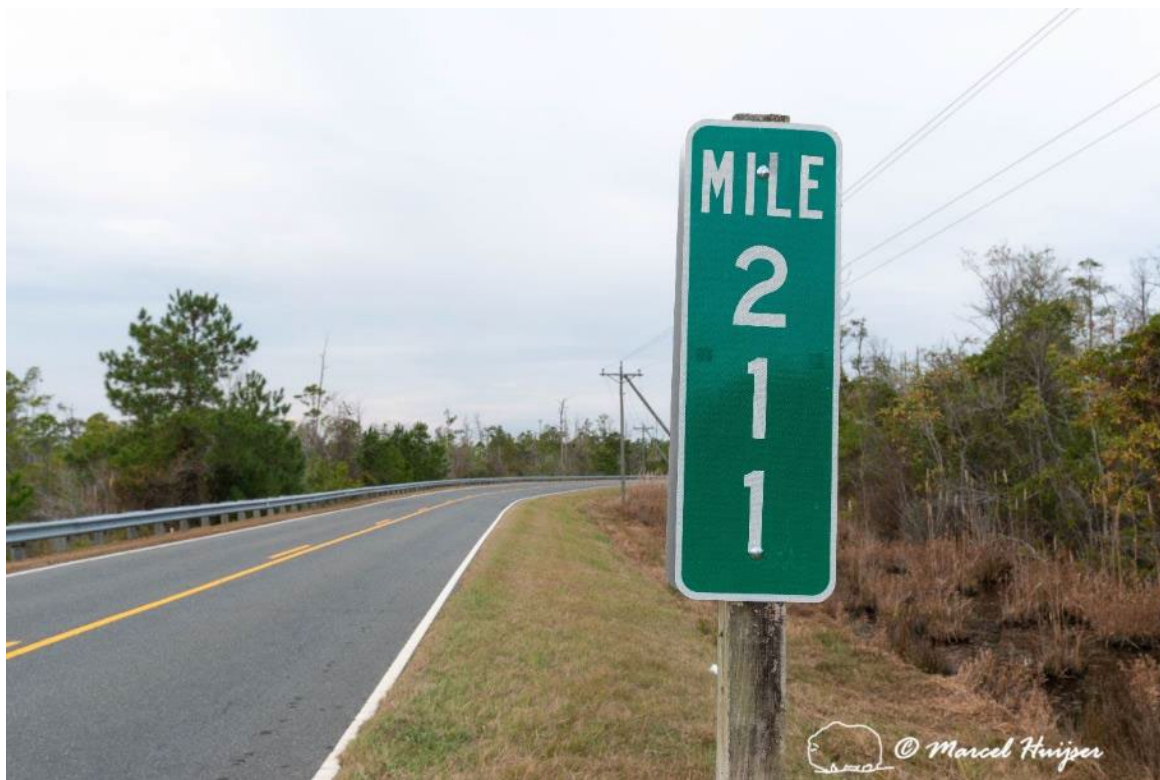
Figure 62: US Hwy 264, near Cub Rd., Alligator River NWR, North Carolina.

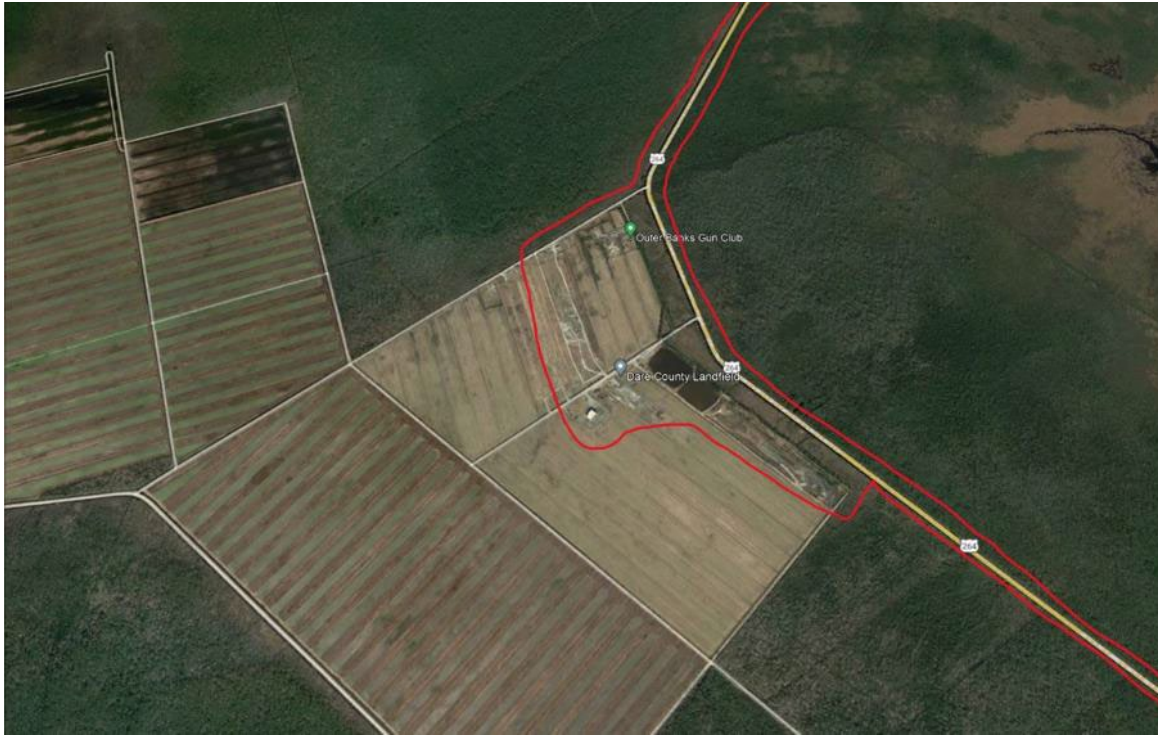
**Figure 63: US Hwy 264, suggested wildlife fence around the landfill and gun club, Alligator River NWR, North Carolina.**

- Potentially include the landfill and the gun club in the fenced road corridor; i.e., make these areas inaccessible to red wolves (Figure 63). This will “cost” habitat, but it will also reduce human-wildlife conflict and habituation of red wolves which can be hazardous to them in the long-term and at other locations after dispersal. Naturally, this will also result in habitat loss for other large mammal species for which the fence is a barrier. Alternatively, smaller areas can be fenced around the two facilities, but then wildlife guards and associated electrified barriers would have to be implemented at the access points.

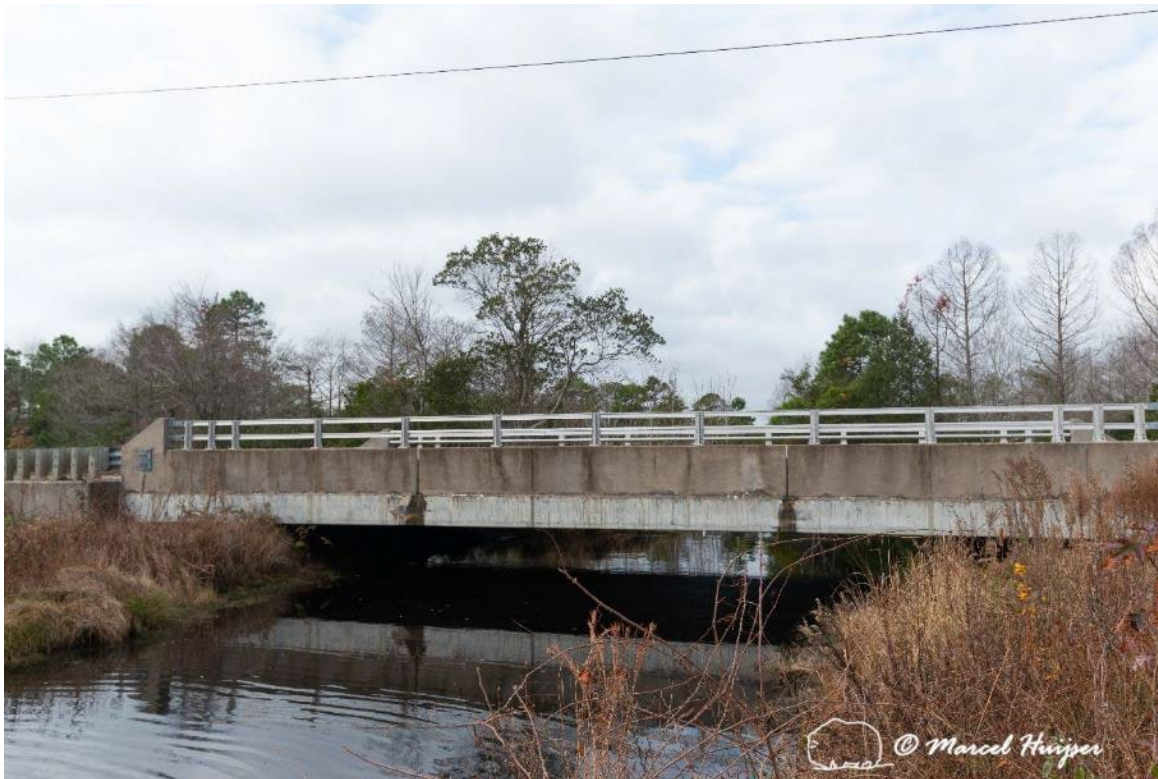
- Existing structures in the area are typically for canals (Figure 64). These structures have no or almost no dry space, and have very low clearance. These structures are not suitable for large terrestrial mammals.

**Figure 64: US Hwy 264, bridge at Point Peter Rd, Alligator River NWR, North Carolina.**

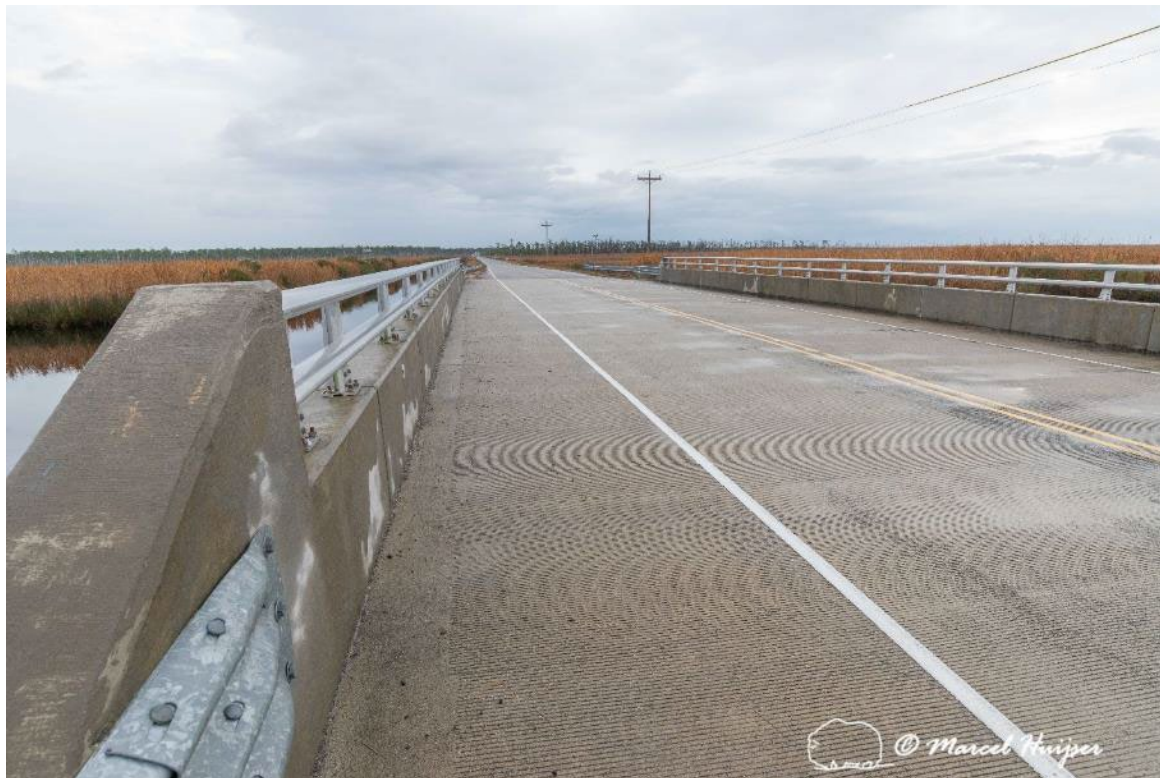
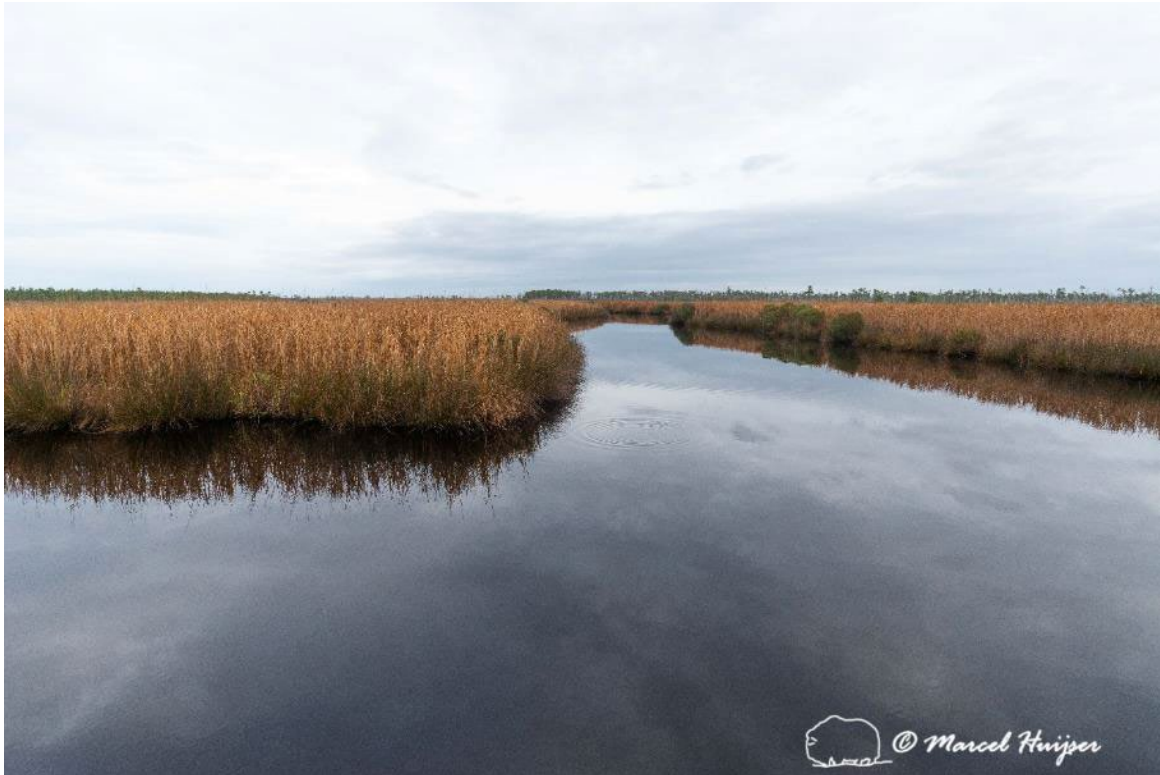
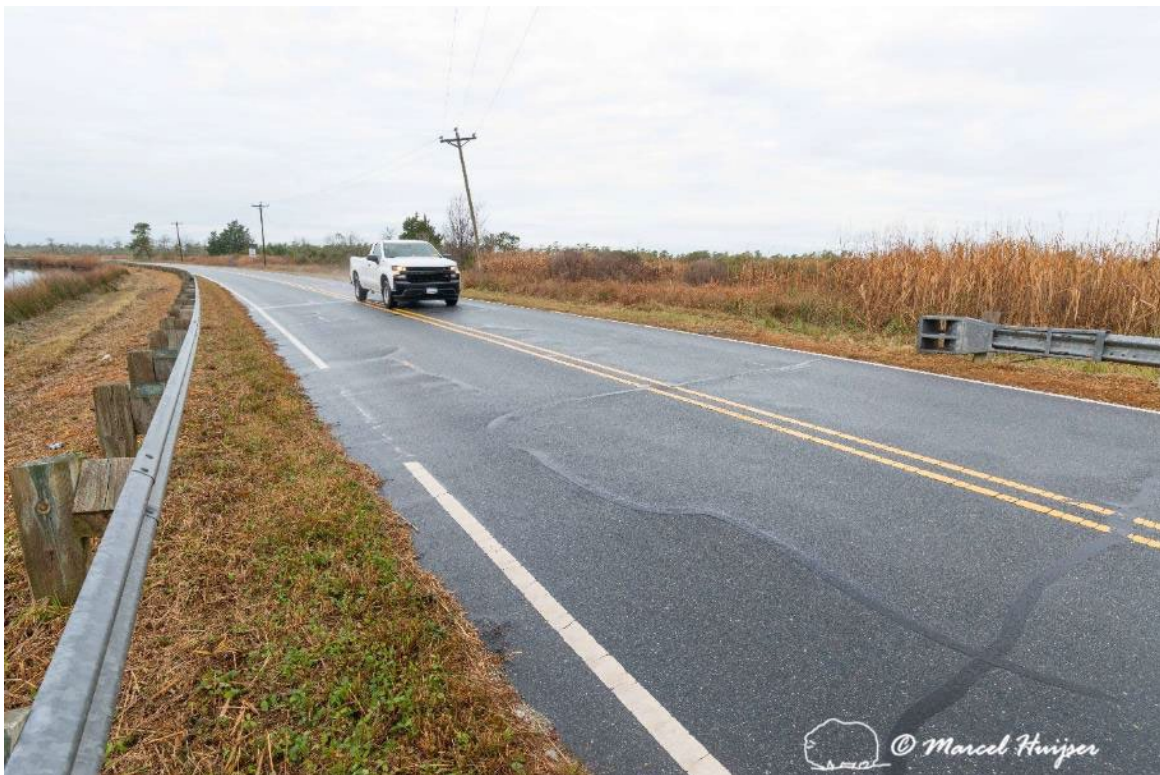
- This area is mostly a wetland. It is possible that the Long Shaol River or Stomper Rd. guides the red wolves to US Hwy 264 (Figure 65, 66, 67).
- Given the relatively low traffic volume in this area (400-550 AADT), general road reconstruction because of human safety or traffic congestion is unlikely. Mitigation measures will likely have to be a stand-alone project.

Figure 65: US Hwy 264, at Long Shaol River, Alligator River National Wildlife Refuge, North Carolina.

Figure 66: US Hwy 264, at Long Shaol River, Alligator River National Wildlife Refuge, North Carolina.

Figure 67: US Hwy 264, at Long Shaol River, Alligator River National Wildlife Refuge, North Carolina.

- To reduce the likelihood of direct red wolf mortality, a 10 ft (3 m) tall chain-link wildlife fence with metal poles along the entire length (both sides of the highway) is recommended.

- In general, if a wildlife fence is implemented, it should be accompanied by wildlife crossing structures.
- The existing bridge may be made suitable with pathways for large terrestrial mammal species.

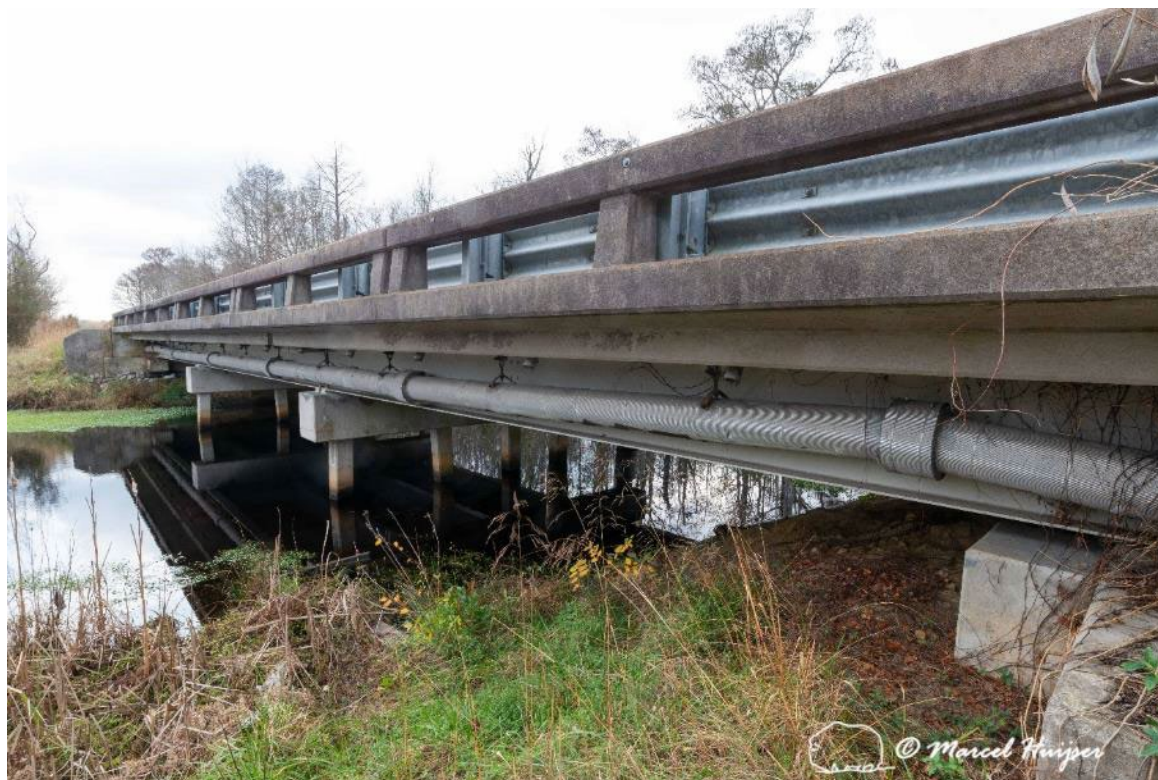
- The bridge across Riders Creek (Figure 72) is currently not suitable for large terrestrial mammals.

**Figure 72: Hwy 94, Bridge across Riders Creek, north of junction with Frying Pan Rd., North Carolina.**

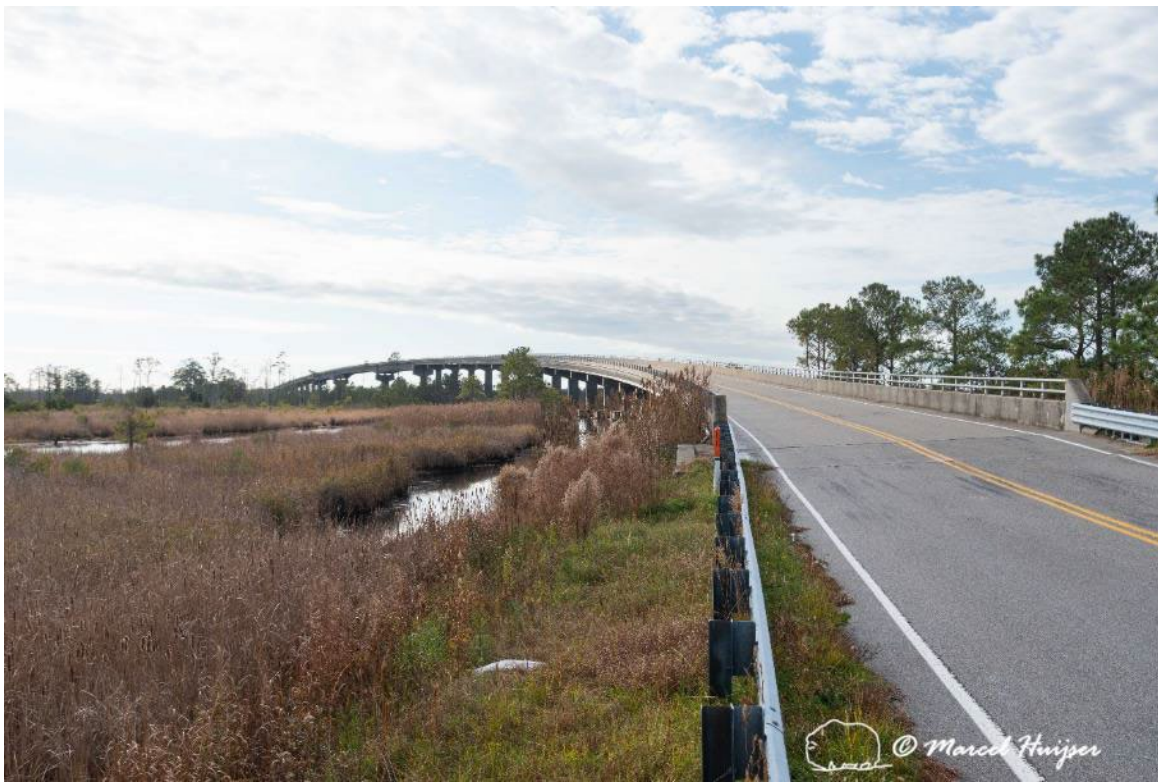
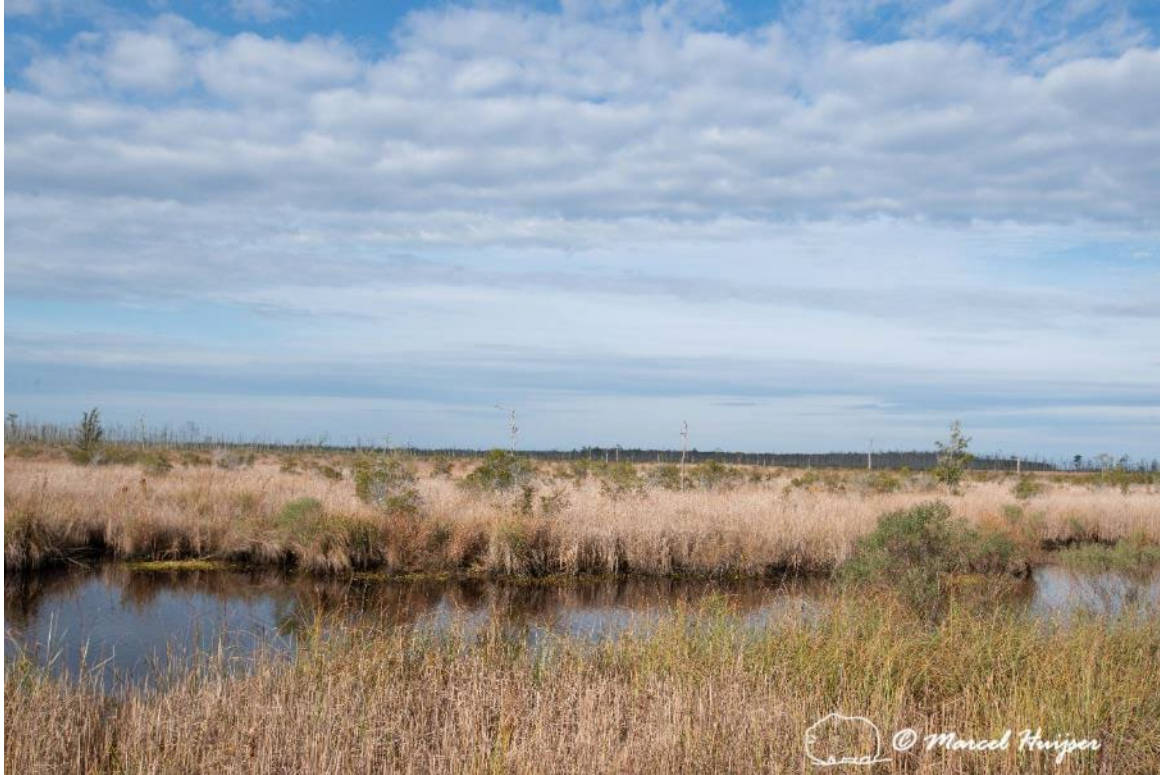
- The bridge across the intracoastal waterway is not suited for red wolves as the habitat is wetlands (Figure 77, 78). Only if the approaches would extend into the dry areas, and if there would be a proper height, could the structure be made functional for red wolves.

**Figure 77: Hwy 94, bridge across Intracoastal Waterway, north of Fairfield, North Carolina.**

**Figure 78: Wetlands adjacent to Hwy 94, bridge across Intracoastal Waterway, north of Fairfield, North Carolina.**

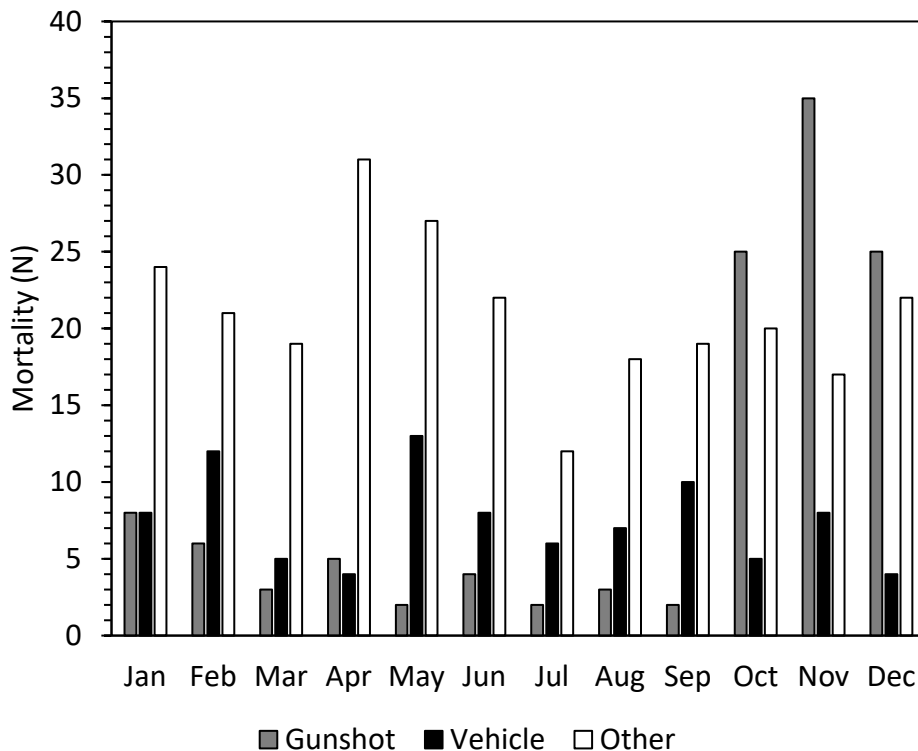
**Figure 83: Red wolf mortality (1988 through 2021,  $N_{\text{total}}=462$ ) by month because of gunshots, vehicle strikes, and other causes.**

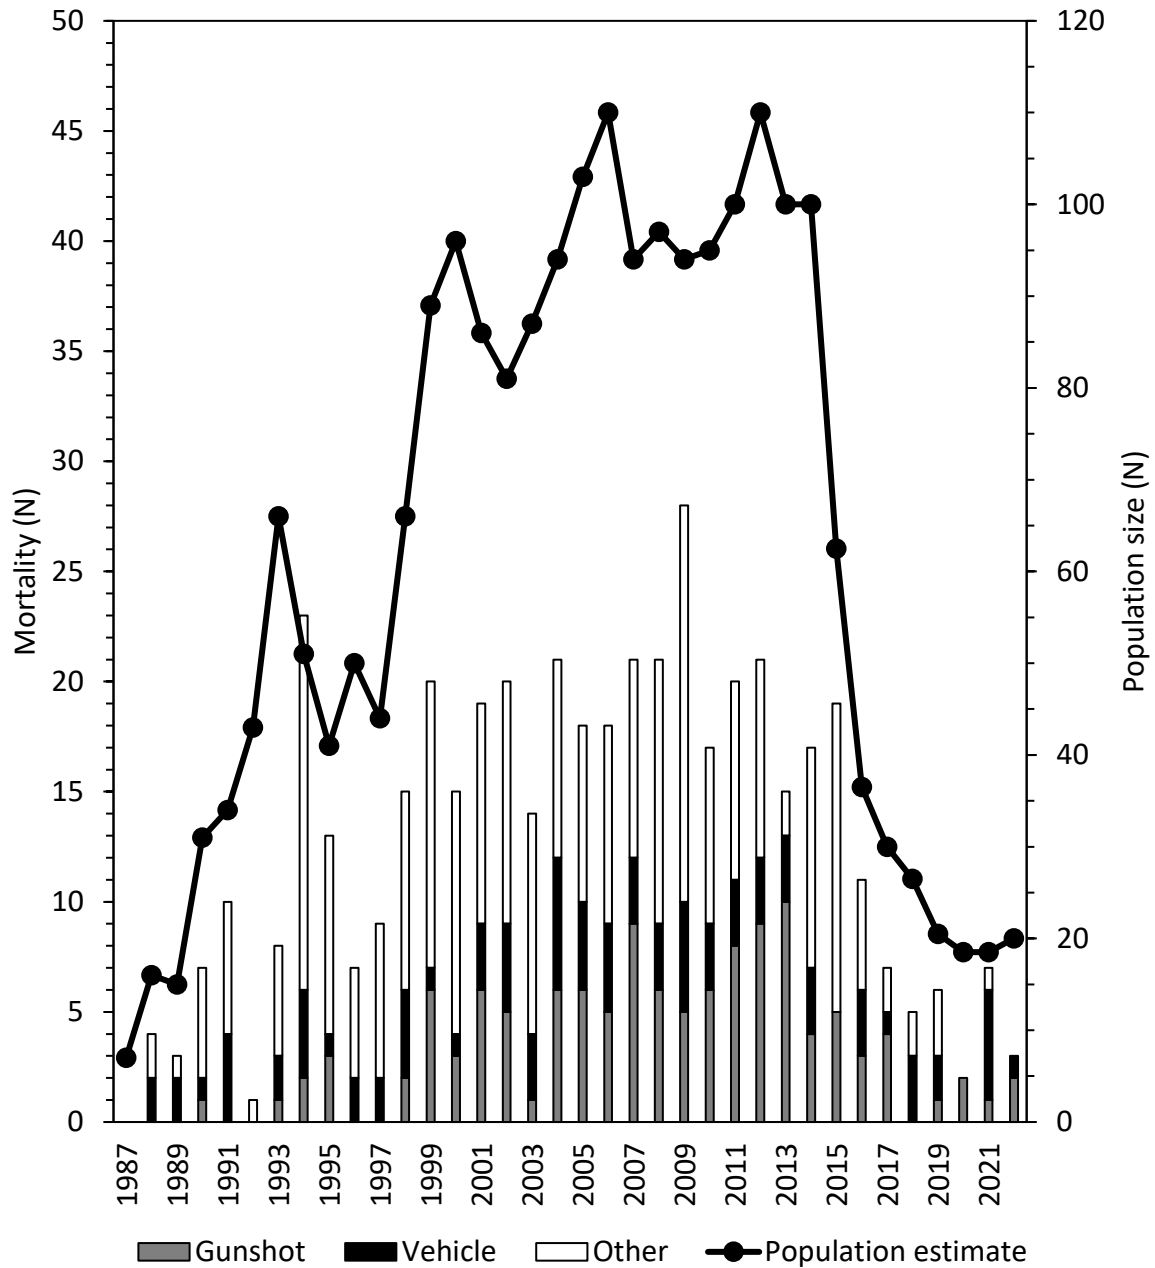
**Figure 84: Annual mortality because of gunshots, vehicle strikes, and other causes between 1987 and 2022 (bars in the graph) and the estimated population size for each year (end of year) for the red wolf (line in graph).**

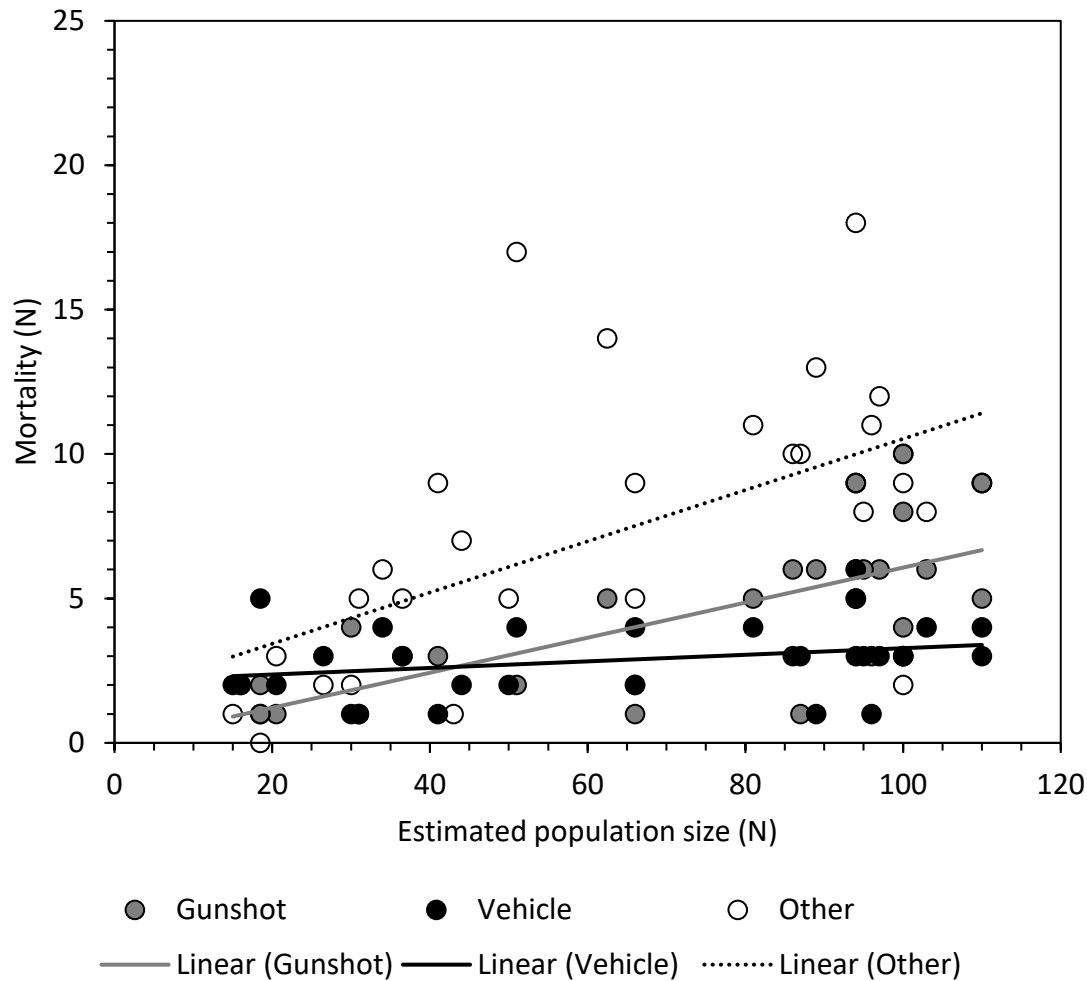
**Figure 85: Absolute mortality (N) because of gunshots, vehicle strikes and other causes in relation to the population size of the red wolf. If a regression line is shown for a response variable, the relationship is significant ( $P \leq 0.05$ ) (see Table 6).**

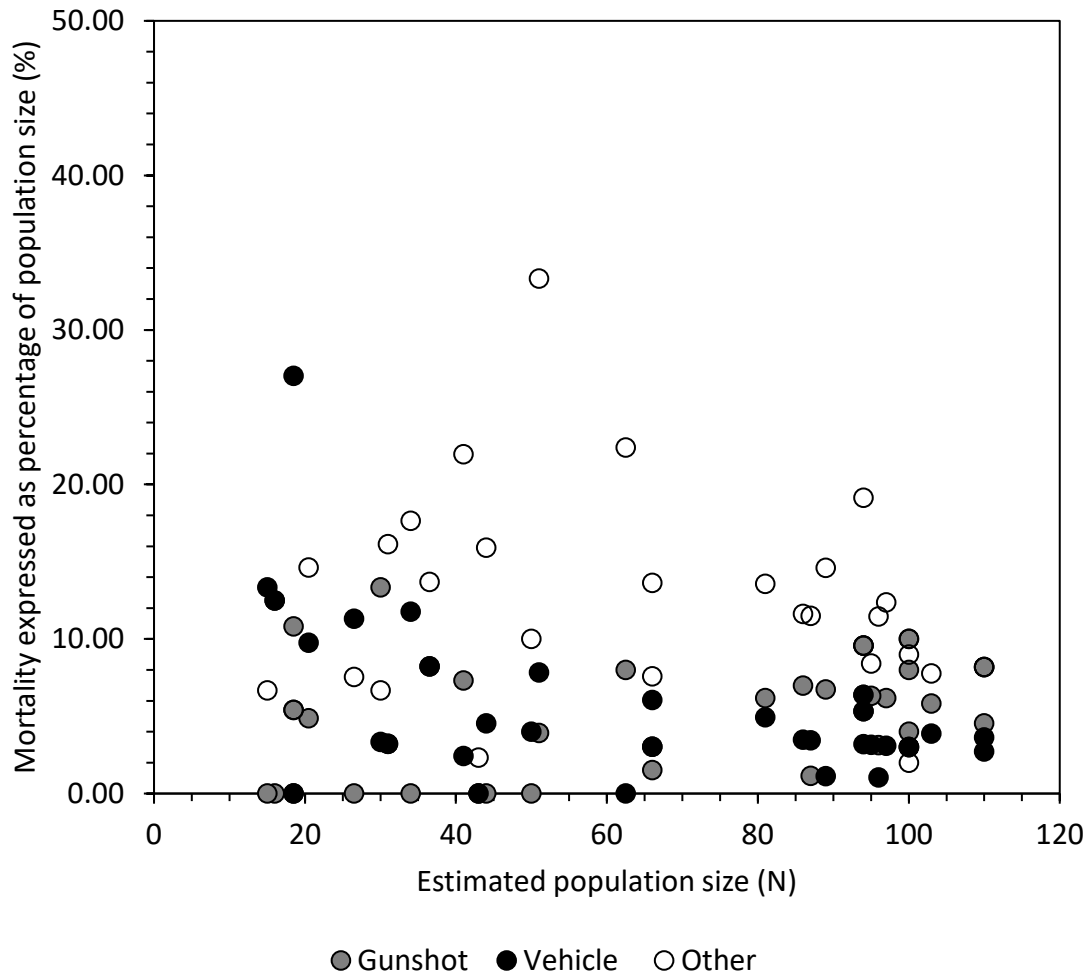
**Figure 86:** Mortality because of gunshots, vehicle strikes, and other causes expressed as a percentage of the total population size, in relation to the population size of the red wolf. If a regression line is shown for a response variable, the relationship is significant ( $P \leq 0.05$ ) (see Table 7).
